# GROUNDWATER MONITORING REPORT

## First Quarter 2016

Department of Ecology VCP ID #: SW1479  
Facility ID: 1794148; Cleanup Site ID: 5266

5603 North Waterfront Drive  
Tacoma, Washington 98407

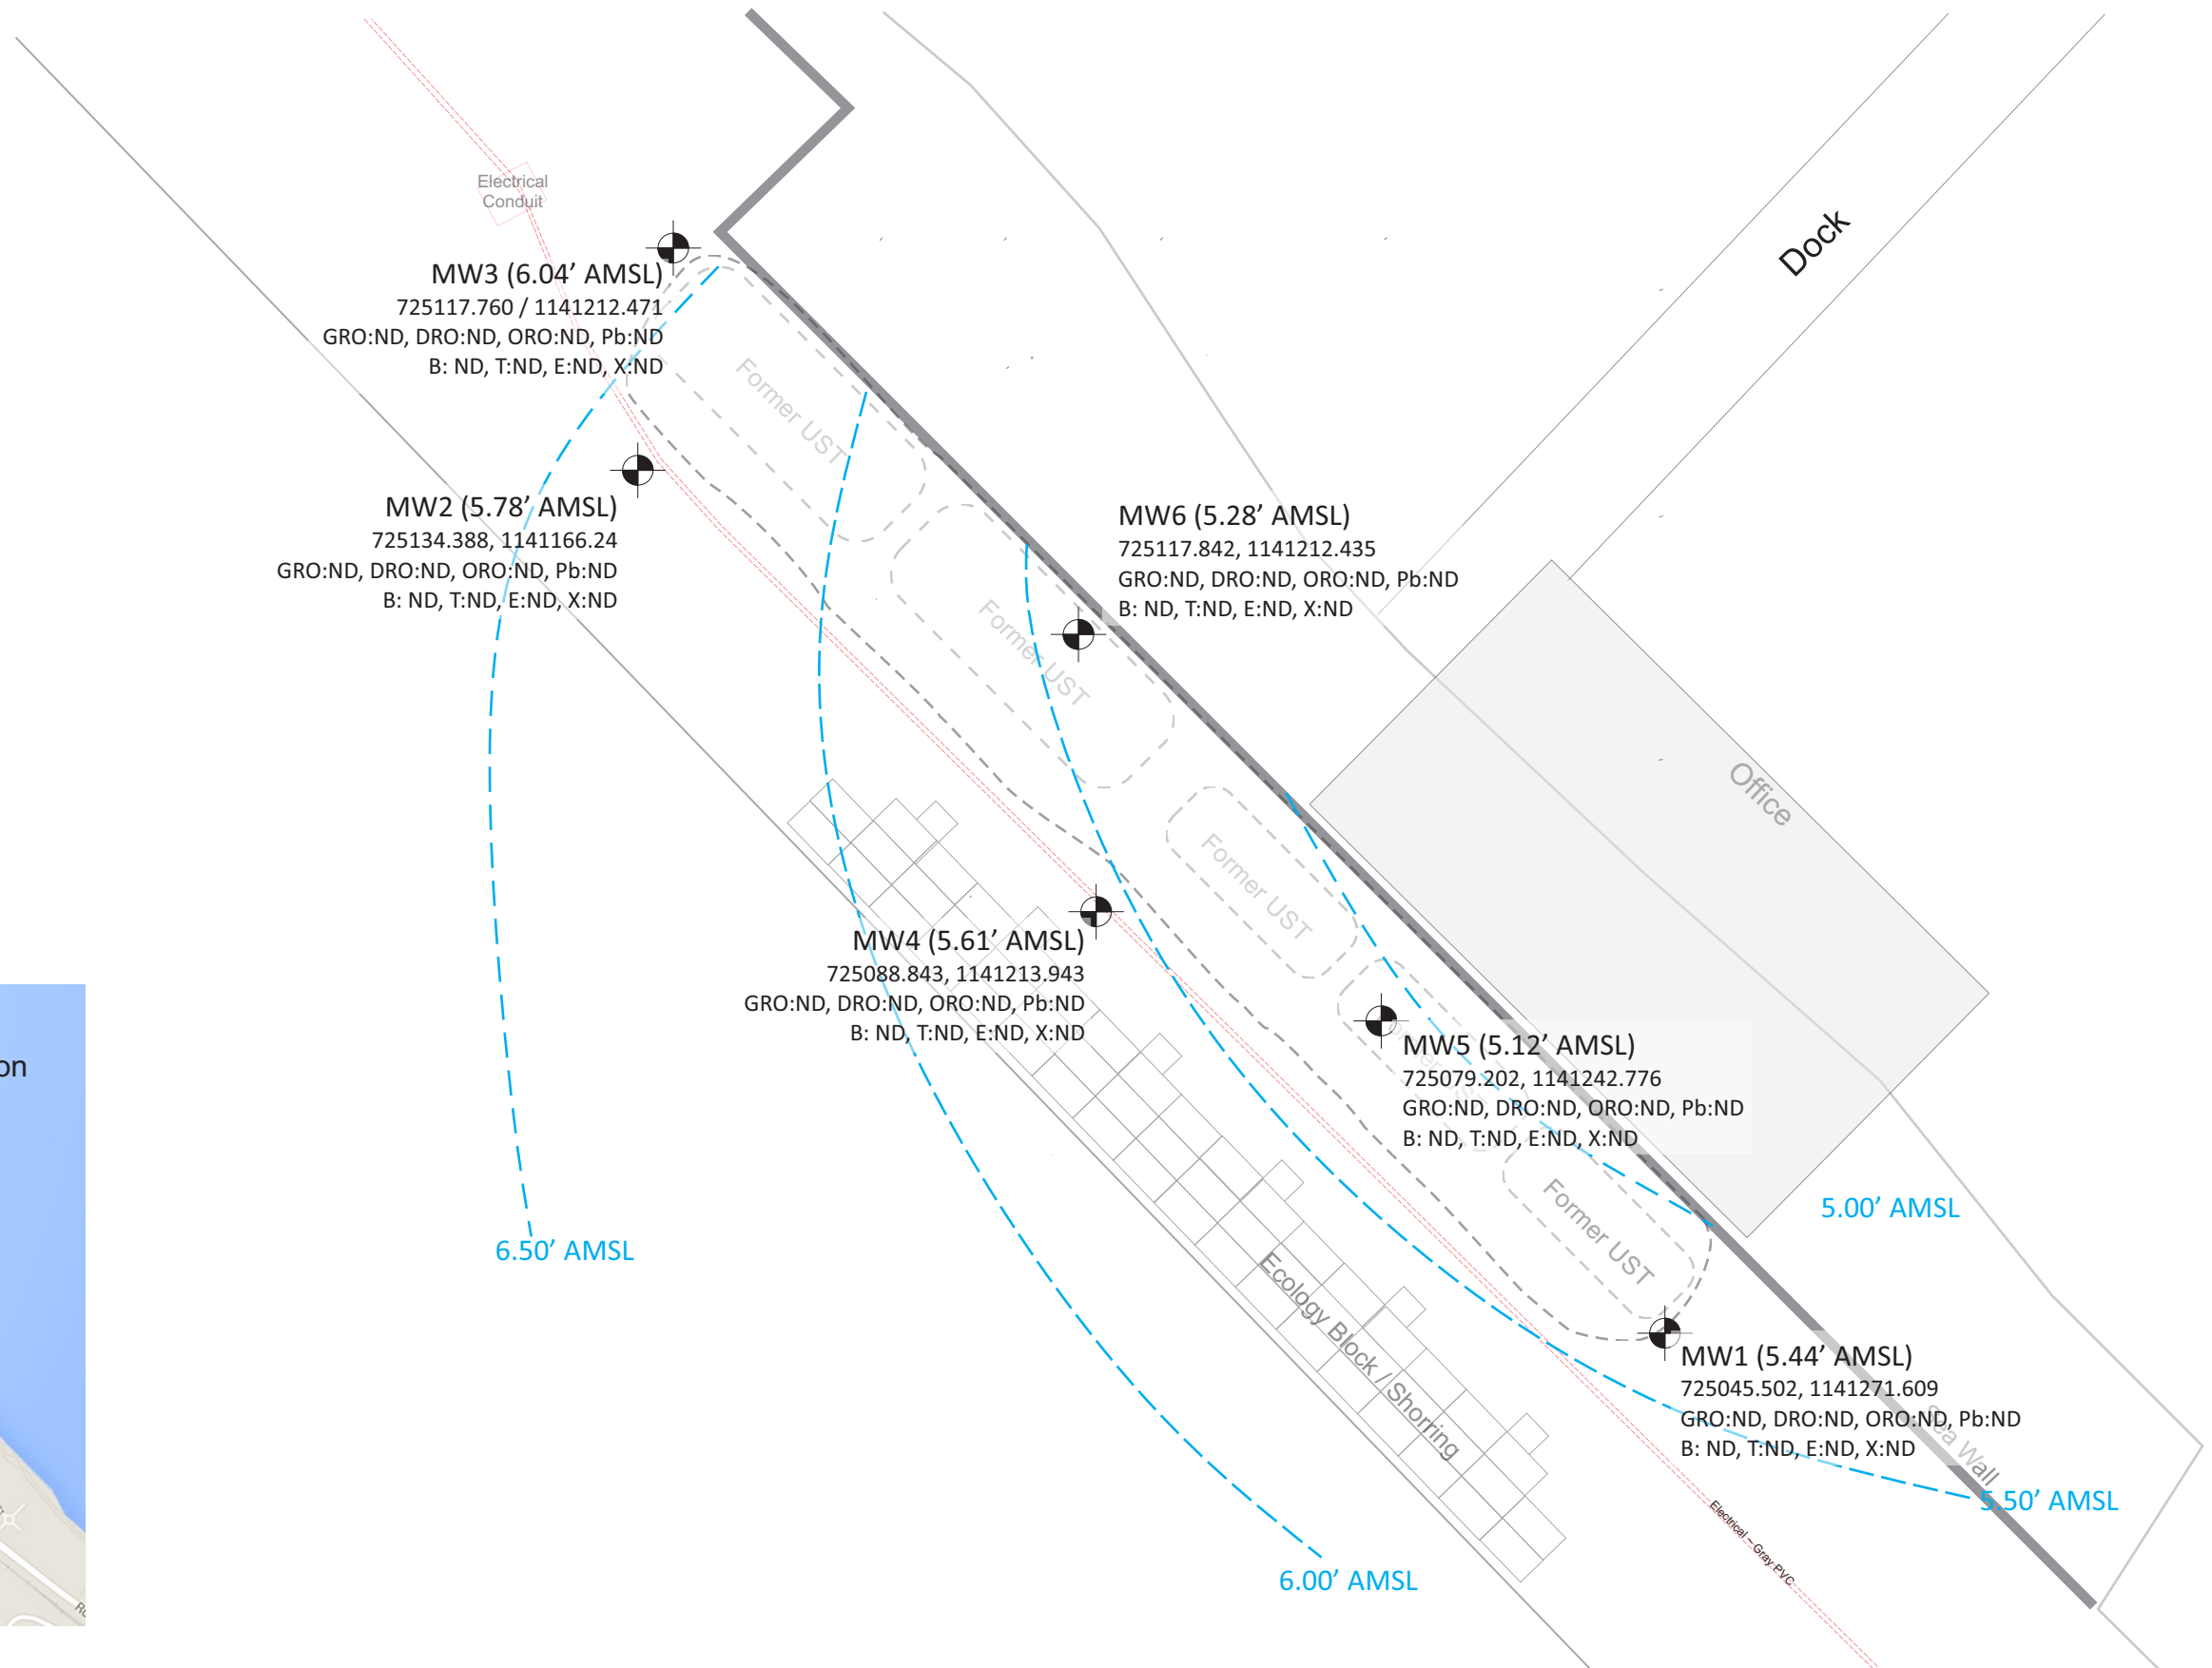
**Groundwater Monitoring Well Location Map & Sample Results**  
 Groundwater Monitoring Project - 1st Quarter 2016  
 5603 North Waterfront Drive  
 Tacoma, Washington

Groundwater flow appears to be toward the north and northeast at an approximate gradient of 0.01 feet/foot (Appendix A, Figure 3). During the August 2015 sampling event the groundwater appeared to flow to the east-southeast. The difference in groundwater flow direction appears to be a result of tidal influence. During the August 2015 sampling event, the tide was rising (coming in) and the groundwater flow was moving with the tide toward the southwest. During the November 2015 sampling event, the tide was falling (going out) and the groundwater flow was moving with the tide to the north and northeast.

**MW3 (6.04' AMSL)**  
 725117.760 / 1141212.471  
 GRO:ND, DRO:ND, ORO:ND, Pb:ND  
 B: ND, T:ND, E:ND, X:ND

**MW2 (5.78' AMSL)**  
 725134.388, 1141166.24  
 GRO:ND, DRO:ND, ORO:ND, Pb:ND  
 B: ND, T:ND, E:ND, X:ND

**MW6 (5.28' AMSL)**  
 725117.842, 1141212.435  
 GRO:ND, DRO:ND, ORO:ND, Pb:ND  
 B: ND, T:ND, E:ND, X:ND

**MW4 (5.61' AMSL)**  
 725088.843, 1141213.943  
 GRO:ND, DRO:ND, ORO:ND, Pb:ND  
 B: ND, T:ND, E:ND, X:ND

**MW5 (5.12' AMSL)**  
 725079.202, 1141242.776  
 GRO:ND, DRO:ND, ORO:ND, Pb:ND  
 B: ND, T:ND, E:ND, X:ND

**MW1 (5.44' AMSL)**  
 725045.502, 1141271.609  
 GRO:ND, DRO:ND, ORO:ND, Pb:ND  
 B: ND, T:ND, E:ND, X:ND
