STATE OF WASHINGTON  
DEPARTMENT OF ECOLOGY

August 1, 2016

**Re: Opinion pursuant to WAC 173-340-515(5) on Proposed Remedial Action for the following Hazardous Waste Site:**

- **Name:** Taqueria El Rinconsito
- **Address:** 301 Central Avenue N, Kent
- **Facility/Site No.:** 3502
- **Cleanup Site ID No.:** 12421
- **VCP No.:** NW3034

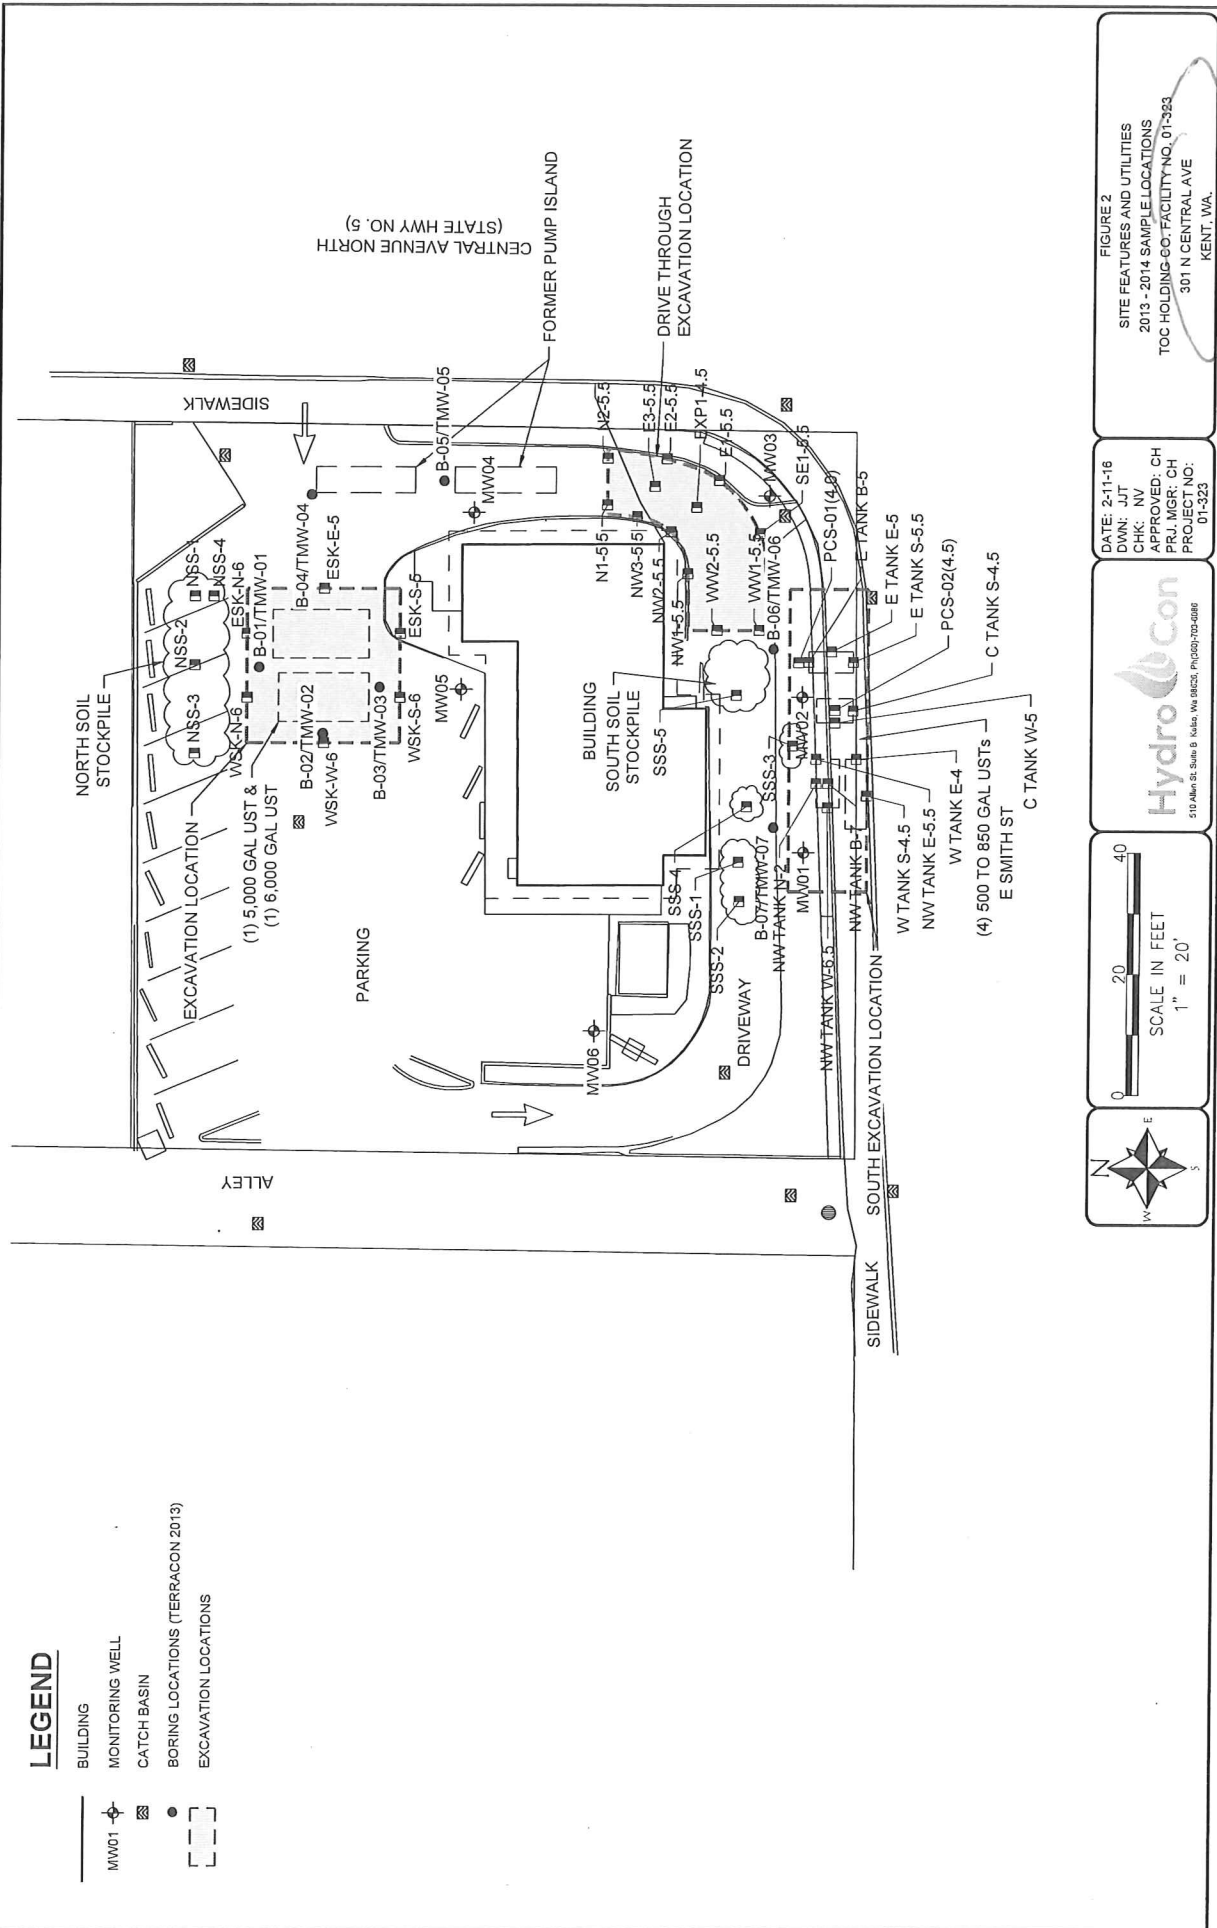
FIGURE 2  
 SITE FEATURES AND UTILITIES  
 2013 - 2014 SAMPLE LOCATIONS  
 TOC HOLDING CO. FACILITY NO. 01-393  
 301 N CENTRAL AVE  
 KENT, WA.

The potential petroleum sources at the Property include a 6,000 gallon and a 5,000 gallon UST in the northeast area and four USTs with capacities between 500 to 800 gallons in the area south of the restaurant. Maximum reported concentrations of soil contamination at the property include 5,700 mg/kg for diesel, 14,000 mg/kg for gasoline, and 0.524 mg/kg for benzene in the south area. Oil range petroleum hydrocarbon was reported at 2,800 mg/kg at one boring near the USTs in the southeast area. There are no borings or ground water wells in the northwest area of the Property. Soil contamination appears to be localized in the south area.

Ground water contamination is identified at monitoring wells MW02 and MW03 in the south area and include high diesel, gasoline, and benzene contamination at 4,600 µg/L, 4,300 µg/L, and 8.1 µg/L, respectively. Ground water is not reported in the wells to the west (MW01), northwest (MW06), or north (MW04, MW05). Petroleum contamination appears to be localized near the former tank location in the south area.

Three soil vapor samples were collected at the south (SG01), southwest corner (SG02), and west (SG03) sides of the restaurant. Exceedances of Ecology screening levels were observed for benzene, ethyl benzene, xylene, ethyl dibromide, naphthalene, and gasoline range petroleum hydrocarbons. The highest exceedances occurred at sampling location SG02, at the southwest corner of the restaurant.
