STATE OF WASHINGTON
DEPARTMENT OF ECOLOGY

Re: Further Action at the following Site:

- **Site Name:** Shell Oil Products SAP 120877
- **Site Address:** 210 NE 45th St, Seattle, WA
- **Facility/Site No.:** 14577491
- **VCP Project No.:** NW2033

The Washington State Department of Ecology (Ecology) received your request for an opinion on your independent cleanup of the Shell Oil Products SAP 169780 facility (Site). This letter provides our opinion. We are providing this opinion under the authority of the Model Toxics Control Act (MTCA), Chapter 70.105D RCW.

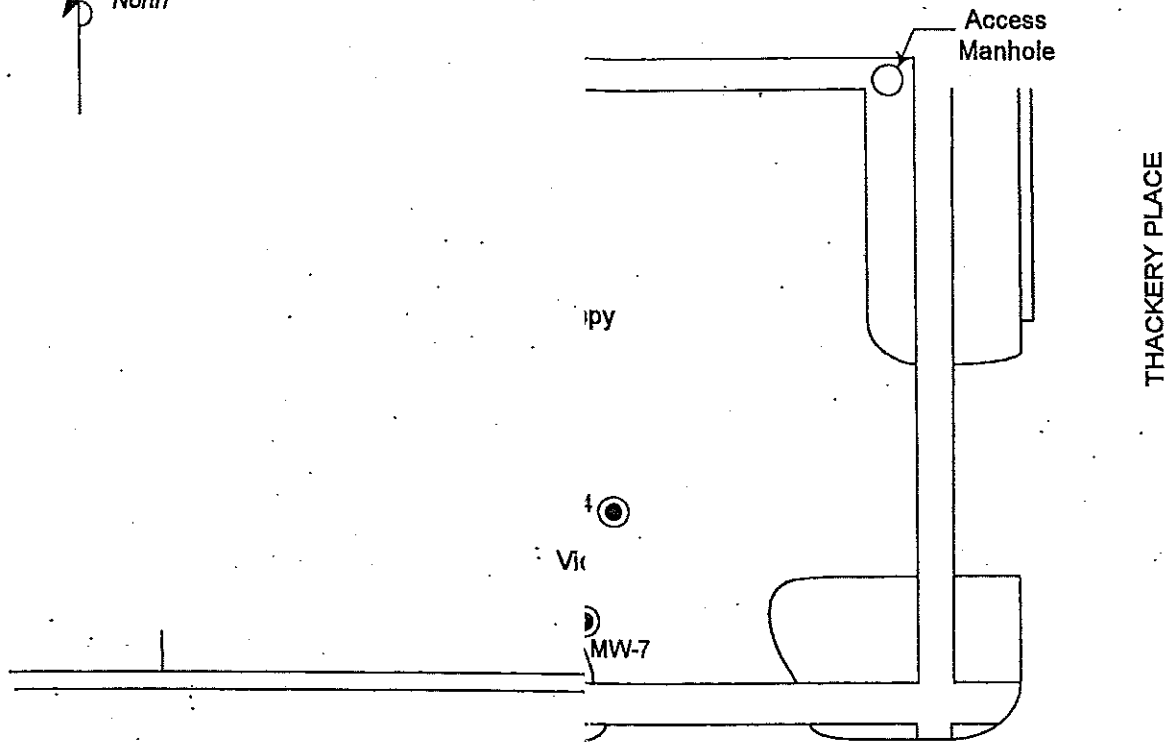
FIGURE 1
APPROXIMATE EXTENT OF IMPACTED MEDIA
Shell Oil Products US - SAP 120877
210 NE 45th STREET
SEATTLE, WASHINGTON

Site maps appear to indicate that there two unconnected areas of both soil and ground water contamination. There is no definitive determination in the reports if the areas are from the same release or different releases. This is a major discrepancy in the site

characterization work completed to date. It is noted that local utility lines surround the Property and may have provided a pathway that resulted in the contamination to the west of the Property.

TPHg, TPHd, TPHo, BTEX were detected at concentrations at or above MTCA Method A ground water cleanup levels. Ground water investigations have not bounded the lateral extent of the releases to the south of the property in the vicinity of MW-6.

The TPHg, TPHd, TPHo and BTEX released to soil and ground water most likely came from leaking product supply lines, the dispenser islands and from leaking underground storage tanks. Site maps appear to indicate that there two unconnected areas of both soil and ground water contamination. There is no definitive determination if the areas are from the same release or different releases. This is a major discrepancy in the site characterization work completed to date.

Various cleanup actions conducted at the Site consisted of the removal of the UST's and excavation and removal of approximately 300 cubic yards of contaminated soil, installation of a soil vapor extraction (SVE) system, ground water extraction and treatment, injection of oxygen releasing compounds (ORC), and enhanced bioremediation injections. However, petroleum contamination of soil and groundwater still remains on the property and extends south across 45th St. The full lateral and vertical extent of the contamination has not been defined.

Ecology has determined your characterization of the Site is not sufficient to select a cleanup action for the Site. Additional sampling is required to determine the lateral and vertical extent of ground water contamination. The Site is described above and in **Enclosure A**.
