STATE OF WASHINGTON DEPARTMENT OF ECOLOGY

Re: Further Action at the following Site:

• Site Name: Morrells Dry Cleaning

Site Address: 608 North 1st Street, Tacoma, Washington 98403

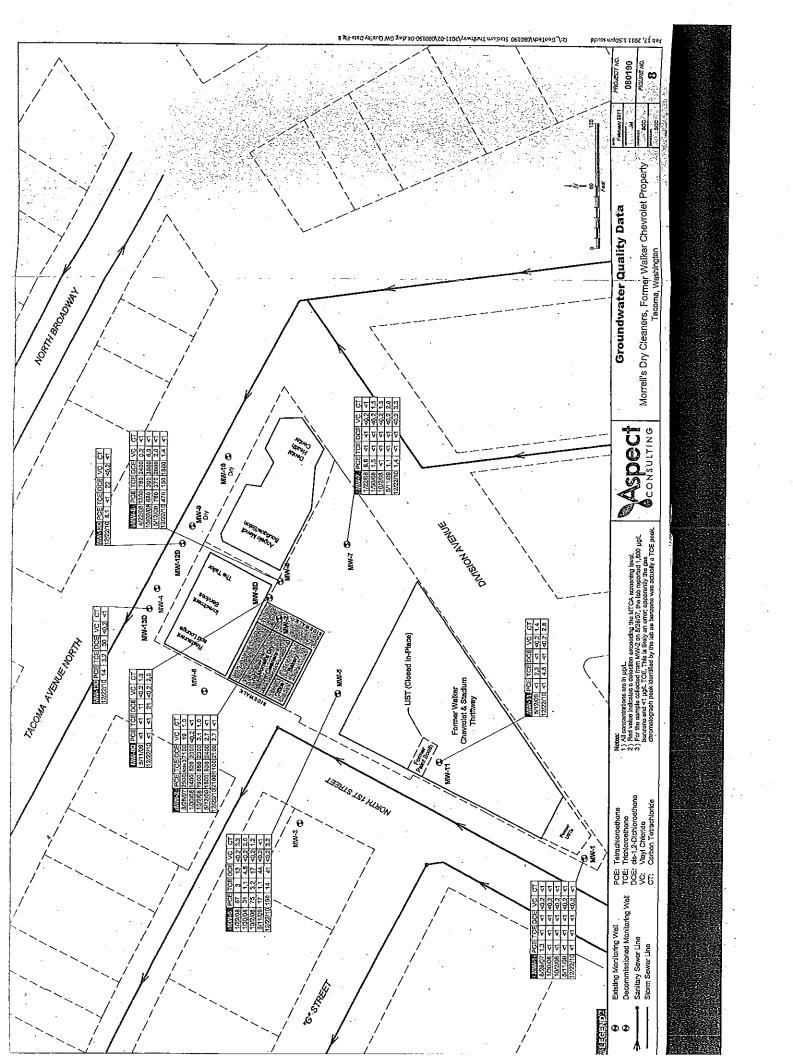
From October 2008 to present, Aspect conducted groundwater sampling and analysis. In May 2009, Aspect installed four additional monitoring wells, MW-8D, MW-9, MW-10, and MW-11. MW-9 and MW-10 were installed to approximately 70 feet bgs and did not produce groundwater in sufficient quantities to collect groundwater samples for analysis. These two wells, along with MW-3, MW-4, and MW-6, appeared to locally define the northern and eastern limits of the perched aquifer (see Figure 7). MW-11 was installed to a depth of approximately 70 feet bgs on the Titus parcel, up gradient of the dry cleaner parcel. Groundwater was found at approximately 50 feet bgs in the perched aquifer. MW-8D was installed to a depth of approximately 116 feet bgs between MW-2 and MW-8. The well was installed through the confining layer and into the lower aquifer, where groundwater was found at approximately 112 feet bgs. The constituents of concern (COCs) were compared to their respective MTCA Method A (or Method B*) Groundwater Cleanup Level (CUL) and were identified as PCE, TCE, DCE', vinyl chloride, and carbon tetrachloride. The highest concentrations of PCE, TCE, DCE*, and vinyl chloride were 2,900 μg/L, 1,100 μg/L, 7,100 μg/L, and 19 μg/L, respectively, and were found in the groundwater from MW-2, indicating a potential source from beneath the dry cleaner. The MTCA Method A (or Method B') Groundwater CULs are 5 μg/L, 5 μg/L, 16 μg/L, and 0.2 μg/L, respectively. PCE and TCE were detected above their respective MTCA Method A CULs in MW-5 and MW-7. Carbon tetrachloride was also detected in MW-5, MW-7, MW-11, and in the deeper well MW-8D, all located up gradient from the Site on the Titus parcel at similar concentrations. No apparent source for this COC has yet been identified (see Figure 8 and Table 2).

In October 2010, Aspect installed two more monitoring wells in Tacoma Avenue North, northwest of MW-9 and MW-10. The wells, MW-12D and MW-13D, were installed to investigate and delineate the VOC contamination in the deep aquifer north of the dry cleaner parcel. In November 2010, all network wells were monitored using passive diffusion bags; the analytical results were consistent with previous analytical results. Low concentrations of PCE, TCE, and DCE were detected above their respective MTCA CULs in both MW-12D and MW-13D (see Figure 8 and Table 2).

- 2. Ecology believes the perched aquifer has been fully defined. The lower aquifer contamination has yet to be fully delineated. Stemen found total lead in the groundwater near MW-2 in September 2008 and it has not been evaluated for since. Ecology recommends an additional deep well be installed at a down gradient location to better define the PCE plume. The COCs for groundwater will be PCE, TCE, DCE, vinyl chloride, benzene, toluene, ethylbenzene, and total xylenes (BTEX), naphthalene, and metals (total lead).

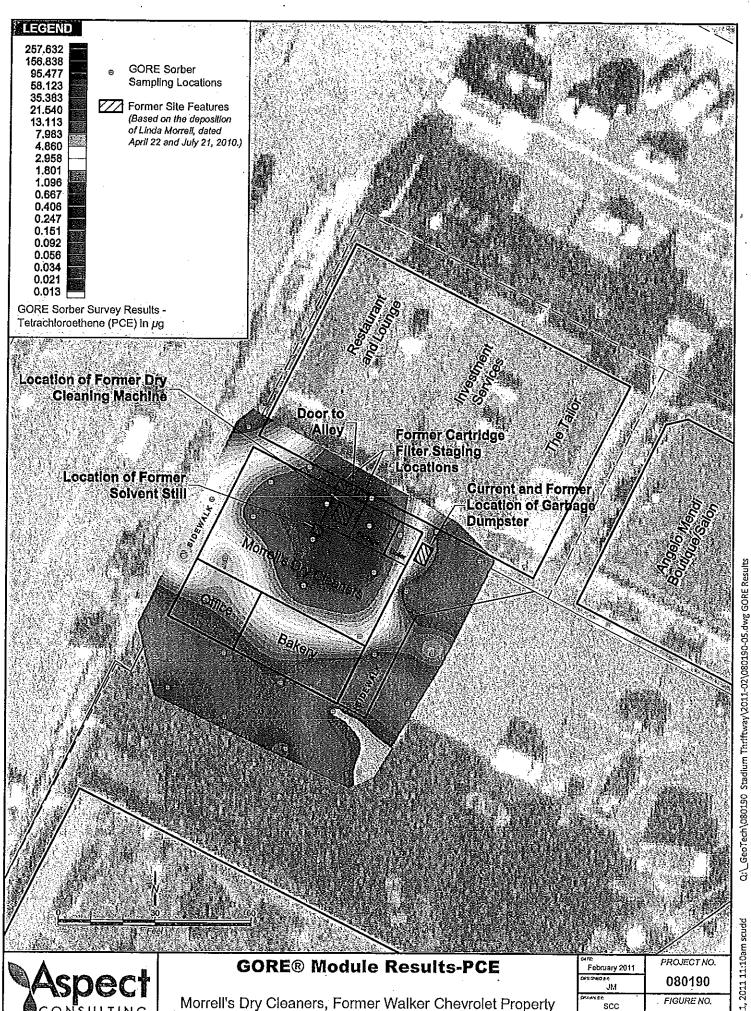
In January 2010, Aspect conducted a soil gas survey at the Site using Gore® passive diffusion modules (PDFs) emplaced underneath the building floor slab, sidewalk, and parking lot. Analysis of the modules indicated that PCE, TCE, DCE, and trans-1,2-dichloroethene were present at elevated concentrations. Contoured results indicated areas of PCE mass near suspected sources of contamination (see Figure 9).

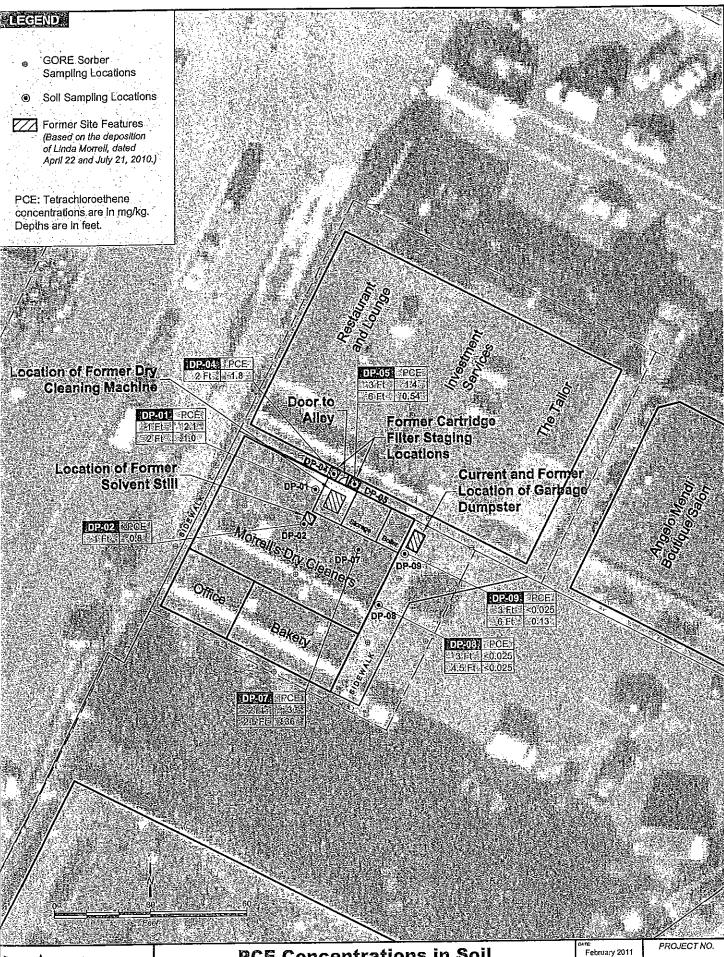
Q:_GeoTech\080190 Stadium Thriftway\2011-02\080190-05.dwg PCE in Soll

In October 2010, Aspect conducted soil sampling activities based on the Gore® PDF results. COCs detected were PCE, TCE, and DCE at concentrations exceeding their respective MTCA CULs. The soil analytical results were generally consistent with the Gore® PDF results, indicating potential source locations under the former PCE dry cleaning machine, solvent still, and filter storage area outside the door to the alley on the north side of the building (see Figure 10 and Table 3).

- 1. The vertical extent of the PCE and TCE present in the Site soil has not been fully delineated. Soil contamination above the applicable MTCA Method A Soil CUL below 6 feet bgs is undefined. Naphthalene was detected above its MTCA CUL; the full horizontal extent of this contamination has not been delineated and no discussion on potential sources occurred in the February 2011 report. Total lead was detected in groundwater from DC PLAS-2-W (near MW-2); no analytical soil data for metals was presented for review and no discussion or speculation on potential sources was included in any previous report. The vertical and horizontal extent of soil contamination needs to be delineated. The soil COCs for further analysis are PCE, TCE, DCE, vinyl chloride, benzene, toluene, ethylbenzene, and total xylenes (BTEX), naphthalene, and metals (lead).
