PERIODIC REVIEW

**Pacific Propeller
Facility Site ID#: 75316173**

**5802 South 228th Street,
Kent, Washington**

October 2016

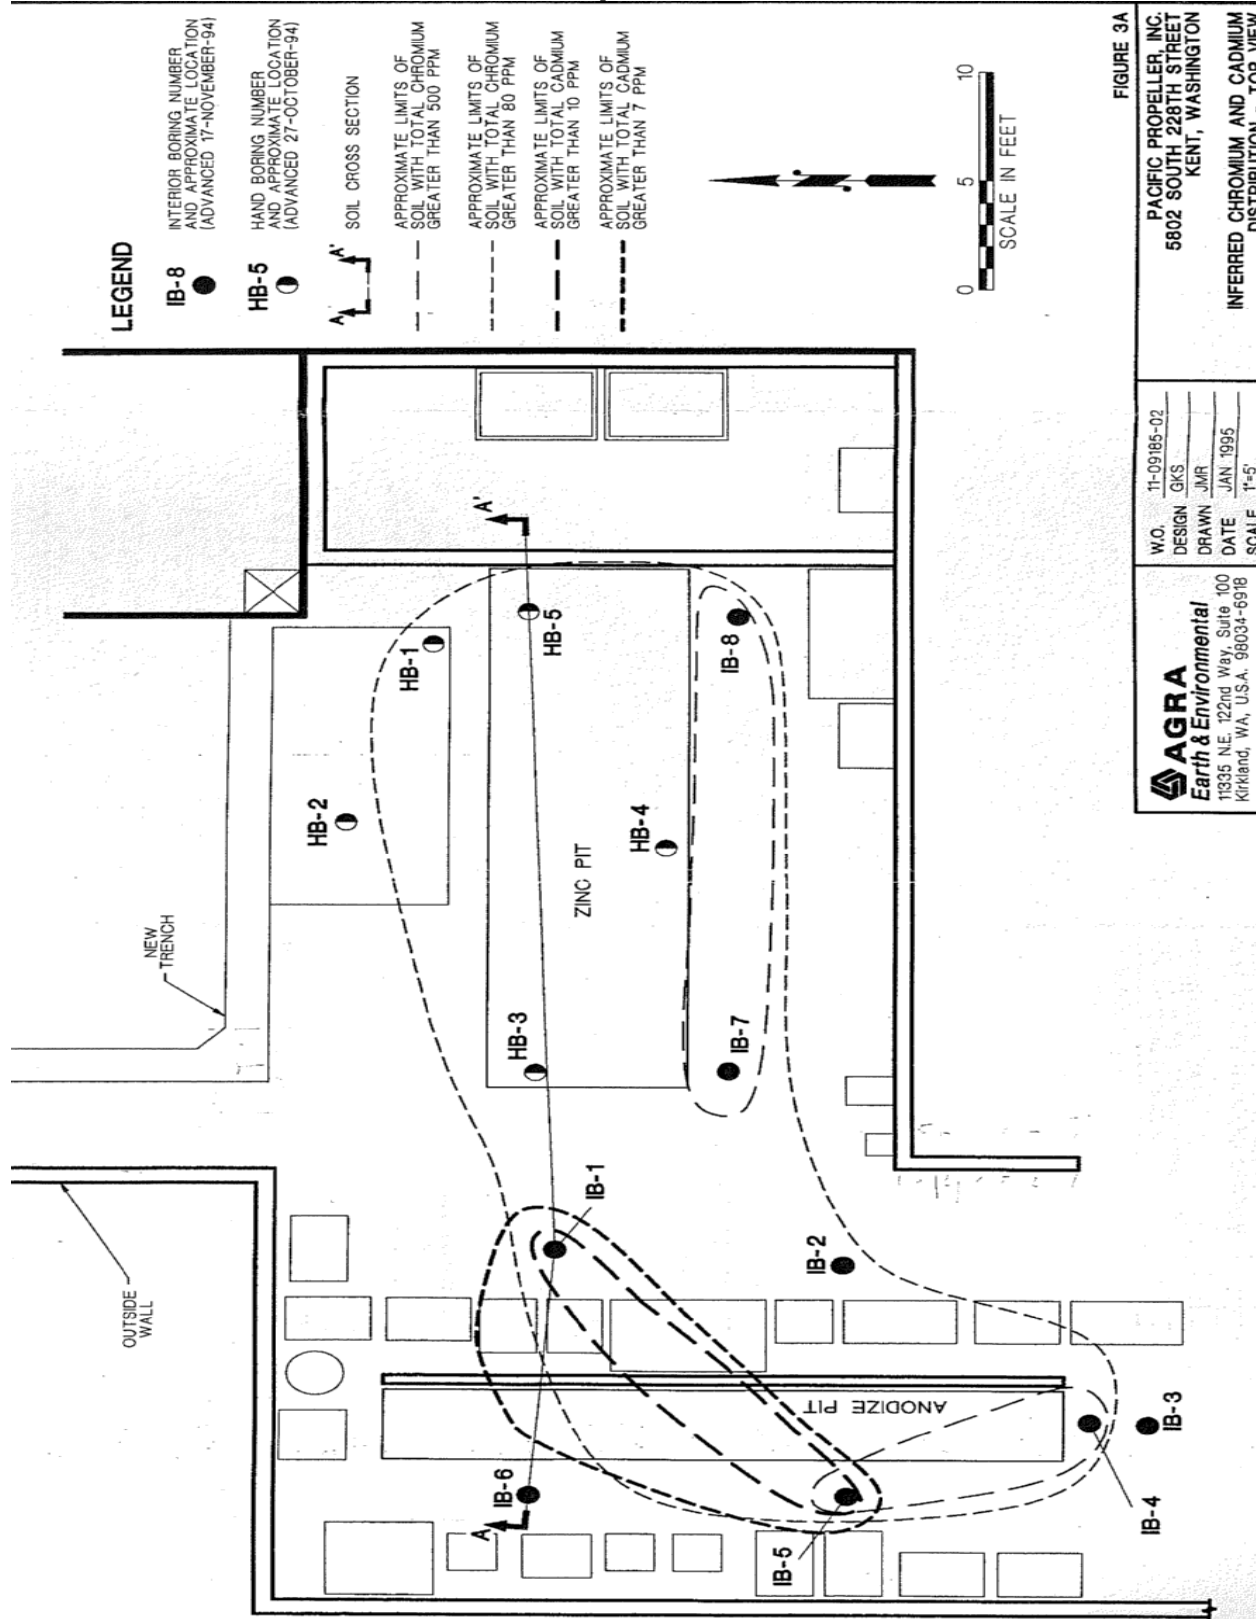
6.3 Contaminant Distribution Map

Chemical analysis of soil samples identified only chromium and cadmium in excess of background levels and cleanup standards in the ground around the bottom of the plating department pits. A complete Phase I/II Environmental Site Assessment of the entire property of both soil and groundwater revealed that no other contamination exists on the property.

All contamination is associated with the plating pits and at a level that is consistent with the seam at the bottom of the Zinc Pit and seepage from the Anodize Pit. Note that lateral migration is the primary mechanism of metal movement; contamination did not travel significantly above or below the depth at which it was released from a pit.

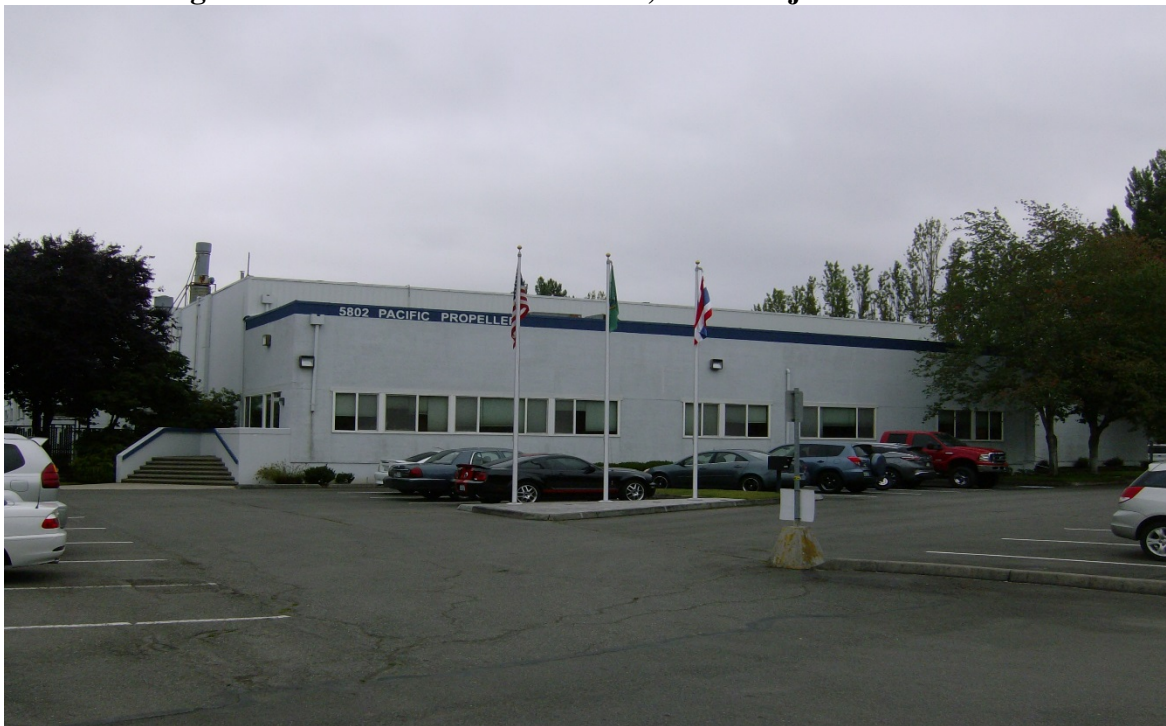
Photo 1: Building view from 228th Street direction, entrance just around left side

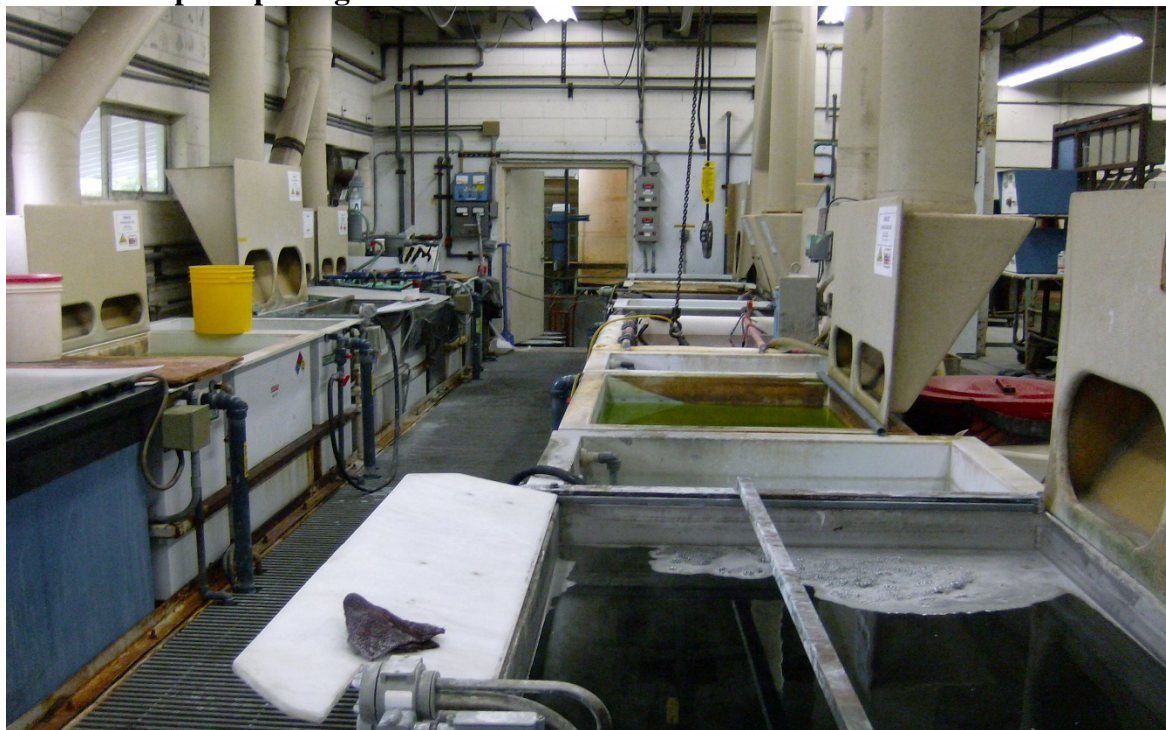
Photo 2: Small parts plating area was excavated

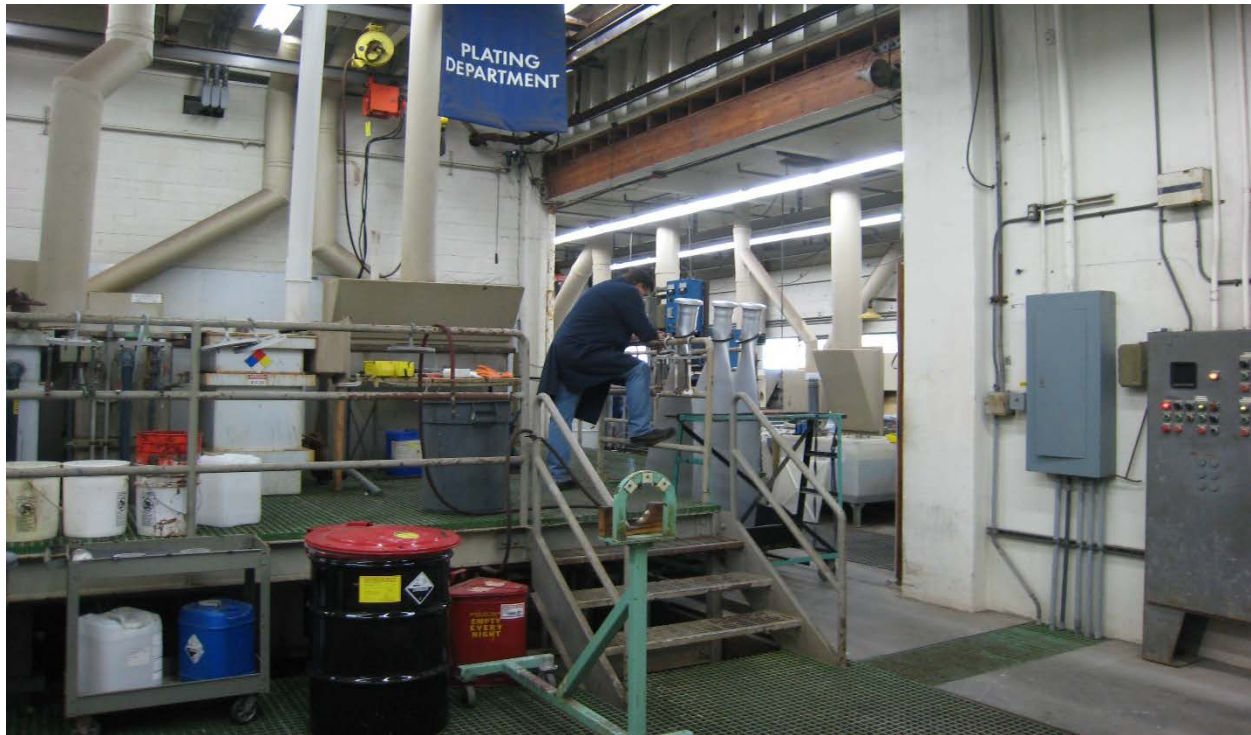
Photo 3: Raised platform in plating area, over containment

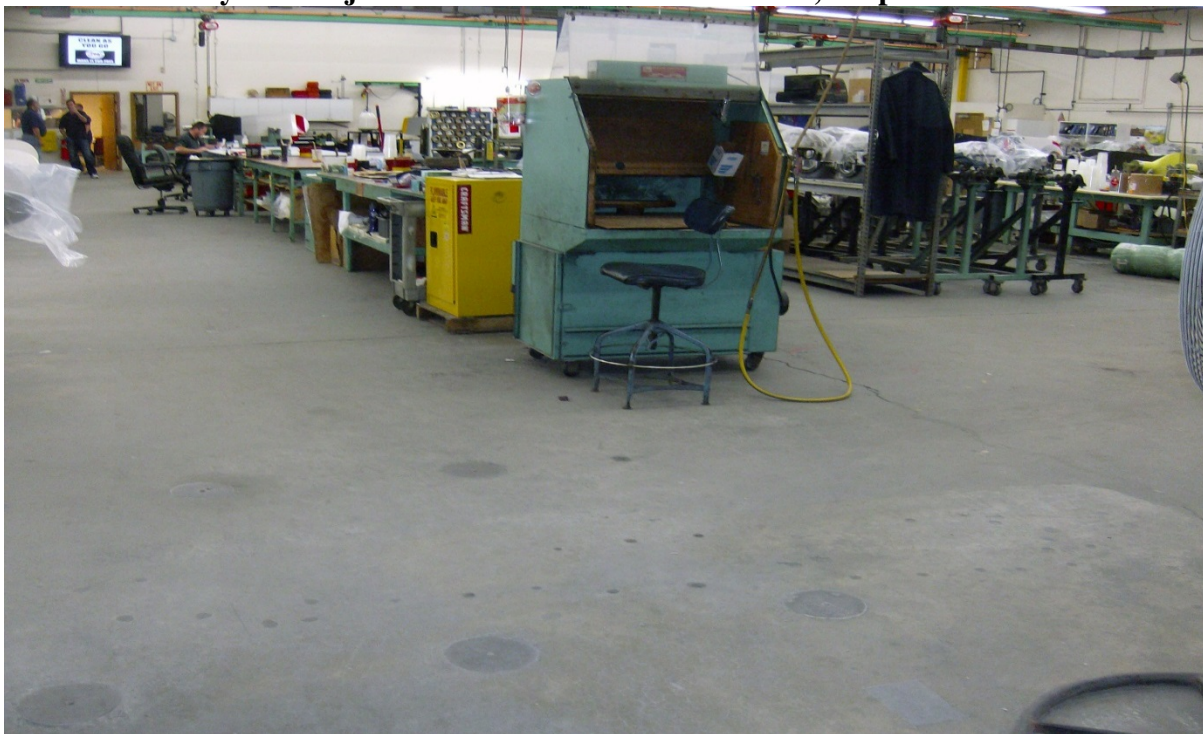
Photo 4: Assembly area adjacent to excavated area to the left, off-picture.
