MEMO

Date: May 14, 2009 ARCADIS Project No.: B0045362.0001

Subject: Unocal Edmonds Bulk Fuel Terminal Willow Creek Restoration: As-built Report and Monitoring Plan

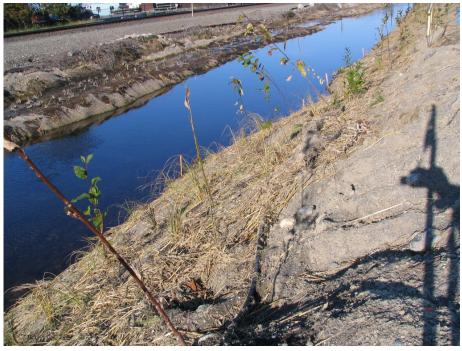
Photo 1. Plot 1

Table 4. Plot 1 (Dimensions: 20 ft x 20 ft)

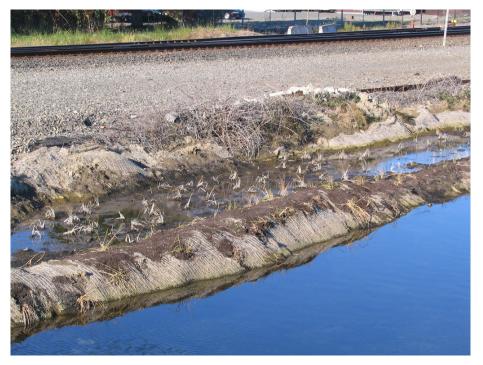
Photo 3. Plot 3

Table 6. Plot 3

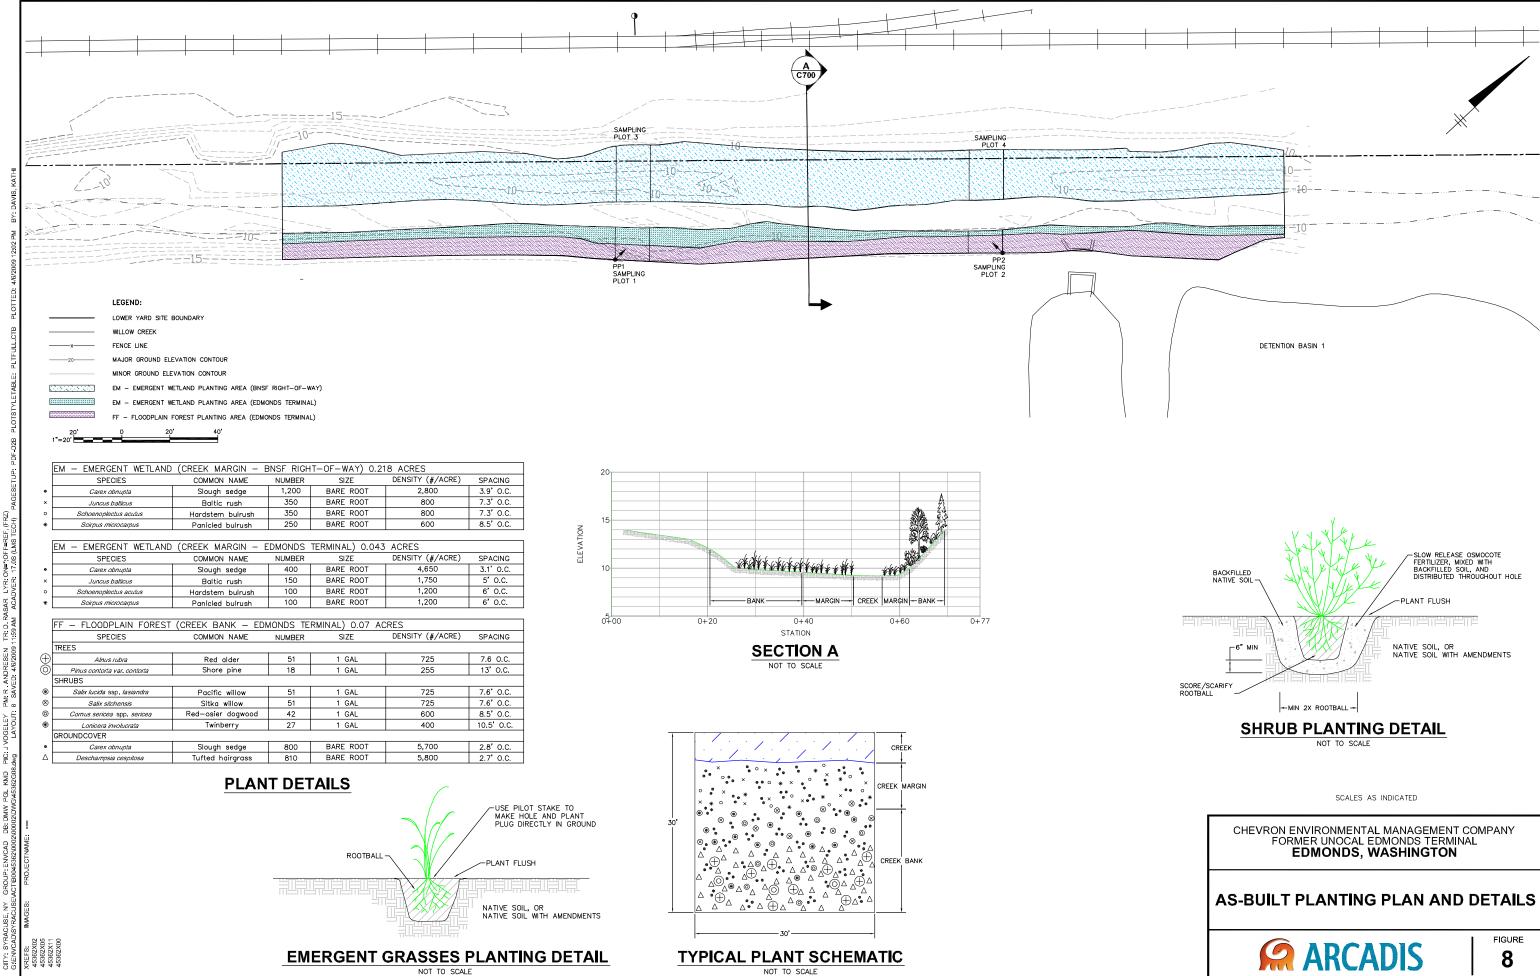
As-built Planting Plan and Details Figure 8 – Phase II As-built Report

Planting of the riparian corridor was conducted over a seven-day period by a team of 5 - 7 people and was completed on September 26, 2008. The final planting plan is shown in Figure 8 – As-Built Planting Plan and Details of the Phase II As-built Report (Attached). Changes from the initial planting plan are described below.

The final density for each species diverged from the original plan. Due to bulk ordering requirements, the total number of plants ordered per species varied. Groundcover species in the Floodplain Forest on the Edmonds Terminal side of the creek were planted at different numbers than originally specified. The final density for each species increased or decreased accordingly. Final densities are included in Figure 8.

Two permanent vegetation plots, Plots 1 and 2, were selectively placed on the Edmonds Terminal side. The location of these plots is shown in Figure 8. Each plot is 20 feet long and extends from the top of the slope down to the creek. These two plots will represent approximately 10% of the revegetated riparian area and will provide a good indicator of the status of the entire restored area. The vegetation plots will be monitored for species composition, survivorship, percent cover, and general health and vigor. Plots 3 and 4 are located immediately opposite Plots 1 and 2 in the Emergent Wetland in the BNSF right-of-way as shown in Figure 8. If access is available at low tide, Plots 3 and 4 will be monitored for the same above parameters. Due to the removal of the coffer dams, and the potential walking hazards of crossing the creek, access is not anticipated. When access to Plots 3 and 4 is not available, vegetation will only be visually monitored for general health and vigor.
