## **PERIODIC REVIEW**

**Park 90/5 Office Park,  
now Airport Way Office Park  
Facility Site ID#: 76316149**

**2203 Airport Way South,  
Seattle, Washington**

**November 2016**

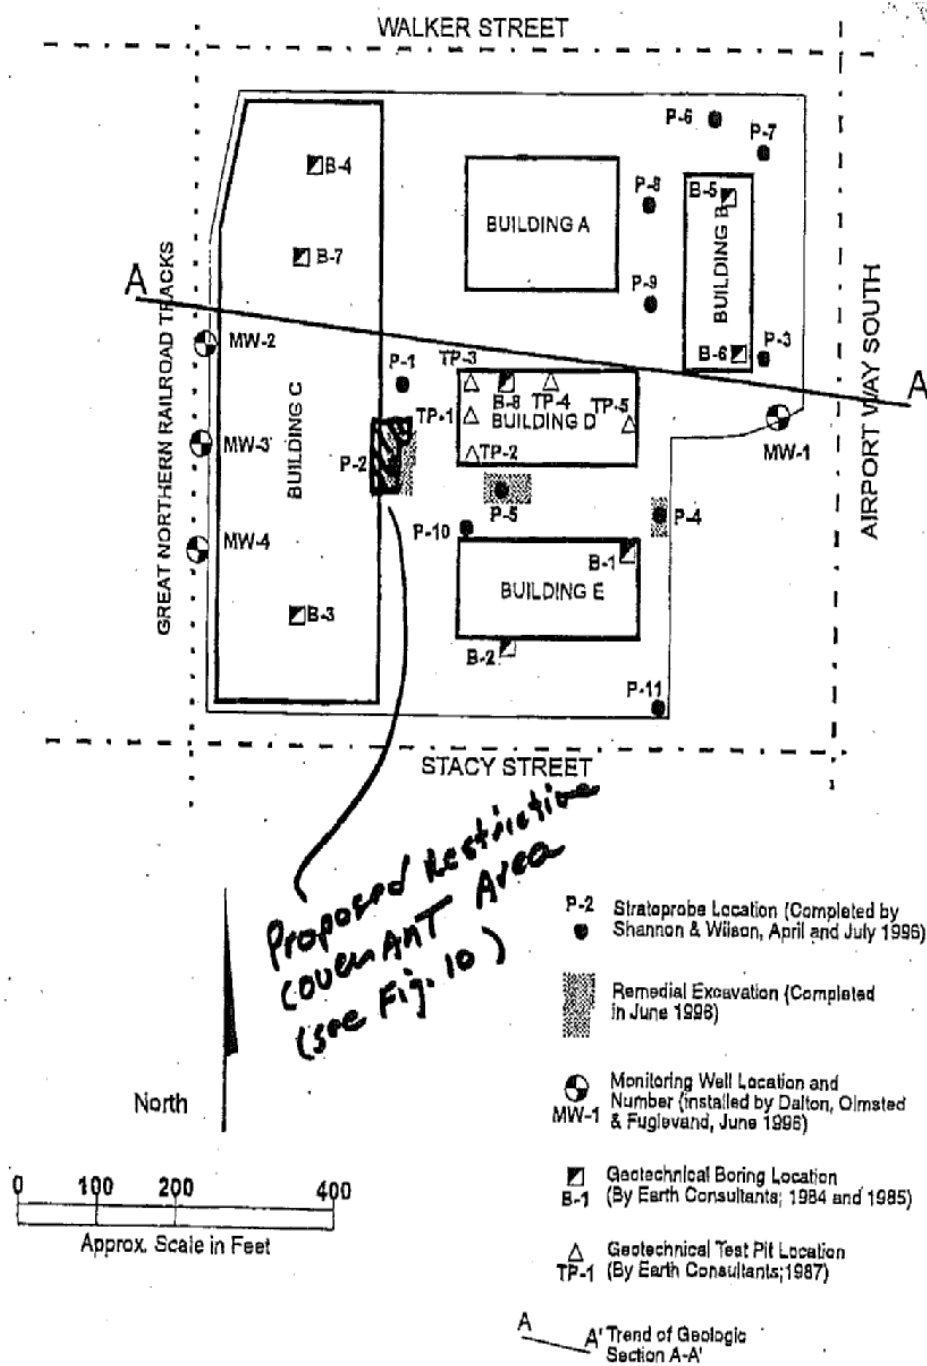
SAB-C04 **FIGURE 4** October 1996  
Dalton, Olmsted & Fuglevand, Inc.

Section 1. A portion of the Property contains petroleum hydrocarbon contaminated soil located under the southeast side of Building C, as shown on attached Figures #4 and #10. The City shall not alter, modify, or remove the existing structure (Building C) in any manner that may result in the release or exposure to the environment of that contaminated soil or create a new exposure pathway without prior written approval from Ecology.

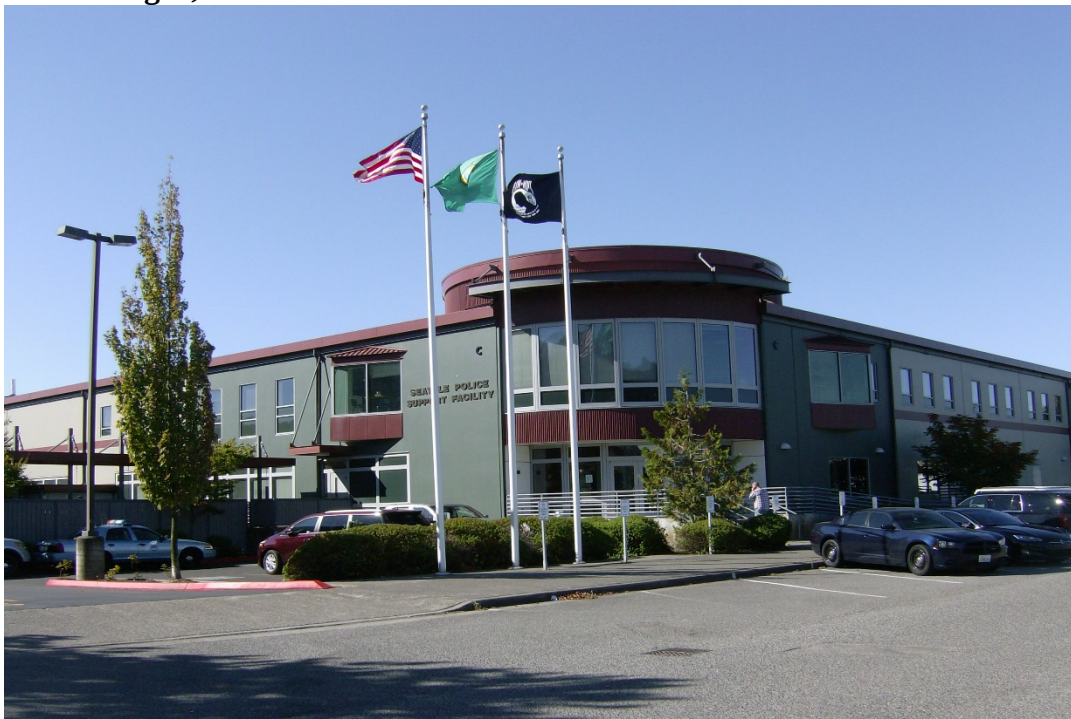
**Photo 1: Building C, north end - from the east**

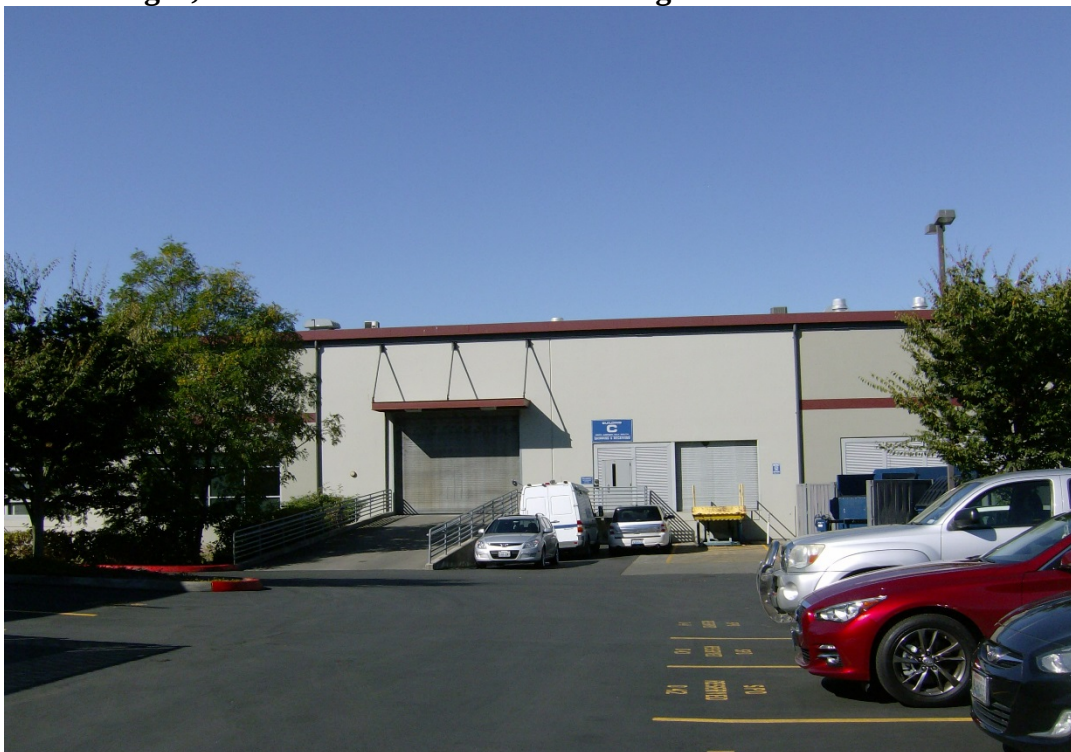
**Photo 2: Building C, covenant area on other side of vegetation - from the southeast**

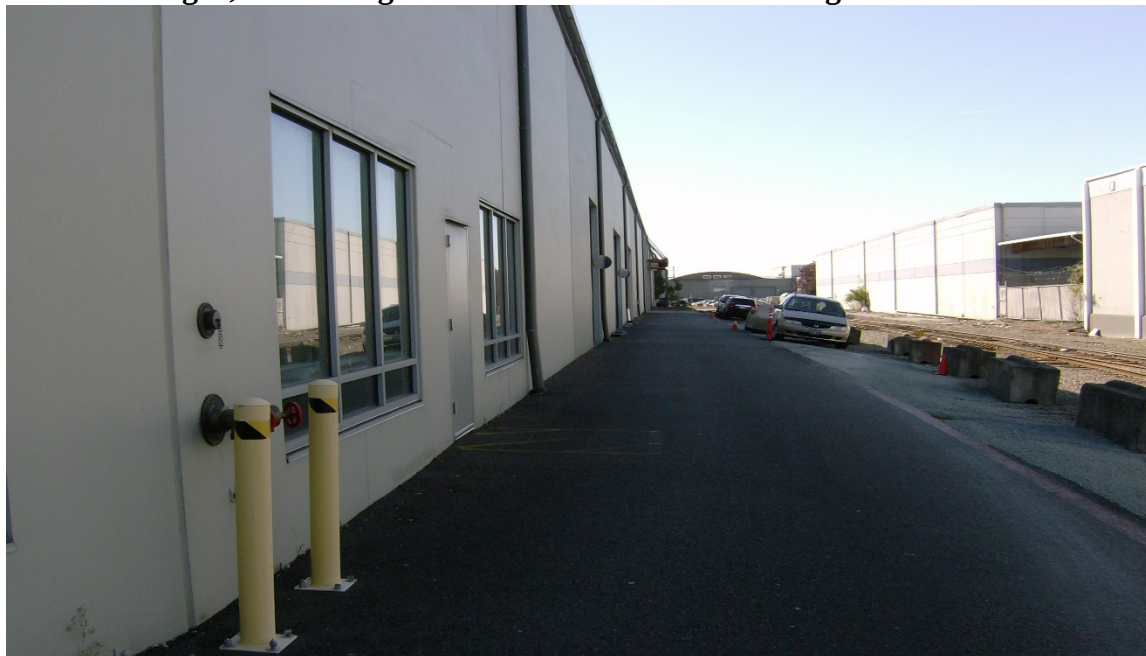
**Photo 3: Building C, back along railroad tracks north end looing south.**

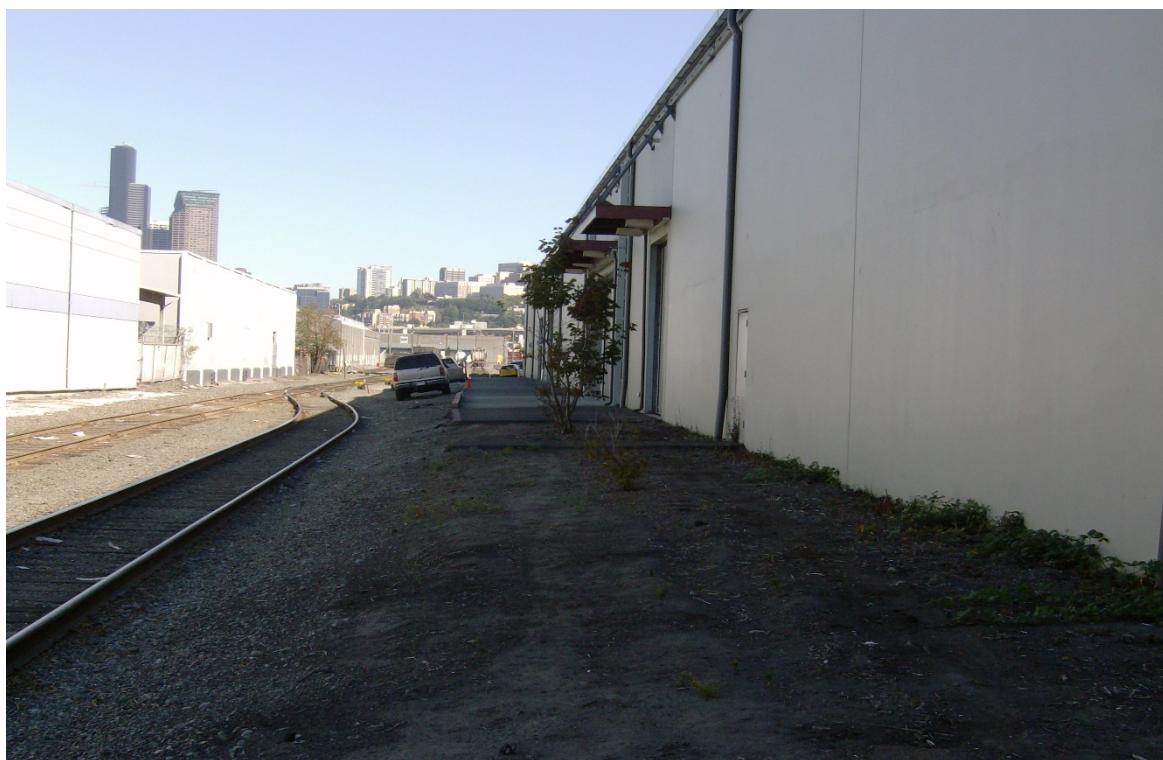
**Photo 4: Building C, back along railroad tracks south end looing North.**
