*Yard Birds Properties  
Limited Partnership*

*Enviros, Inc.  
210 Marina Park Building  
25 Central Way  
Kirkland, Washington 98033-6156*

*October 1994 Quarterly Groundwater  
Monitoring Report  
of the Yard Birds Property  
Olympia, Washington*

*November 4, 1994*

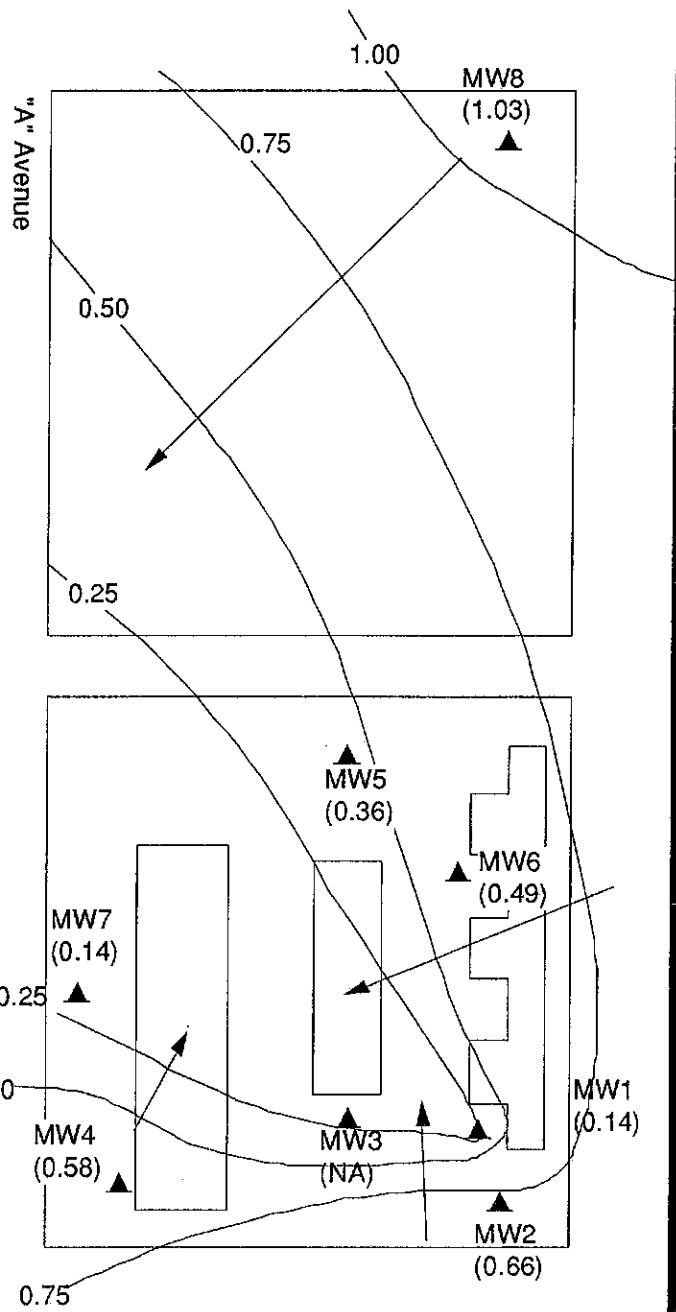
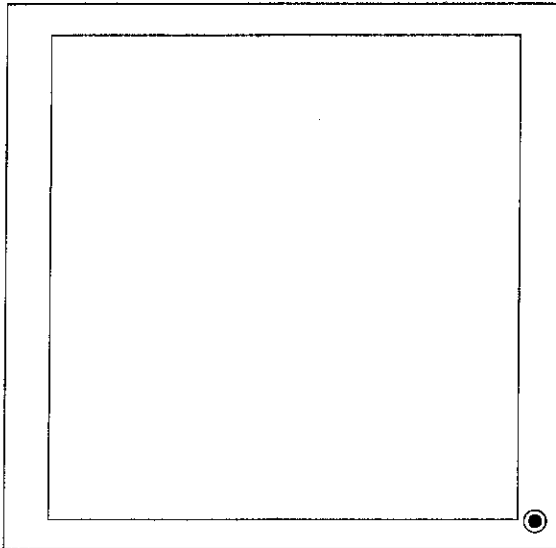
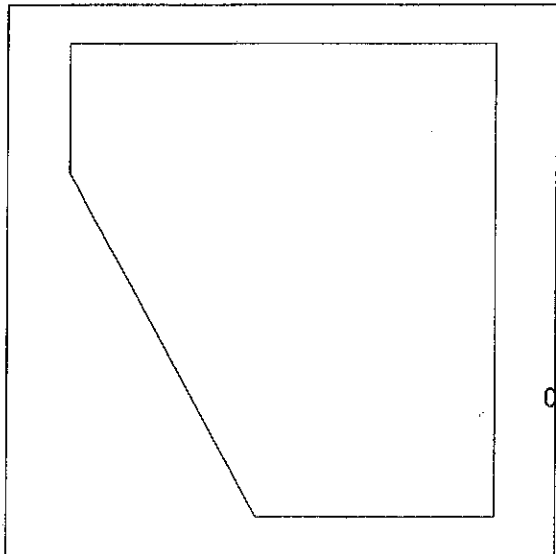
Figure 2. Groundwater Elevation Contour Map for Water Level Measurements Taken on October 6, 1994 at the Yard Birds Property in Olympia, WA.

Based on groundwater data obtained to date, it appears that the groundwater flow direction is predominantly toward the east and northeast on the Farmers Market block, and towards the northwest on the block to the east of the Farmers Market (parking lot). An anomalously steep hydraulic gradient is present on the southwest corner of the Farmer's Market Block that may be attributed to grading and filling or an unknown subsurface structure. The geometry of the groundwater contours is consistent with a filled channel.

During groundwater sampling, 3-inches of diesel-type product was observed in well MW-1. Previously, product thickness measurements in this well have ranged from a sheen measured shortly after installation of the well, to 4-inches of product during quarterly sampling performed July 6, 1994.

It should also be noted that the groundwater chemical data is consistent with hydraulic head measurements and the suspected presence of some anomalous subsurface feature in the area of well MW-1 and MW-2. While diesel product continues to be observed in well MW-1, upgradient well MW-2 located just 30 feet to the southwest had no product and the WTPH-D concentration is below the method detection limit.

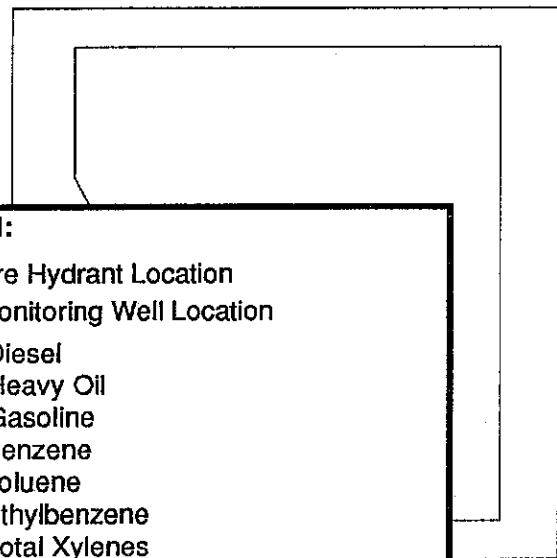
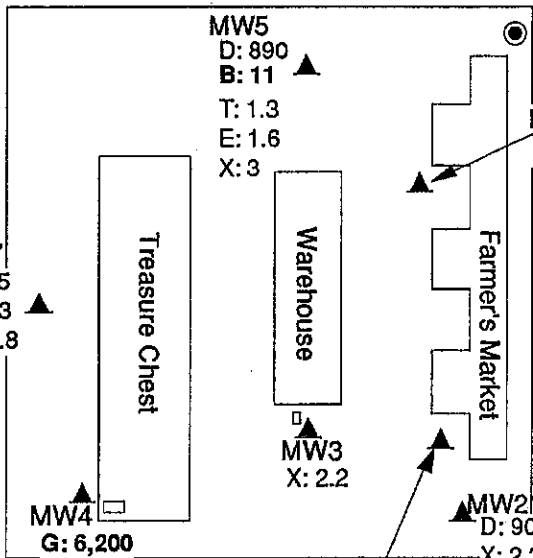
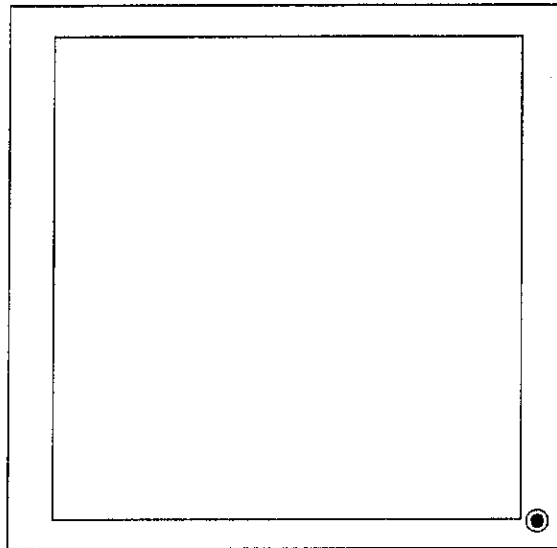
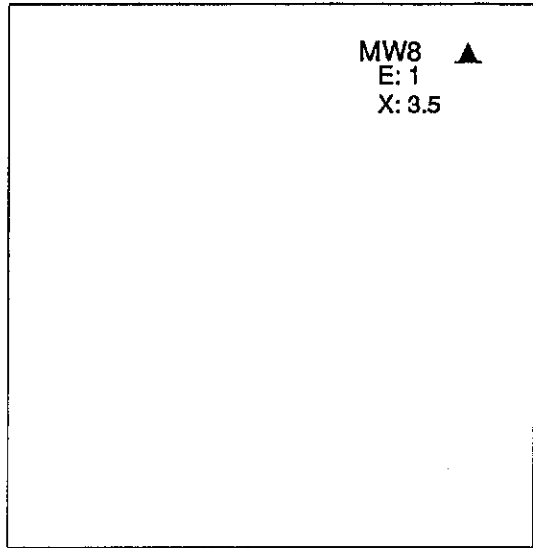
Groundwater samples were collected from the seven wells on the Farmer's Market block and were analyzed for gasoline, BTEX, diesel, and heavy oil. Floating product was observed in monitoring well MW1. The analysis of the groundwater sample collected from MW1 indicated the floating product is either diesel or heavy oil. Gasoline and BTEX were detected in a sample from monitoring well MW4 above MTCA Method A cleanup levels. Elevated levels of benzene (11 and 51 ppb) were detected in samples from monitoring wells MW5 and MW6. Levels of heavy oil (1,200 ppb) slightly above the MTCA Method A cleanup level were detected in monitoring well MW6. See Figure 6 for an illustration of the analytical results. Table 6 summarizes the analytical data.

MW5  
D: 890  
B: 11  
T: 1.3  
E: 1.6  
X: 3

MW6  
D: 860  
O: 1,200  
G: 720  
B: 51  
T: 3.2  
E: 3.1  
X: 9.3

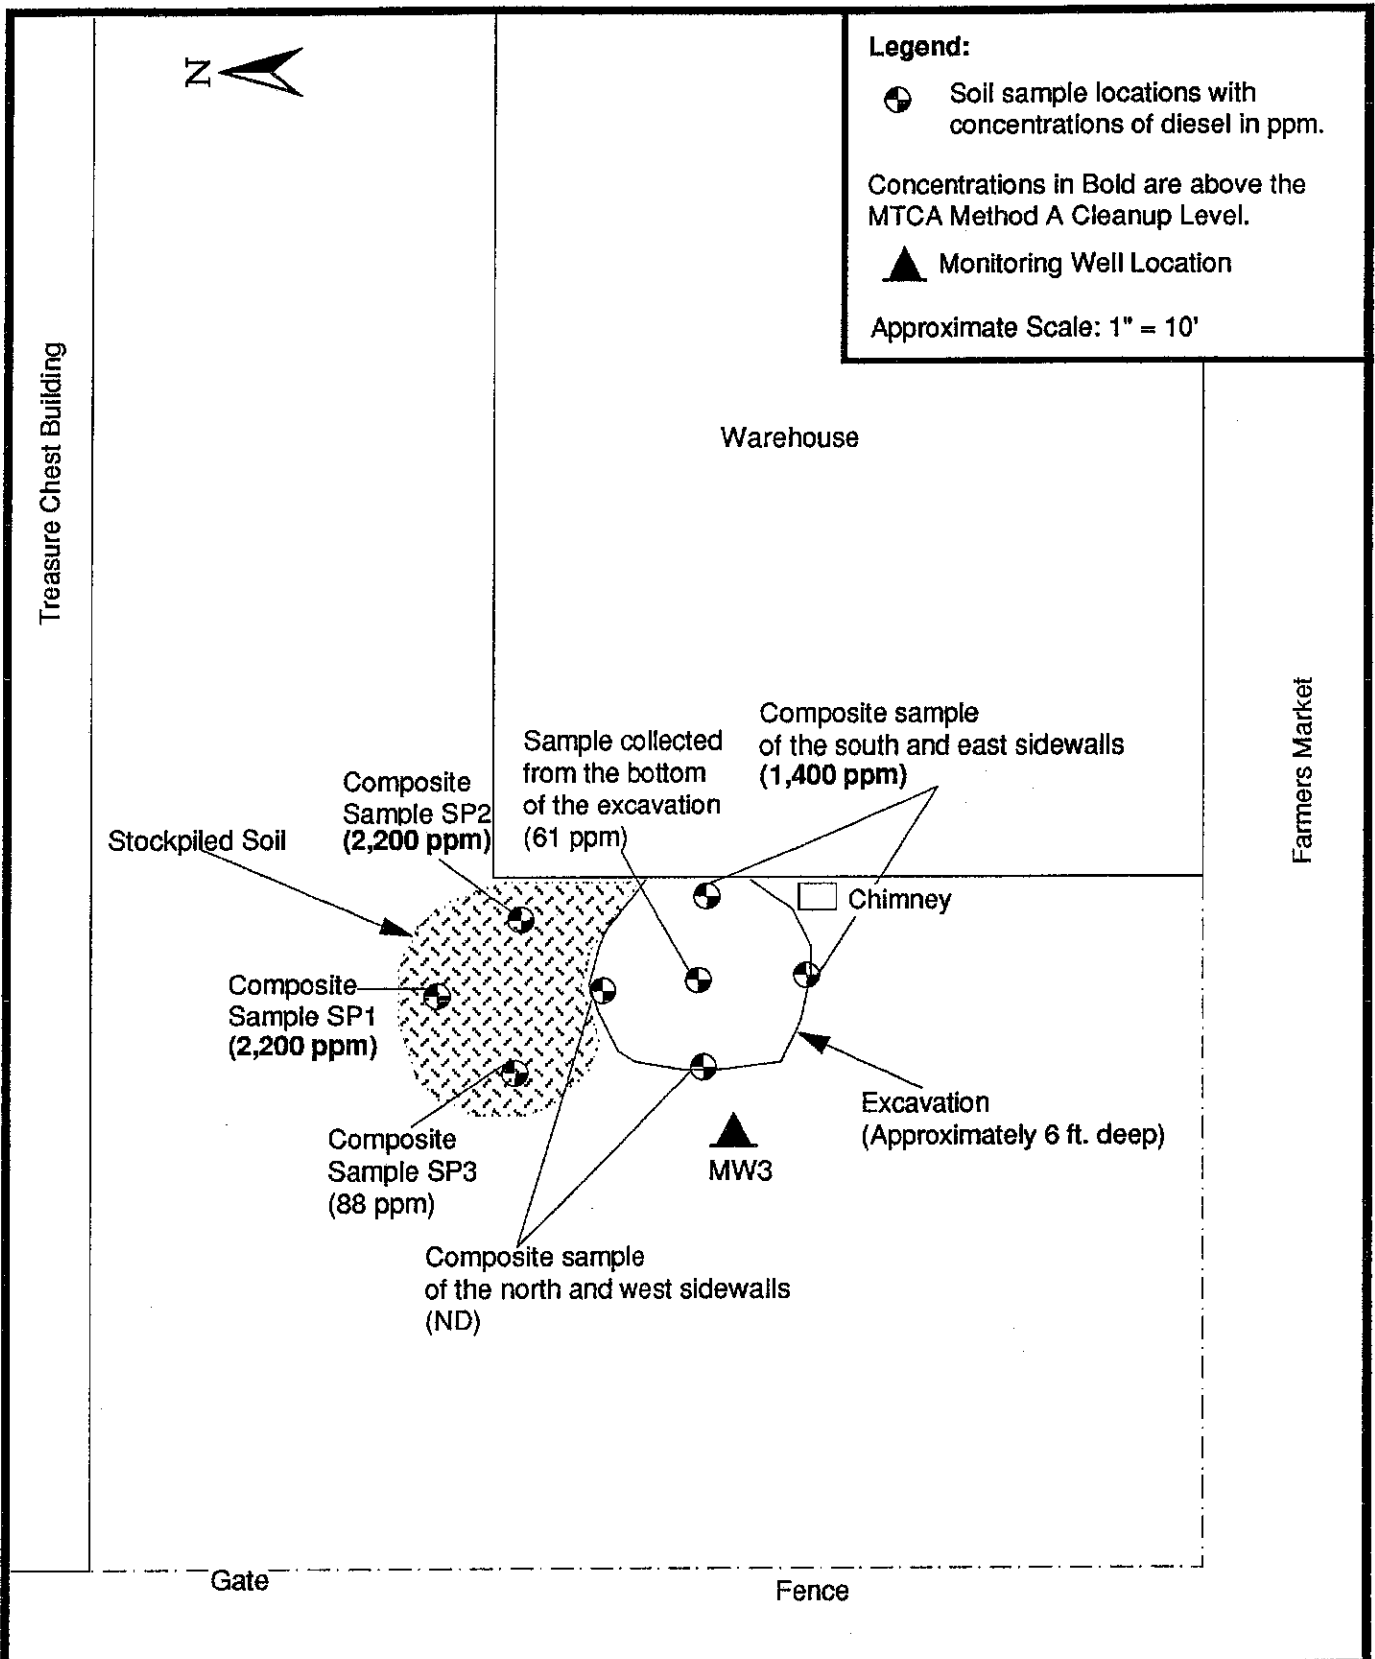
Figure 7. Sampling Locations and Analytical Results from the Heating Oil UST Excavation at the Yardbirds Property in Olympia, WA.

Also on March 22, 1994, the heating oil UST was removed from the west end of the warehouse building adjacent and to the north of the Farmer's Market. Corrosion holes were noticed on the tank. A layer of contaminated soil was observed at approximately 5.5 feet below ground surface. An additional 15 tons of soil was removed from the excavation in an attempt to remove the most severely contaminated soil. Two composite soil samples were collected from the four sidewalls, and a soil sample was collected from the bottom of the excavation. Free product from monitoring well MW-1 was pumped down using Foss Environmental's vacuum truck.

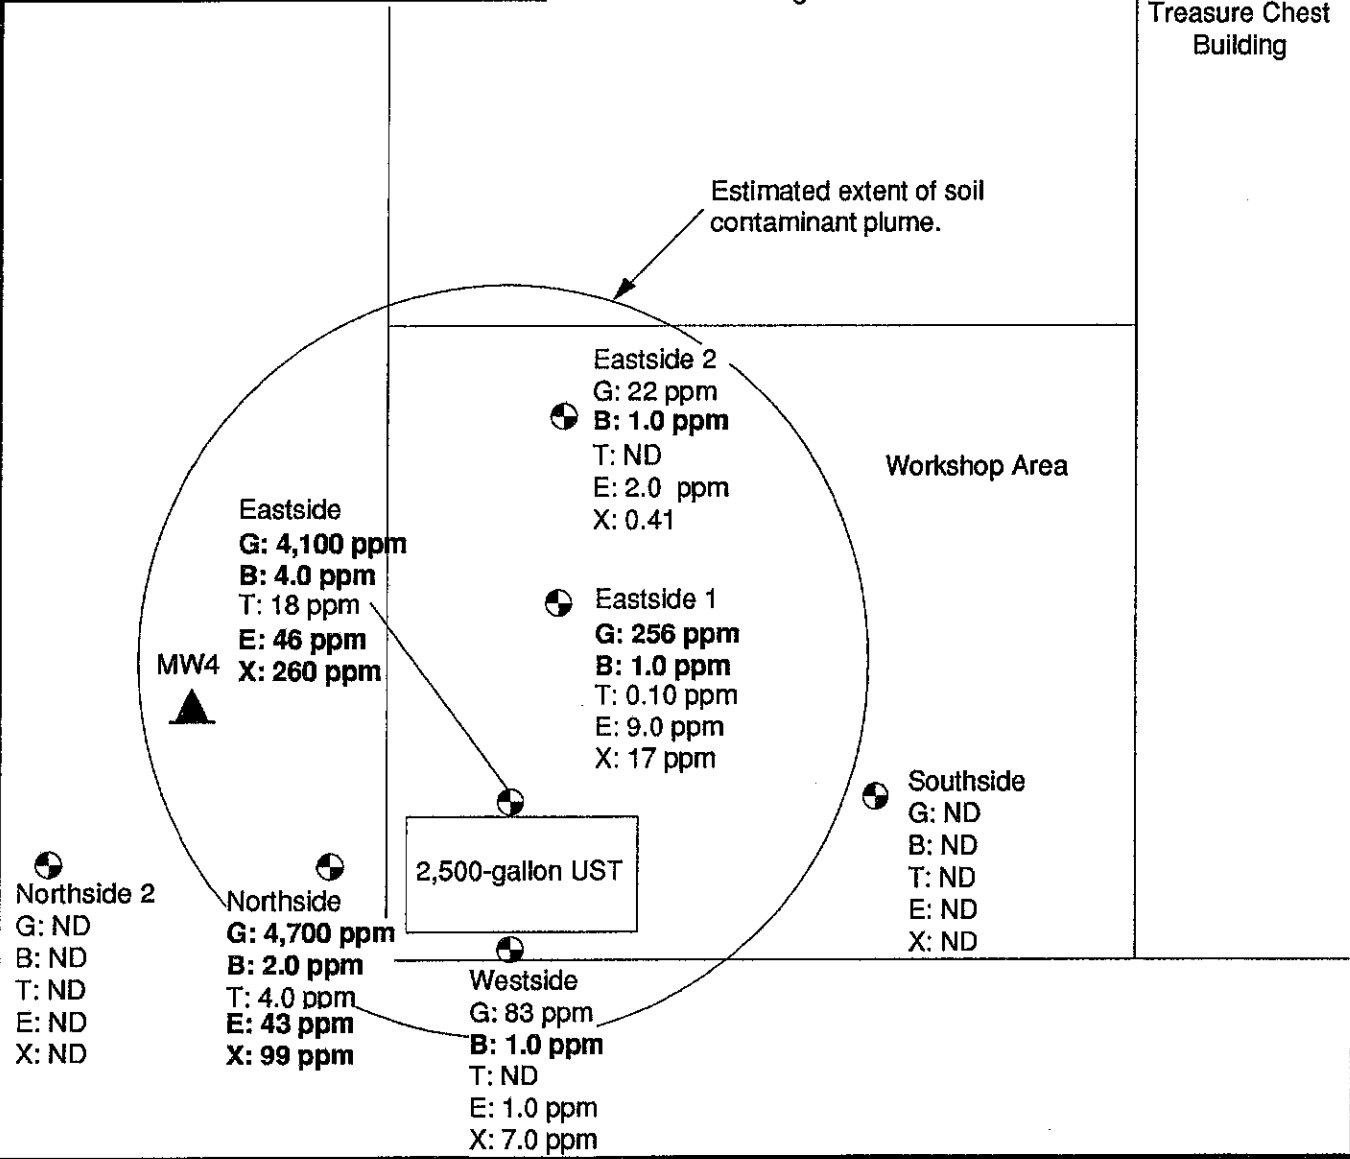
Figure 8. Sample Locations and Analytical Results in the Vicinity of the Gasoline Tank at the Yard Birds Property in Olympia, WA

Estimated extent of soil contaminant plume.

Floating petroleum hydrocarbon product was observed in a well within the Farmer's Market and diesel contaminant concentrations were above Ecology cleanup levels. Gasoline contamination above Ecology cleanup levels was also observed in the well adjacent to the gasoline UST of the Treasure Chest and in one down-gradient well.
