TACOMA PUBLIC UTILITIES
SOIL REMEDIATION
NEAR PORT OF TACOMA, PIER 7
TACOMA, WASHINGTON

JULY 2015

TACOMA PUBLIC UTILITIES
Soil Remediation Near Port of Tacoma, Pier 7
Tacoma, Washington
July 2015

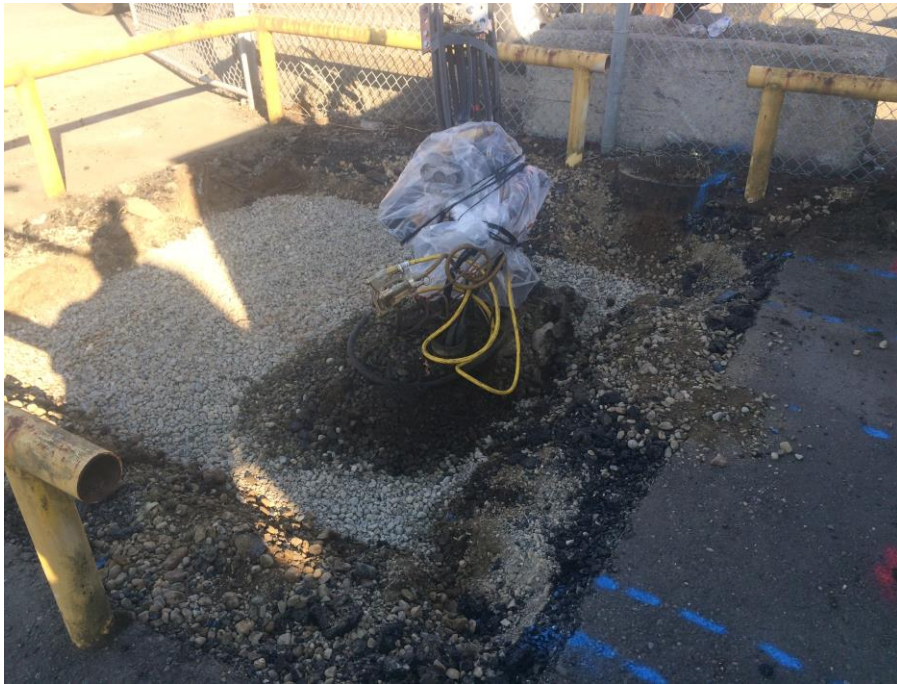
Upon removing the pad, impacted soils were observed to be constrained primarily in the small area of the well pad (Figures 2 and 3). Field screening did not indicate impacts to the soils in the other areas directly below the pad. At this point, NRC began to vacuum excavated soils from the area of the release using a Vactor truck (Figure 4). The remedial excavation initially pro-

Figure 3: Impacted soils were constrained primarily to the area of the well pad.

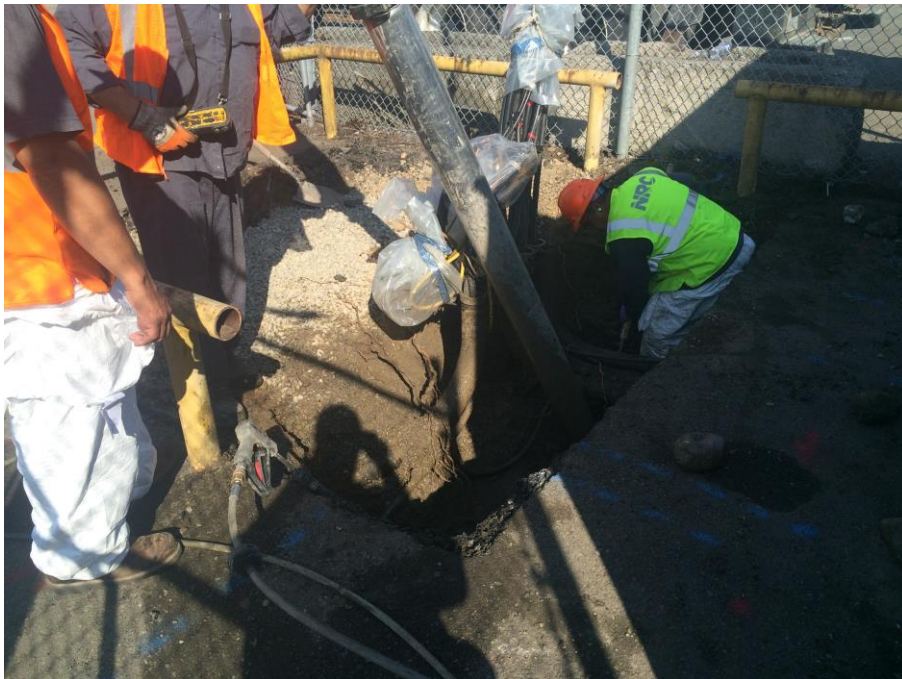
Figure 4: Excavating impacted soils using a Vactor truck.

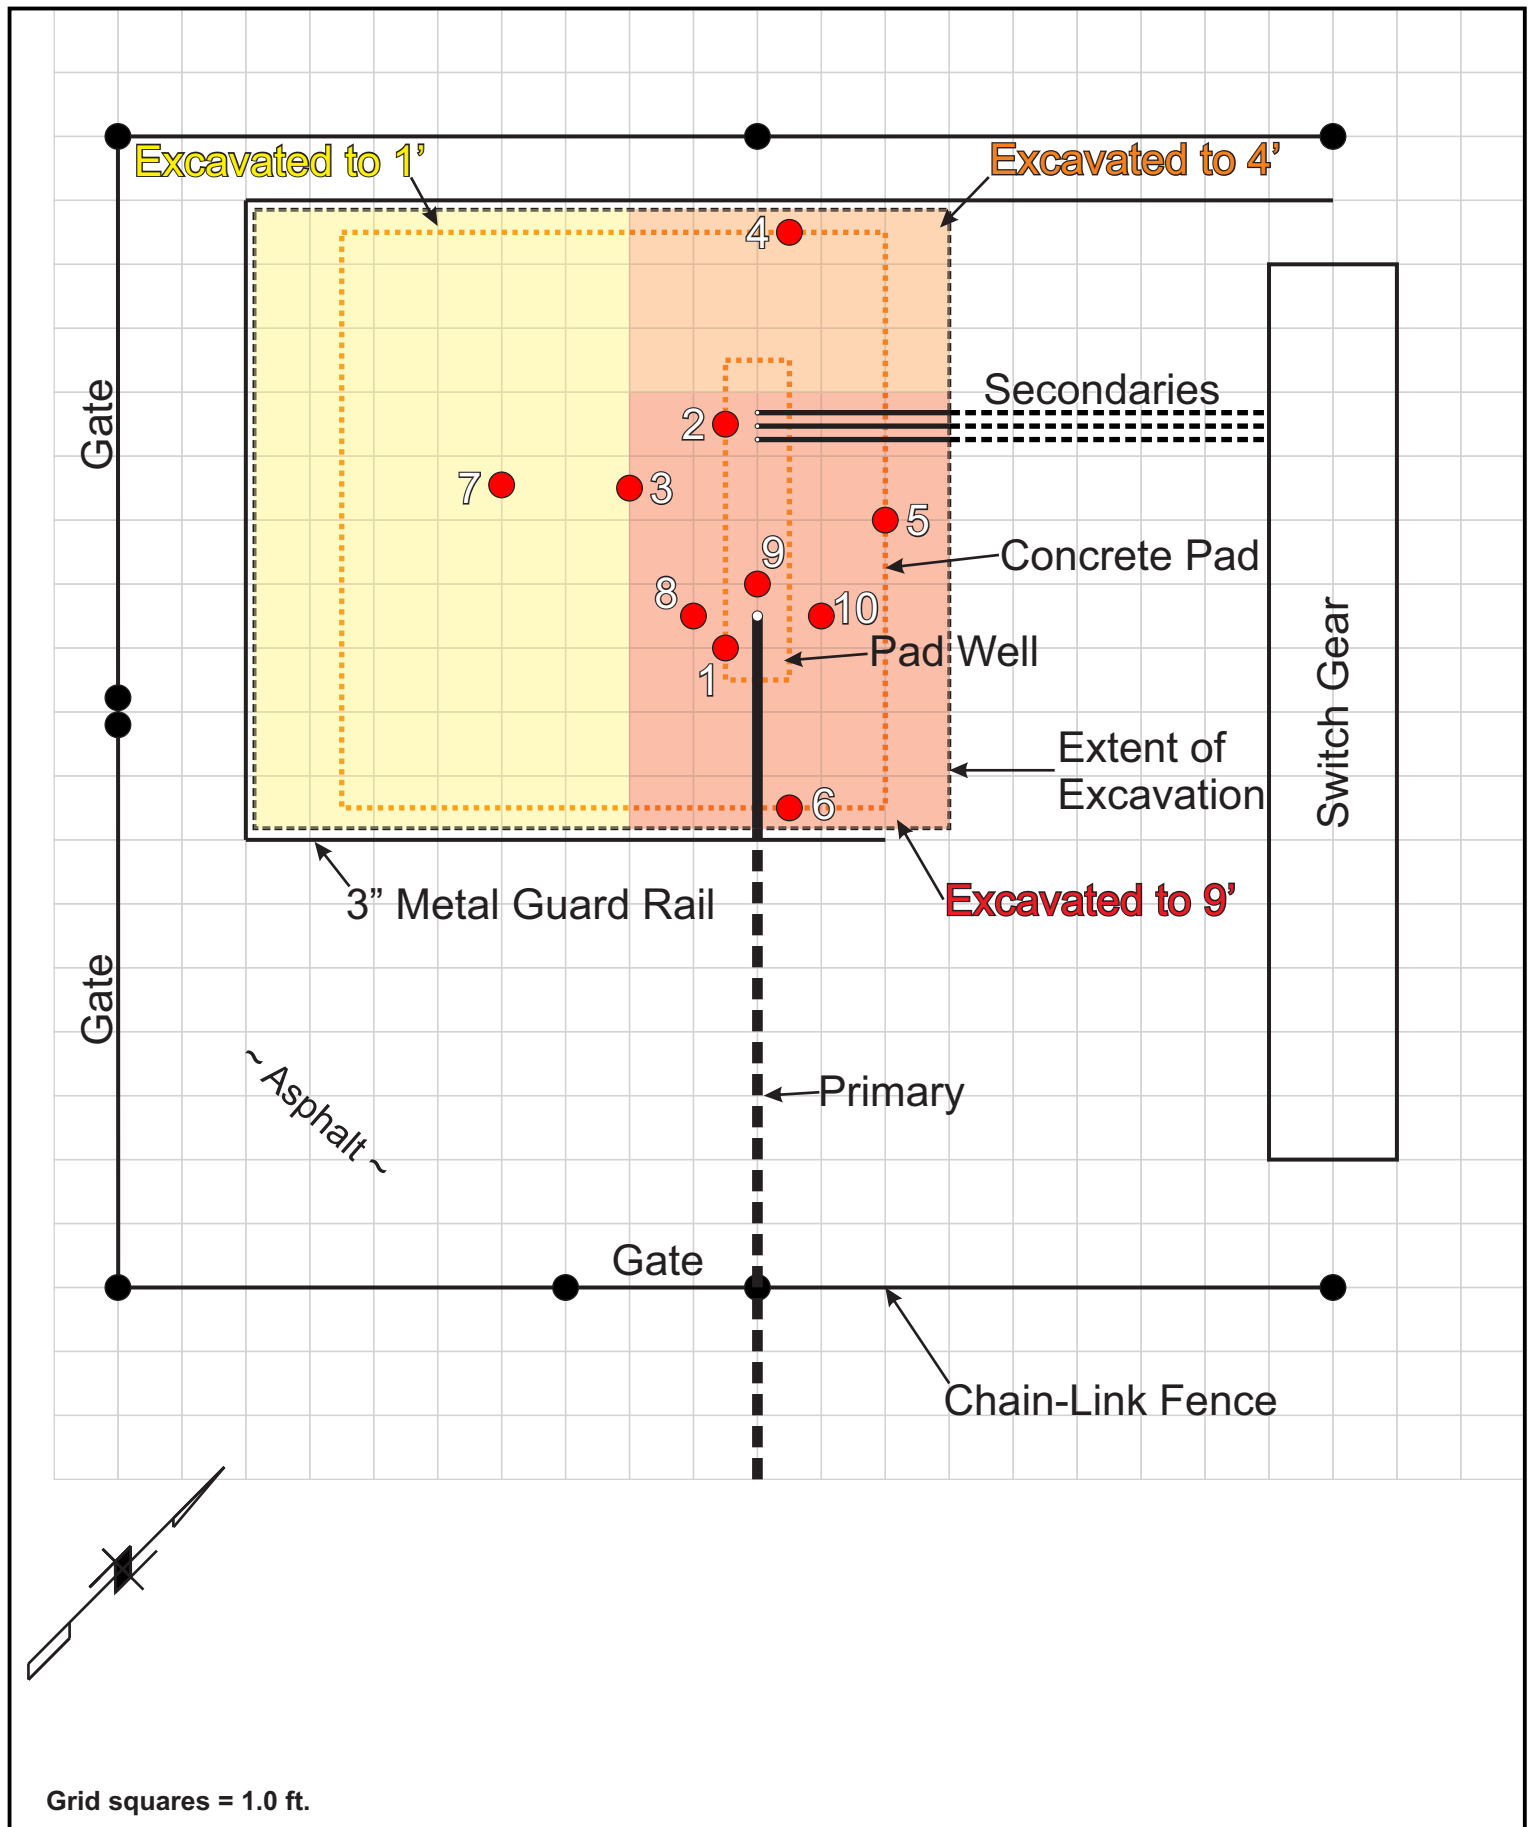
Figure 2
 Site and Sample Location Diagram
 Tacoma Public Utilities: Port of Tacoma Pier 7 Transformer Cleanup

ceeded to a depth of one foot uniformly over the entire area below the concrete pad (see Figure 2). Soils on the western half of the excavation, which did not appear to be impacted, were removed to accommodate the placement of structural fill following remediation. The eastern half of the excavation (in the area below the pad well and conduits) was subsequently deepened to four feet to expose the soils below the conduits. At this point, field screening indicated only minor impact in the soils below the primary conduit.

At this point, the southeastern portion of the excavation (below the primary conduit; see Figure 2) was excavated to a depth of five feet and resampled (sample 8). Chemical analyses of sample 8 still indicated similarly high concentrations of mineral oil (17,000 mg/kg). The excavation was subsequently deepened to seven feet and resampled (sample 9). Again, analysis indicated high concentrations of mineral oil (11,000 mg/kg). The excavation was then extended to a depth of 8½ feet, at which point groundwater was encountered.

As shown on Figure 2, the final excavation covered an area of approximately 10 feet by 11 feet, which approximately corresponds to the area below the concrete pad. The western half of the excavation extended to a depth of one foot, the northeastern portion to a depth of four feet, and the southeastern portion to a depth of nine feet. The estimated excavated volume is just over 16 cubic yards. The excavated soils to a depth of 4½ feet consist of brown sand and gravel. Soils below the 4½ feet to the final depth of the excavation at 9 feet consist of brown sand. These materials are known in this area to be imported or reworked (fill). As discussed above, groundwater was encountered in the excavation at a depth of 8½ feet and appeared to be tidally influenced.
