# PERIODIC REVIEW

Provisioners Express Facility Site ID#: 91612121

2102 West Valley Highway North, Auburn, Washington

**TOXICS CLEANUP PROGRAM**

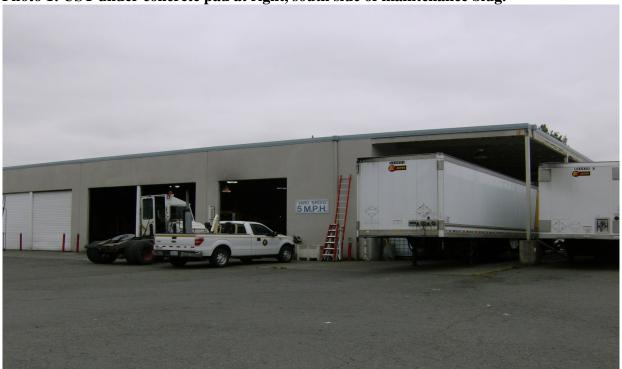
Photo 1: UST under concrete pad at right, south side of maintenance bldg.

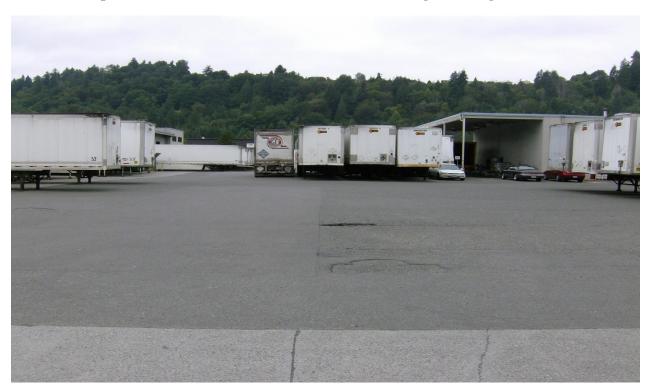
Photo 2: Asphalt area southeast of the maintenance building at the right.

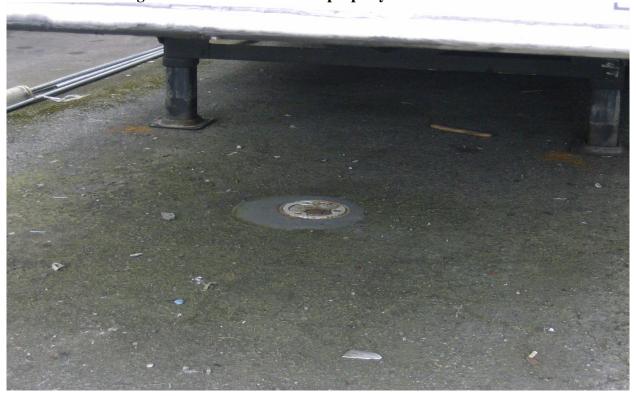
Photo 3: Monitoring wells are still in use at the property
