**ENVIRONMENTAL UPDATE  
FLEISCHMANN'S YEAST FACILITY  
SUMNER, WASHINGTON**

**SUMNER NATURAL RESOURCES LLC  
D&M JOB NO.: 34848-006-005  
January 8, 1999**

Report  
Environmental Update  
Fleischmann's Yeast Facility  
Sumner, Washington  
D&M Job No.: 34848-006-005

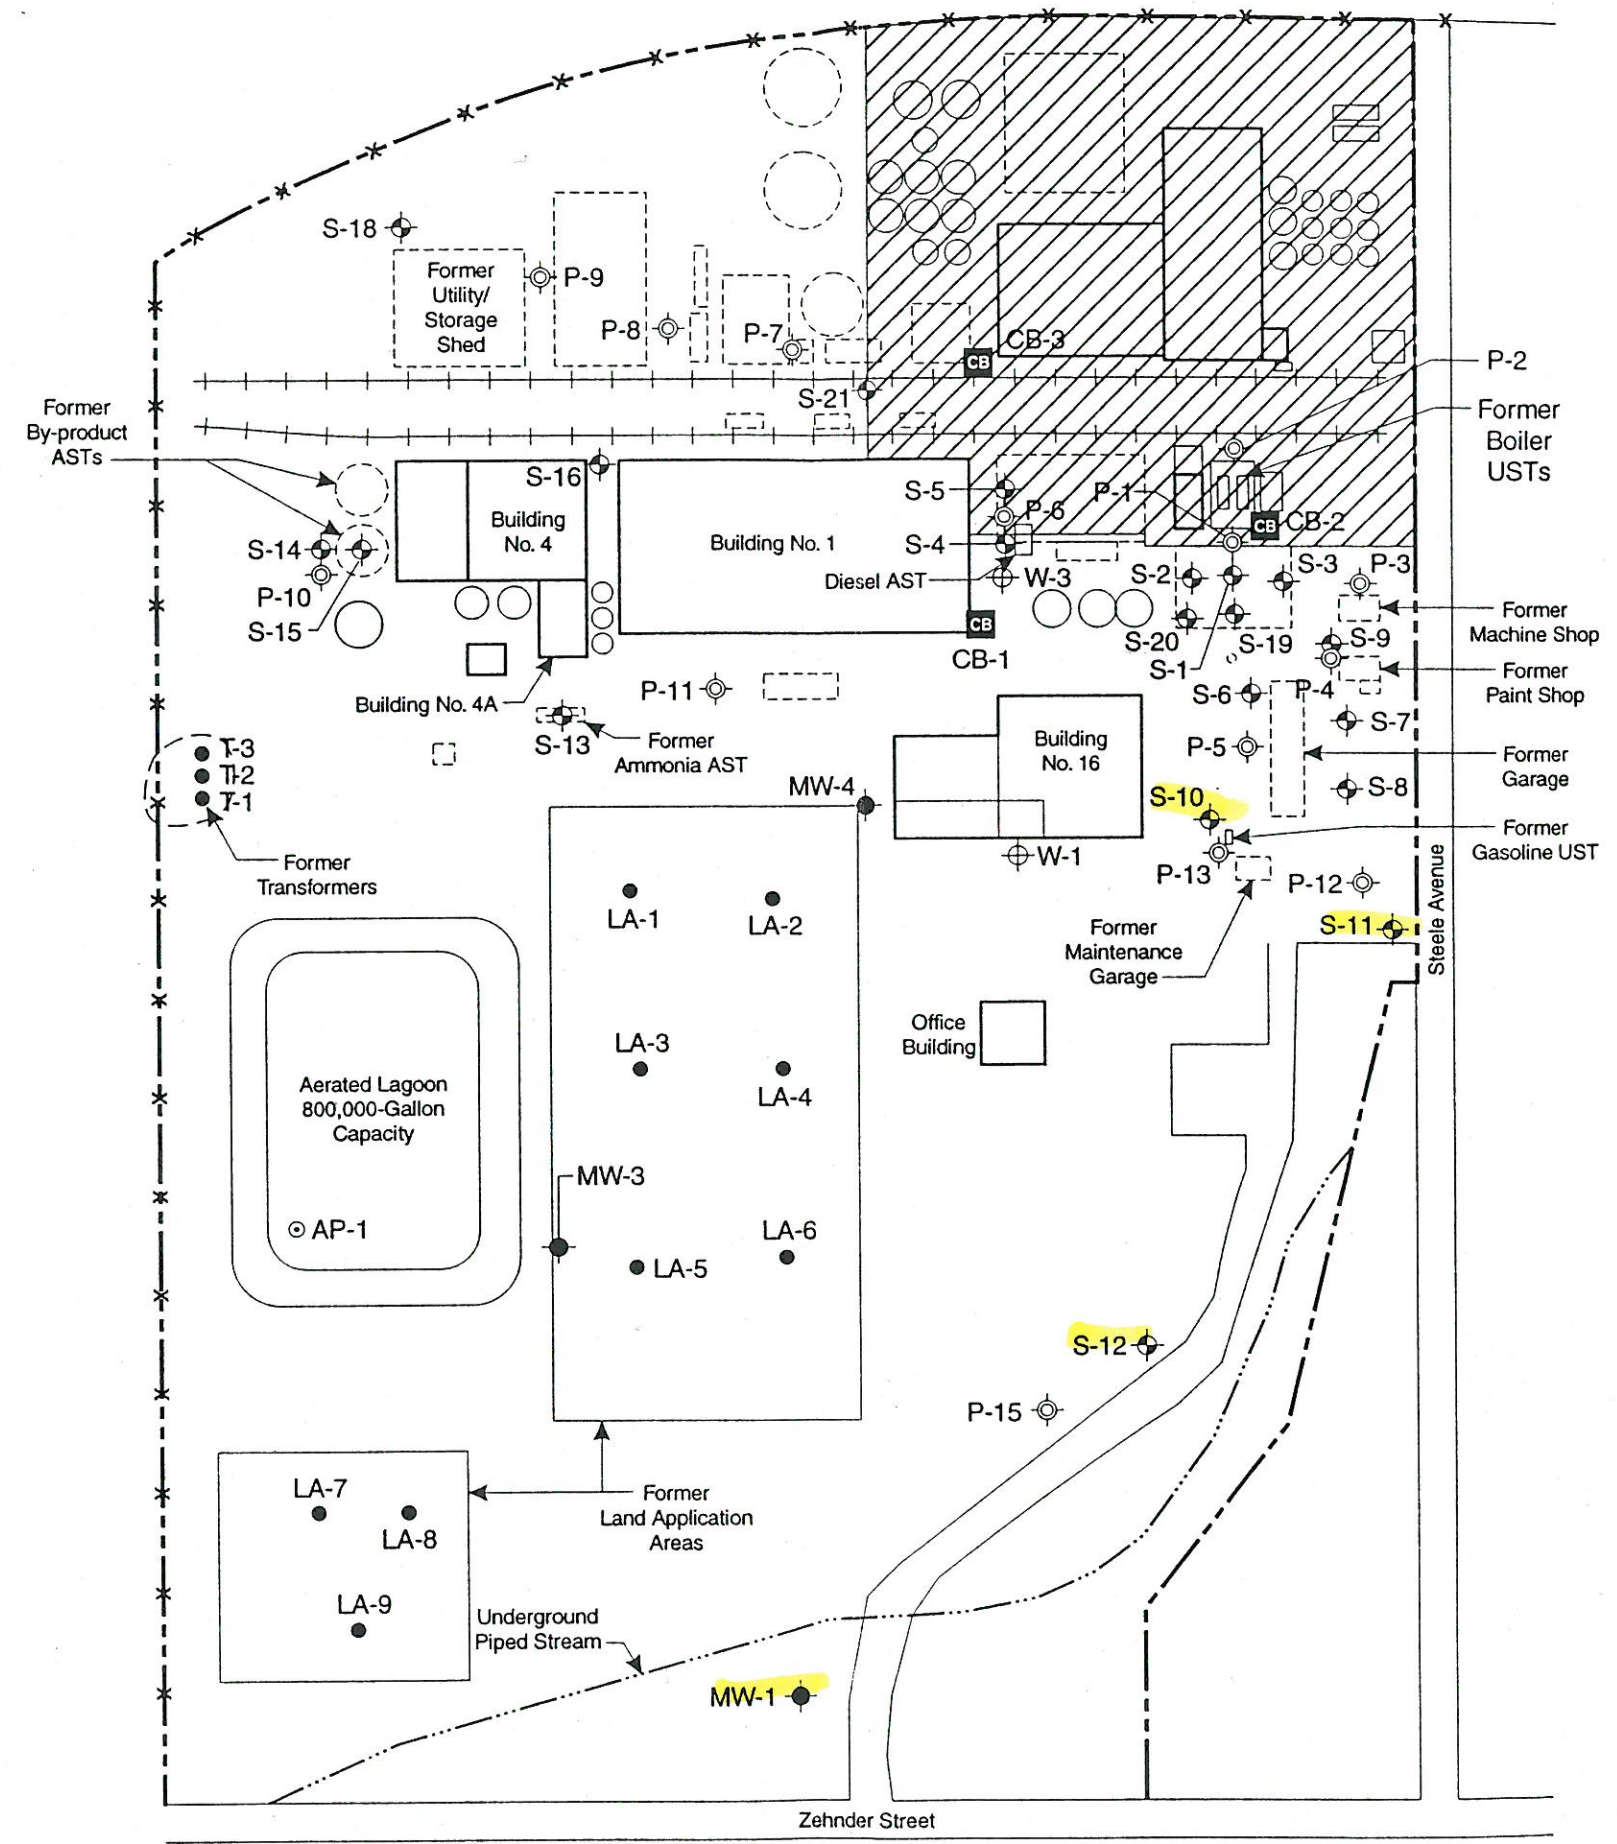
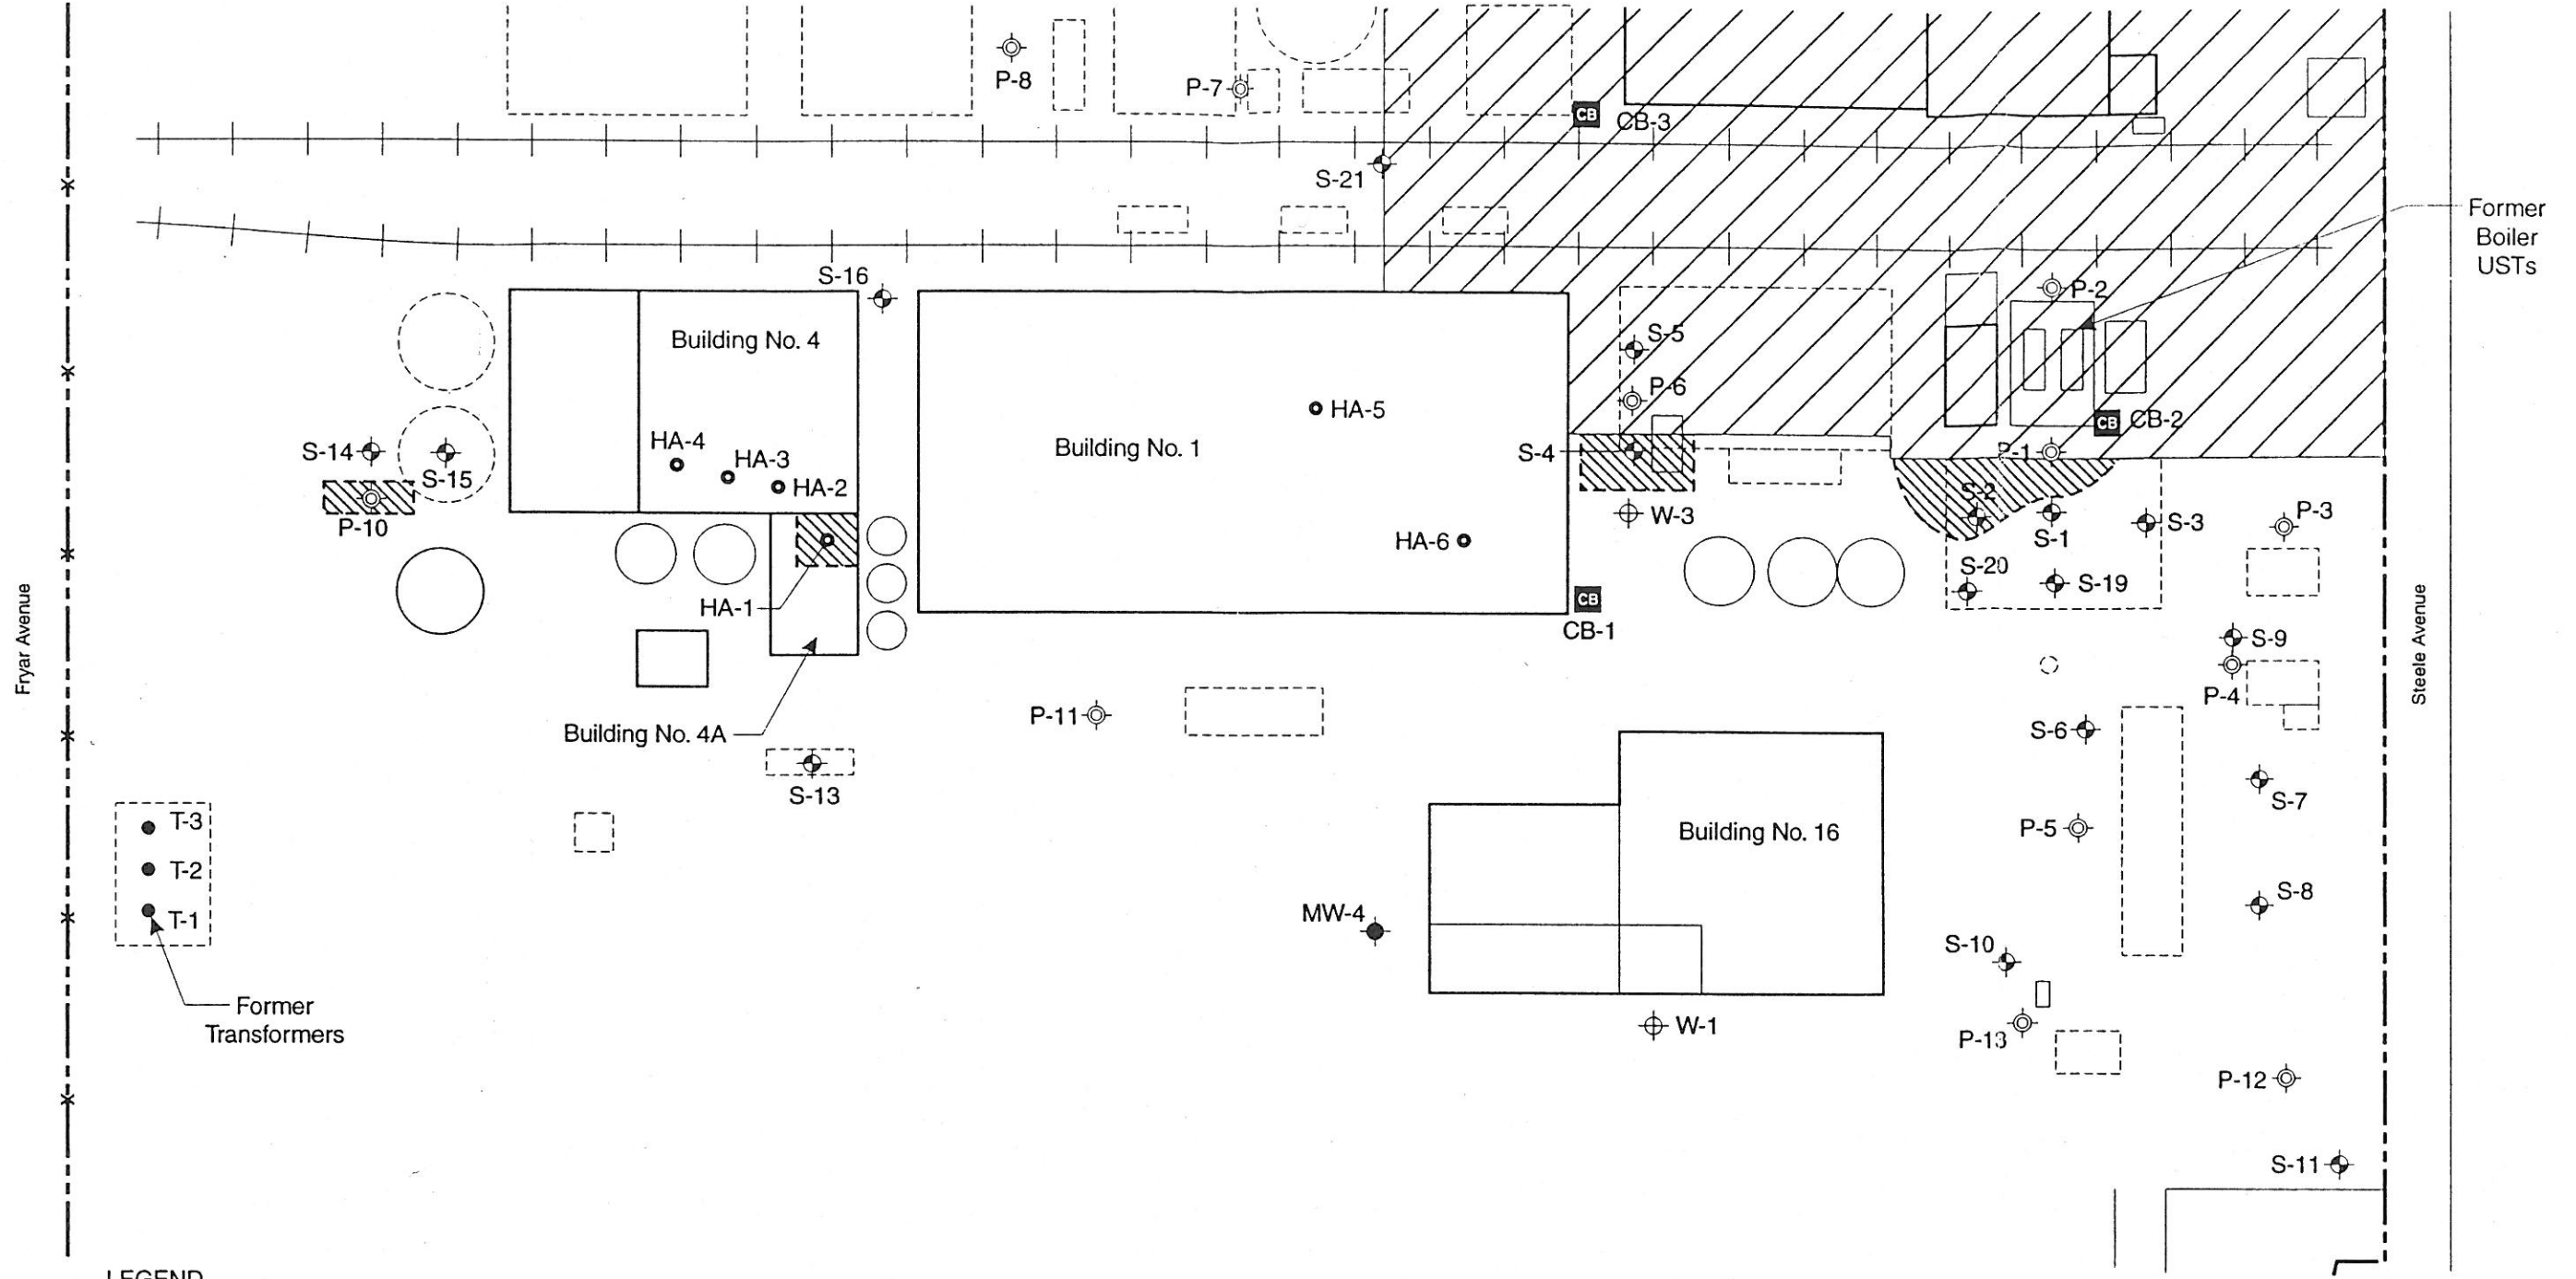
Figure 2  
**SITE PLAN AND SAMPLE LOCATIONS**

Two borings (S-4, S-5) were advanced west and north of the diesel AST located east of Building No. 1 (Figures 2 and 3). A slight hydrocarbon odor and sheen was noted in soil and groundwater collected from boring S-4. Hydrocarbon odors or sheen were not noted in boring S-5. Analyses of soil samples from borings S-4 indicated petroleum hydrocarbon concentrations exceeding MTCA Method A cleanup levels between 1 and 4 feet bgs (Table 4). Petroleum hydrocarbons were not detected in the soil sample analyzed from boring S-5.
