M E M O R A N D U M

FROM: Chris Carter, Principal Scientist

SUBJECT: Summary of Brooklyn Chevron No. 9-0129 Ecology File Review and Groundwater Flow

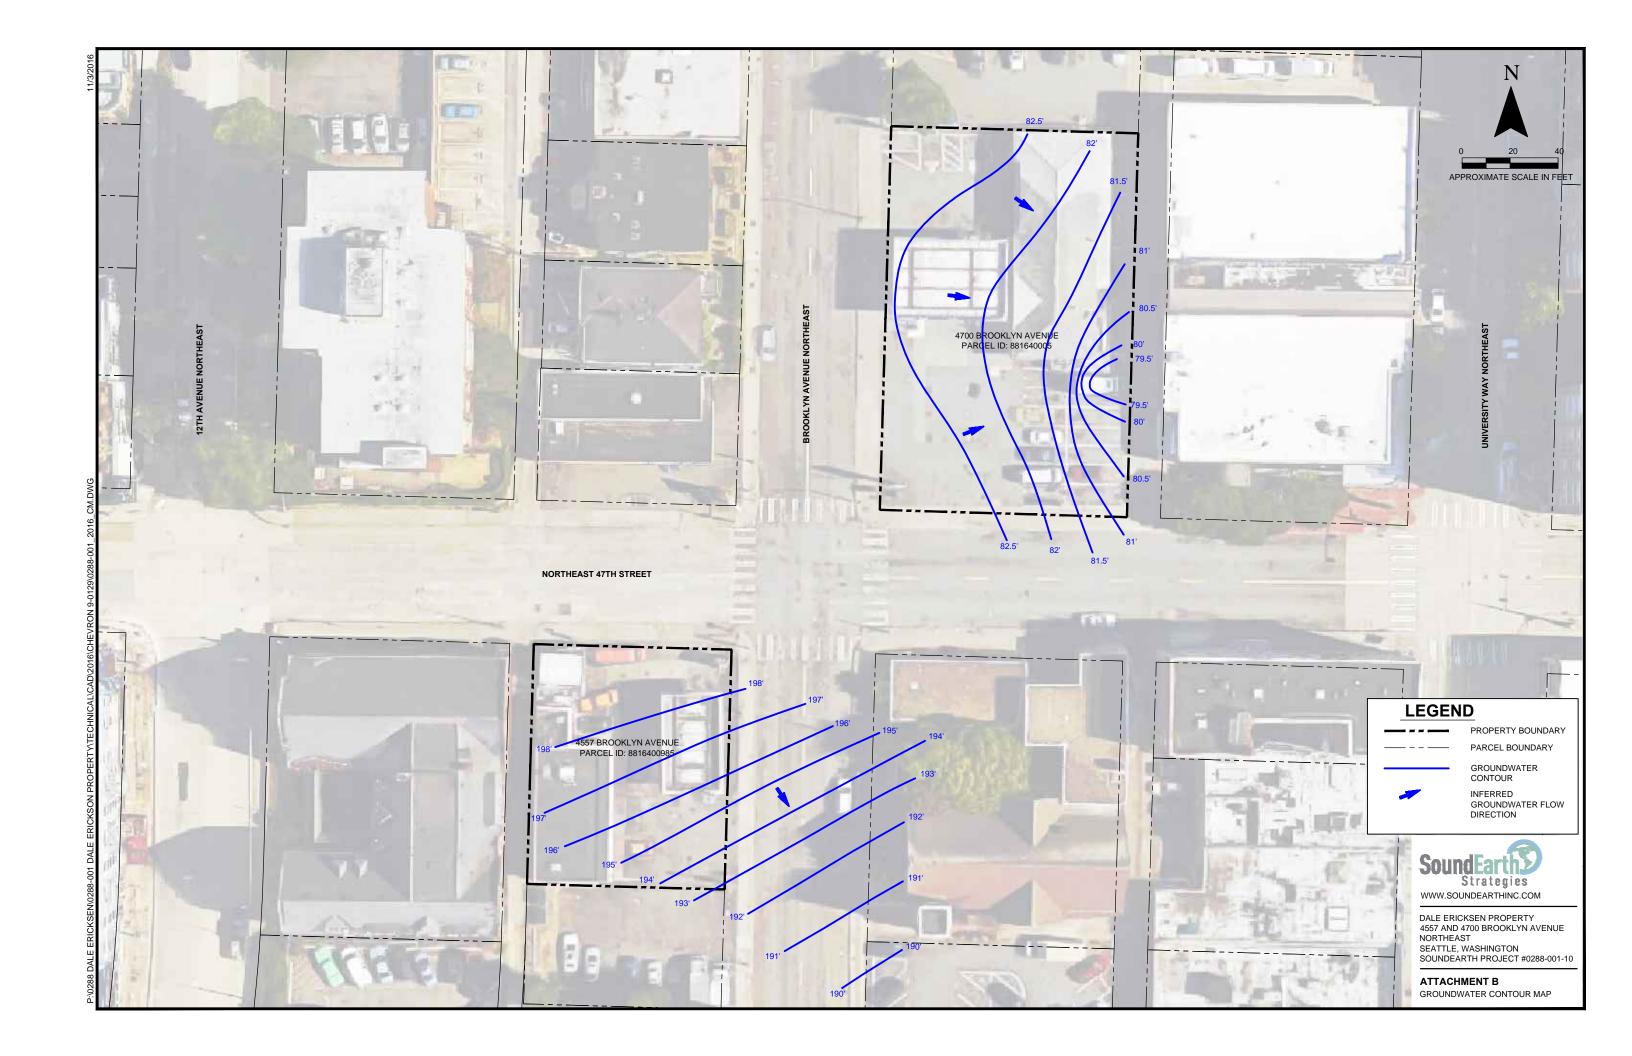
ATTACHMENT B SOUNDEARTH FIGURE OF GROUNDWATER GRADIENTS AT THE CHEVRON PROPERTY AND THE ERICKSON PROPERTY

Based on the groundwater flow direction toward the southeast from both the Chevron property and the Erickson property as inferred by SoundEarth (Attachment B) and the calculated southeasterly groundwater flow direction reported by Leidos at the Chevron property in June 2014 (Attachment C), together with the absence of any apparent petroleum hydrocarbon contaminated groundwater beneath the northeastern portion of the Erickson Property since March 2011, there does not appear to be petroleum hydrocarbon-impacted groundwater originating from the Chevron property that is extending southwest onto the Erickson property.

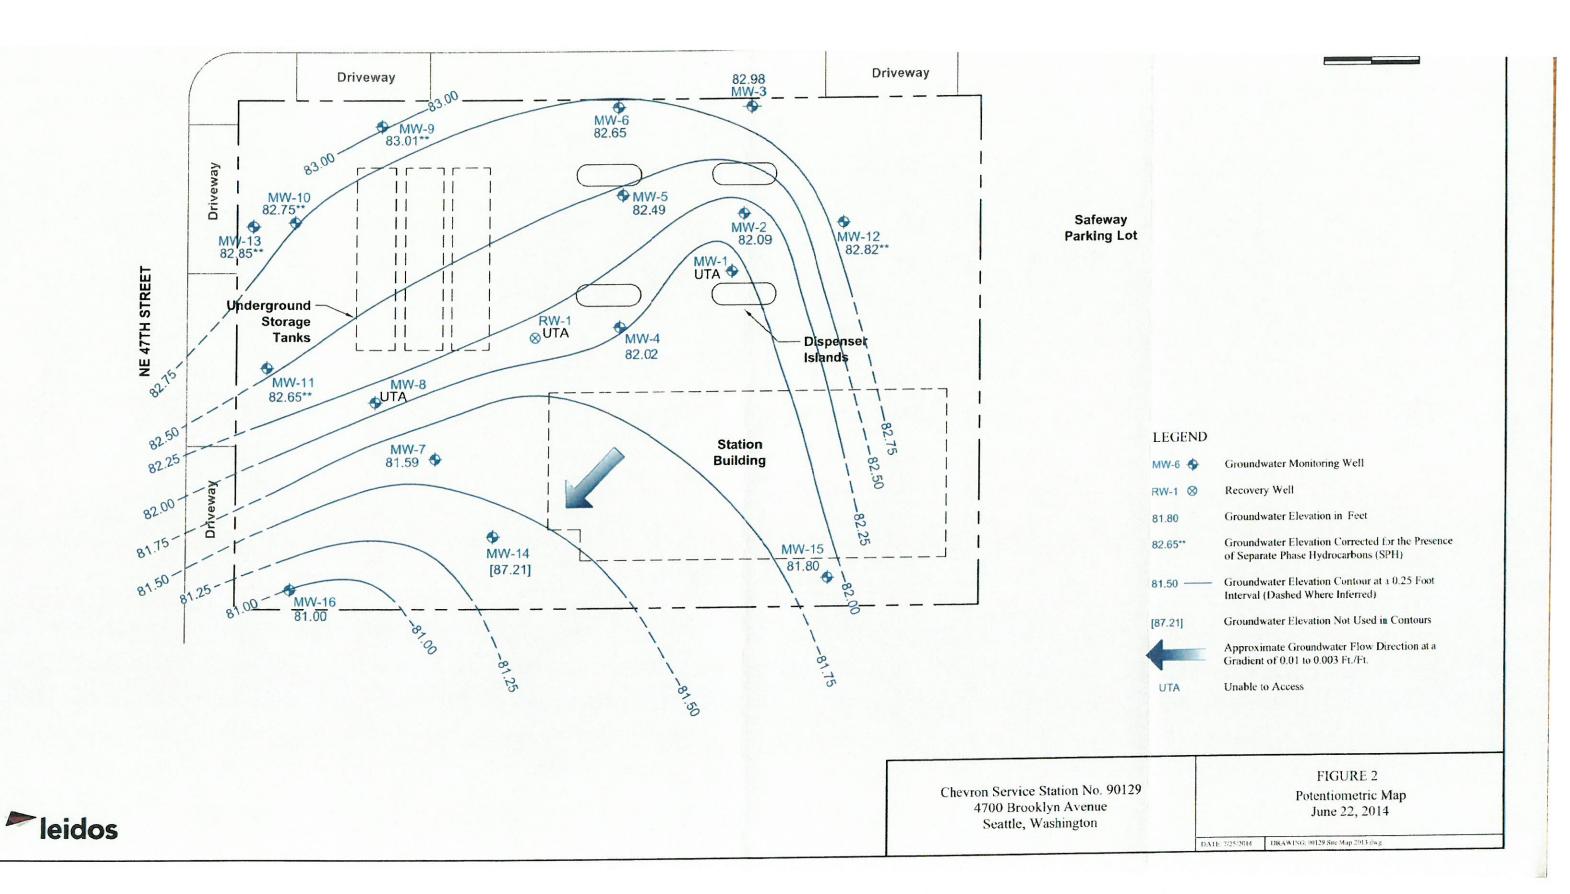
ATTACHMENT C CHEVRON SERVICE STATION NO. 90129 JUNE 22, 2014, POTENTIOMETRIC MAP BY LEIDOS

Previous work by others at the Chevron property revealed that there is light non-aqueous phase liquid (LNAPL) beneath the southwestern corner of the Chevron property and likely in the adjoining right-ofways (ROWs) of Brooklyn Avenue Northeast and Northeast 47th Street (Attachment A). There is not sufficient data to fully define the extent of the LNAPL to the west and south of the Chevron property; however, a review of the groundwater data and soil stratigraphy for both the Chevron property and for the Erickson property, which review was conducted by a SoundEarth licensed hydrogeologist, concluded that the groundwater flow direction at the Chevron property trends toward the southeast, away from the Erickson property (Attachment B). This conclusion is consistent with the results of work performed at the Chevron property by Leidos Engineering, LLC (Leidos) in 2014 (Attachments A and C). The groundwater flow direction at the Chevron property was determined by Leidos to be toward the southeast on June 22, 2014, at a gradient ranging from 0.1 to 0.003 foot per foot (ft/ft; Attachment C).
