STATE OF WASHINGTON
DEPARTMENT OF ECOLOGY

Re: No Further Action at the Following Site:

- **Site Name:** Lake Goodwin Store 2013
- **Site Address:** 4726 Lakewood Road, Stanwood, WA 98292
- **Facility/Site No.:** 12889948
- **Cleanup Site ID No.:** 12352
- **VCP No.:** NW2974

Description and Diagrams of the Site

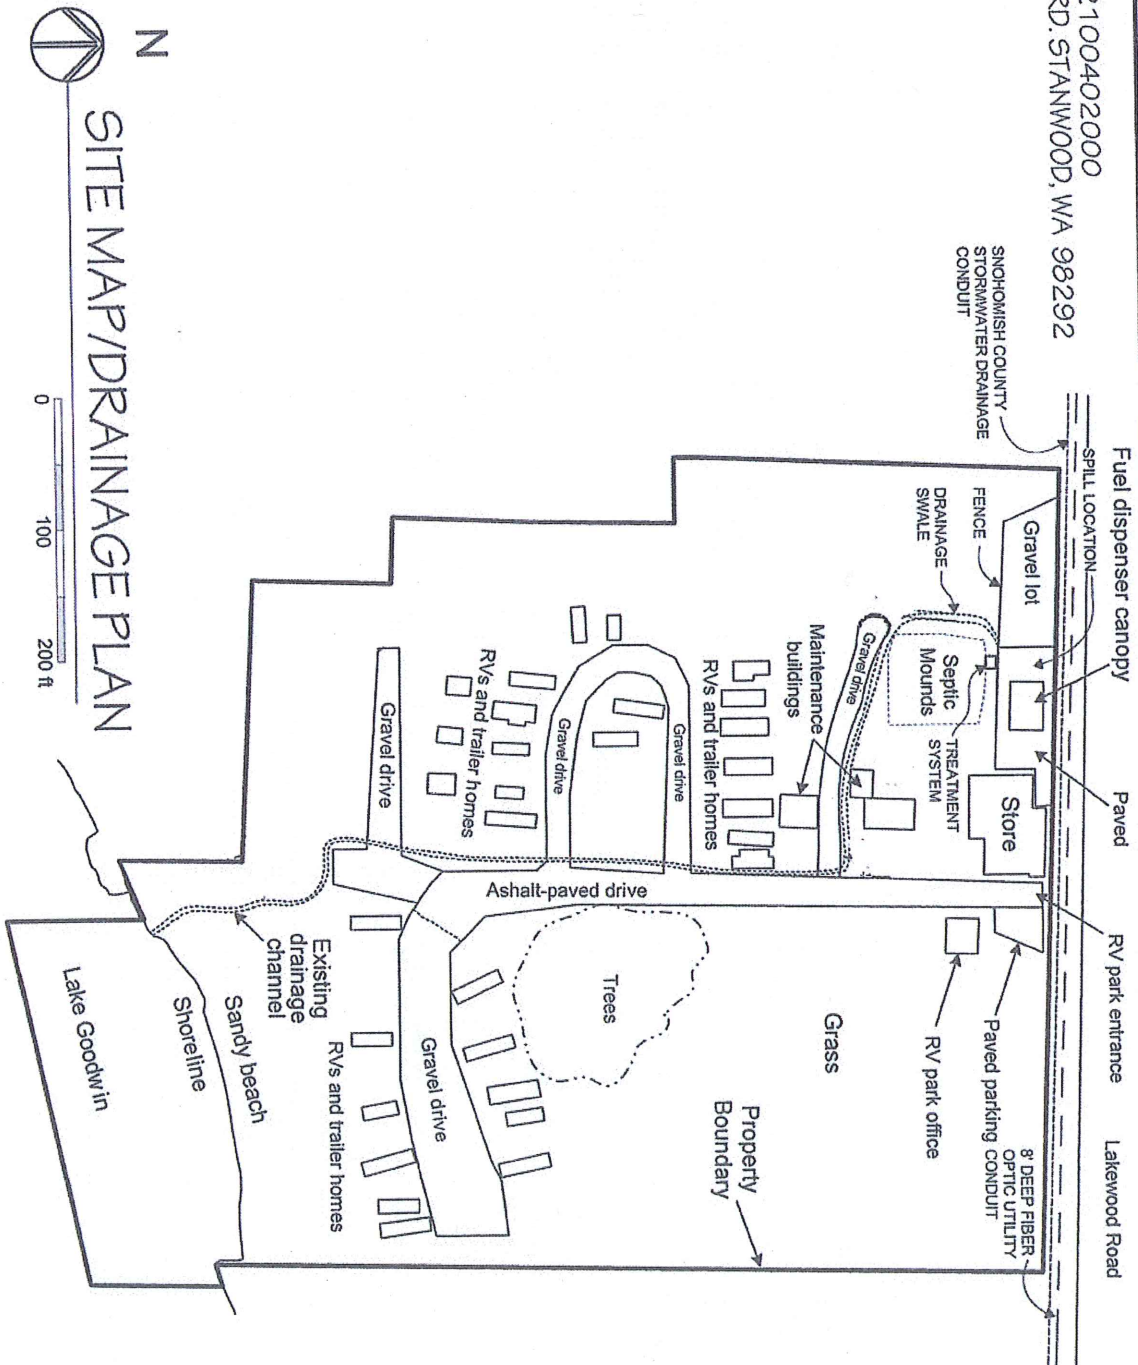
SITE MAP/DRAINAGE PLAN

Surface/Storm Water System: Lake Goodwin is located approximately 700 feet south of the point of the release, at the south boundary of the Property. In the vicinity of the Site, storm water flows over the asphalt surface toward the grassy area south of the gasoline station, then overland towards a swale that drains to Lake Goodwin (see **Figure 2**).

A dissolved-phase gasoline plume at concentrations exceeding MTCA Method A ground water cleanup levels was detected in all monitoring wells (MW-4 through MW-6) when they were sampled on December 19, 2013 (**Figure 5**). TPHg was confirmed at concentrations above MTCA Method A cleanup levels in soil at locations FS1 and FS2, which were located adjacent to the fence between the asphalt and grassy swale (see **Figure 2**).

On March 5 and 6, 2014, approximately 39 tons of contaminated soil were removed from an 800 square-foot area, partially in the grassy area just south of the fence and partially beneath the asphalt north of the fence. Confirmation soil samples FS3, FS4 and FS5 were collected from within the excavation area but do not appear to have been appropriately placed to demonstrate that all contaminated soil was removed (see **Figure 2**). Backfill material consisted of 18.46 tons of ¾ inch washed rock.

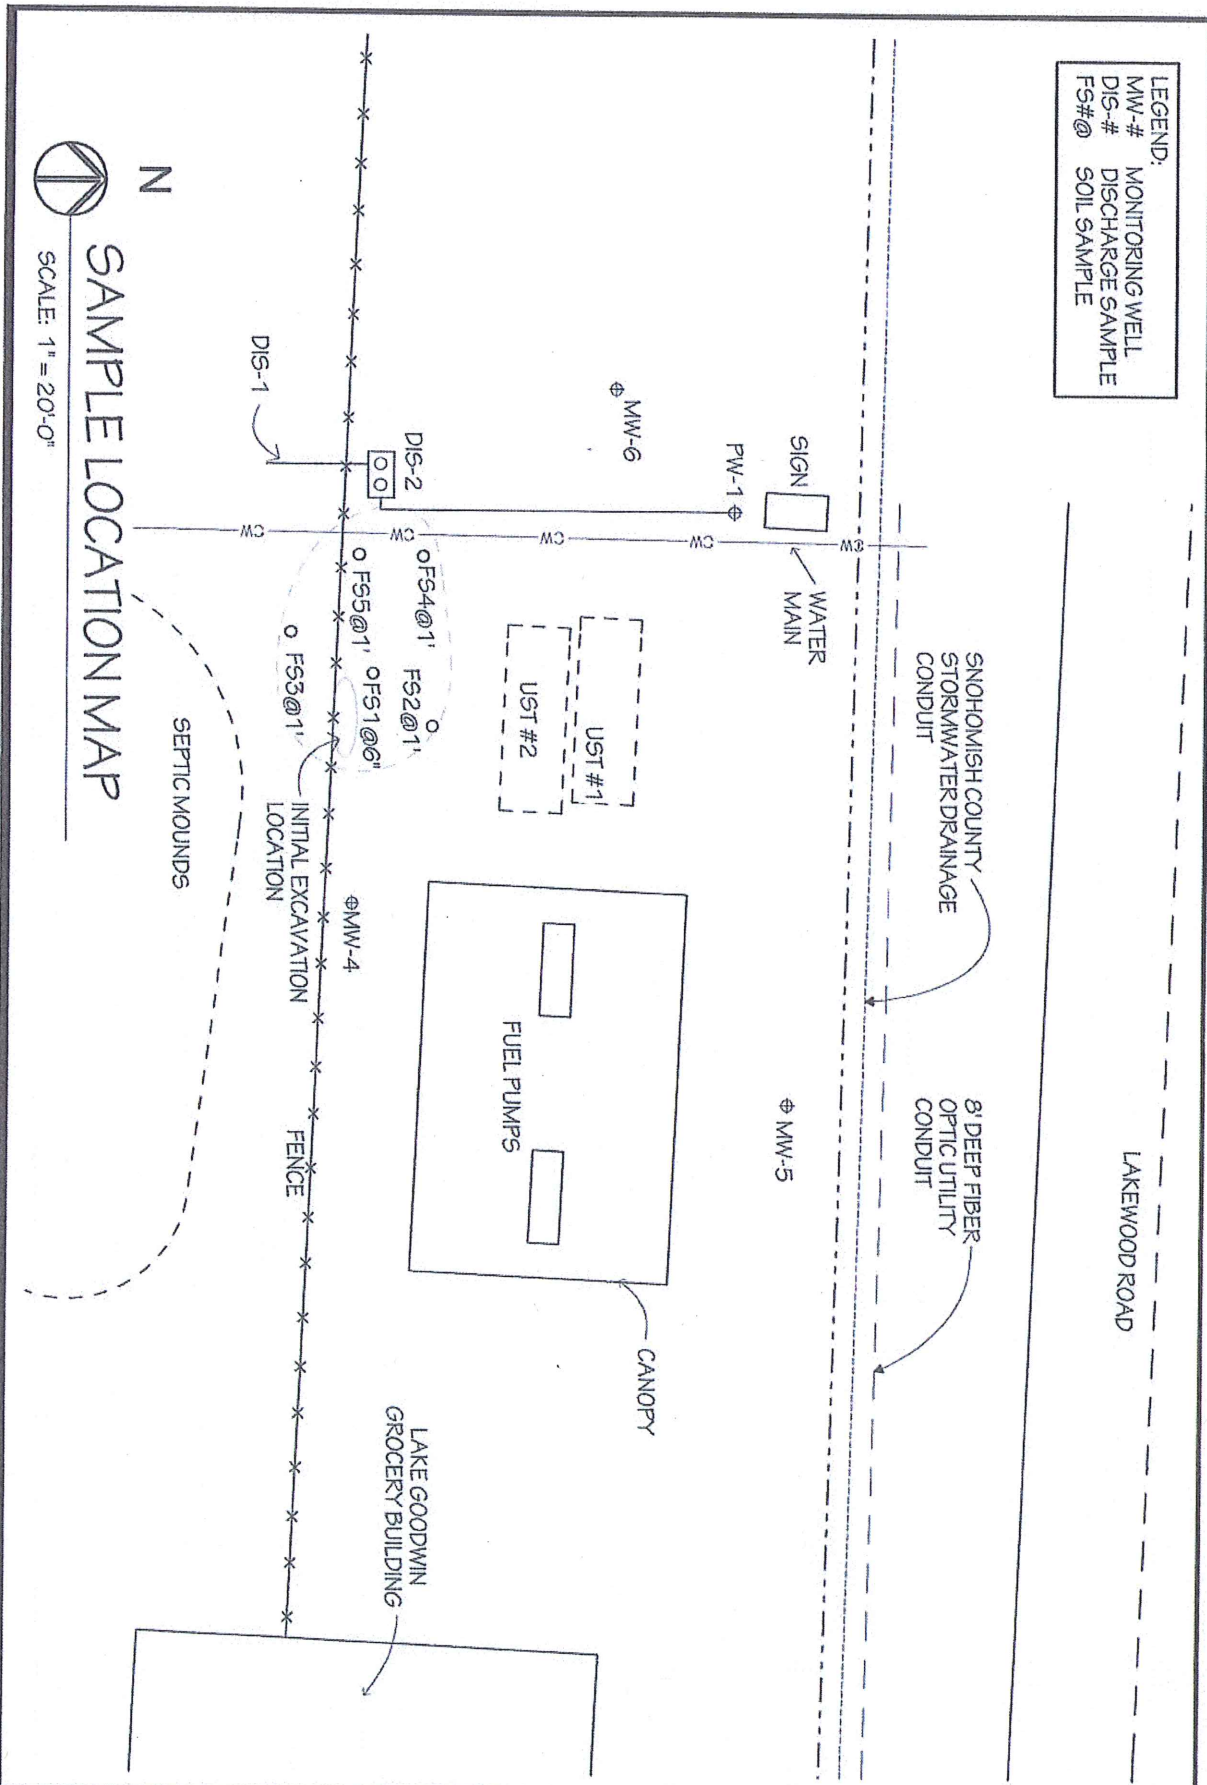
FIGURE 2
 SOIL SAMPLE
 LOCATION
 MAP

Property History and Current Use: The Property was first developed with a grocery store and gasoline station in 1926. Two previous release areas were identified at the Property prior to the 2013 release. The first release was identified in 2007 and was related to an historic dispenser island located at the northwest corner of the existing grocery store building. The second release occurred in April 2008 along the perimeter of the existing UST system footprint. Impacts to the Property from these releases were remediated and a No Further Action opinion letter was issued by Ecology in March 2013. The two gasoline USTs (capacities of 12,000 and 8,000 gallons) currently in use were installed in 1998 and are located on the west side of the grocery store (**Figure 3**).

Well PW-1, located in the northwest corner of the service station area (**Figure 3**), was reportedly installed during construction of the present service station in 1998, to regulate the shallow ground water levels during installation of the UST system. Pumping of this well has continued after 1998 to prevent periodic rises in shallow ground water from flooding the service station property. This well is 12 inches in diameter and equipped with a sump pump that is actuated by a float switch and runs intermittently. Discharge from PW-1 is routed through a garden hose to the grassy swale south of the service station. Estimates of the intermittent discharge, based on field observations, indicate an average discharge rate of approximately 10 gpm and a daily discharge volume on the order of 5,000 gallons.

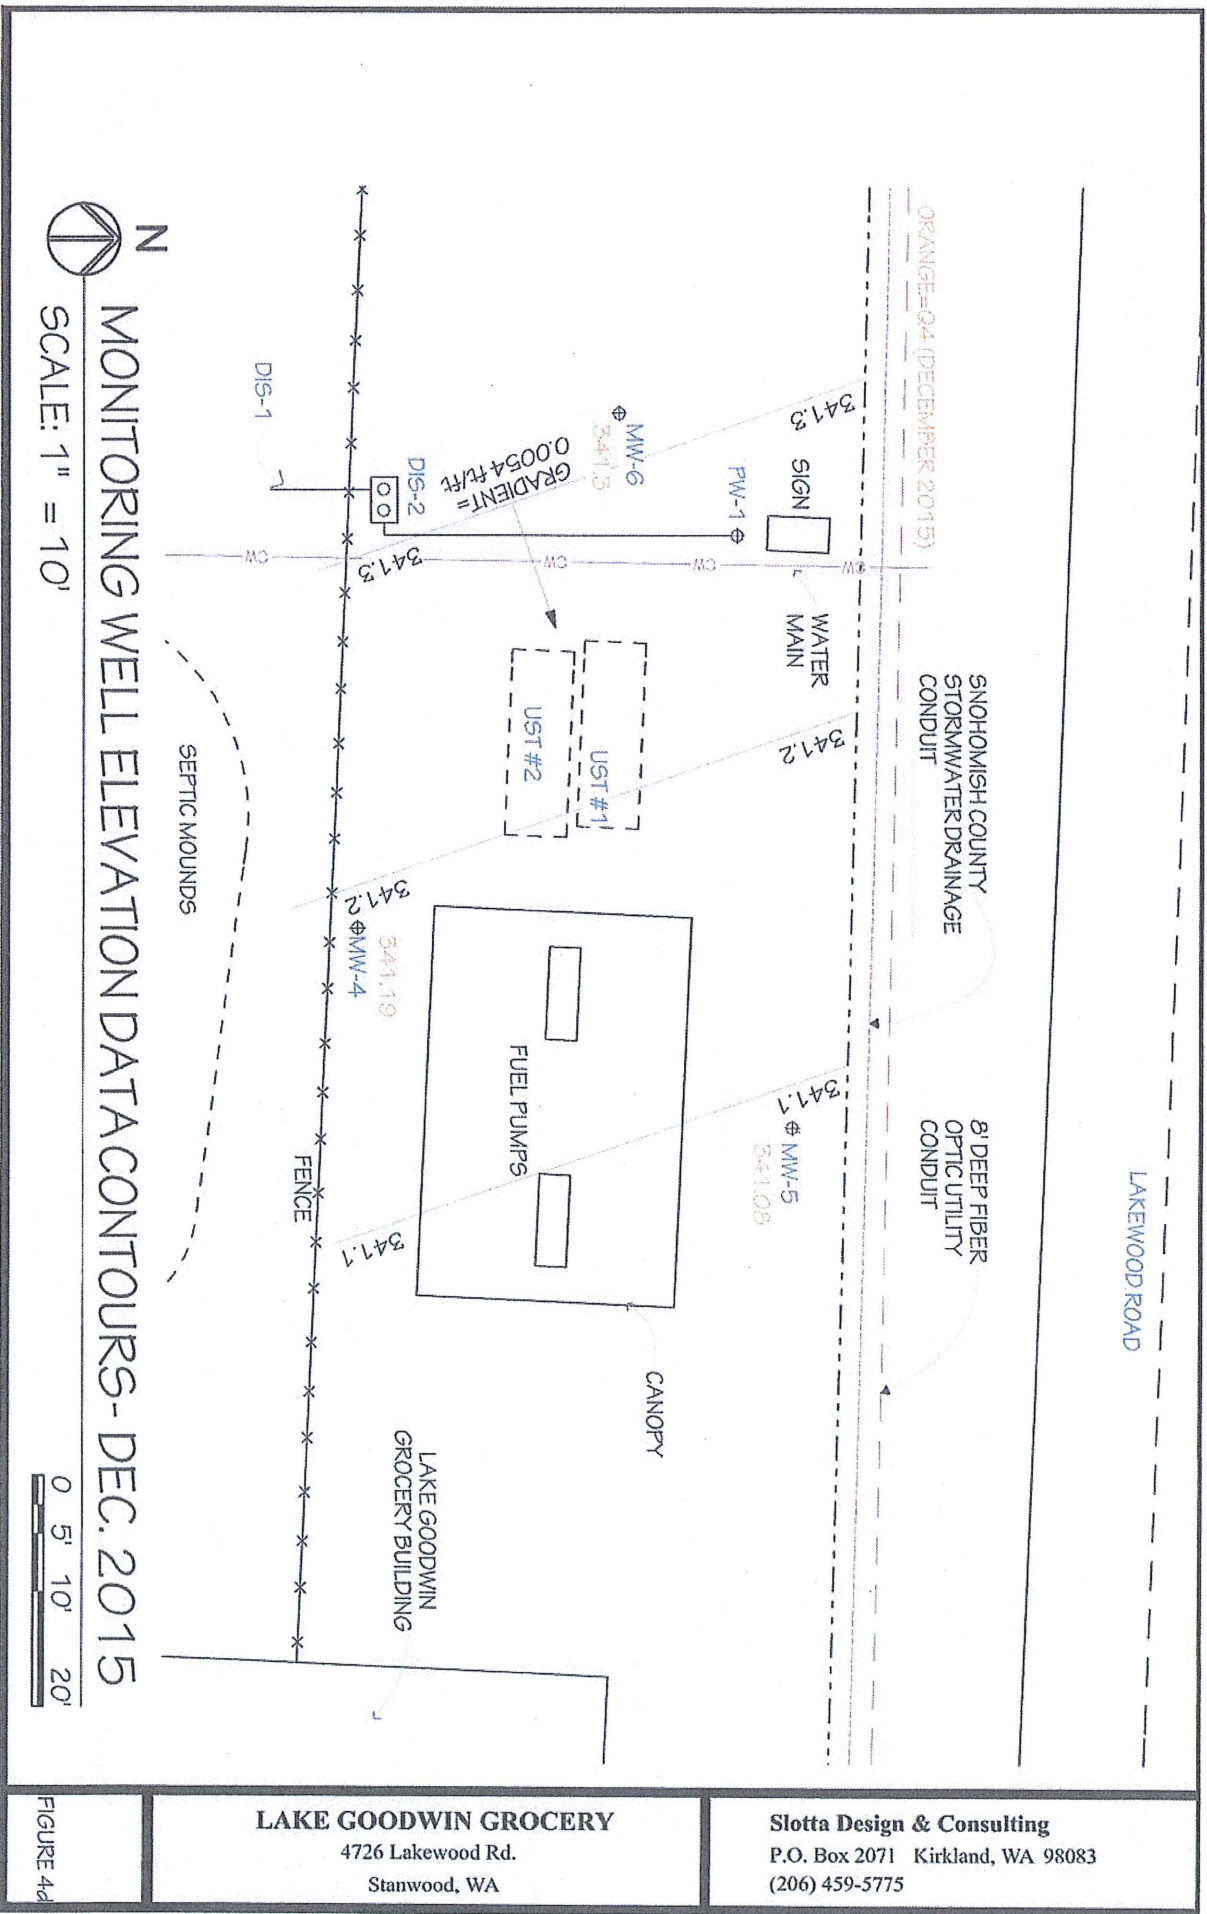
Enclosure A, Figure 4

Ground Water: The depth to ground water on the Site is within 1 to 4 bgs. Ground water elevation data from Site monitoring wells indicates a primary flow direction to the northeast and an average gradient of 0.006 feet per foot (**Figure 4**). Local factors that influence ground water flow direction and gradient include on-Site pumping well PW-1, a mounded septic system located southeast of PW-1 that serves the convenience store and the trailer park, a County surface water diversion drain, a fiber-optic utility conduit, and a water main (see **Figures 2 and 3**). Prior to completing water-level measurements and collecting water samples from pumping well PW-1, the air sparge system and sump pump were shut off and the well was allowed to stabilize for a period of at least 15 minutes.

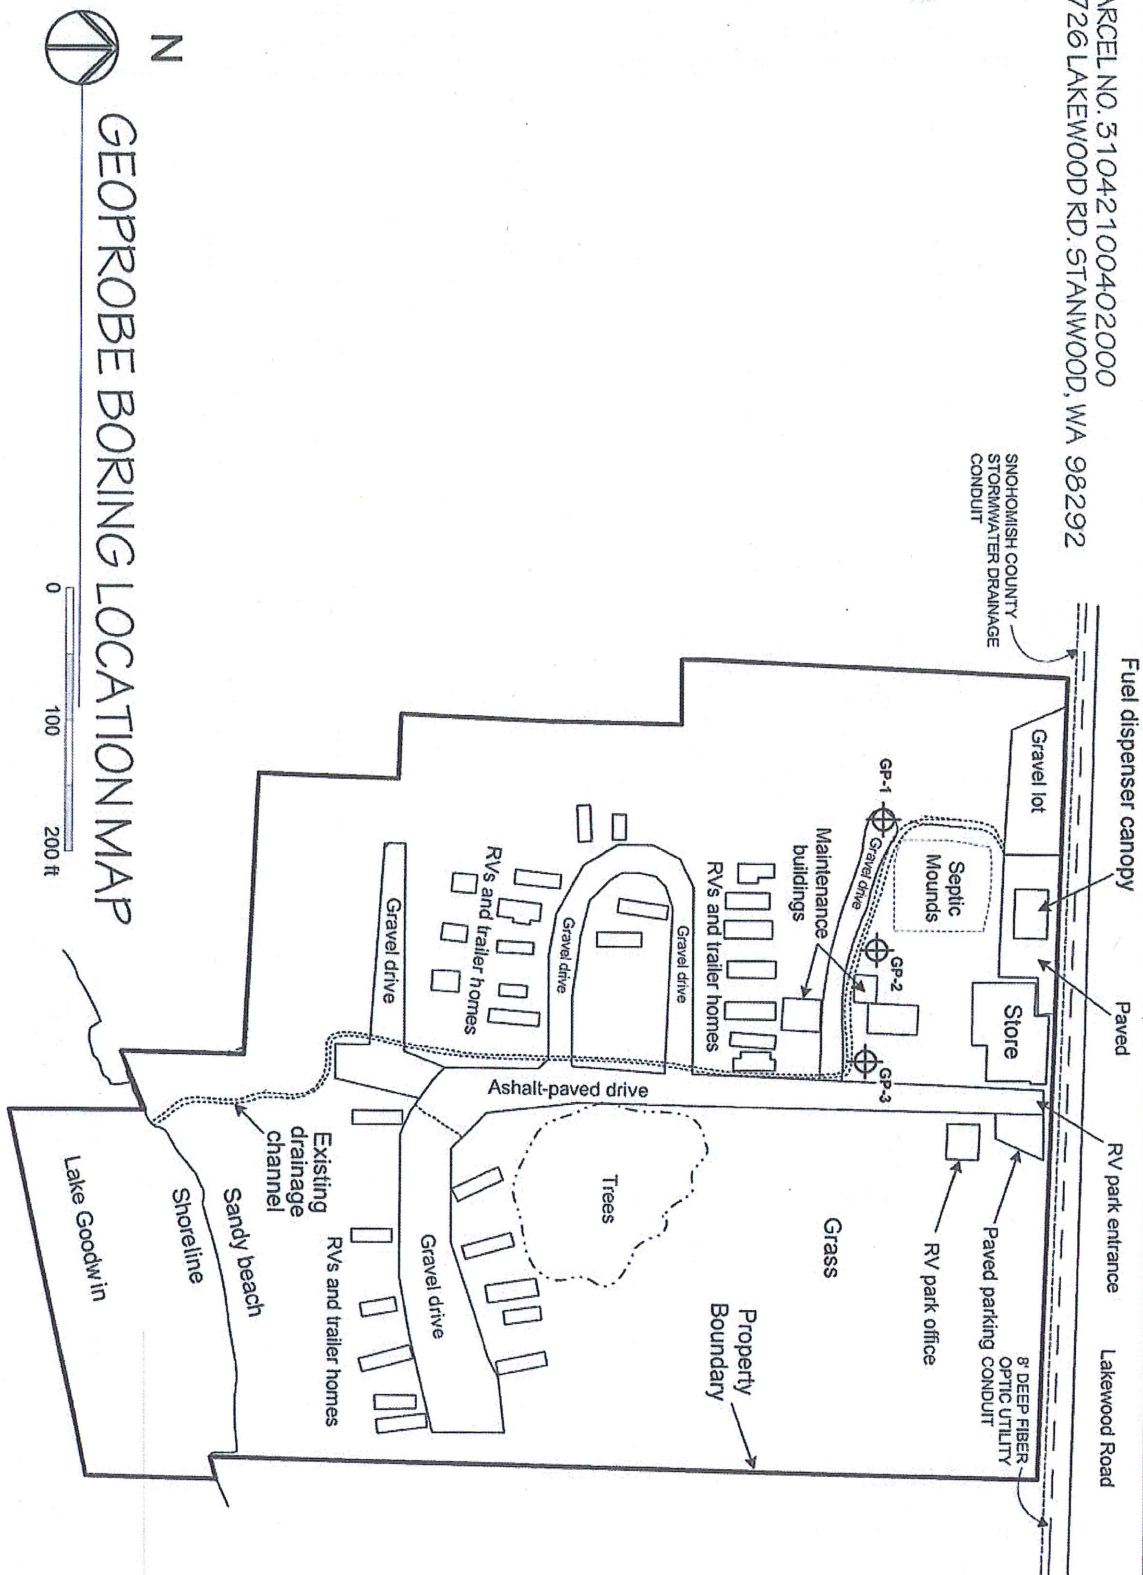
Enclosure A, Figure 6

Three confirmation soil borings were drilled at the Site on September 9, 2016, in the area of the grassy swale south of the gasoline station, to assess potential residual soil and ground water impacts from well PW-1 discharges subsequent to the release (**Figure 6**). Soil samples were collected from each boring at a depth of 4 feet bgs (above the ground water level observed at the

time of drilling), followed by collection of ground water probe samples above the total boring depths of 9 feet bgs. None of these soil or ground water samples contained TPHg or BTEX at concentrations greater than MTCA Method A cleanup levels. These sampling results resolve the issue raised in the April 1, 2014 Ecology opinion letter regarding potential residual soil impacts from the gasoline spill.
