TECHNICAL MEMORANDUM

**RE: EMERGENCY ACTION CLEANUP
CRAFTSMAN DISTRICT BOATYARD EXPANSION AREA
NORTH MARINA AMERON/HULBERT SITE
EVERETT, WASHINGTON**

**Emergency Action
Cleanup Areas and Compliance
Monitoring Sample Locations**

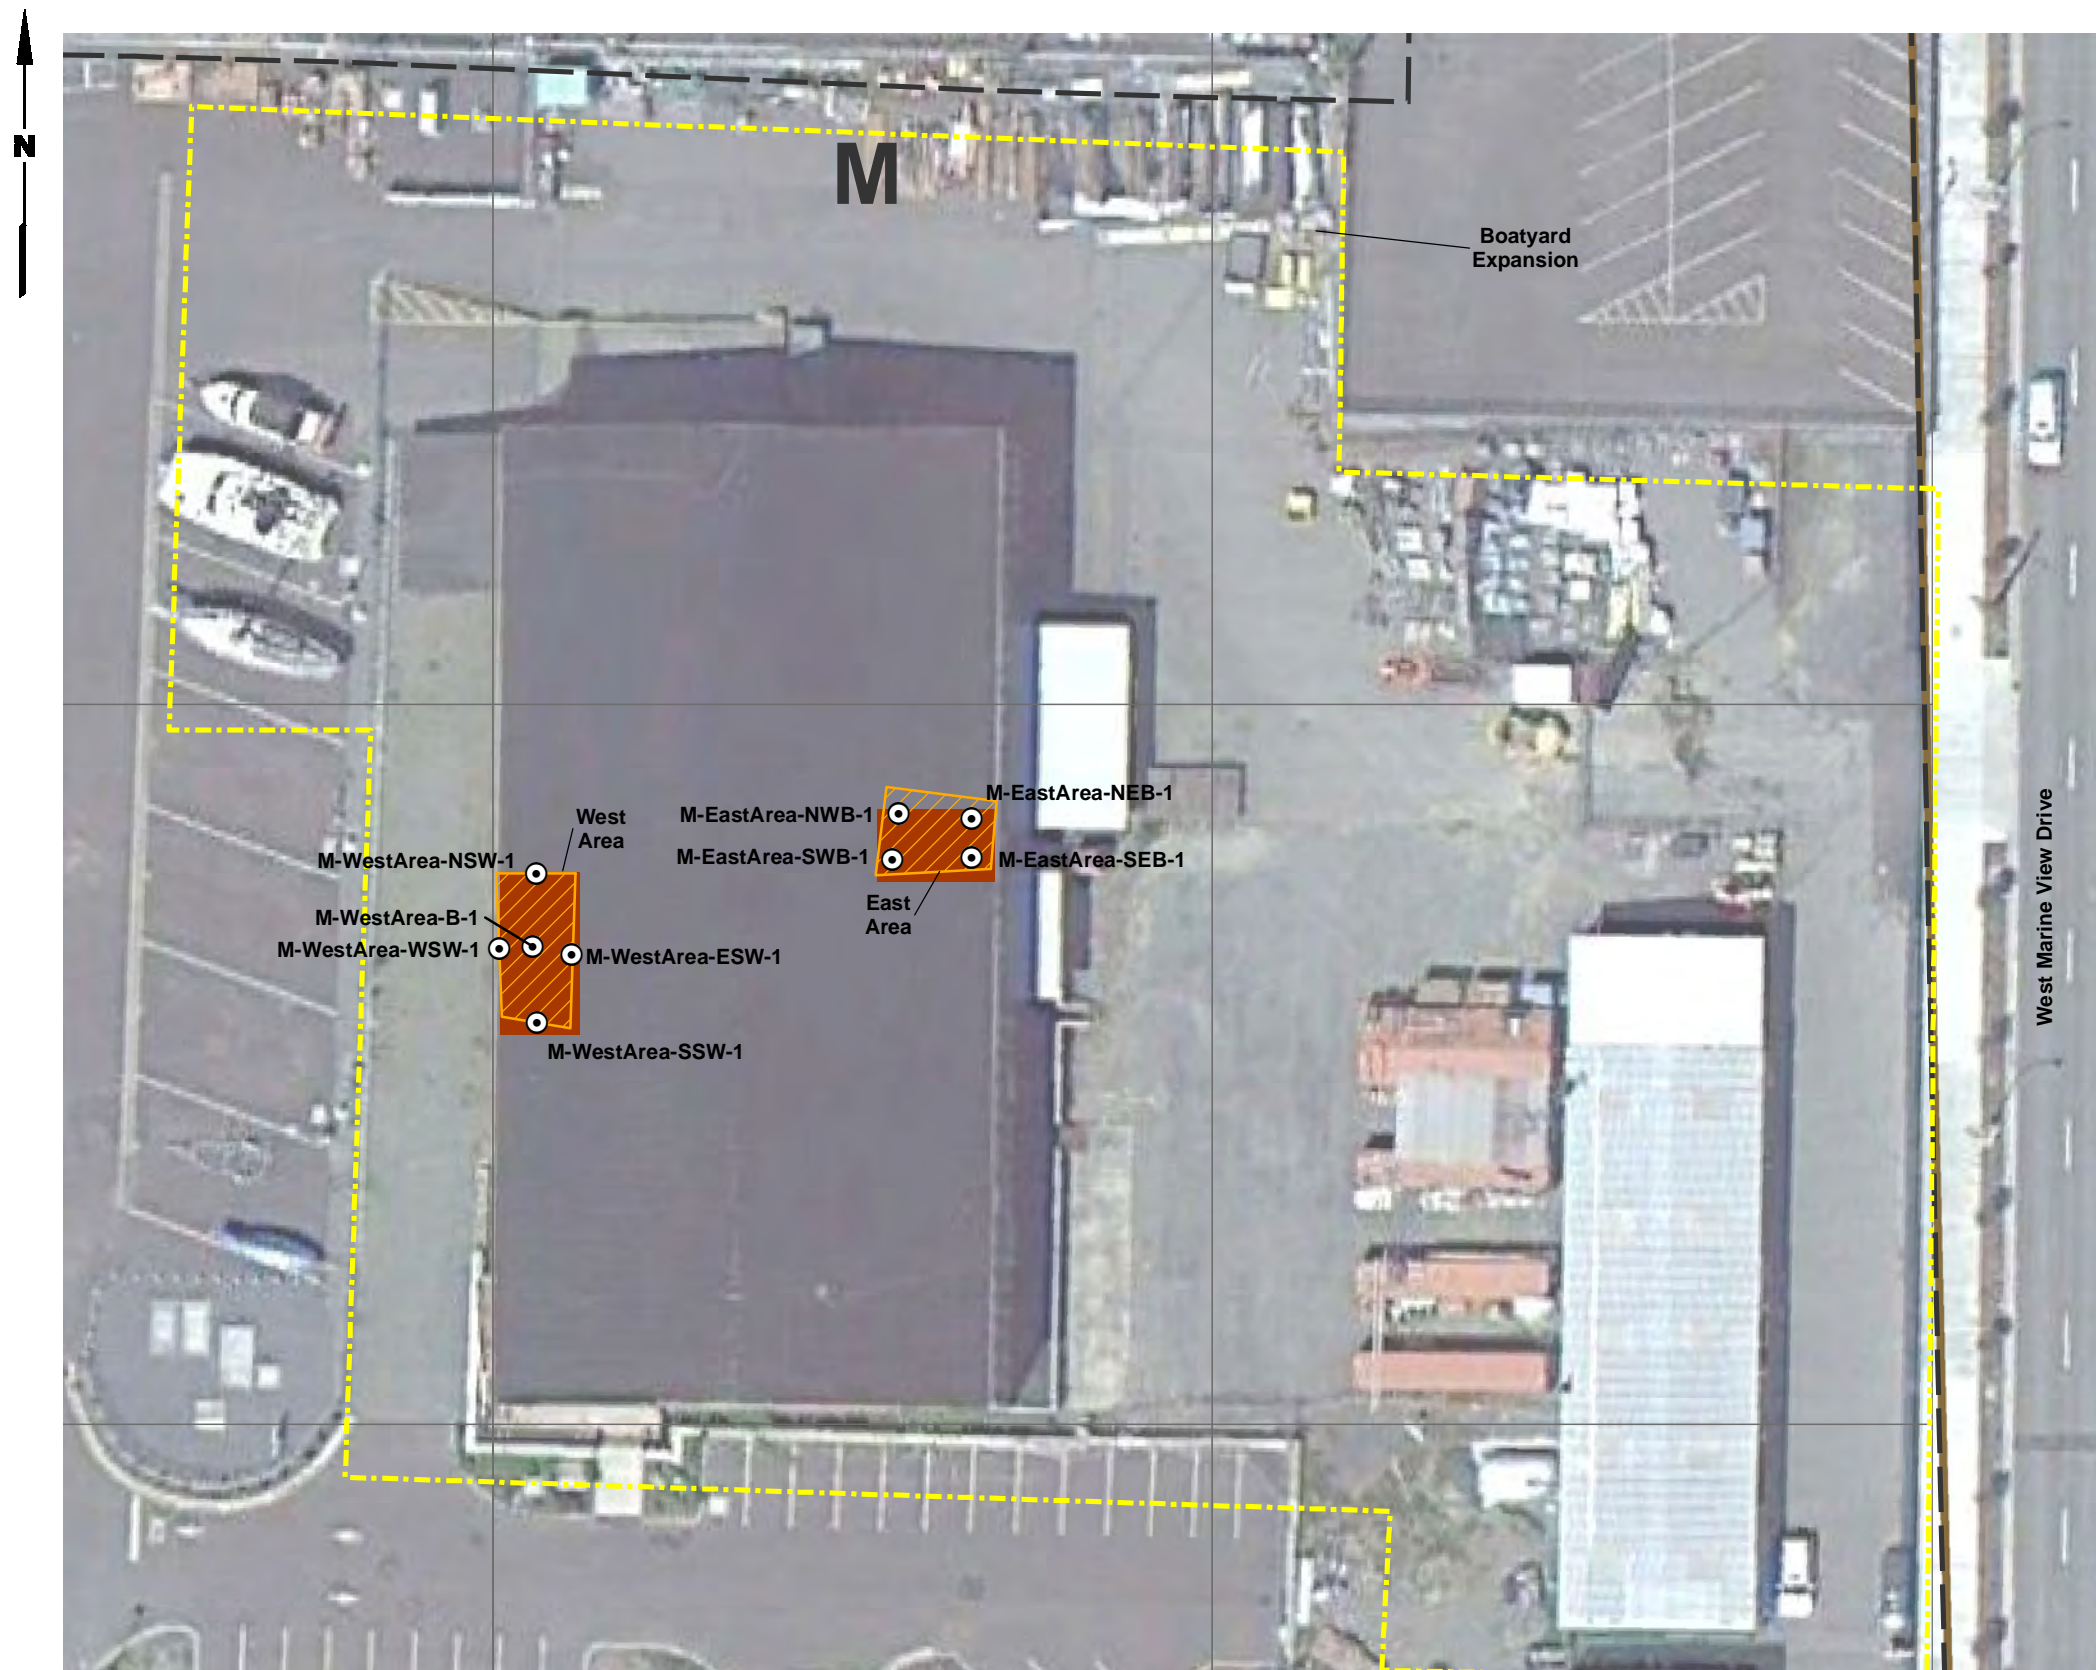
Figure
1

the excavation (Figure 1). The samples were analyzed for diesel- and heavy oil-range petroleum hydrocarbons by Method NWTPH-Dx. Petroleum hydrocarbons were not detected in any of the compliance monitoring samples in the West Area at concentrations greater than the laboratory reporting limits. Results of compliance monitoring sampling in the West Area are presented in Table 1.

Excavation activities were completed on August 22, 2011. Based on visual observation compliance monitoring (discussed in the next section), the West Area excavation extended to 2 to 3 ft BGS within the visually affected area. The total volume of soil removed from this area was approximately 44 cubic yards.

Prior to East Area excavation, clean overburden material (crushed rock) was removed and stockpiled for reuse as excavation backfill. Additionally, a concrete slab located on top of the affected material was demolished and transported to an offsite recycling facility. Petroleum hydrocarbon soil contamination in the East Area was initially excavated to a depth of about 1.5 ft BGS. However, because petroleum hydrocarbons were observed during field screening and sheen was observed in water that collected at the base of the excavation, the excavation was continued to a depth of about 2.5 ft BGS, at which point field screening no longer indicated the presence of petroleum hydrocarbons and sheen was no longer observed to be present. Compliance monitoring (discussed in the next section) confirmed that concentrations of petroleum hydrocarbons were below the Site PSLs. The total volume of soil removed from this area was about 35 cubic yards.
