STATE OF WASHINGTON
DEPARTMENT OF ECOLOGY

January 25, 2012

RE: Further Action At The Following Site:

- **Site Name:** United Airlines SeaTac International Airport
- **Site Address:** 2230 South 161st Street
- **Facility/Site No.:** 1623532
- **VCP Project No.:** NW2257

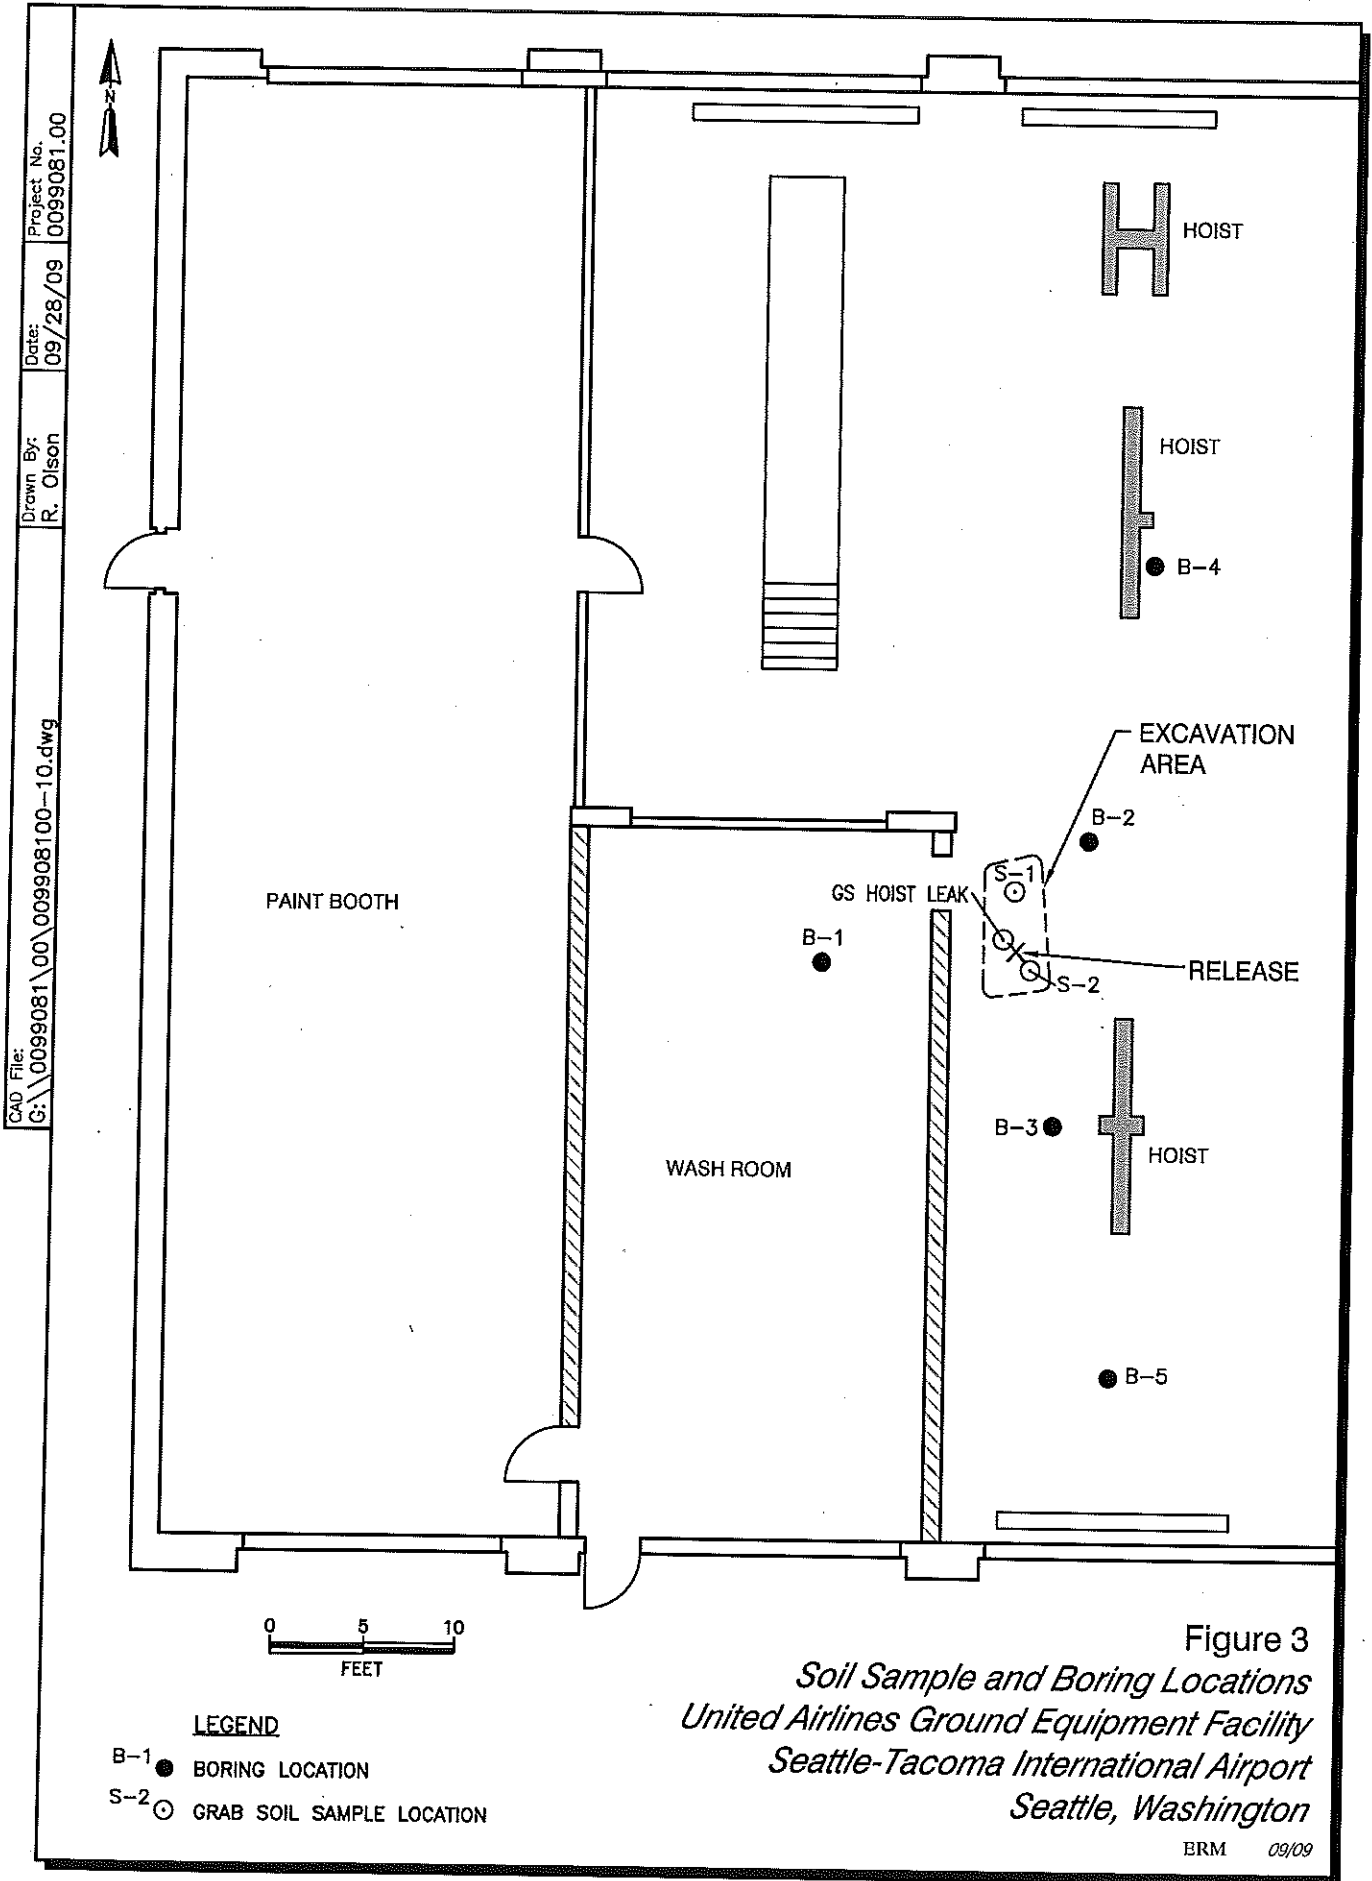
Figure 3
 Soil Sample and Boring Locations
 United Airlines Ground Equipment Facility
 Seattle-Tacoma International Airport
 Seattle, Washington

borings that have been drilled 6 feet away from the release may not have adequately characterized the vertical extent of contamination. In addition, it is unknown to what extent a gravel lens underlying the spill location may have influenced contaminant migration.

A fine gravel lens encountered in soil borings at depths of 9 to 10 feet below the ground surface ranges in thickness from approximately 1 to 5 feet. Based on the boring logs, the gravel lens thickens and slopes to the west and apparently pinches out to the north and south. The gravel lens directly underlies the hoist leak location such that hydraulic oil migrating vertically downward through the sand and gravel may have flowed into this more permeable zone as a preferential pathway. The only soil sample collected from the gravel lens was in boring B-2 at the base of the lens which yielded a total petroleum hydrocarbon heavy oil concentration of 1,200 mg/kg.

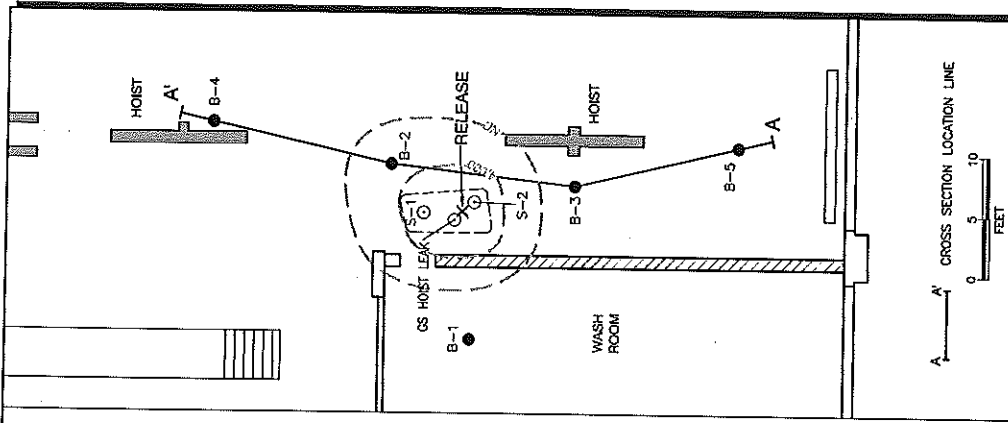
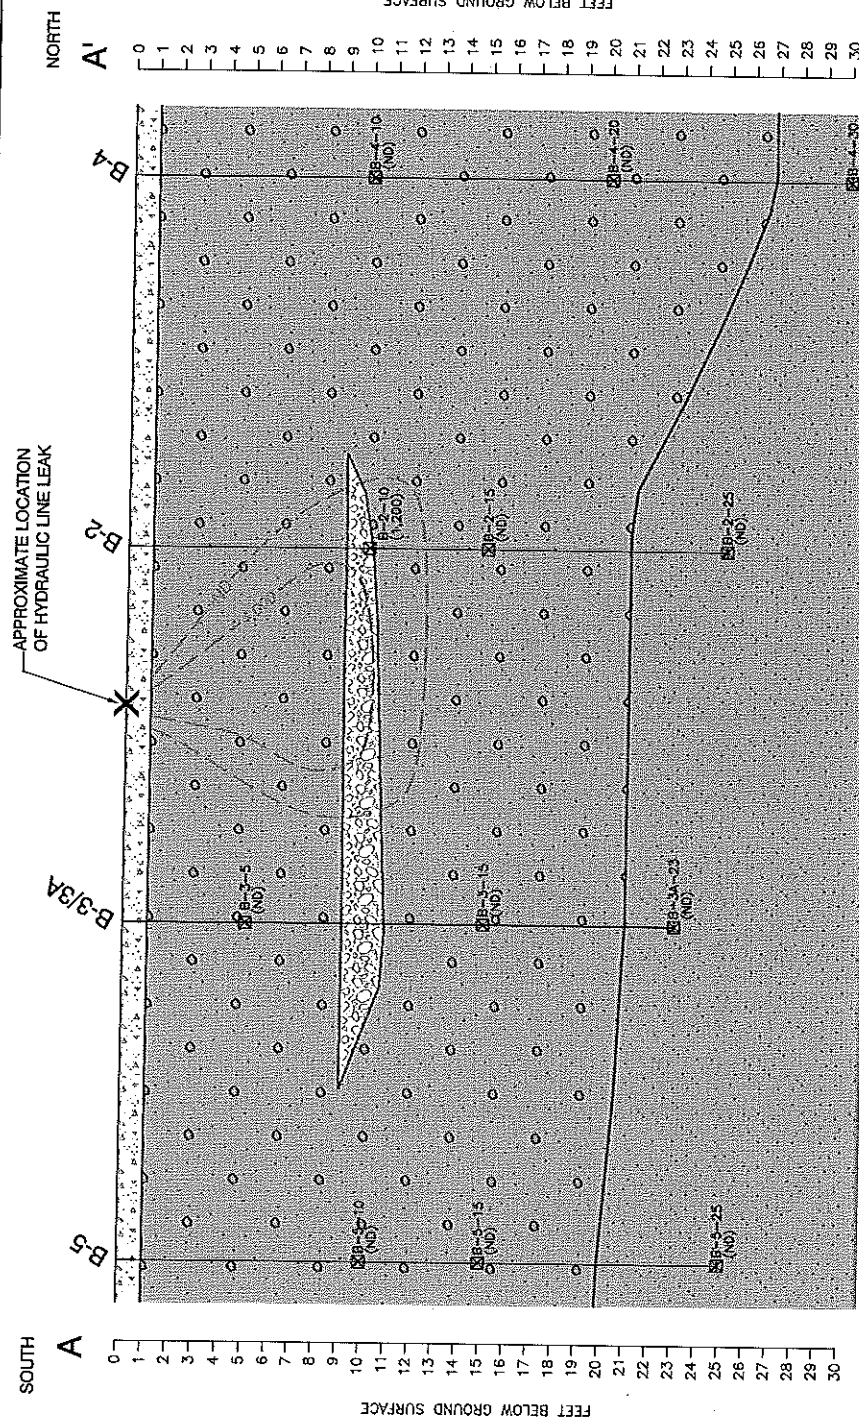
Figure 4
Cross Section A-A'
 United Airlines Ground Equipment Facility
 Seattle-Tacoma International Airport
 Seattle, Washington
 ERSA 09/09

Ground water was not encountered in five soil borings ranging in depth from 23 to 30 feet below the ground surface that were advanced to investigate soil potentially impacted by the release. Ground water was also not encountered in three soil borings drilled in 2002 to depths of 60 feet below the ground surface with the exception of a discontinuous perched zone at a depth of 20 to 25 feet in boring Lft-1.

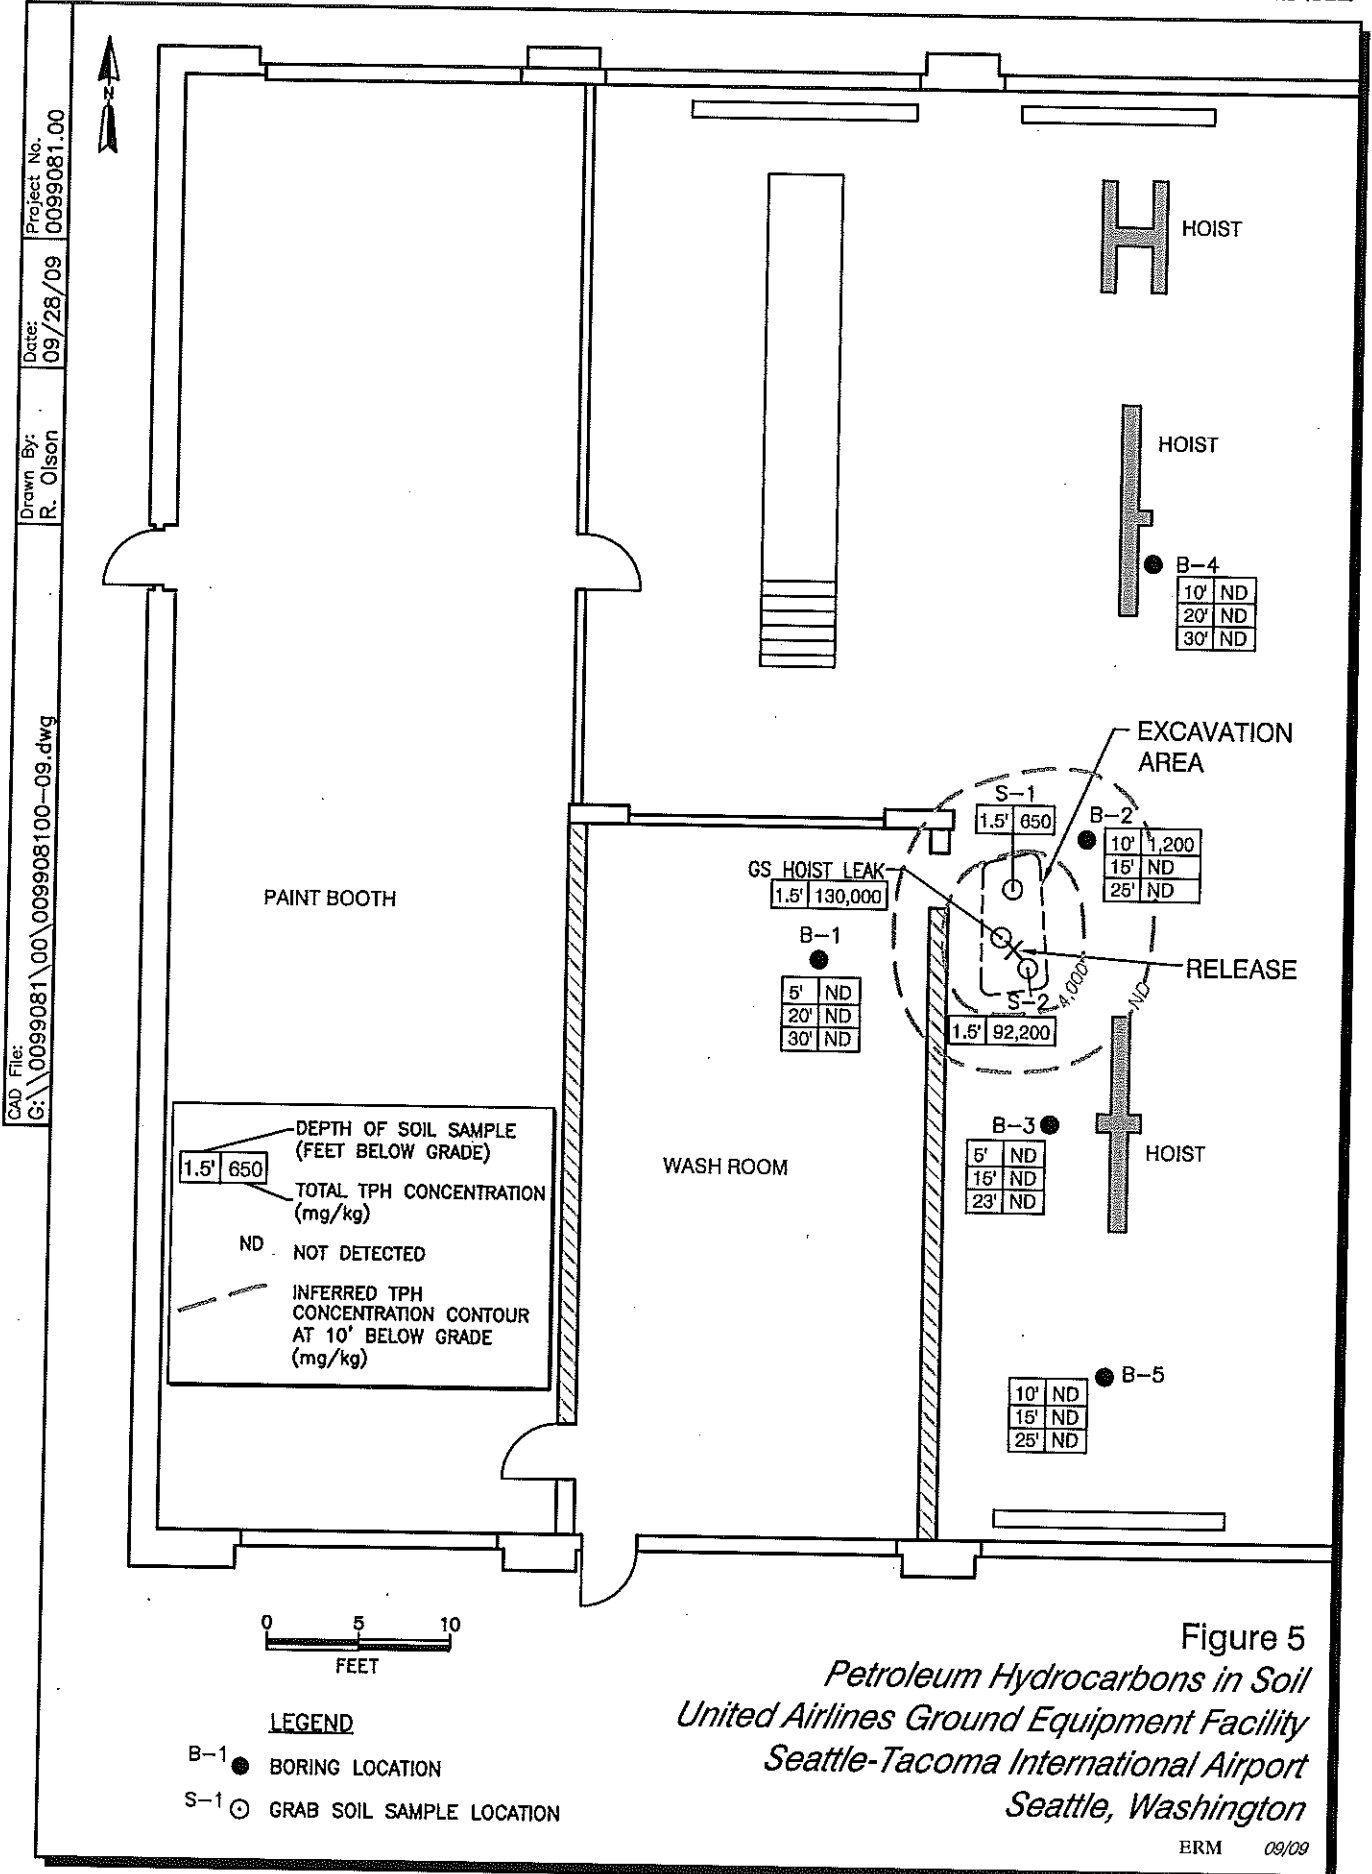
Figure 5
 Petroleum Hydrocarbons in Soil
 United Airlines Ground Equipment Facility
 Seattle-Tacoma International Airport
 Seattle, Washington

On June 30, 2009, approximately five cubic feet of contaminated soil was removed to a depth of three feet below ground surface using an air knife and vacuum truck. An estimated 50± cubic yards of soil with concentrations above cleanup levels was left in place, because it is not readily accessible for excavation due to the proximity of structural footings and underground infrastructure.
