## **ENVIRONMENTAL CAP INSPECTION REPORT**

### **FORMER CASCADE TIMBER NO. 3 LOG SORT YARD**

**Consent Decree No. 94-2-03590-3  
Washington State Department of Ecology Facility Site ID # 1206  
Inspection Date: February 4, 2017**

**March 22, 2017**

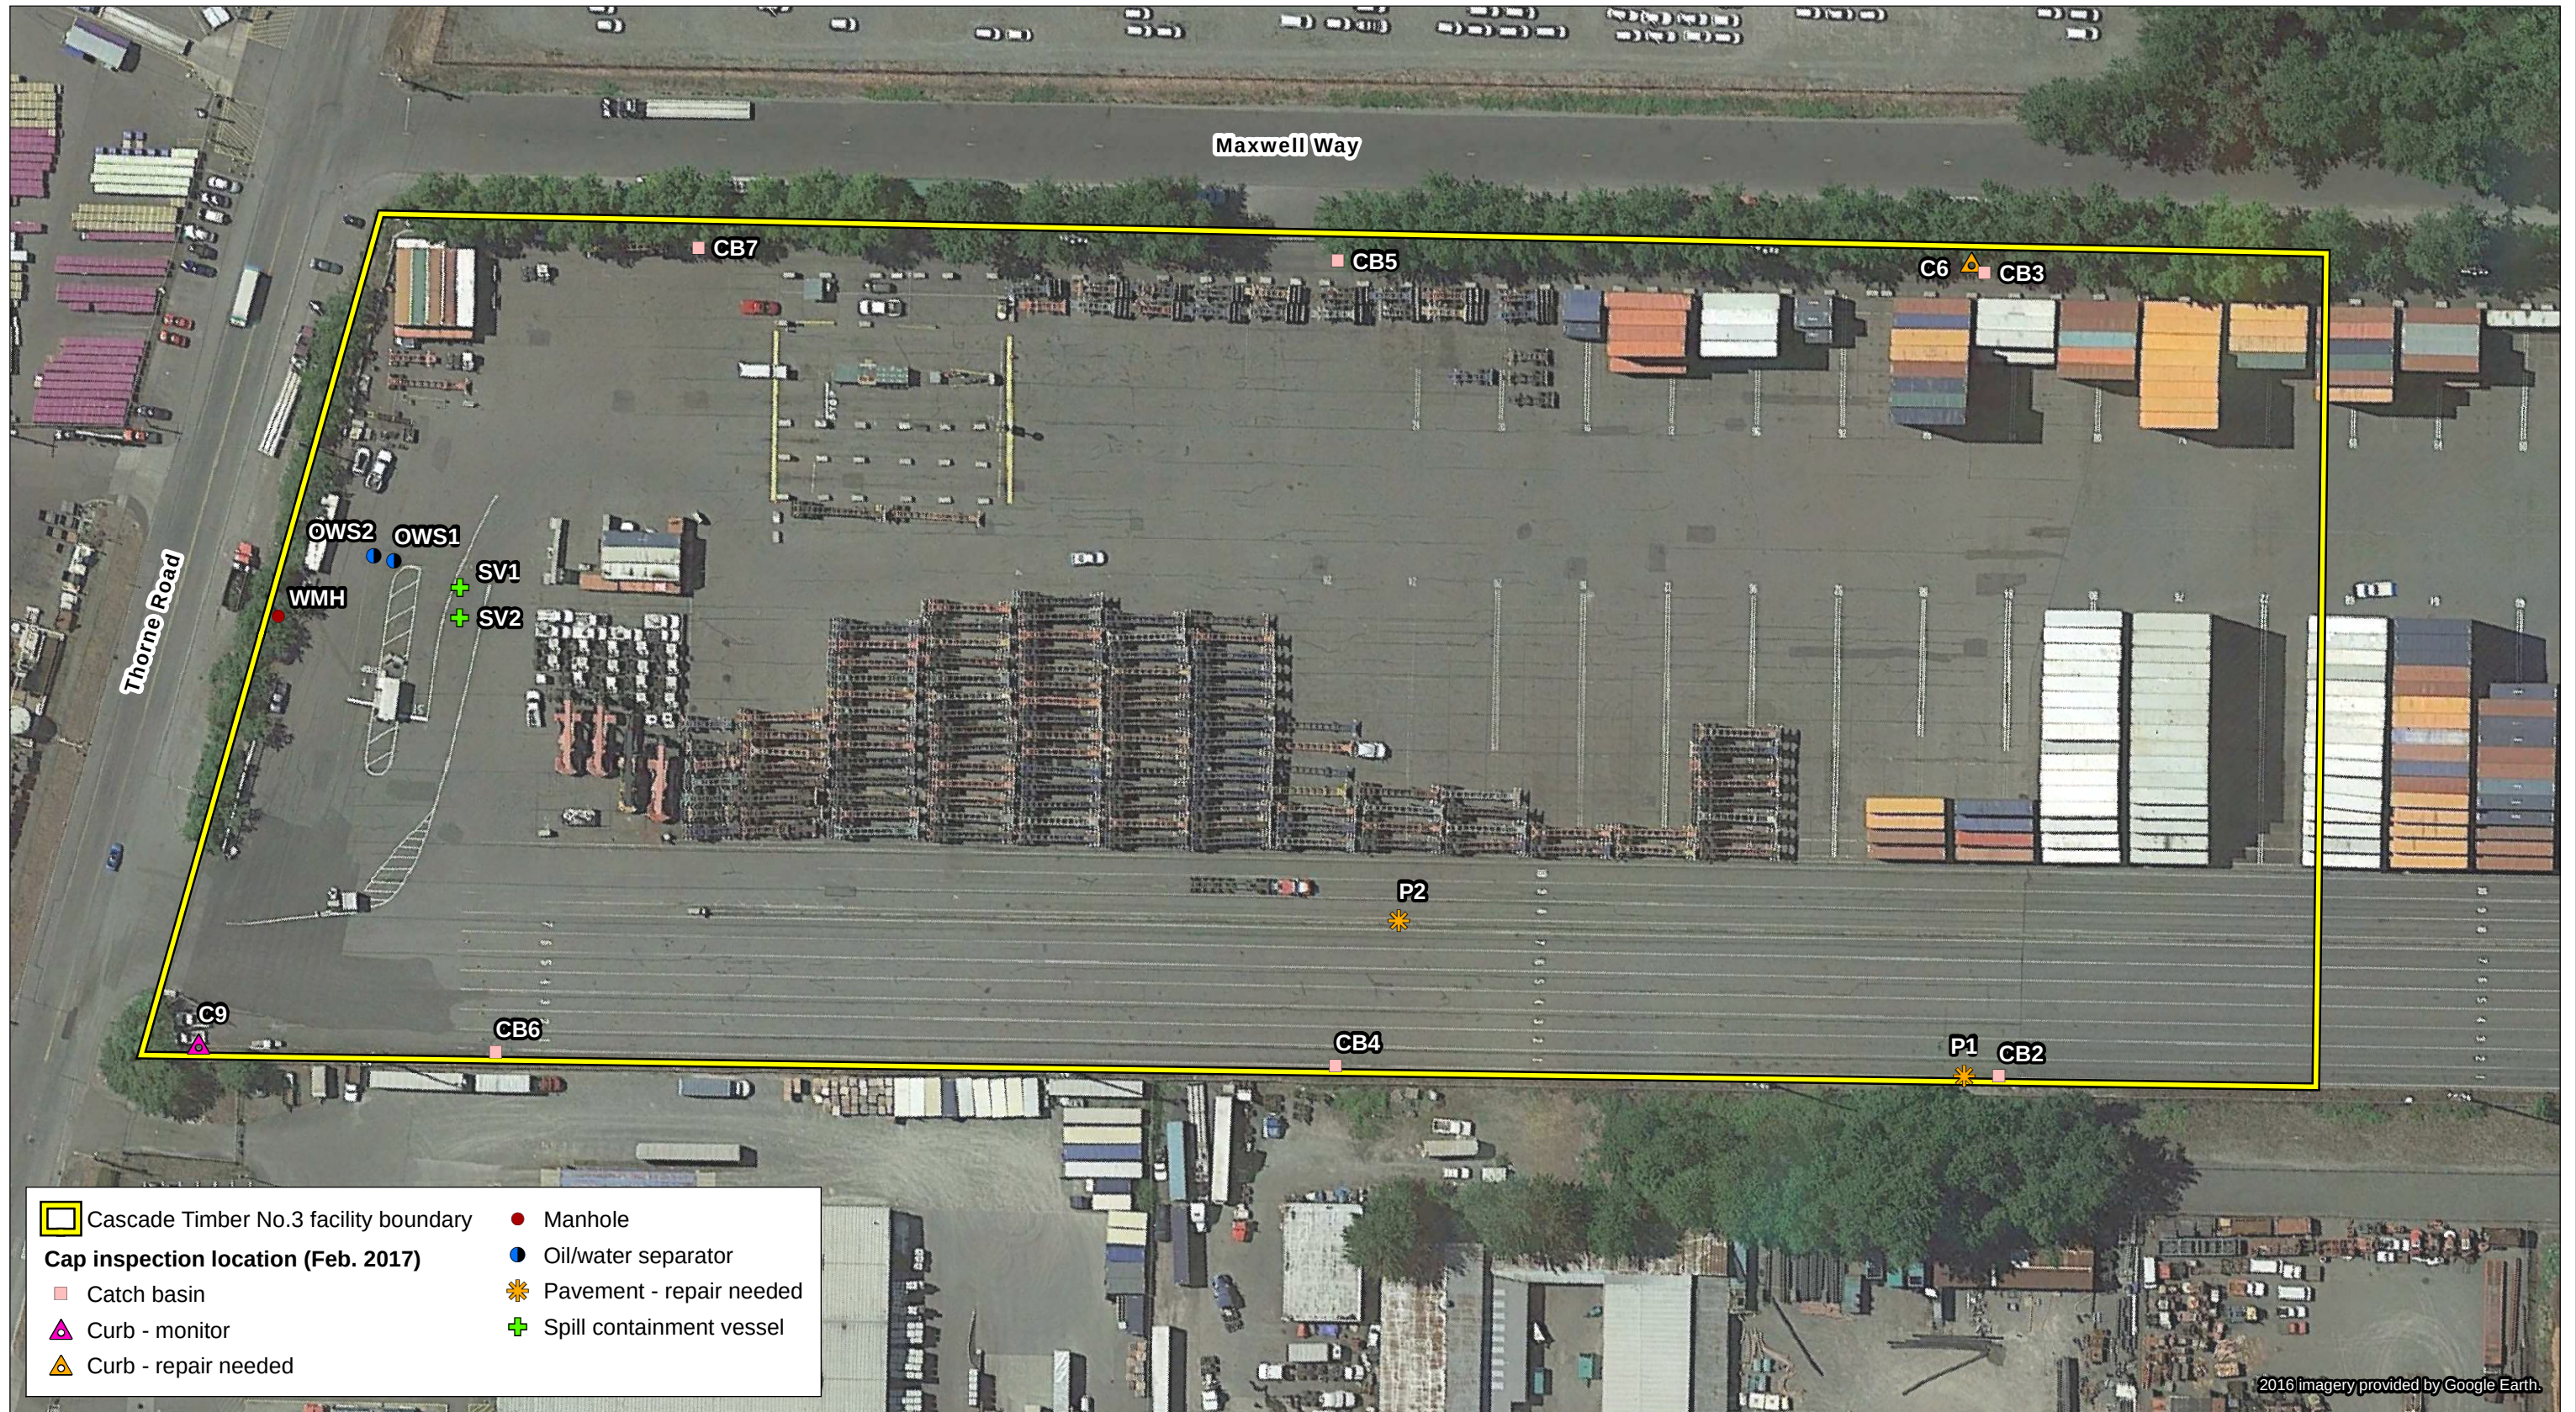
Figure 2. Cascade Timber No. 3 field observations

No cracks wider than 1/8 in. were observed except for those located around the perimeters of spill containment vessel manholes SV1 and SV2; surface deterioration was also noted at pavement inspection locations P1 and P2 (Figure 2). These items are listed in Table 2, together with photos showing the damage and recommendations for repair.

Numerous portions of the curb surrounding the facility were observed to have been recently repaired (Figure 2 and Table 3). One portion of the curb on the northwest side of the facility is broken and should be repaired (Section 3.2.1 and Figure 2). Another portion of the curb located near the southern corner of the facility is deteriorating and should be monitored during future inspections (Figure 2).

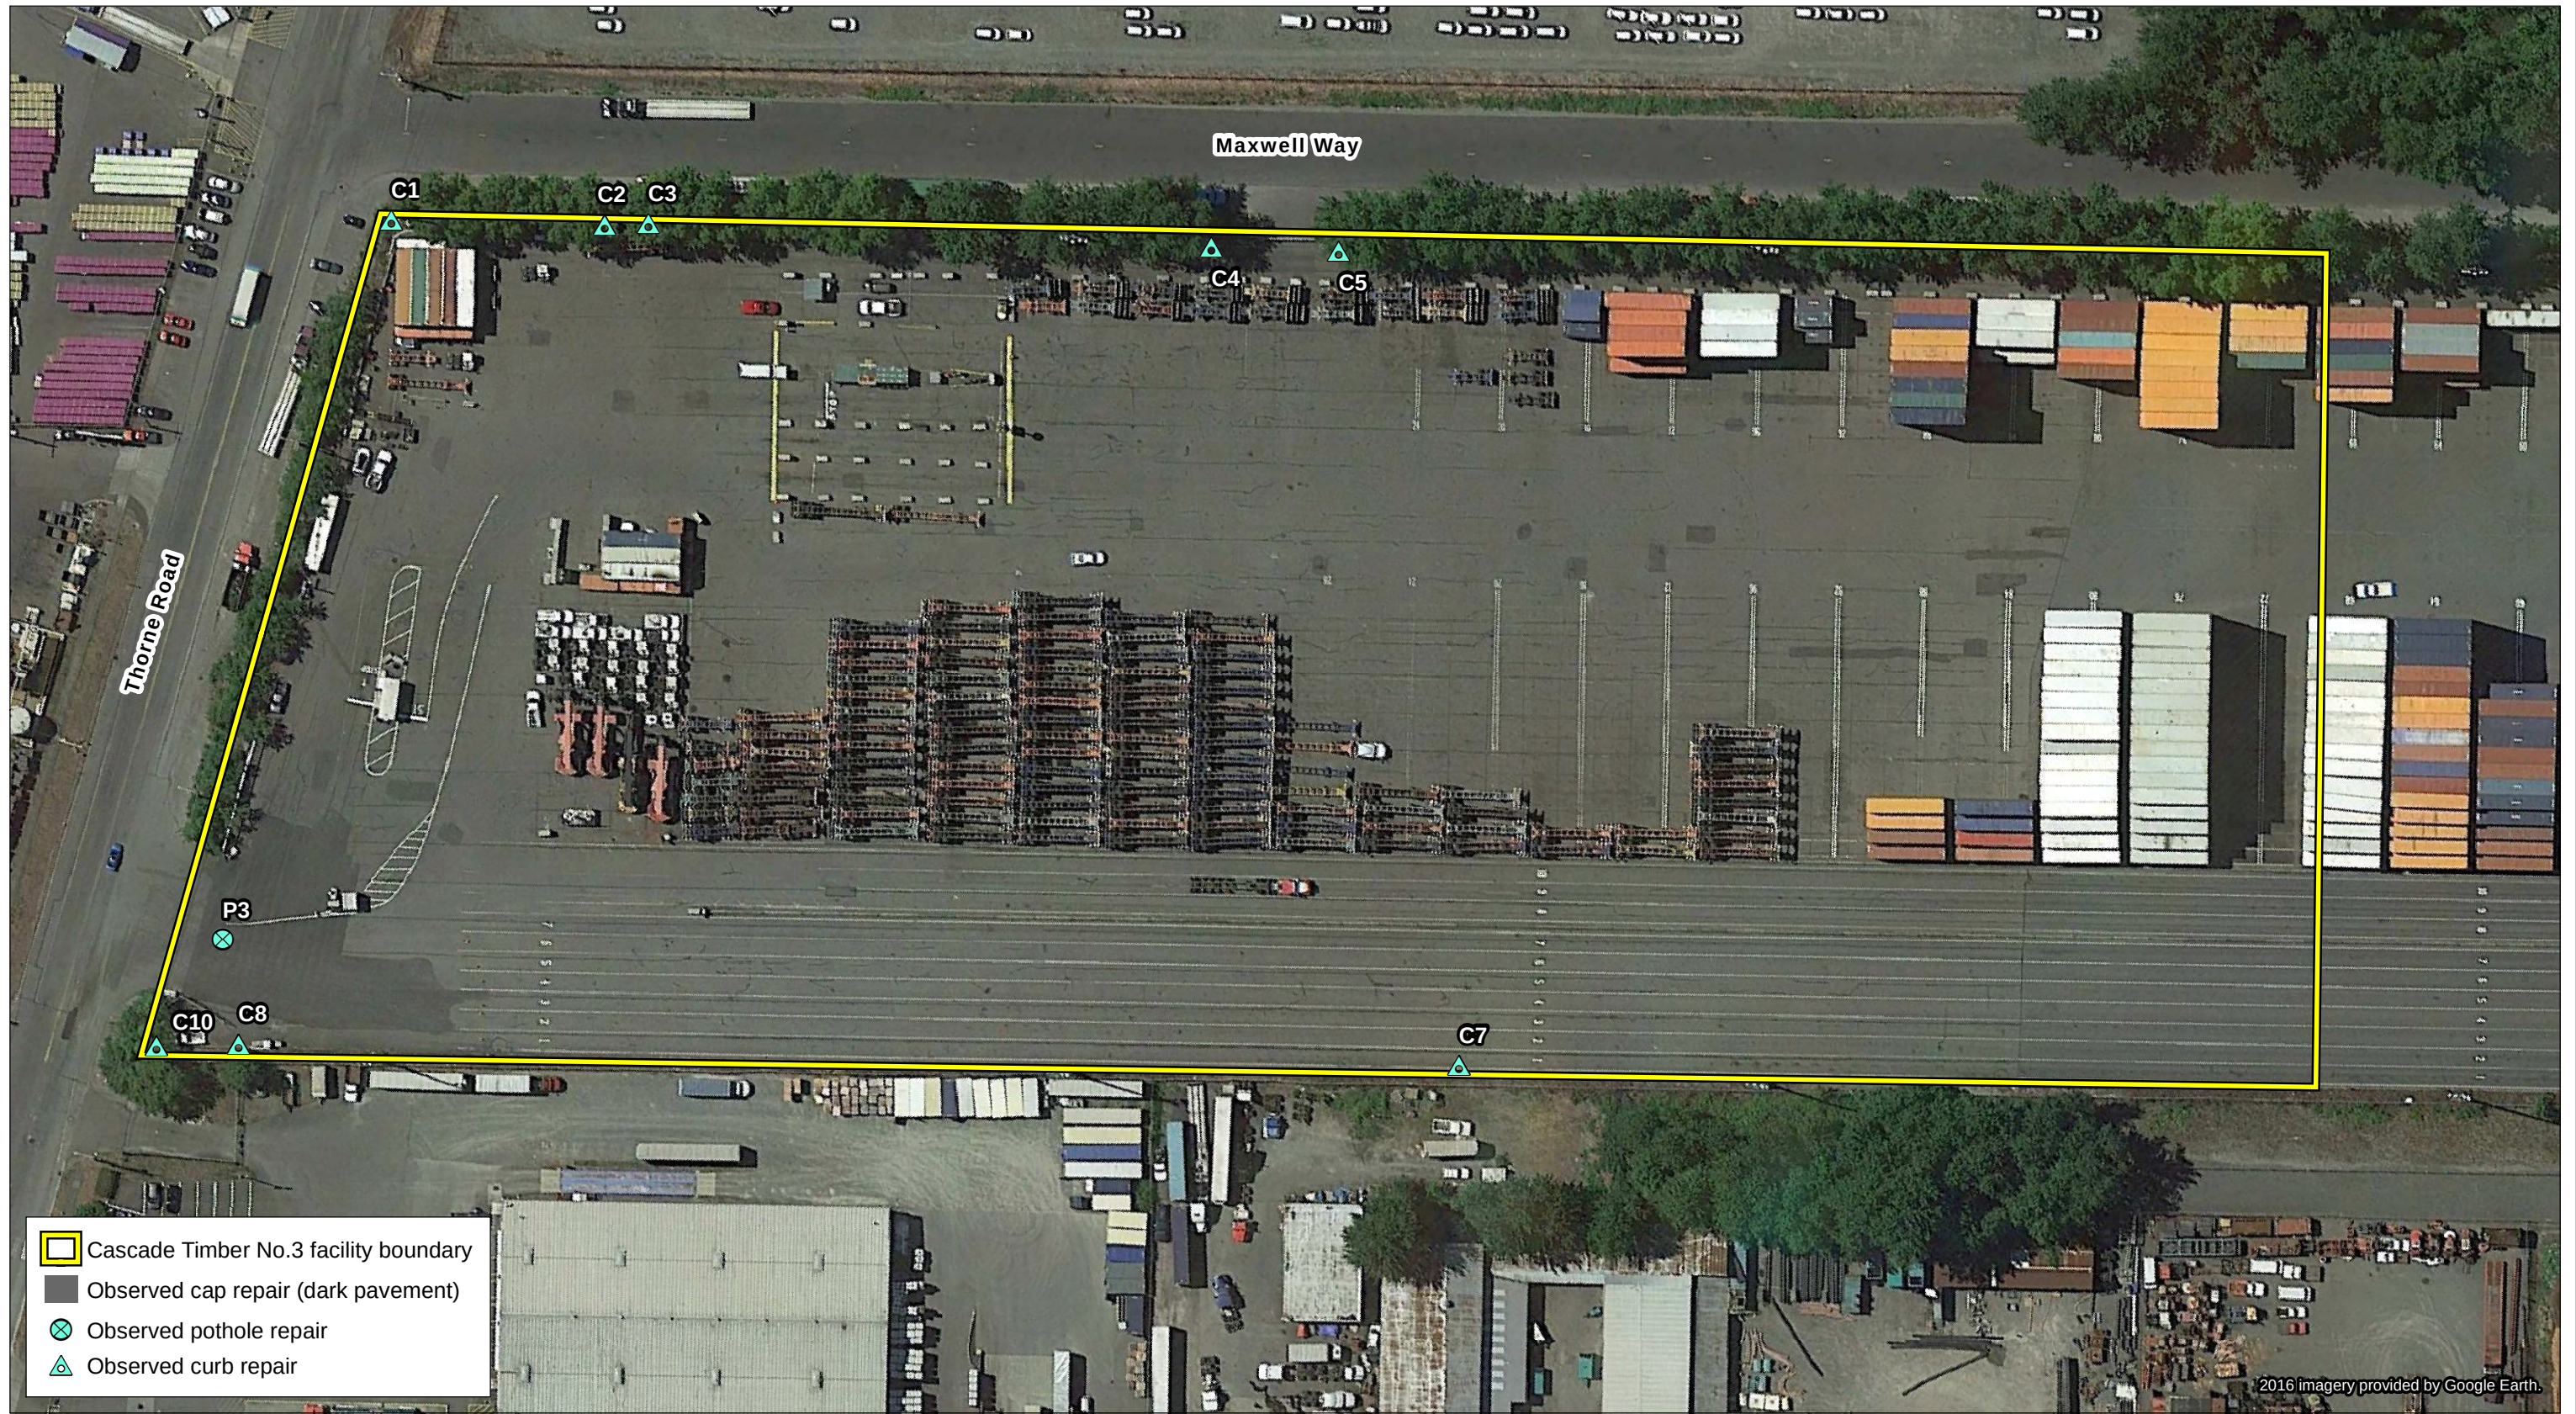
Figure 3. Cascade Timber No. 3 cap repair — Summer 2015

In general, the environmental cap was observed to be in good condition, with the exception of the localized items described below. A summary of the cap conditions is provided in Table 1. The general appearance of the cap indicated that it is being well maintained. Many newly repaired (i.e., sealed) cracks were observed, indicating that the Port has implemented measures to address maintenance needs identified during the previous survey (Hart Crowser 2014). Most recently, the Port made cap repairs during the summer of 2015; a summary of these repairs is presented in Figure 3. During the summer 2015 repairs, cracks 1/8 in. or wider were blown out (i.e., cleaned using pressurized air) and sealed with rubberized mastic. In high-traffic areas, large repairs were covered with a slurry seal to protect the rubberized mastic. Curbs were repaired where necessary.

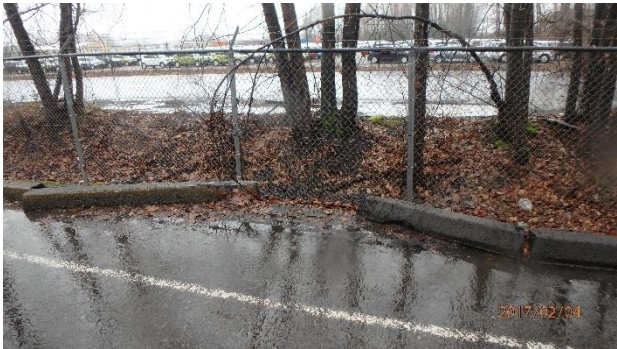
| Location ID <sup>a</sup> | Observations | Recommended Actions | Photos |
|---|---|---|---|
| C6 | curb broken in several locations (within 15 ft); middle portion of curb no longer located on cap | repair curb | |

Two areas of curb damage and two areas of pavement deterioration were observed during this inspection. The first area of curb damage is located on the north side of the cap, in the vicinity of catch basin CB3 (C6 on Figure 2). The curb is broken in several locations and is not aligned with the surrounding curb. In addition, the middle portion of the damaged curb is no longer located on the cap; it is now in the ditch north of the cap. The curb should be repaired in this area to prevent water from draining off the capped area.

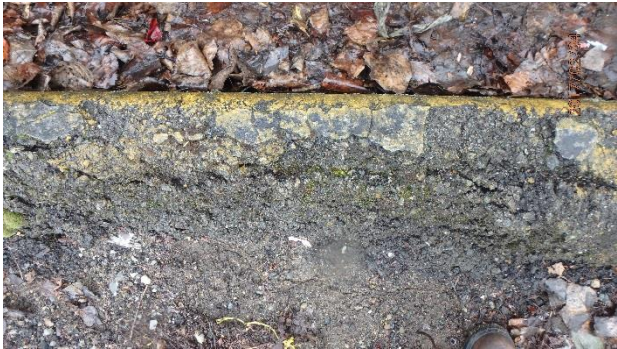
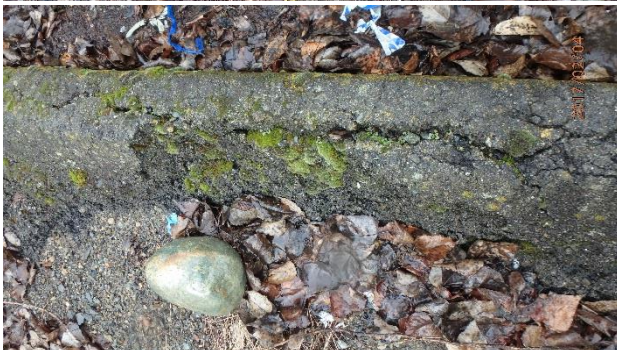
| Location ID <sup>a</sup> | Observations | Recommended Actions | Photos |
|---|---|---|---|
| C9 | curb deterioration in area approximately 15 ft long | none; monitor during future inspections | |

The second area of curb damage is located in the southwest corner of the facility (C9 on Figure 2). A section of curb approximately 15 ft long is deteriorating and should be monitored during future inspections.

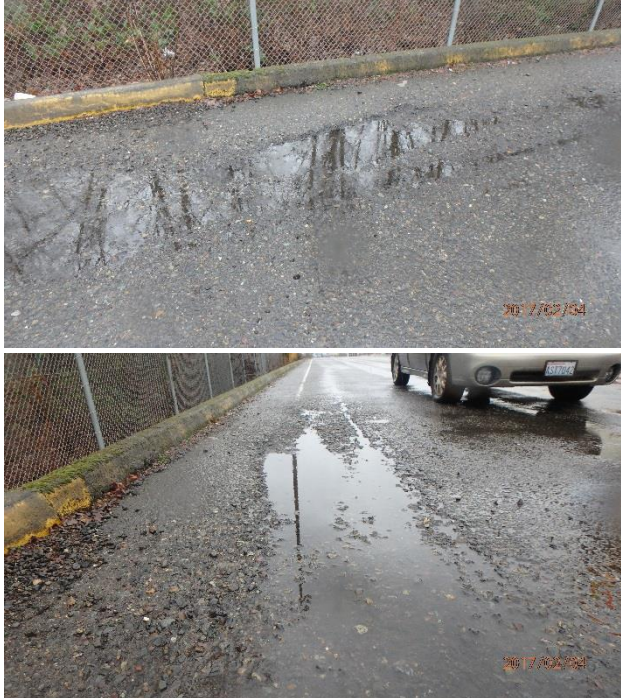
| Location ID <sup>a</sup> | Observations | Recommended Actions | Photos |
|---|---|---|---|
| P1 | pavement surface deterioration (raveling) in area approximately 2.5 x 20 ft | patch | |

The first area of pavement deterioration is located in the vicinity of catch basin CB2 (P1 on Figure 2; Table 2) and is approximately 2.5 ft wide by 20 ft long. The second area of pavement deterioration is located near the center of the facility on the west side (P2 on Figure 2; Table 2) and is approximately 6 ft wide by 30 ft long. The two areas

exhibit shallow surficial deterioration (less than 1 in. deep). No sub-base is exposed in either area. These areas should be repaired.

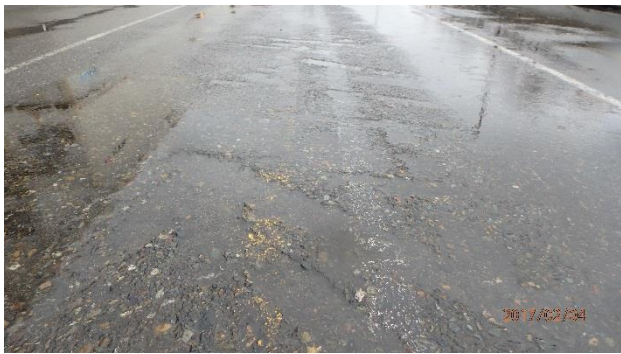
| Location ID <sup>a</sup> | Observations | Recommended Actions | Photos |
|---|---|---|---|
| P2 | surficial rutting in area approximately 30 x 6 ft | patch | |

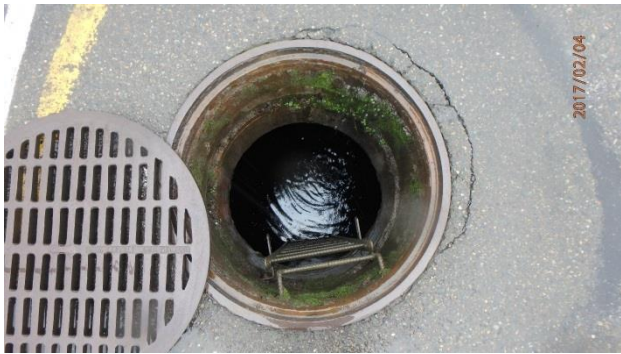
| Location ID <sup>a</sup> | Observations | Recommended Actions | Photos |
|---|---|---|---|
| SV1 | cracks wider than 1/8 in. around spill containment vessel cover | repair pavement | |

As described, cracking was observed around the two spill containment vessel manholes (SV1 and SV2 on Figure 2); these areas of cracking should be repaired.

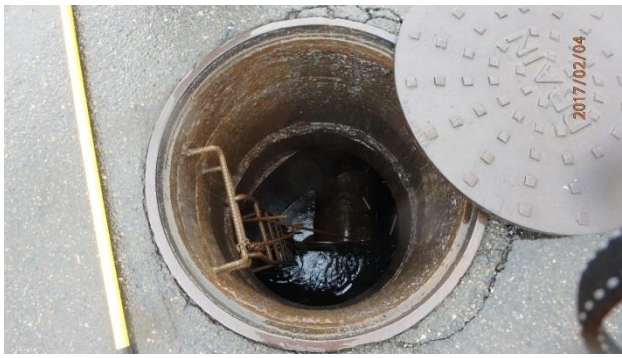
| Location ID <sup>a</sup> | Observations | Recommended Actions | Photos |
|---|---|---|---|
| SV2 | cracks wider than 1/8 in. around spill containment vessel cover | repair pavement | |

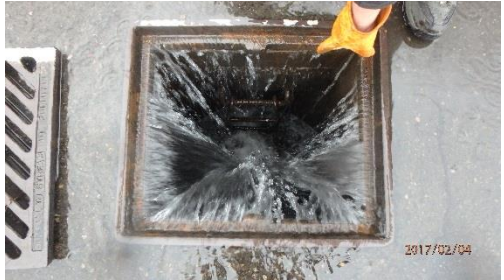
| Location ID <sup>a</sup> | Type of Structure | Observed Condition | Sediment Accumulation (inches) | Additional Observations | Recommended Actions | Photos |
|---|---|---|---|---|---|---|
| CB2 | catch basin | functioning normally | 6 | catch basin insert present | Continue to maintain catch basin under tenant ISGP. | |

In the previous inspection report, it was recommended that the filter insert in catch basin CB2 be replaced due to its deteriorated condition (Hart Crowser 2014). The filter insert appears to have been replaced as it was observed to be in good condition during the inspection.

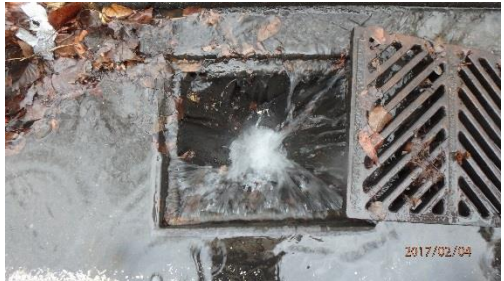
| Location ID <sup>a</sup> | Type of Structure | Observed Condition | Sediment Accumulation (inches) | Additional Observations | Recommended Actions | Photos |
|---|---|---|---|---|---|---|
| CB3 | catch basin | functioning normally | 0.5 | catch basin insert present; organic debris accumulating in vicinity of catch basin | Continue to maintain catch basin under tenant ISGP. | |

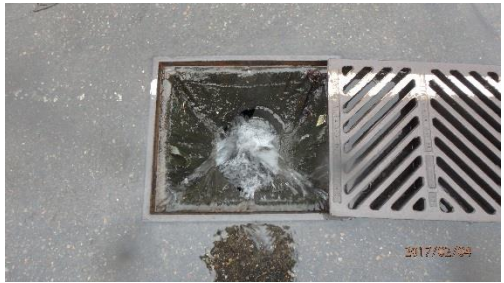
| Location ID <sup>a</sup> | Type of Structure | Observed Condition | Sediment Accumulation (inches) | Additional Observations | Recommended Actions | Photos |
|---|---|---|---|---|---|---|
| CB4 | catch basin | functioning normally | 1 | catch basin insert present | Continue to maintain catch basin under tenant ISGP. | |

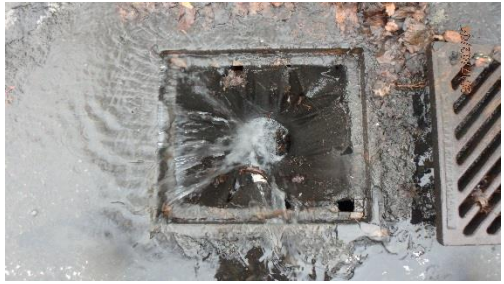
| Location ID <sup>a</sup> | Type of Structure | Observed Condition | Sediment Accumulation (inches) | Additional Observations | Recommended Actions | Photos |
|---|---|---|---|---|---|---|
| CB5 | catch basin | functioning normally | 0.5 | catch basin insert present; organic debris in vicinity of catch basin | Continue to maintain catch basin under tenant ISGP. | |

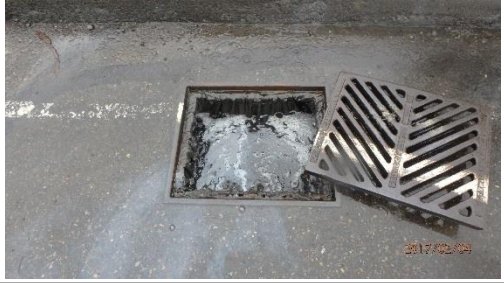
| Location ID <sup>a</sup> | Type of Structure | Observed Condition | Sediment Accumulation (inches) | Additional Observations | Recommended Actions | Photos |
|---|---|---|---|---|---|---|
| CB6 | catch basin | functioning normally | 3 | catch basin insert present | Continue to maintain catch basin under tenant ISGP. | |

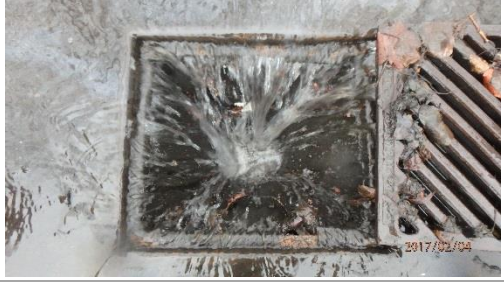
| Location ID <sup>a</sup> | Type of Structure | Observed Condition | Sediment Accumulation (inches) | Additional Observations | Recommended Actions | Photos |
|---|---|---|---|---|---|---|
| CB7 | catch basin | functioning normally | 6 | catch basin insert present; some ponding in vicinity of catch basin; organic debris accumulating in vicinity of catch basin | Continue to maintain catch basin under tenant ISGP; remove accumulated organic debris to prevent surface ponding. | |

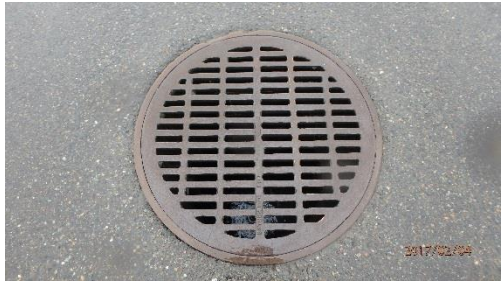
| Location ID <sup>a</sup> | Type of Structure | Observed Condition | Sediment Accumulation (inches) | Additional Observations | Recommended Actions | Photos |
|---|---|---|---|---|---|---|
| OWS1 | oil/water separator | functioning normally | nm | could not open grated cover (cover stuck due to grit/traffic loads); some floatables visible | Restore accessibility, remove floating debris. | |

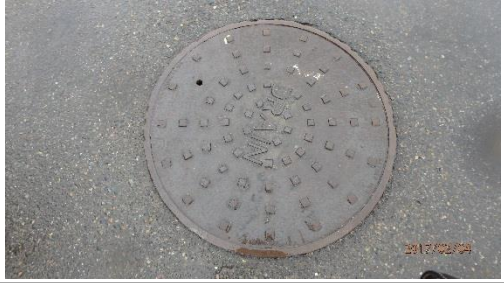
| Location ID <sup>a</sup> | Type of Structure | Observed Condition | Sediment Accumulation (inches) | Additional Observations | Recommended Actions | Photos |
|---|---|---|---|---|---|---|
| OWS2 | oil/water separator | could not open lid due to lack of sufficient lift points and tight fit in lid ring | nm | none | Restore accessibility; observe structure during next stormwater compliance survey. | |

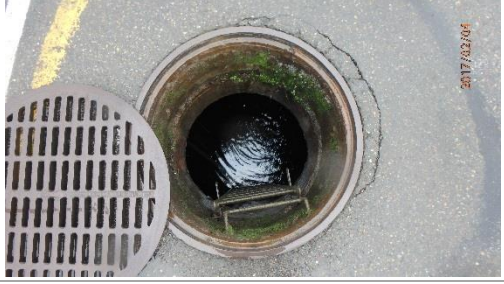
The spill containment vessel appeared to be in good condition and able to function as intended. The north side of the spill containment vessel had approximately 4 in. of sediment accumulation centered under the grate, and no sediment accumulation near the sides of the vault. Cracking observed around the spill containment vessel access manholes is discussed in Section 2.2.

| Location ID <sup>a</sup> | Type of Structure | Observed Condition | Sediment Accumulation (inches) | Additional Observations | Recommended Actions | Photos |
|---|---|---|---|---|---|---|
| SV1 | spill containment vessel | functioning normally | approximately 4 in. under grate, less near sides of vault | some floatables; cracking wider than 1/8 in. in pavement around cover | Repair cracked pavement; remove accumulated sediment and floatables from vault. | |

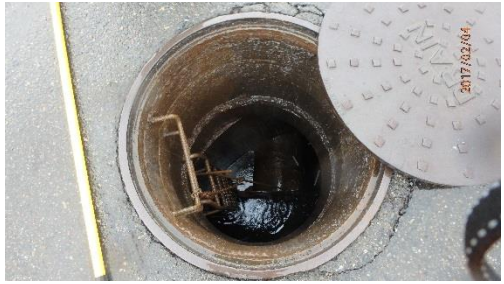
| Location ID <sup>a</sup> | Type of Structure | Observed Condition | Sediment Accumulation (inches) | Additional Observations | Recommended Actions | Photos |
|---|---|---|---|---|---|---|
| SV2 | spill containment vessel | functioning normally | 0 | cracking wider than 1/8 in. in pavement around cover | Repair cracked pavement. | |

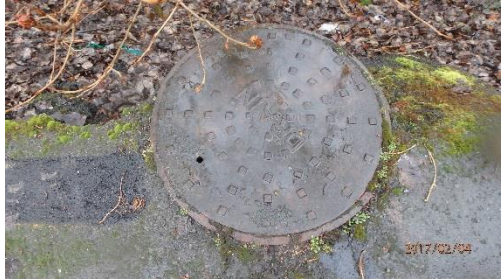
| Location ID <sup>a</sup> | Type of Structure | Observed Condition | Sediment Accumulation (inches) | Additional Observations | Recommended Actions | Photos |
|---|---|---|---|---|---|---|
| WMH | manhole | could not open lid due to lack of sufficient lift points and tight fit in lid ring | nm | none | Observe structure during next stormwater compliance survey. | |
