February 20, 2017

HWA Project No. 98165-670

**Subject: Gas Sampling Annual Report, 2016
Everett Landfill/Tire Fire Site
Everett, Washington**

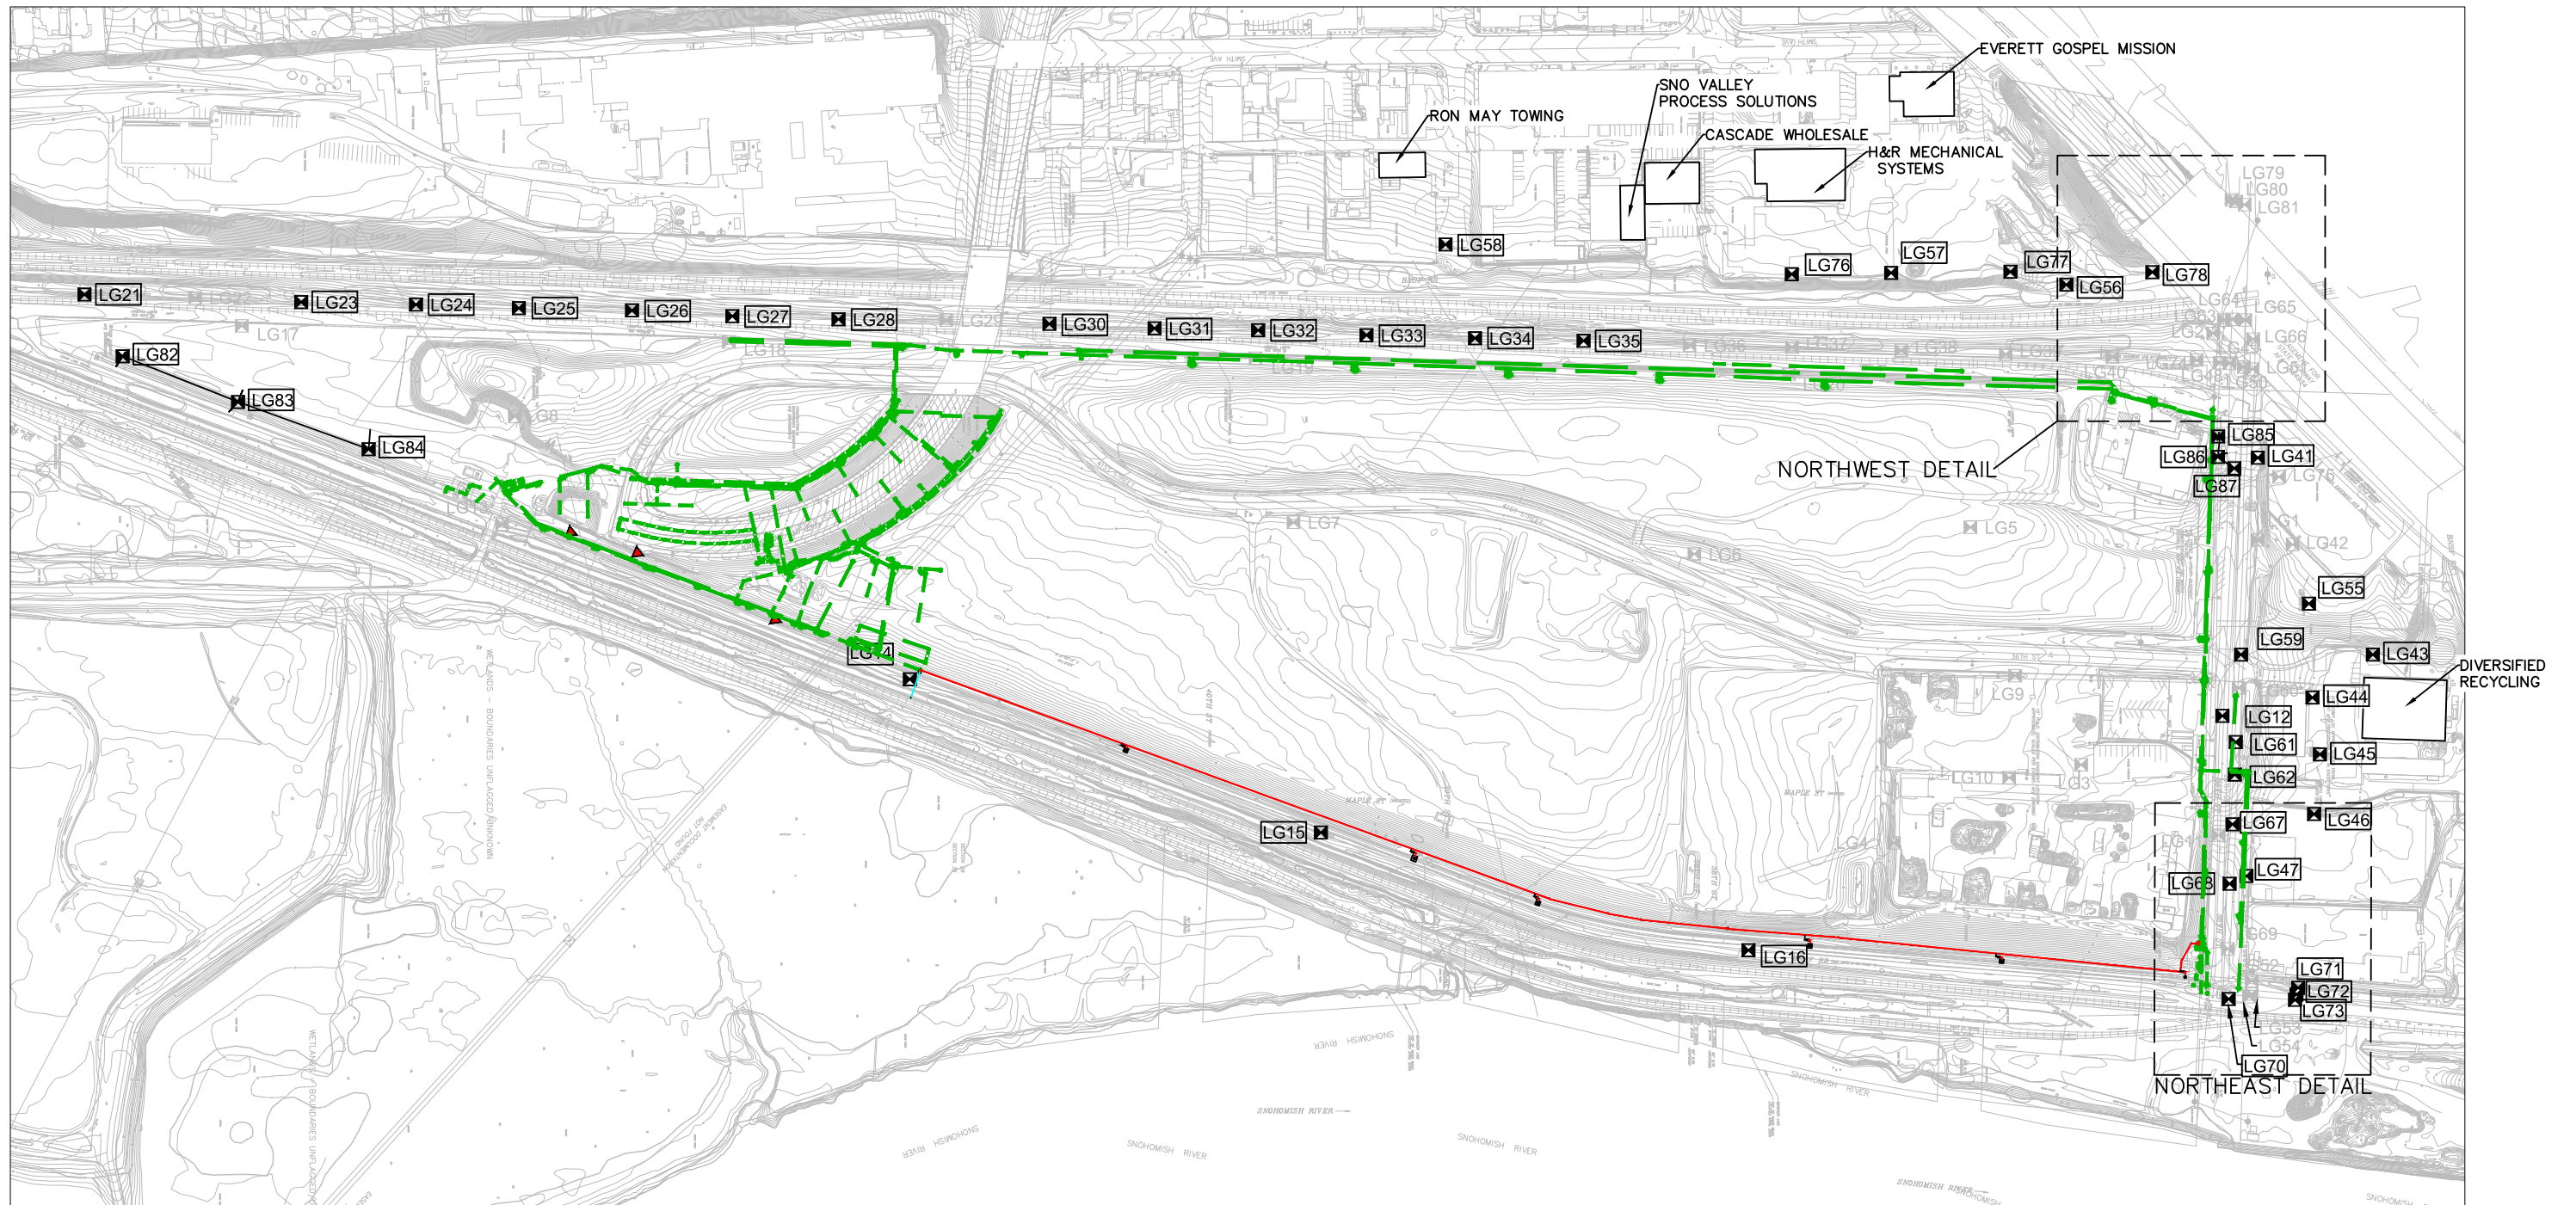
FIGURE NO.
1
PROJECT NO.
1998-165
TASK-660

- LG-61 appears to be damaged. The monument was destroyed and is no longer usable.
- LG-62 and 67 could not be located and have likely been buried or damaged by nearby construction activities.
- LG-46 is covered by preload/fill materials on private property.

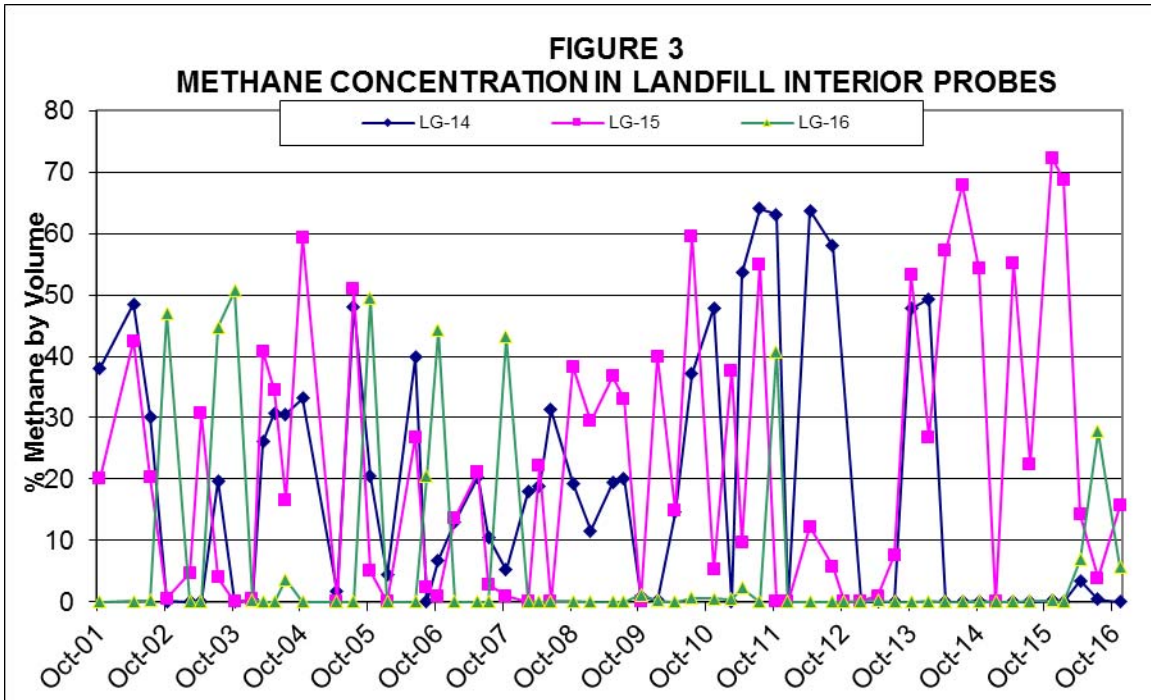
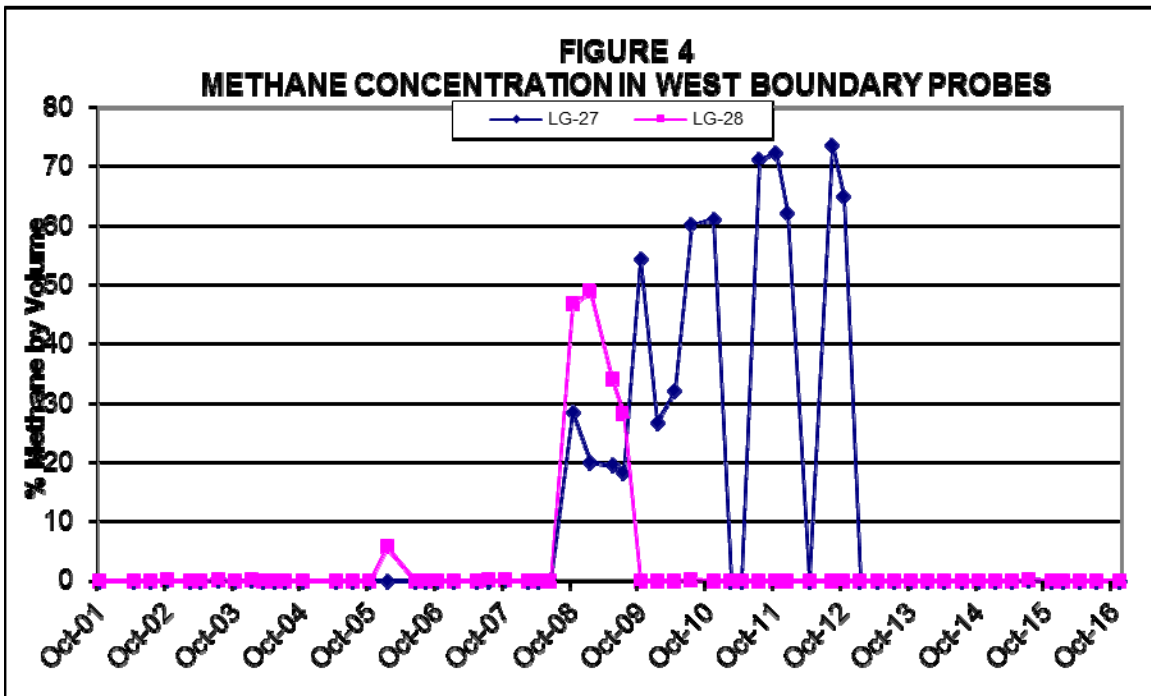
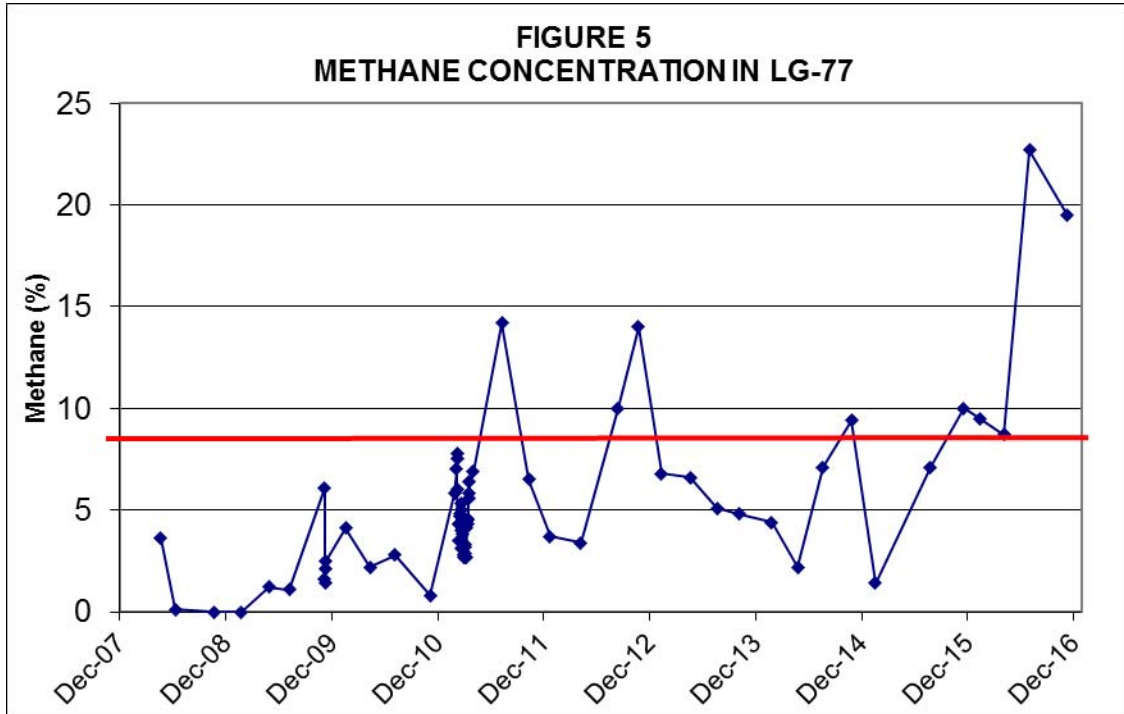
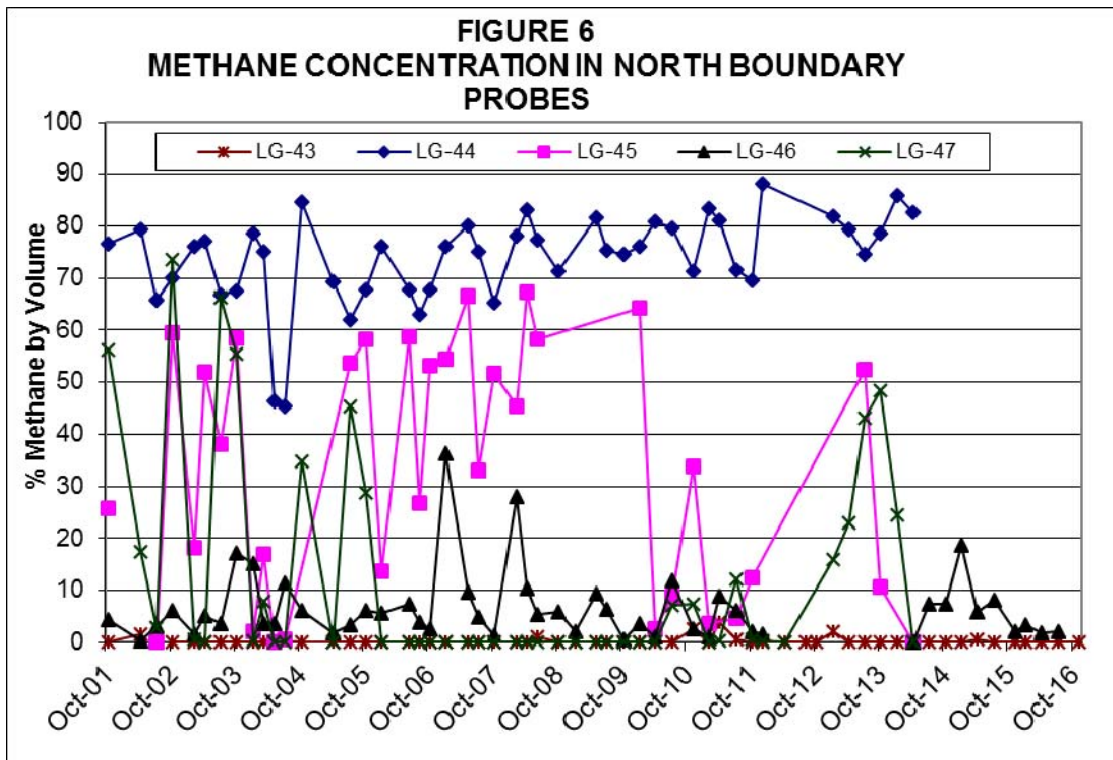
Landfill interior – Methane exceeding 5% by volume (which equals 100% of the lower explosive limit, or LEL) had been historically detected in most of the Landfill interior gas probes (which were completed in or near waste), as expected. By 2008, all but gas probes LG-14, LG-15, and LG-16 within the Landfill footprint were decommissioned in accordance with Chapter 173-160 WAC in preparation for site development activities. Of these three remaining probes, LG-15 generally had the highest methane concentrations in 2016, with concentrations up to 69%. Probe LG-14 has not had any methane exceeding 5% since January 2014. Methane concentration in LG-16 increased after the first quarter of 2016 (with concentrations of 6 to 28%) after a period of low concentrations (below 5%) from 2011 to January 2016. Interior probes have not exhibited any apparent trends over time since January 2008 (Figure 3).

values measured in this probe. Figure 5 shows the LG-77 methane concentrations over time.

North end of Landfill – Methane exceeding 5% by volume was historically detected in one or more of the LG-44, LG-45, LG-46, and LG-47 probes installed at the Landfill northern perimeter. All of these probes are on private property that is being redeveloped, including building demolition and major site grading, which has resulted in loss of all of these probes. Most other northern perimeter probes have not contained appreciable methane concentrations (Table 1, Figure 6).
