# SITE HAZARD ASSESSMENT

#### **Jackpot Food Mart 056 (PetroSun 1056)**

500 George Washington Way  
Richland, WA 99352

*Site scored/ranked for the February 2012 update*

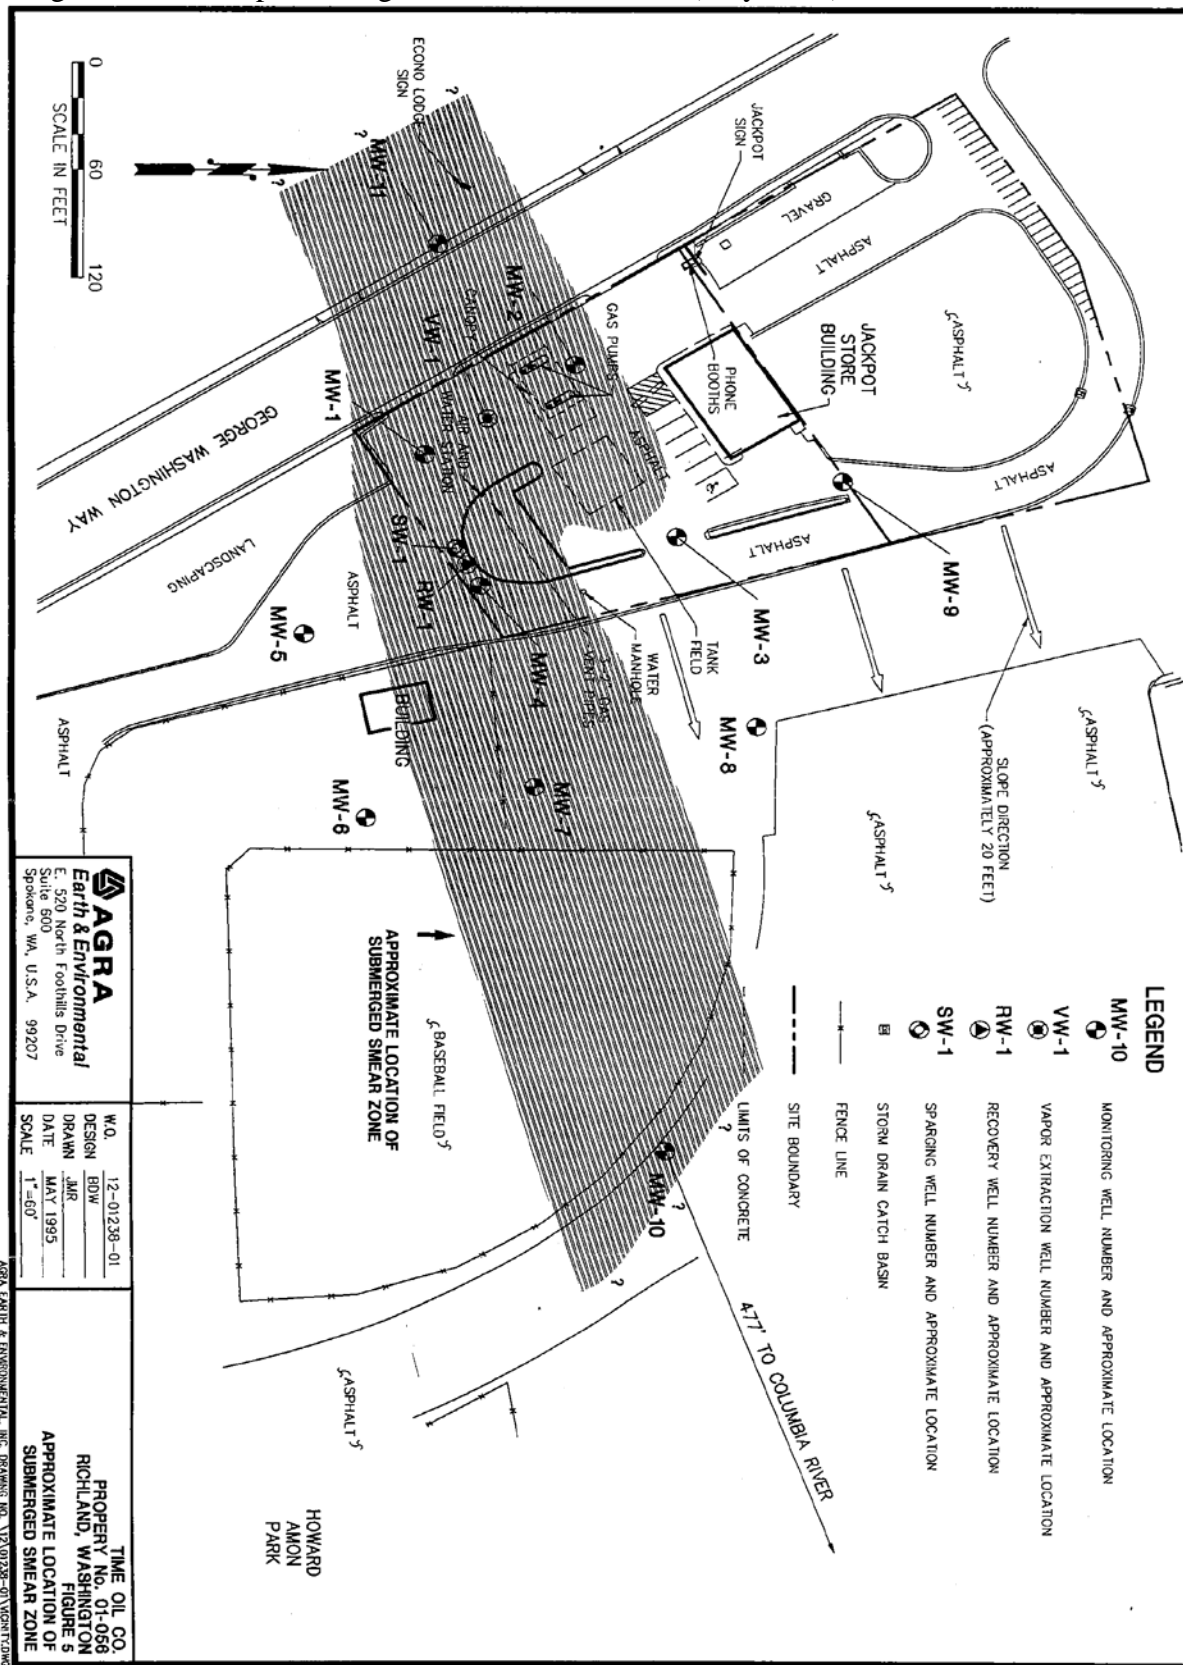
Figure 5. Site Map Showing Wells Present on Site (May 1995)

AGRA Earth and Environmental, Inc. (AEE) of Spokane, Washington performed additional work including the installation of **six more groundwater monitoring wells (MW-6 through MW-11), one groundwater/vapor extraction well (RW-1) and one groundwater air sparging well (SW-1)** (see Figure 5). Monitoring wells MW-6, MW-8 and MW-9 were installed cross-gradient from the plume in order to define lateral limits of affected groundwater on the sides of the plume (2). The other wells were oriented to determine the linear extent of contamination down gradient and up gradient.

Soil analysis from within the area of affected ground water indicated that there was a 5-foot layer of submerged contaminated soil (referred to as the smear zone) approximately 5 to 10 feet below the static level of the groundwater. The location of the wells and the extent of the smear zone are shown in Figure 5. A cross-section of the smear zone is shown in Figure 6. AEE speculated that the initial soil contamination event occurred prior to the construction of McNary Dam (1953) on the Columbia River. After the completion of the dam, the level of the Columbia River (~820 feet east of site) increased causing a similar increase in the groundwater and submerging the contaminated soil.

**Groundwater samples taken from MW-1 through MW-4, MW-7, MW-10, MW-11 and RW-1 contained target analyte concentrations exceeding MTCA cleanup levels at the time. MW-7, MW-10, MW-11 are located outside of Jackpot Foodmart property lines.** Groundwater at the site ranged from 27.2 to 28.5 feet bgs and in Howard Amon Park the groundwater level ranged from 9.6 to 17.7 feet bgs. In addition, more work was performed to determine the feasibility of using air sparging coupled with a vapor extraction system to remediate the site.

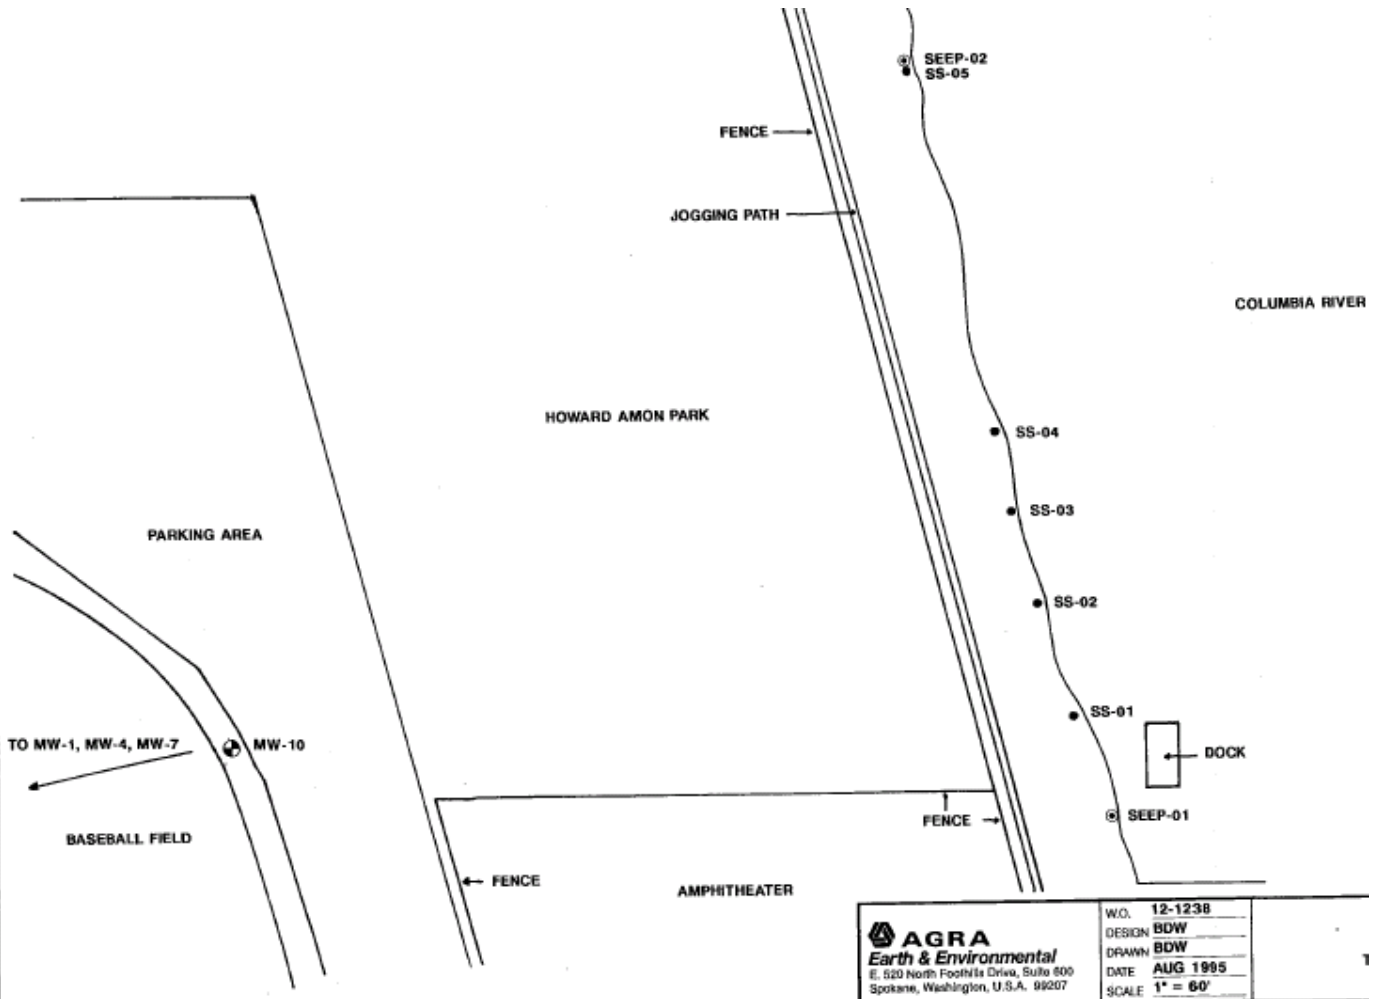
Figure 7. Map Showing Where Seep Samples Were Taken Along the Columbia River Downgradient from the Site.

During 1995 AEE also performed soil/seep sampling along the bank of the Columbia River and a limited risk assessment for Howard Amon park. Five soil samples and two seep samples were collected (see Figure 7) and analyzed for TPH-G and BTEX. All soil and seep samples were below limits of detection except for Seep-02 which had a toluene value of 0.66 ug/L. AEE speculated that the toluene may have been the result of motor boats and other recreational water craft using the river and shoreline. In the risk assessment report, AEE concluded that visitors to the site and Howard Amon Park were not at risk because the contamination was 8 to 10 feet below grade and all drinking water at park was provided by city water coming from off site. AEE did indicate that there was the potential for visitors of the park to come in contact with groundwater along the banks of the Columbia River but that soil and seep sample data indicated that contaminants were not present.

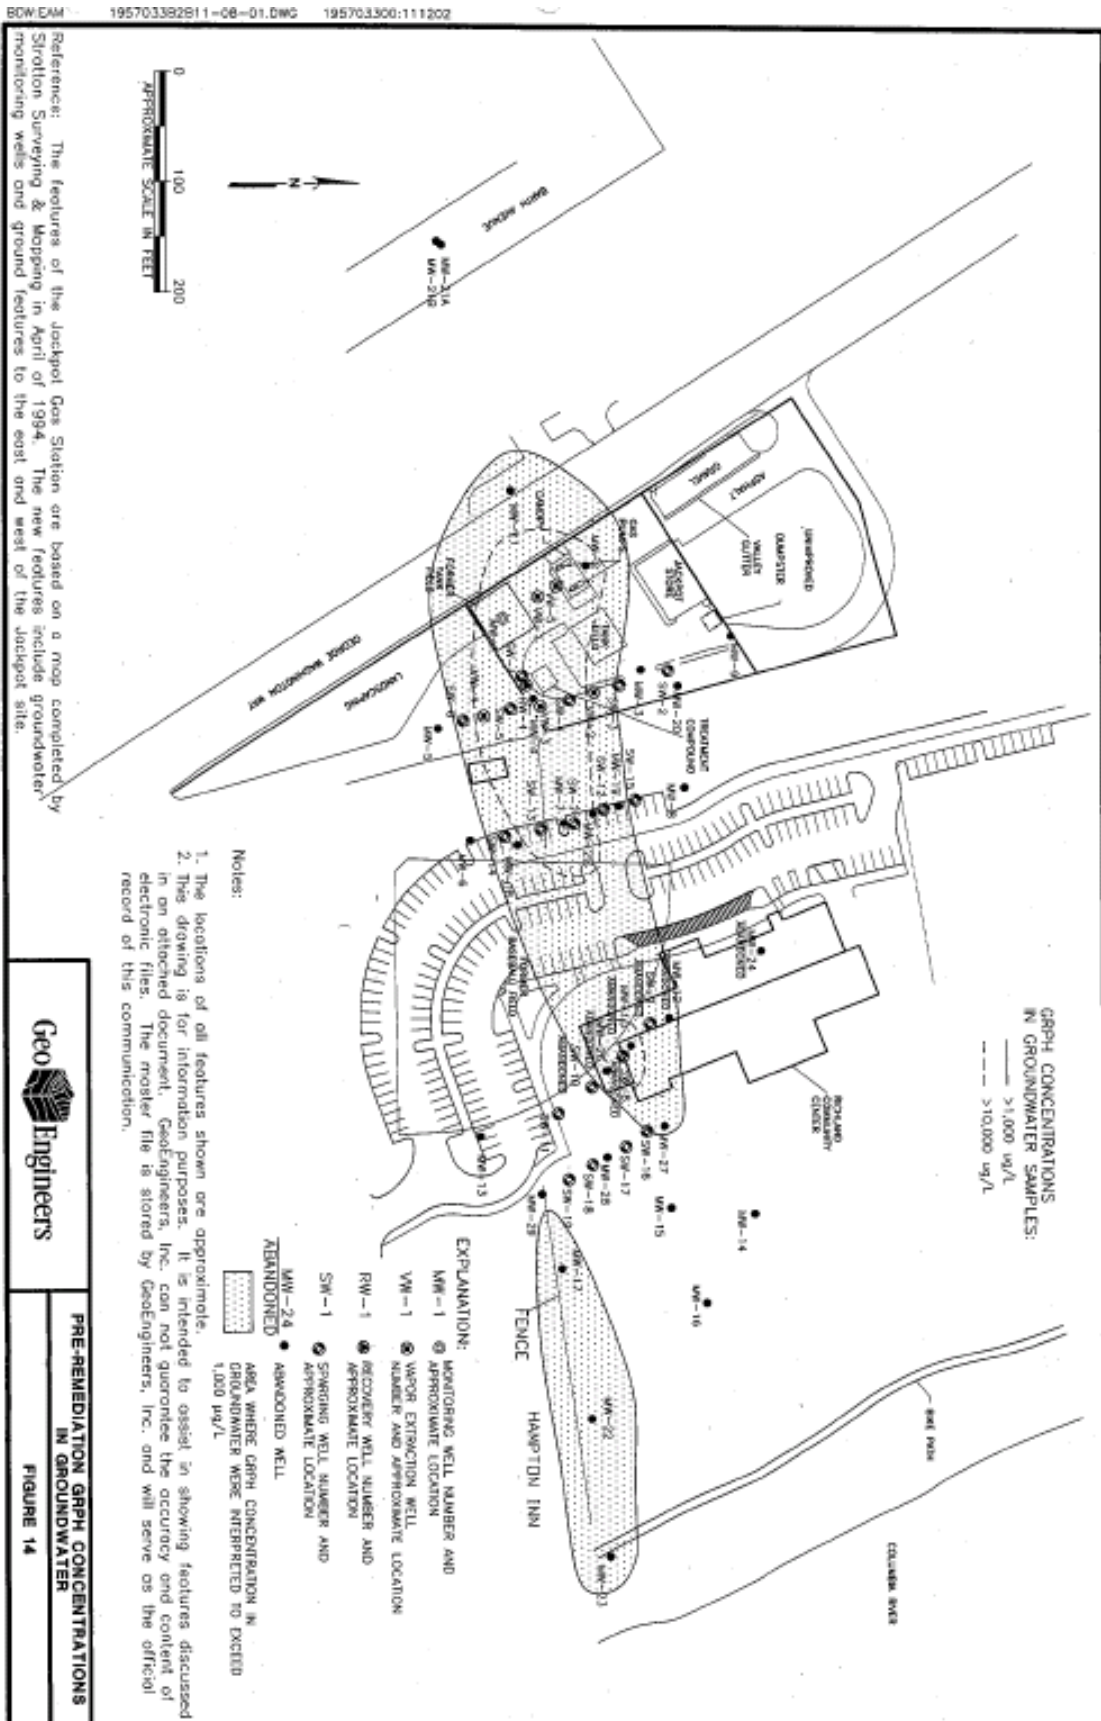
Figure 8. Map of Site Showing Contamination Prior to Remediation.

**Substantial reductions of contaminants of concern were made during this time period by a combination of 3 subsystems of air sparging wells and vapor extraction. Compare Figures 8 and 9.**

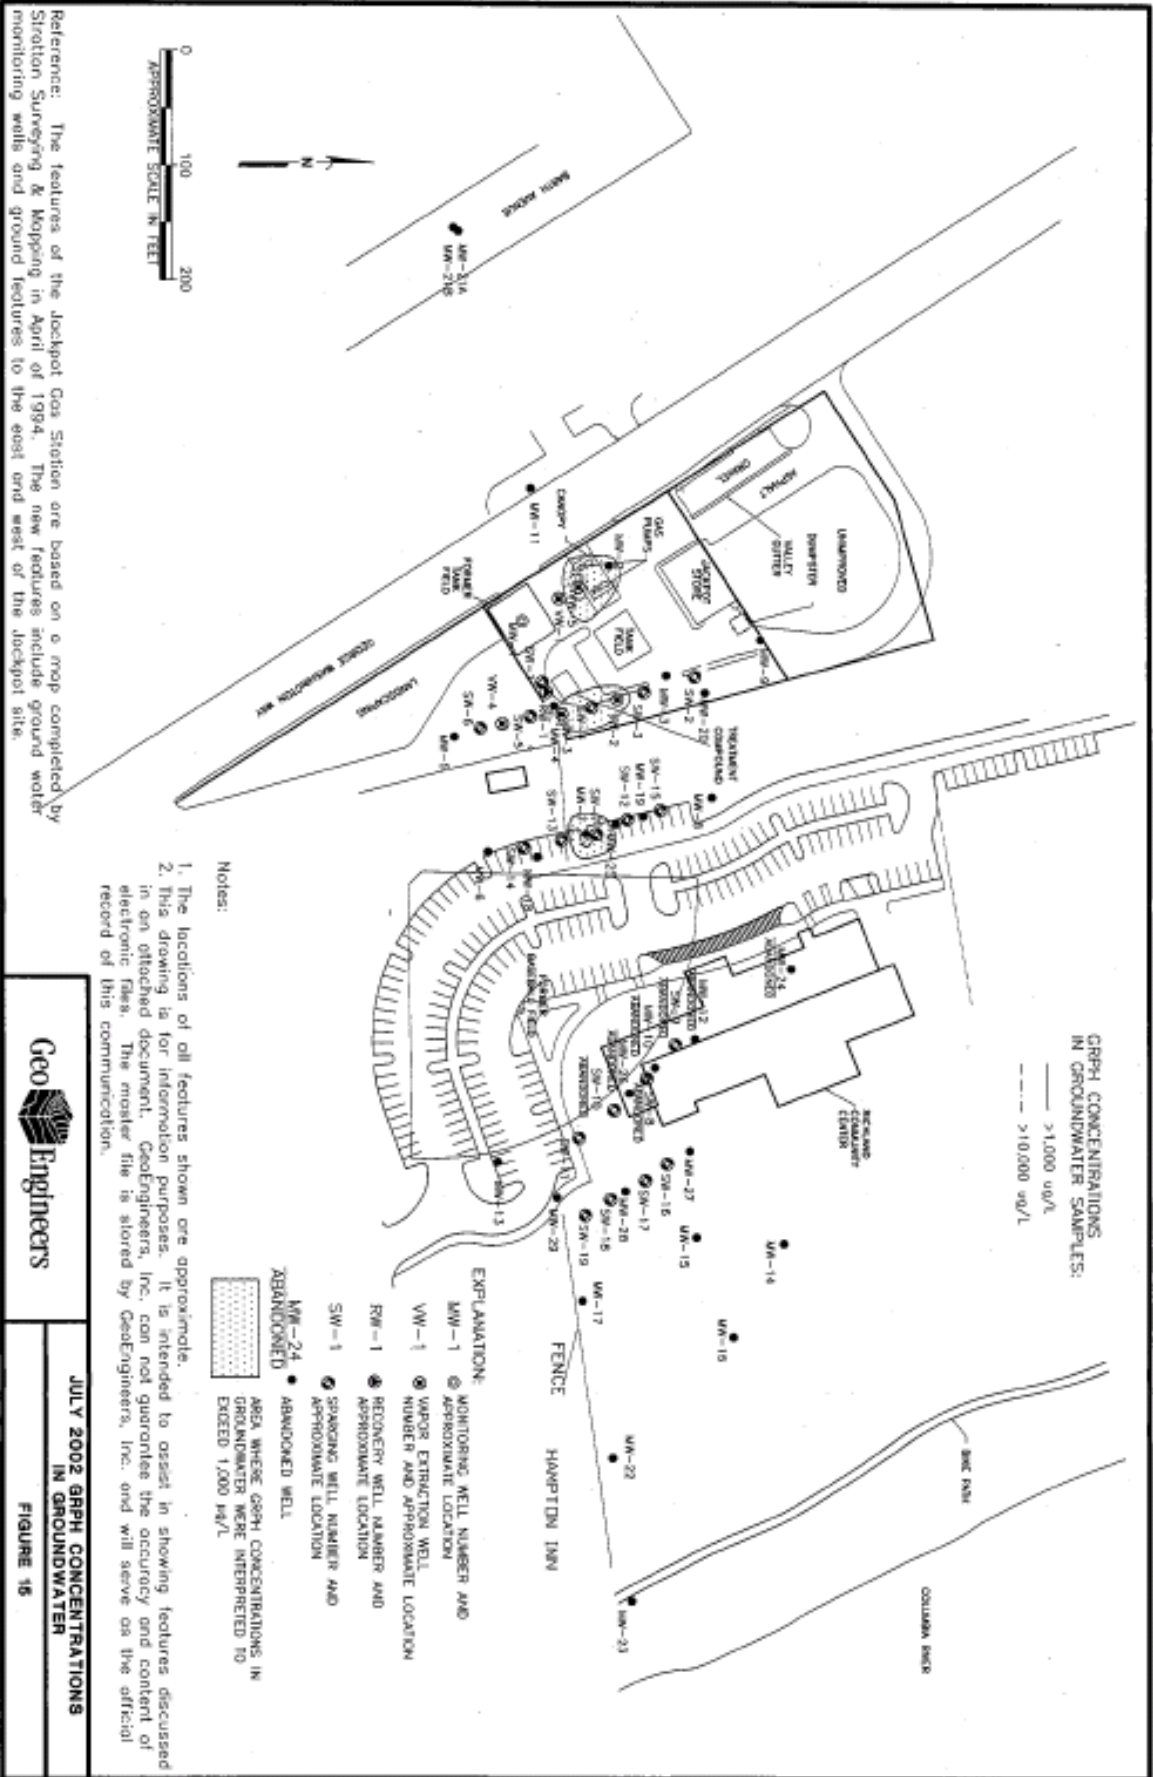
Figure 9. Map Showing Extent of Contamination Post-remediation (July 2002)

**JULY 2002 GRPH CONCENTRATIONS IN GROUNDWATER**  
**FIGURE 16**

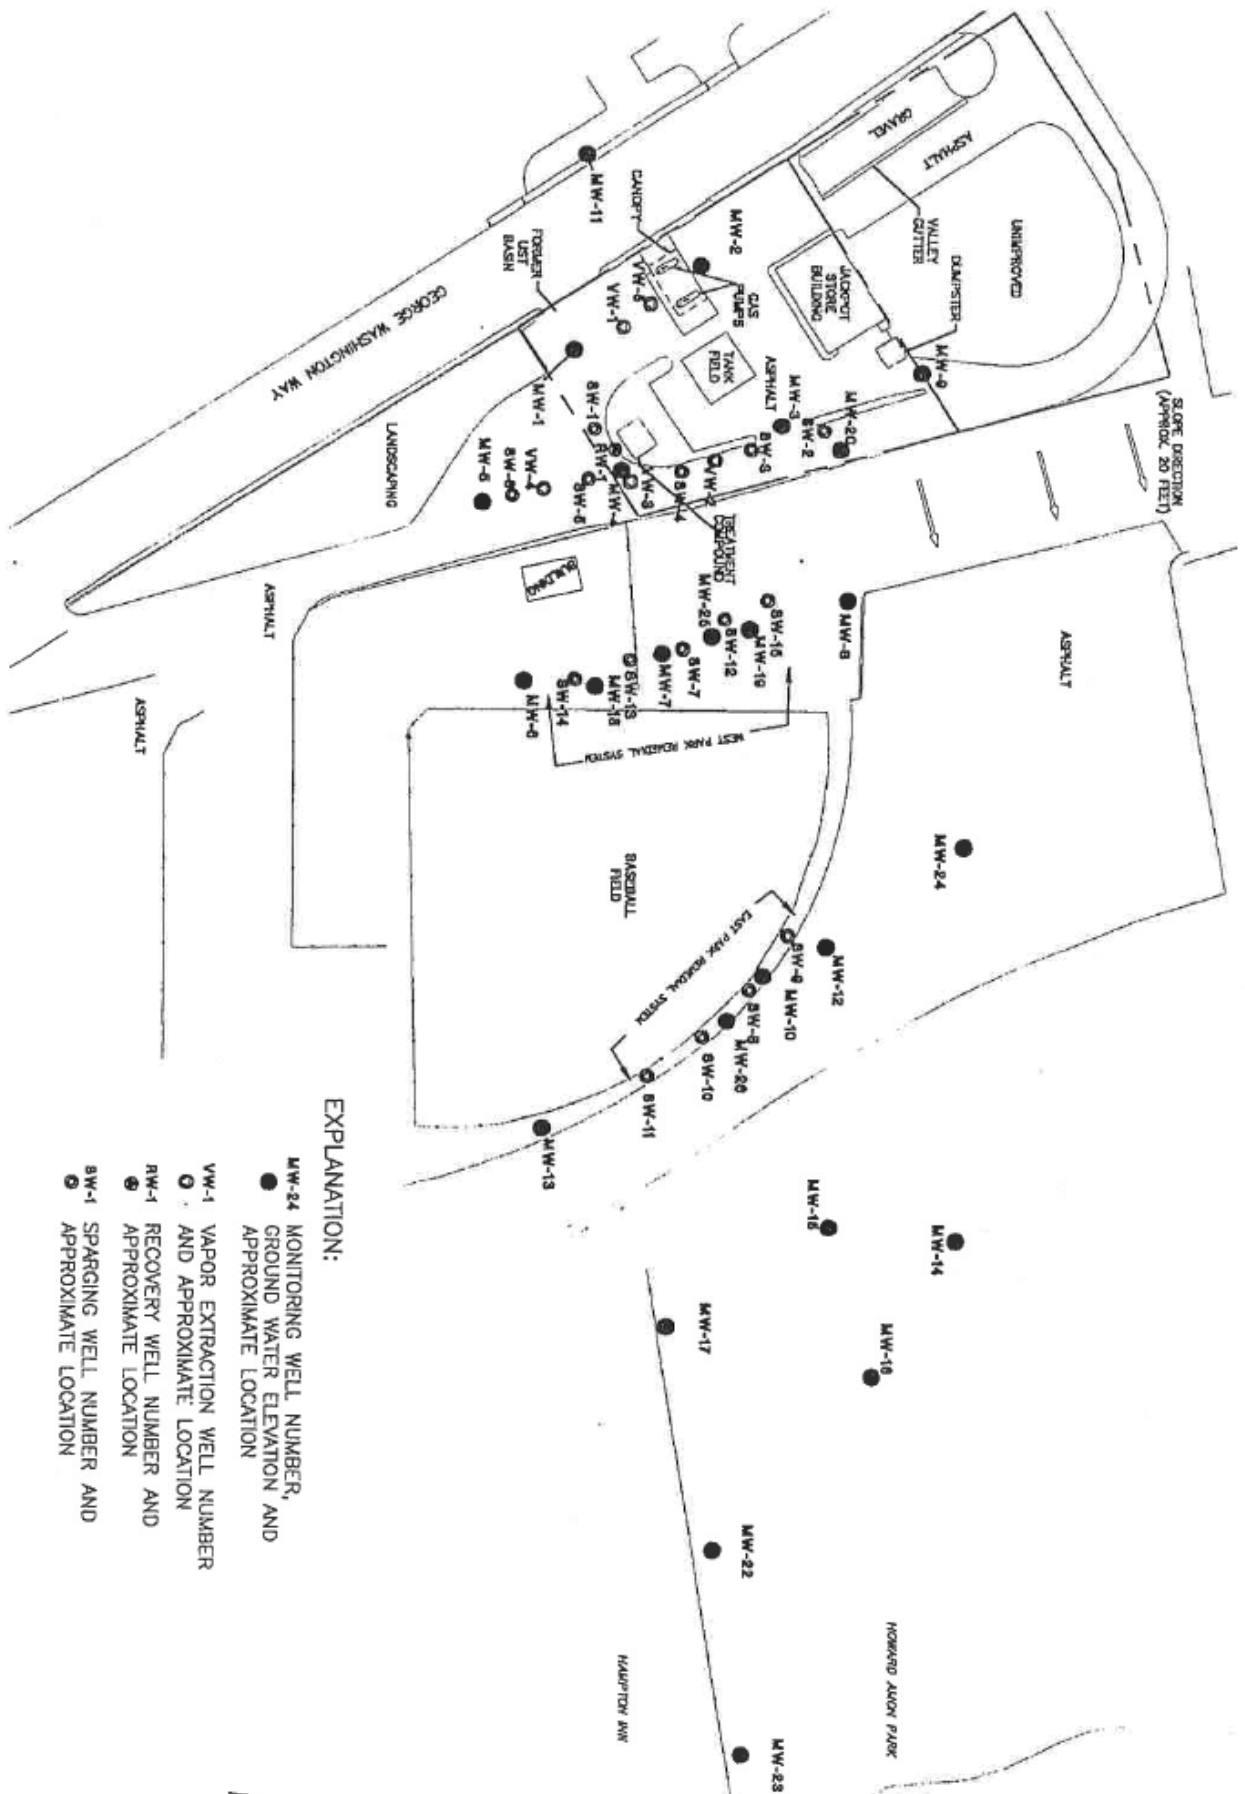
Figure 10. Site Map Showing the West and East Side Remedial Systems

**Due to the success of the SPRS system, additional remediation systems were installed in Howard Amon Park and near the former baseball field.** Installation of air sparging and SVE wells east and west of the baseball field were completed in December of 1997. The remedial subsystem on the east side became known as the East Park Remedial System (EPRS) and became fully operational in May 1998. The remedial subsystem on the west side became known as the West Park Remedial System (WPRS) and became fully operational in January 1999 (see Figures 10 and 11).

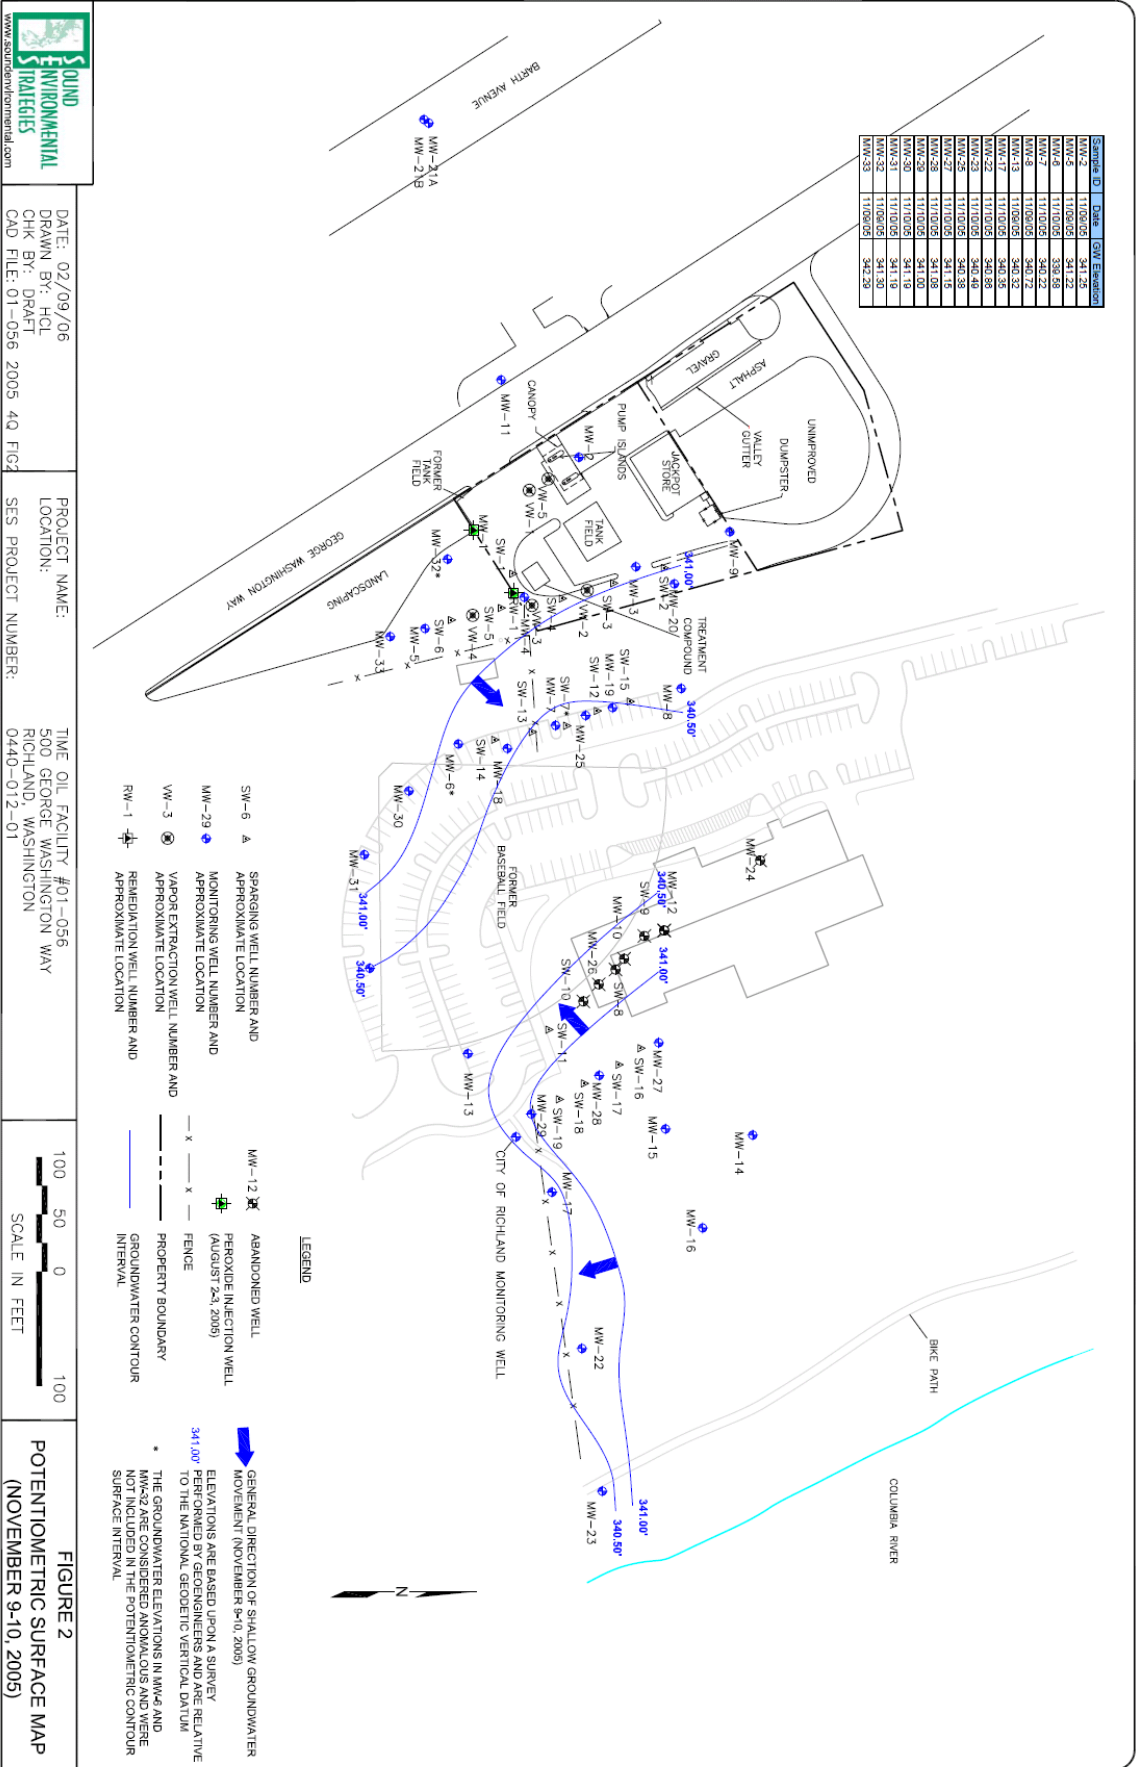
Figure 12 Site Map Showing the Direction of Groundwater Flow

**In July of 2004, GeoEngineers installed 4 more monitoring wells (MW-30 through MW-33) as it was determined that groundwater flow had a tendency to migrate in an east-southeast direction in the central portion of the site (see Figure12). Beginning in 2005 a new environmental contractor, Sound Environmental Strategies (SES), began performing ground water monitoring on a quarterly basis. Between first and second quarters of 2006 the EPRS-2 system was decommissioned and approximately 10 monitoring wells were decommissioned. In late 2006, SES installed three new remediation wells (PE-1, -2, and -3) which were equipped with Plume Eater® technology in 2007.** The third quarter 2008 report was the last ground water monitoring that SES performed at the site. Analytical data from the last four quarters indicate that both GRPH and lead still exceeded MTCA, Method A Cleanup Levels for Ground Water at the time. Contamination was grouped in three hot spots- near the former tank field, just southeast of the tank field, and due east of the tank field near the Community Center parking lot. Sound Environmental Strategies' contract ended in mid-2008 and they did not perform any more work at the site. According to Ryan Bixby at SES, the SPRS system stopped functioning in June of 2008 (phone interview).

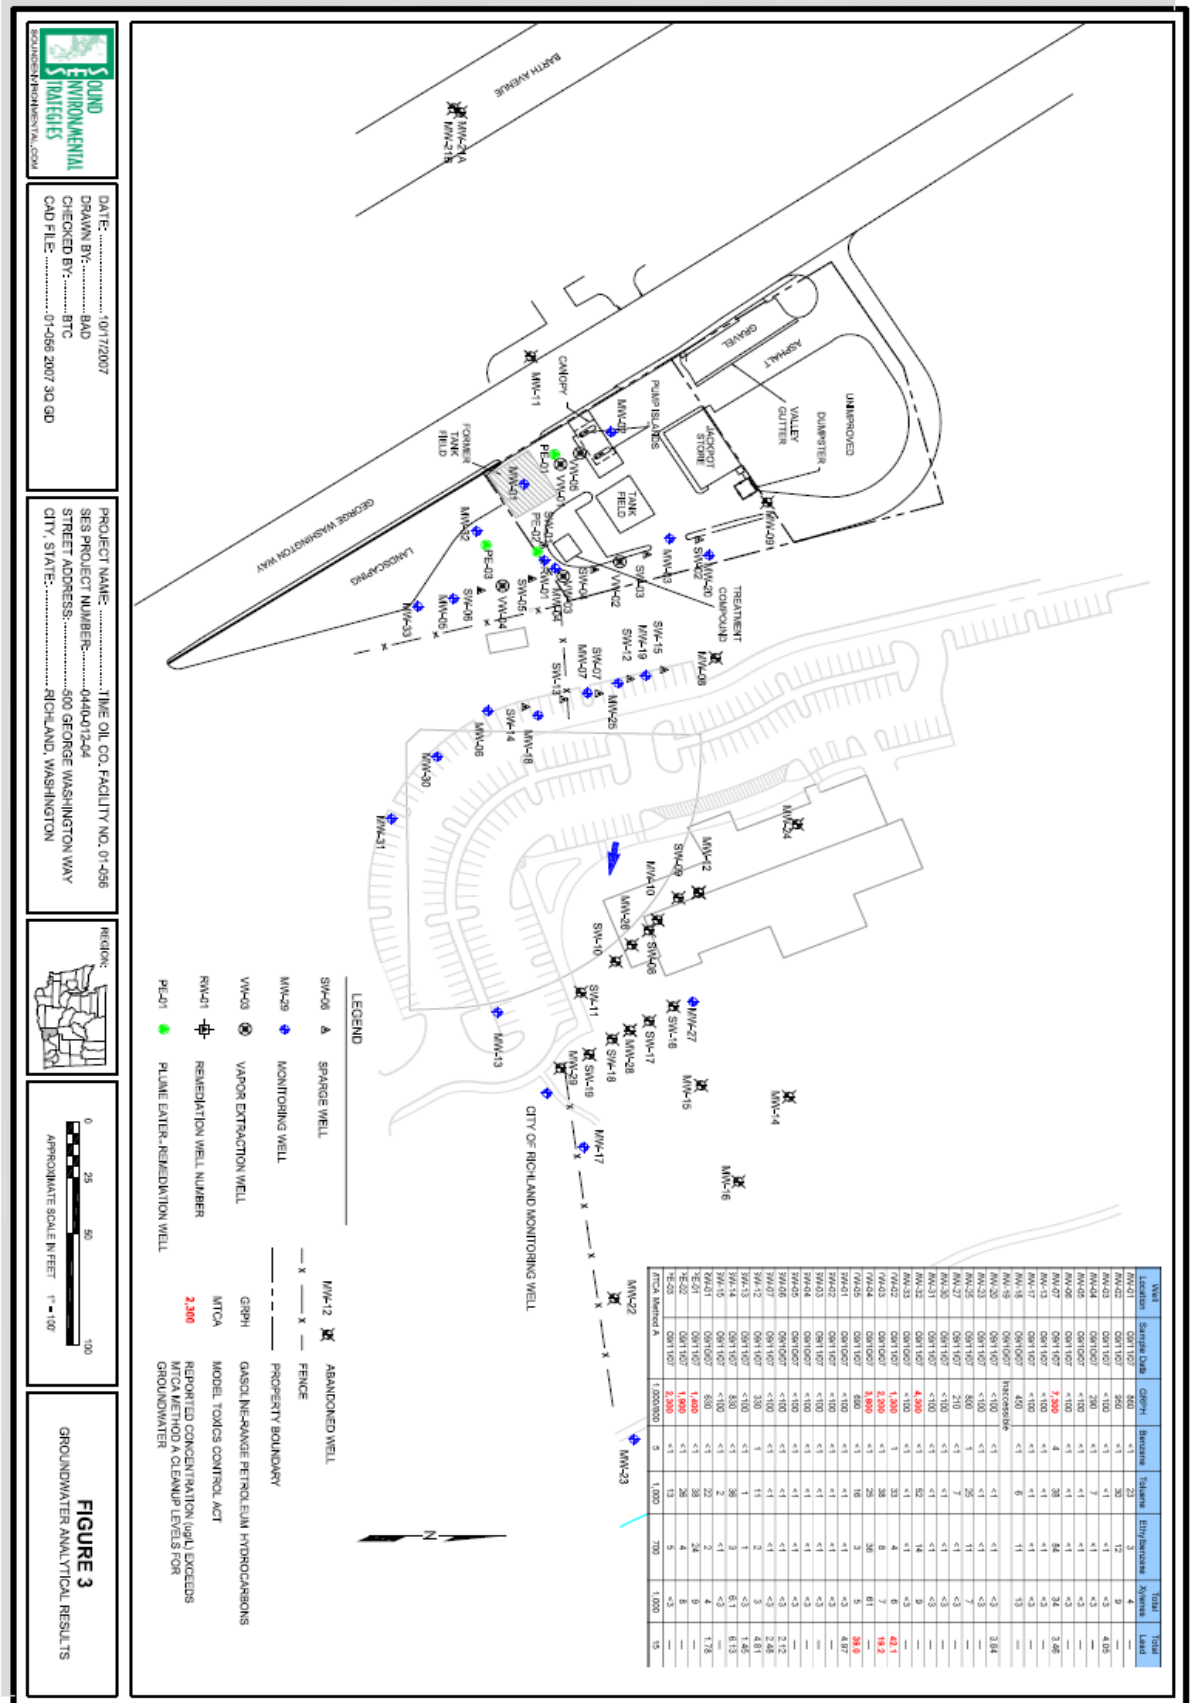
Figure 13. Site Map Showing Treatment Compound and Decommissioned Wells

The treatment compound (SPRS) is still at the site in its original location (see Figures 13 and 14). Presently, it is not operating. It is secure inside a chain link fence that is kept locked at all times. The blower room seemed to be in good shape but it was obvious that the system had not been used for some time. During the inspection, I took photos of the site. I was able to locate many of the monitoring wells (on and off-site) and vaults and all appeared in good shape. There is a substantial grade change going from the site to the park below. The slope has been landscaped by the city of Richland and terminates in the parking lot of the Community Center (see Figure 14, lower photo). I was able to locate the monitoring wells located along the perimeter of the parking lot and also MW-17 and MW-23 in the park near the Columbia River. I walked along the shoreline and noticed a cutaway bank but there was no seeping water coming out of the bank (see Figure 15).

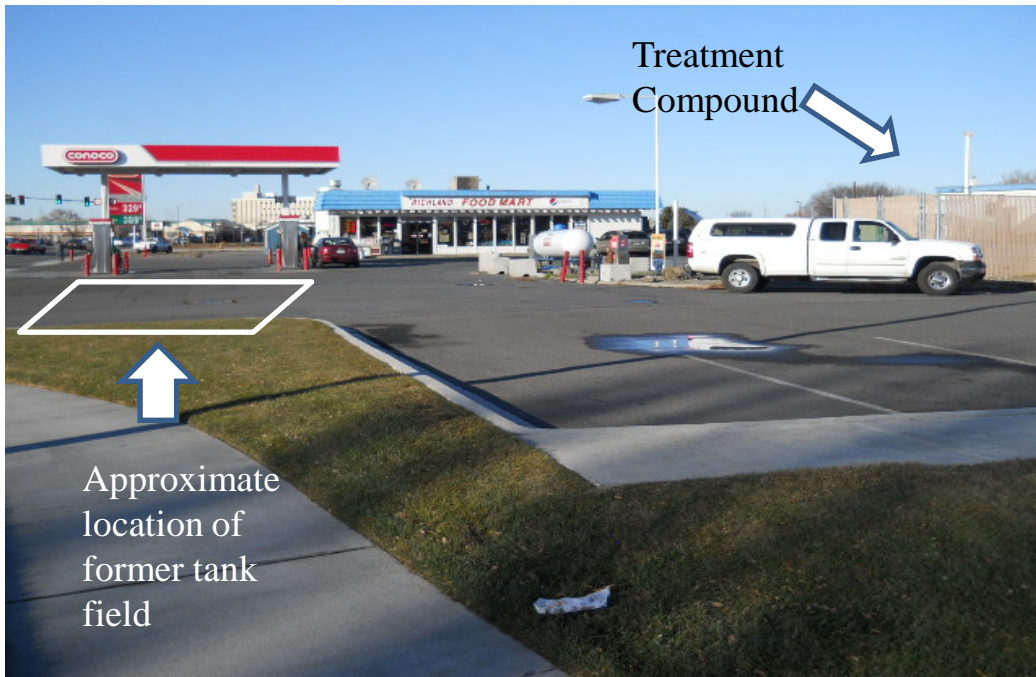
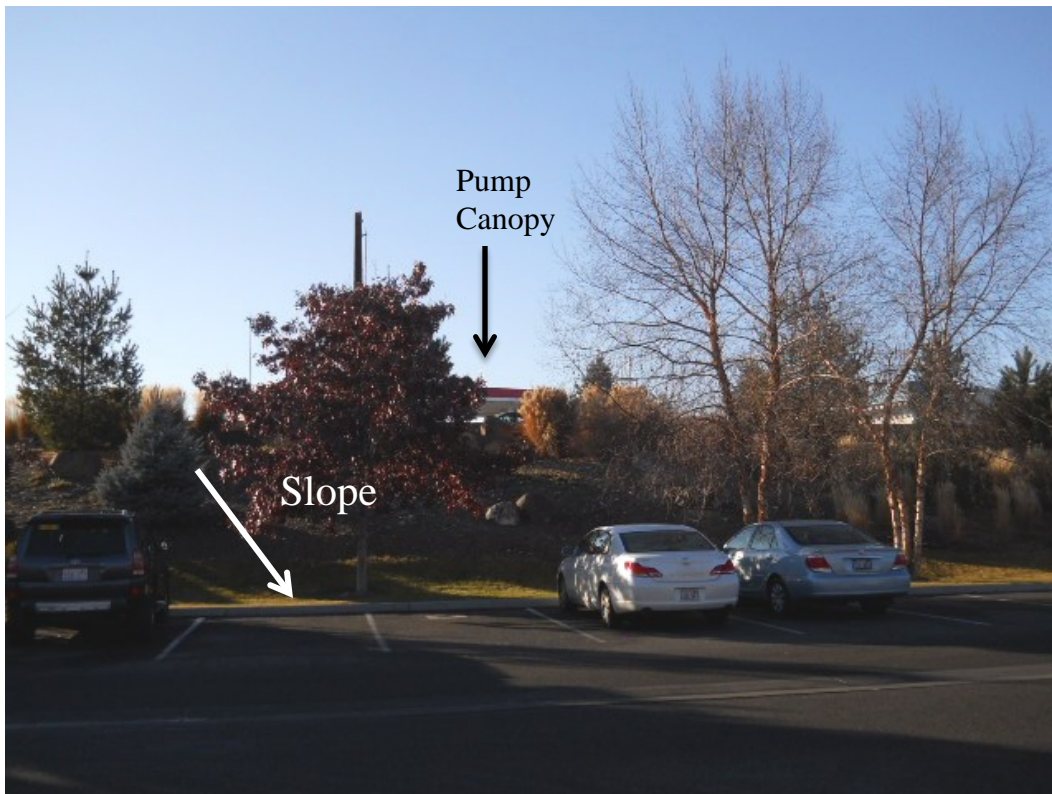
Figure 14. Photos Taken During Site Visit on 011012

Photo taken in the Richland Community Center parking lot looking to west. Top of canopy above gas pumps can be seen.

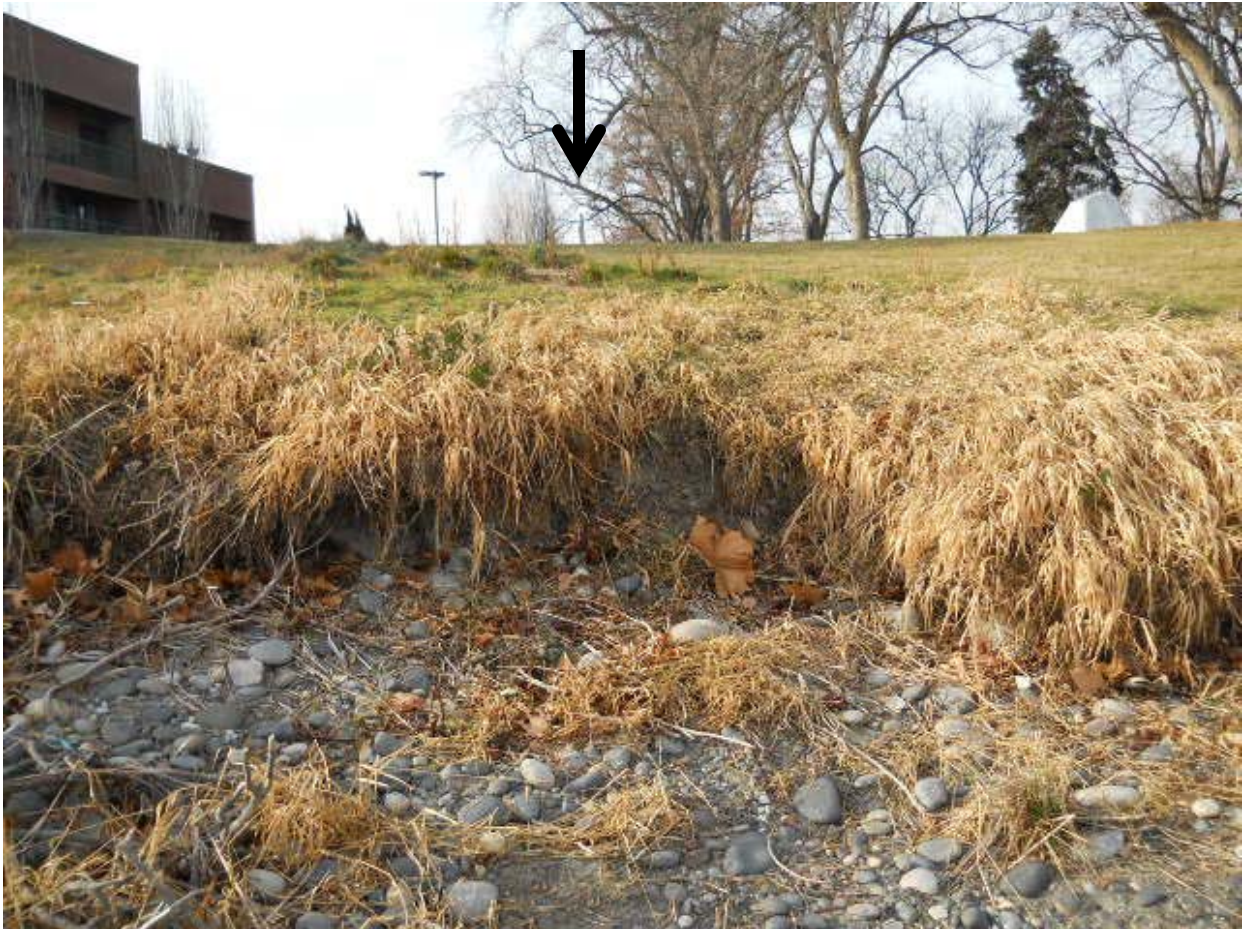
Figure 15. Photo of Cutaway Bank Along Columbia River Downgradient of the Jackpot Food Mart (Looking West. Arrow is pointing to fencepost of fence shown on many of the site maps).
