**ENVIRONMENTAL CAP
INSPECTION REPORT
FORMER PORTAC FACILITY**

**Order on Consent DE 88-S326 (September 22, 1988)
Washington State Department of Ecology Facility ID # 1215
Inspection Date: February 8, 2017**

March 30, 2017

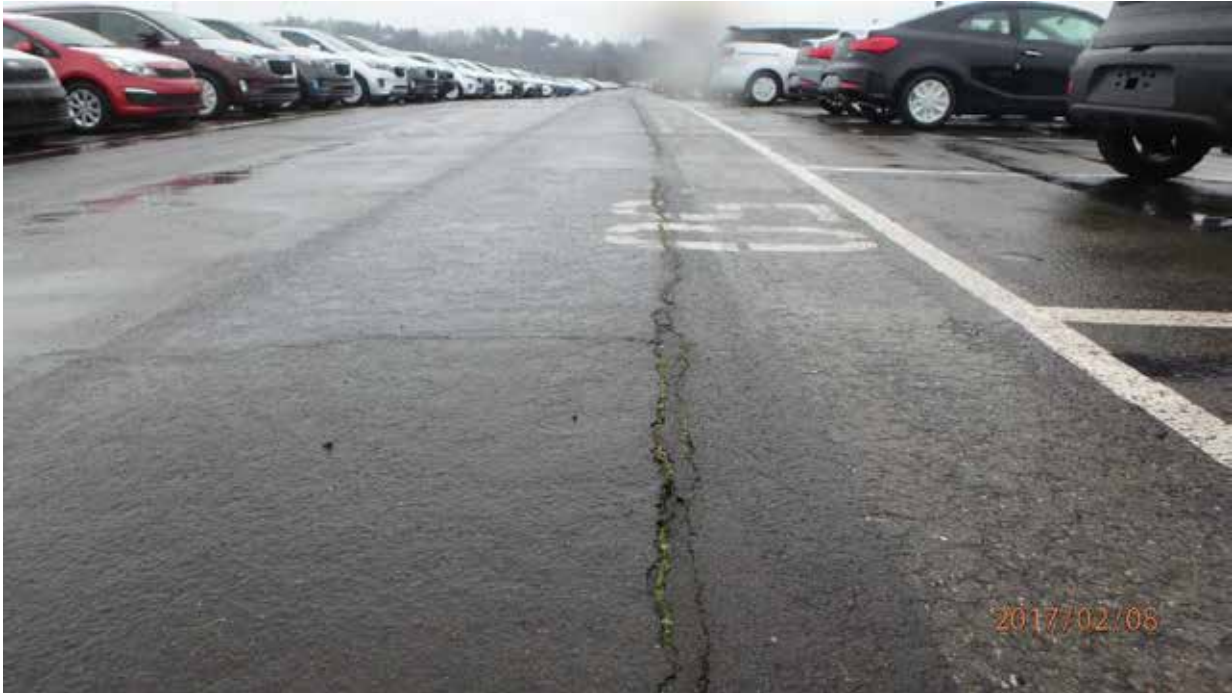
Figure 3. Representative crack A

Example photos of cracks observed at the former Portac facility are presented in Figures 3 and 4. Photos were taken of each crack observed during the inspection. These photos are included in Appendix A, which lists the cracks observed on the environmental cap and provides additional details regarding cap condition.

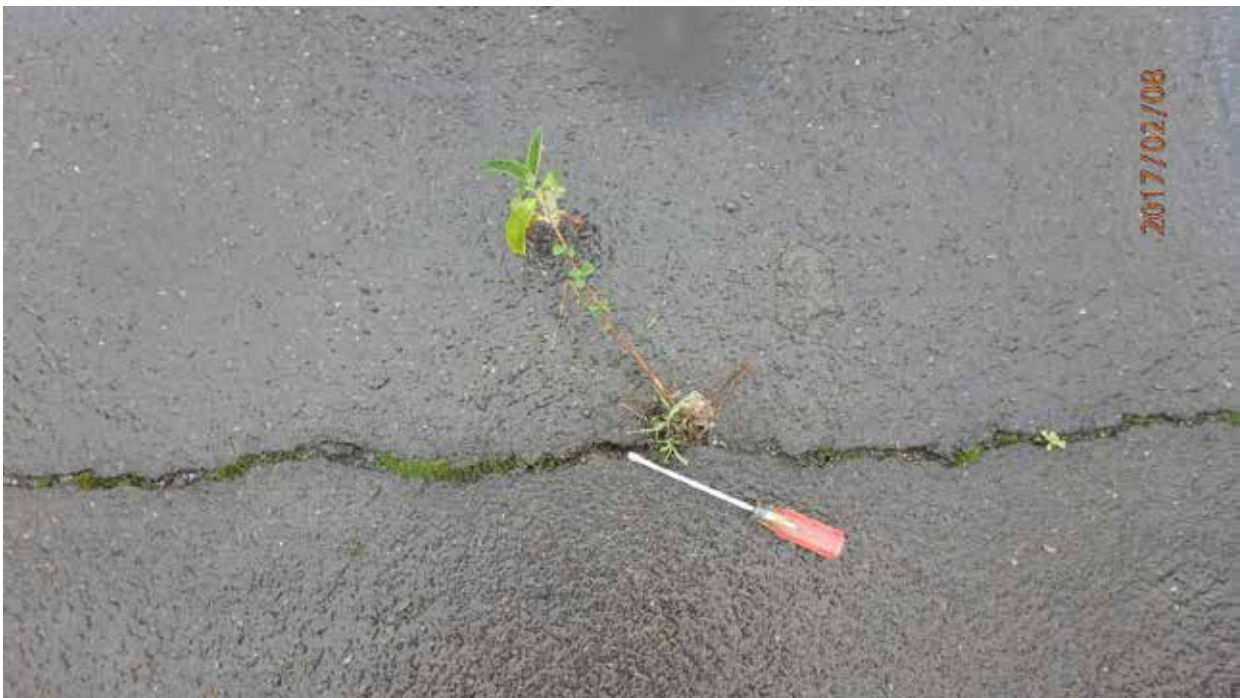
Figure 4. Representative crack B

Note: width of screwdriver blade is 1/8 in.

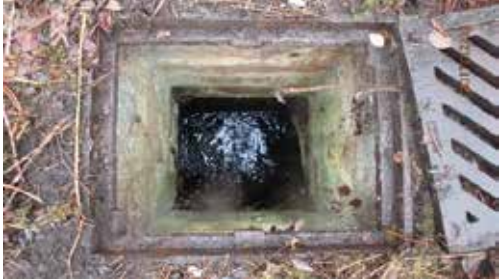
Location ID ^a	Type of Structure	Observed Condition	Sediment Accumulation (inches)	Additional Observations	Recommended Actions	Photos
CB9	catch basin	structurally sound, functioning normally	nm (could not observe bottom of chamber)	none	continue to maintain catch basin under stormwater permit

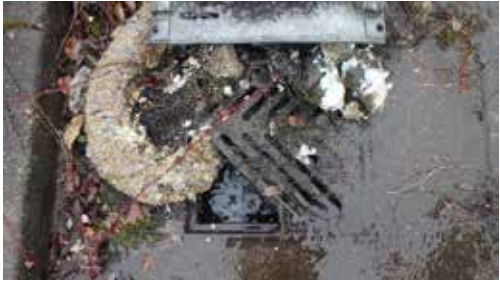
CB10	catch basin	functioning normally	nm (did not open due to surface debris; see photo)	water level approximately 6 in. from top of structure; grate broken; boom broken	replace broken grate; remove debris from around grate; continue to maintain catch basin under stormwater permit

All stormwater structures should continue to be maintained under the Port's municipal stormwater permit. The broken grate on catch basin CB10 should be replaced (Figure 2; Table 2). It is also recommended that the broken booms observed at catch basins CB10, CBMH2, CBMH3, CBMH5, and CBMH6 be removed, and that accumulated sediment and debris be removed from inside and around these structures (Figure 2; Table 2).

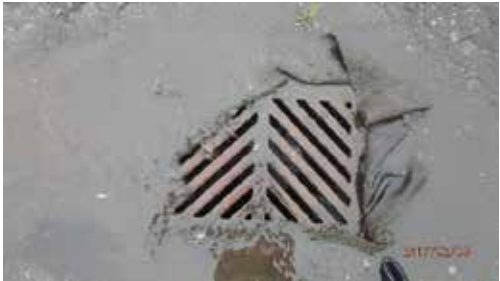
CB11	catch basin	functioning normally	approx. 6	catch basin insert present; sediment accumulation around grate	remove sediment from around grate; continue to maintain catch basin under stormwater permit

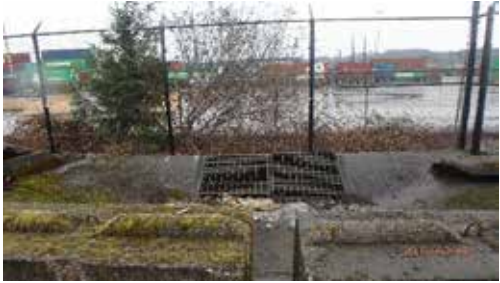
Location ID ^a	Type of Structure	Observed Condition	Sediment Accumulation (inches)	Additional Observations	Recommended Actions	Photos
CBMH1	catch basin manhole	functioning normally	nm; some debris noted (see additional observations)	sediment and debris accumulation in basin; standing water of approximately 1 in. depth on south side of basin	remove accumulated sediment and debris; continue to maintain structure under stormwater permit

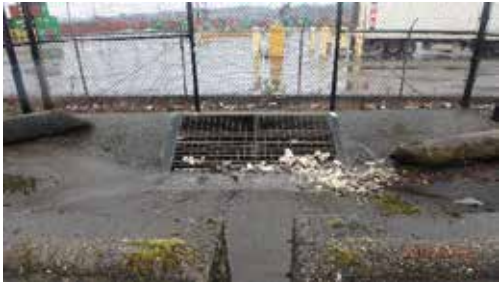
CBMH2	catch basin manhole	functioning normally	nm; some debris noted (see additional observations)	broken boom; sediment and debris accumulation in basin	remove accumulated sediment and debris; continue to maintain structure under stormwater permit

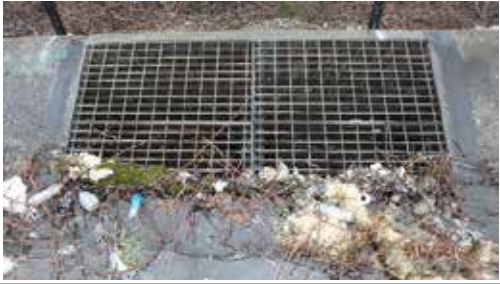
CBMH3	catch basin manhole	functioning normally	nm; some debris noted (see additional observations)	broken boom; organic debris and sediment accumulation in basin; standing water of approximately 1/2 in. depth on south side of basin	remove accumulated sediment and debris; continue to maintain structure under stormwater permit

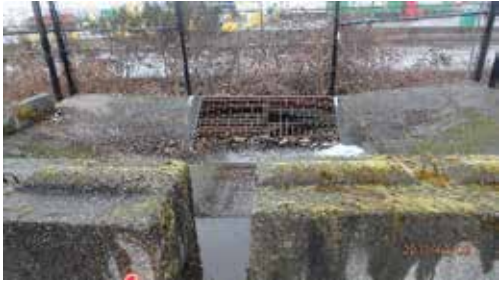
CBMH4	catch basin manhole	functioning normally	nm; some debris noted (see additional observations)	organic debris accumulated on grate; sediment accumulated in sump	remove accumulated sediment and debris; continue to maintain structure under stormwater permit

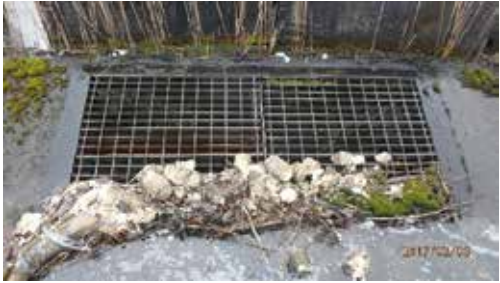
Location ID ^a	Type of Structure	Observed Condition	Sediment Accumulation (inches)	Additional Observations	Recommended Actions	Photos
CBMH5	catch basin manhole	functioning normally	nm; some debris noted (see additional observations)	broken boom; sediment and debris accumulated on grate; plant growth around perimeter of basin	remove boom; remove accumulated sediment and debris; remove vegetation around basin perimeter; continue to maintain structure under stormwater permit

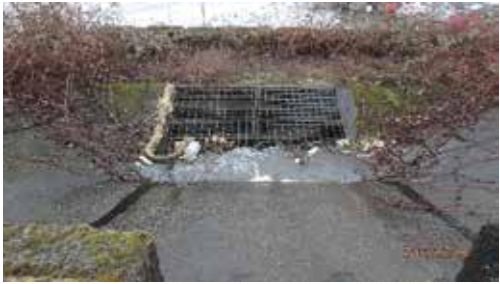
CBMH6	catch basin manhole	functioning normally	nm; some debris noted (see additional observations)	broken boom; vegetation in and around basin; debris in basin	remove boom; remove vegetation; remove debris continue to maintain structure under stormwater permit

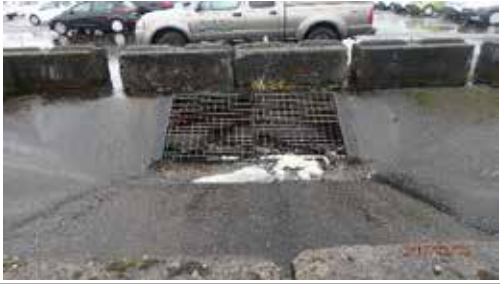
CBMH7	catch basin manhole	functioning normally	none in surface basin	vegetation growing around perimeter of basin; foam on grate; standing water approximately 2 in. deep in a large area on west side of basin	remove vegetation; remove foam; continue to maintain structure under stormwater permit

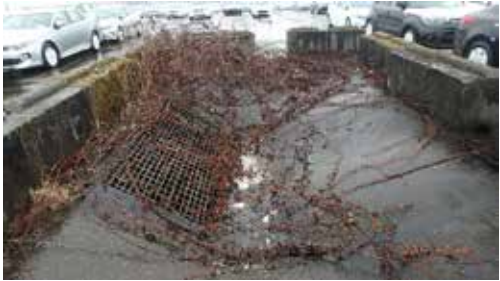
CBMH8	catch basin manhole	functioning normally	none in surface basin (other than vegetation)	numerous blackberry bushes in and around basin	remove vegetation; continue to maintain structure under stormwater permit

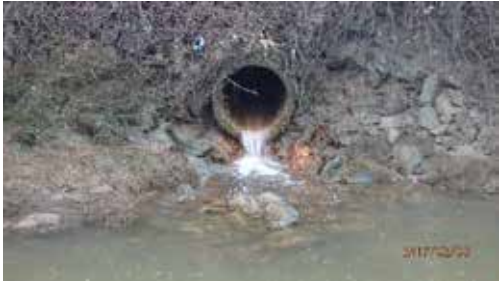
Location ID ^a	Type of Structure	Observed Condition	Sediment Accumulation (inches)	Additional Observations	Recommended Actions	Photos
OF1	outfall	functioning normally; unable to observe structure due to tide	na	unable to access outfall due to tide	observe structure during next inspection

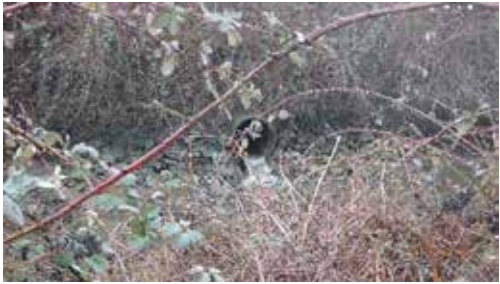
OF2	outfall	functioning normally; unable to observe structure due to tide	na	unable to access outfall due to tide	observe during next inspection

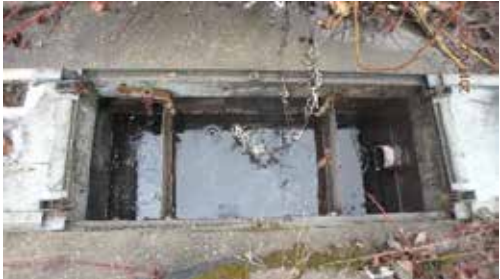
OVS	oil/water separator	structurally sound, functioning normally	less than 1	less than 1 in. sediment accumulation in center of vault/under lid; no sediment accumulation away from center of vault; minor floatables in first chamber	remove debris from around lid; remove floatables from first chamber; continue to maintain structure under stormwater permit

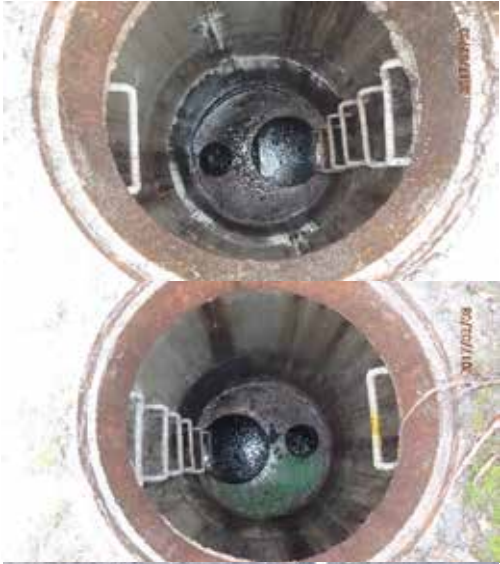
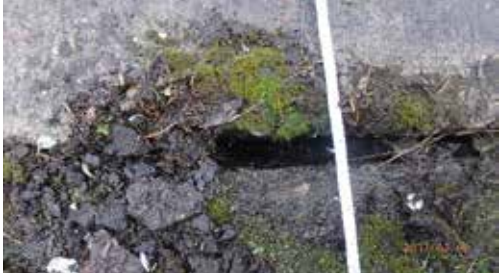
Location ID ^a	Type of Structure	Observed Condition	Sediment Accumulation (inches)	Additional Observations	Recommended Actions	Photos
SV1	spill containment vessel	appears to be functioning normally	nm (confined space entry required to probe vault bottom)	1 in. separation between access manhole and pavement on south side; floatables in west chamber; foam and minor floatables in east chamber	repair separated pavement; remove floating material from east and west chambers during next maintenance cycle; continue to maintain structure under stormwater permit

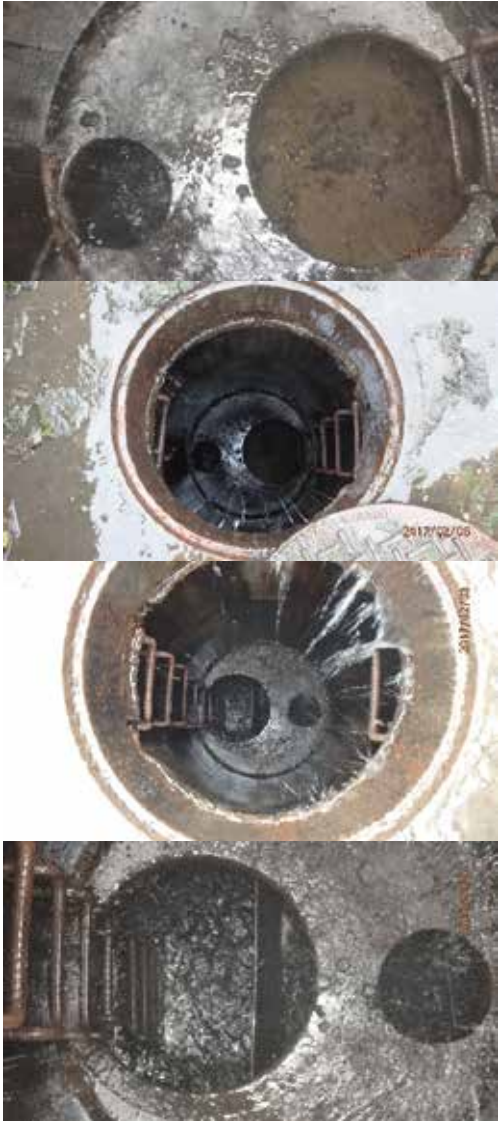
Location ID ^a	Type of Structure	Observed Condition	Sediment Accumulation (inches)	Additional Observations	Recommended Actions	Photos
SV2	spill containment vessel	appears to be functioning normally	nm (confined space entry required to probe vault bottom)	floatables in east chamber; mud accumulating on pavement in vicinity	remove floating material during next maintenance cycle from east chamber; remove accumulated mud; continue to maintain structure under stormwater permit

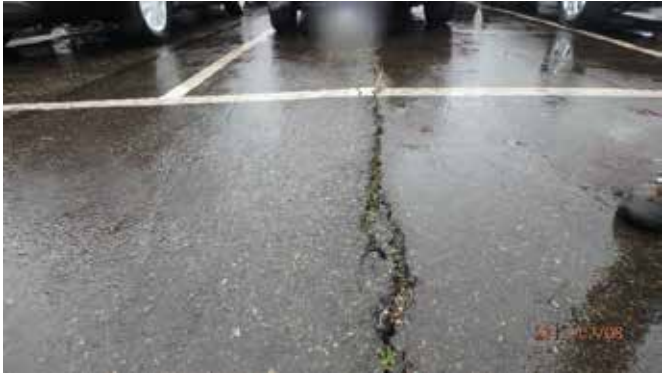
Location ID ^a	Observations	Recommended Actions	Photos
P1	crack approximately 3/4 in. wide in previously unrepaired pavement extending south from the recorded coordinates; ^b vegetation in crack	repair crack

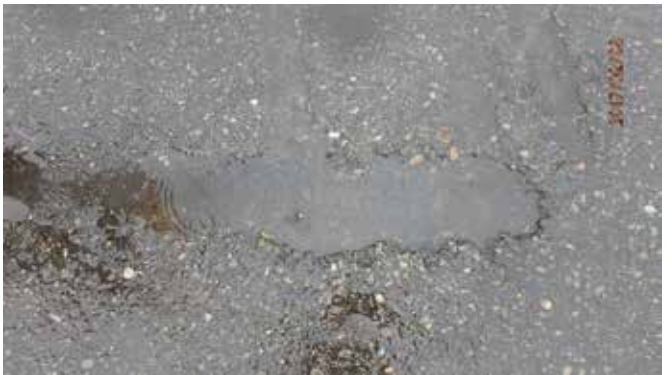
P2	gouge in pavement; approximately 36 x 8 in.	repair by patching or providing a pavement overlay

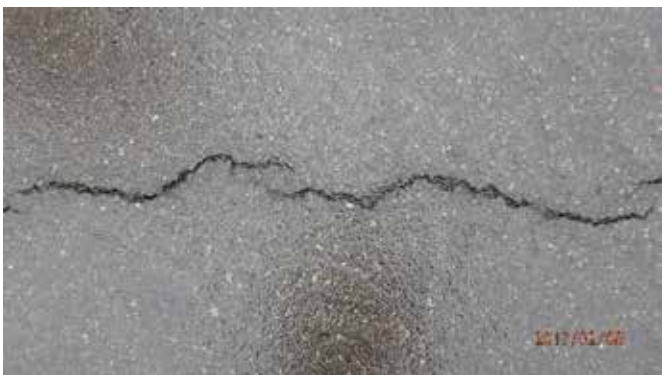
P3	crack wider than 1/8 in. in previously unrepaired pavement extending approximately 15 ft west from the recorded coordinates ^b	repair crack

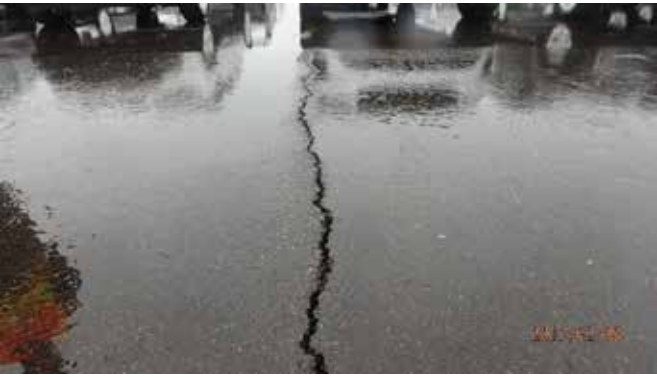
Location ID ^a	Observations	Recommended Actions	Photos
P4	crack wider than 1/8 in. in previously unrepaired pavement extending approximately 15 ft south from the recorded coordinates; ^b some vegetation in crack	repair crack

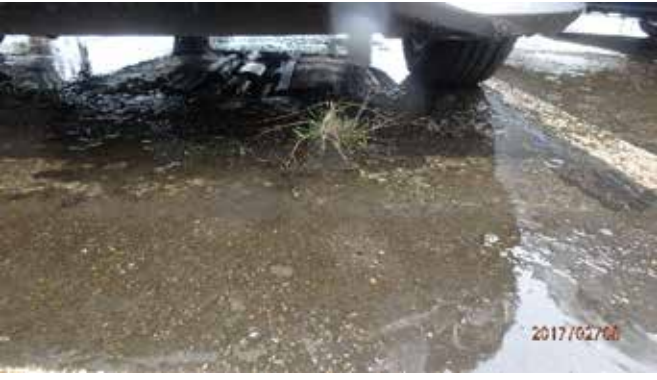
P5	crack in pavement caulking wider than 1/8 in. with vegetation	repair crack

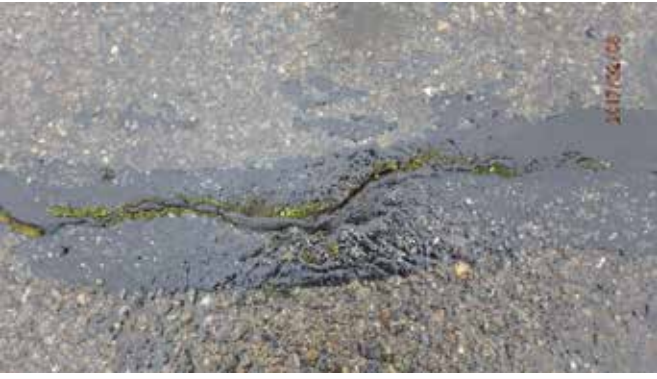
P6	crack in pavement caulking wider than 1/8 in. extending south approximately 40 ft from the recorded coordinates ^b	remove caulk and repair crack

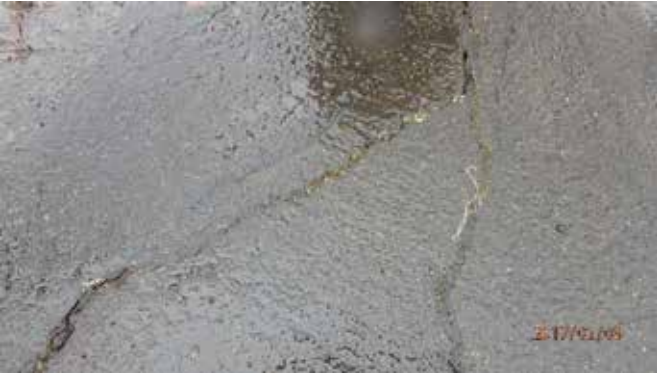
P7	crack in slurry overlay wider than 1/8 in.	repair crack

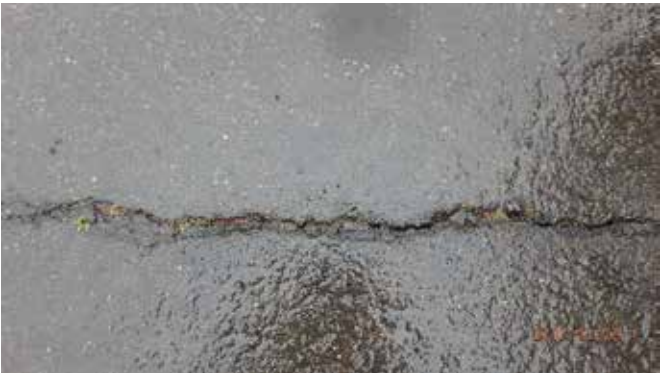
Location ID ^a	Observations	Recommended Actions	Photos
P8	crack in slurry overlay wider than 1/8 in. with vegetation	repair crack

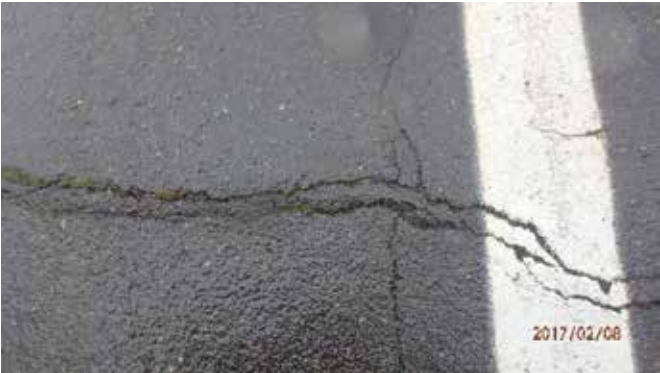
P9	crack in slurry overlay wider than 1/8 in.	repair crack	 
P10	crack in slurry overlay wider than 1/8 in.; sections of pavement between cracks appear loose and may become unattached from surrounding pavement	repair crack

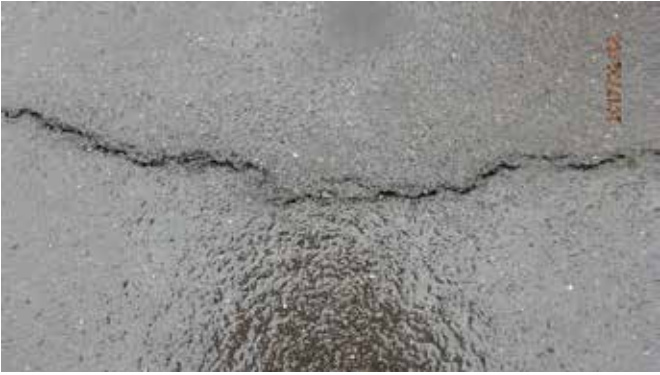
Location ID ^a	Observations	Recommended Actions	Photos
P12	crack in slurry overlay wider than 1/8 in. extending north and south from the recorded coordinates ^b	repair crack

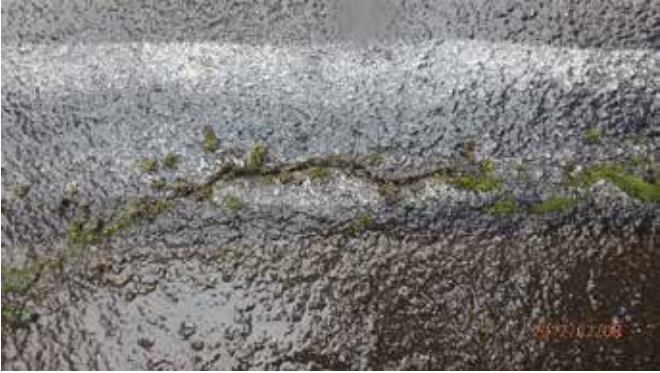
P13	crack in slurry overlay wider than 1/8 in. extending north and south from the recorded coordinates ^b	repair crack

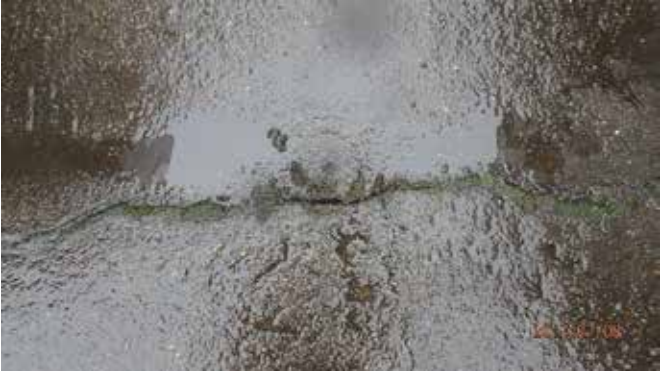
P14	crack in slurry overlay wider than 1/8 in. extending east and west at least 30 ft from the recorded coordinates; ^b pavement on north side of crack at higher elevation than pavement on south side	repair crack

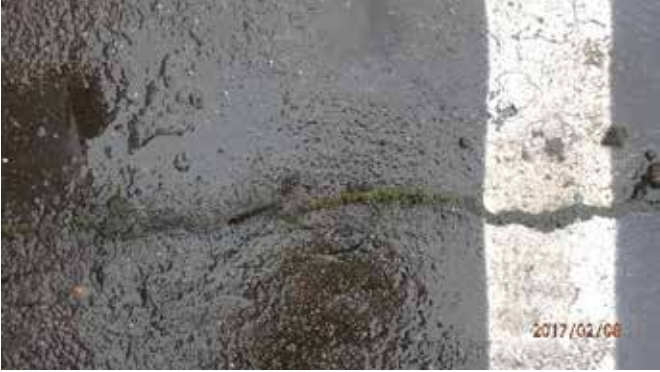
P15	crack in slurry overlay wider than 1/8 in. extending east and west from the recorded coordinates ^b	repair crack

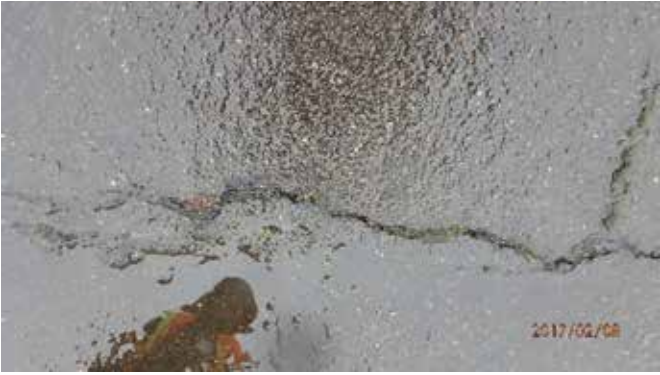
Location ID ^a	Observations	Recommended Actions	Photos
P16	crack in slurry overlay wider than 1/8 in. extending north and south from the recorded coordinates ^b	repair crack

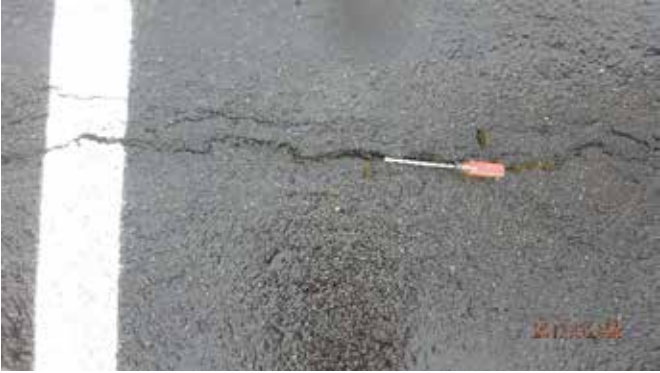
P17	crack in slurry overlay wider than 1/8 in. extending north and south from the recorded coordinates ^b	repair crack

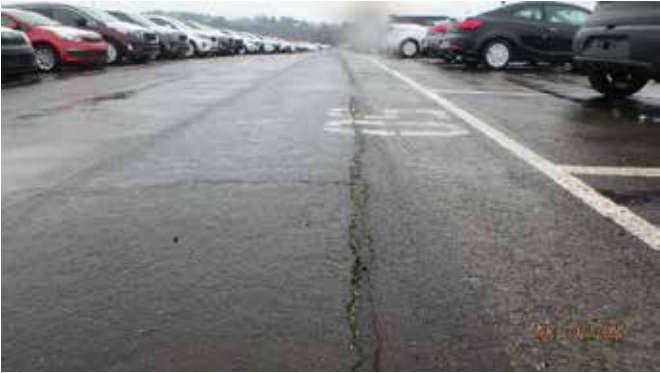
P18	crack in slurry overlay wider than 1/8 in. extending east and west from the recorded coordinates; ^b pavement on north side of crack at higher elevation than pavement on south side	repair crack	[no photo]
P19	crack in slurry overlay wider than 1/8 in. extending east and west from the recorded coordinates ^b	repair crack

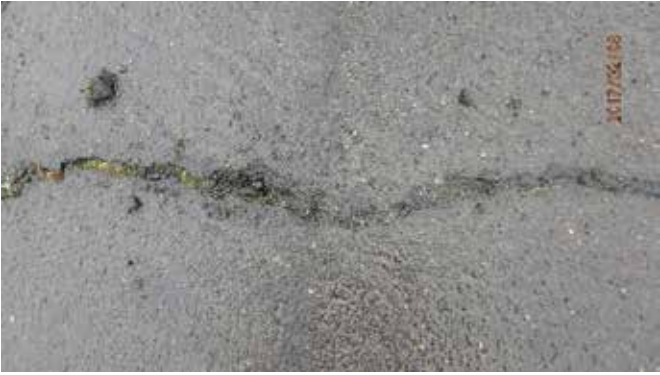
Location ID ^a	Observations	Recommended Actions	Photos
P32	crack wider than 1/8 in. in slurry overlay extending approximately 30 ft from the recorded coordinates; ^b crack previously repaired using caulk; caulk now coming out of crack	repair crack

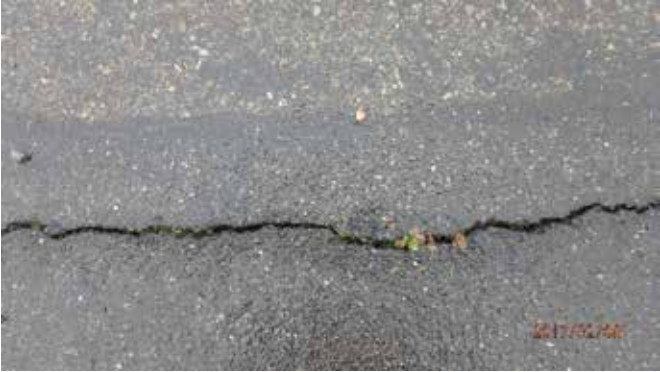
P33	crack wider than 1/8 in. in slurry overlay extending approximately 50 ft northeast from the recorded coordinates ^b	repair crack

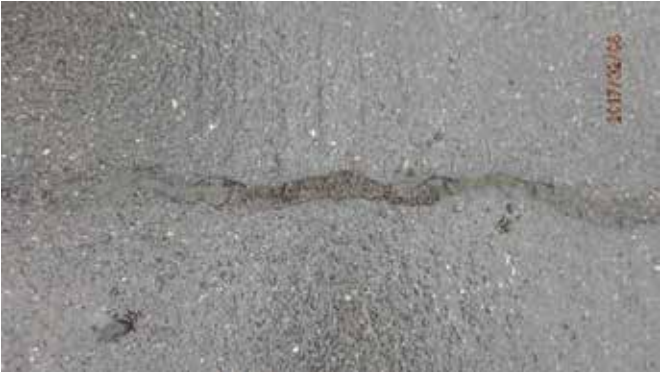
P34	crack wider than 1/8 in. in slurry overlay extending approximately 20 ft east from the recorded coordinates ^b	repair crack
