## ENVIRONMENTAL CAP INSPECTION REPORT

### FORMER LOUISIANA PACIFIC/ PONY LUMBER FACILITY

Enforcement Order No. DE 92TC-S312 (December 21, 1992)  
Washington State Department of Ecology Facility Site ID# 1209  
Inspection Date: February 15, 2017

March 31, 2017

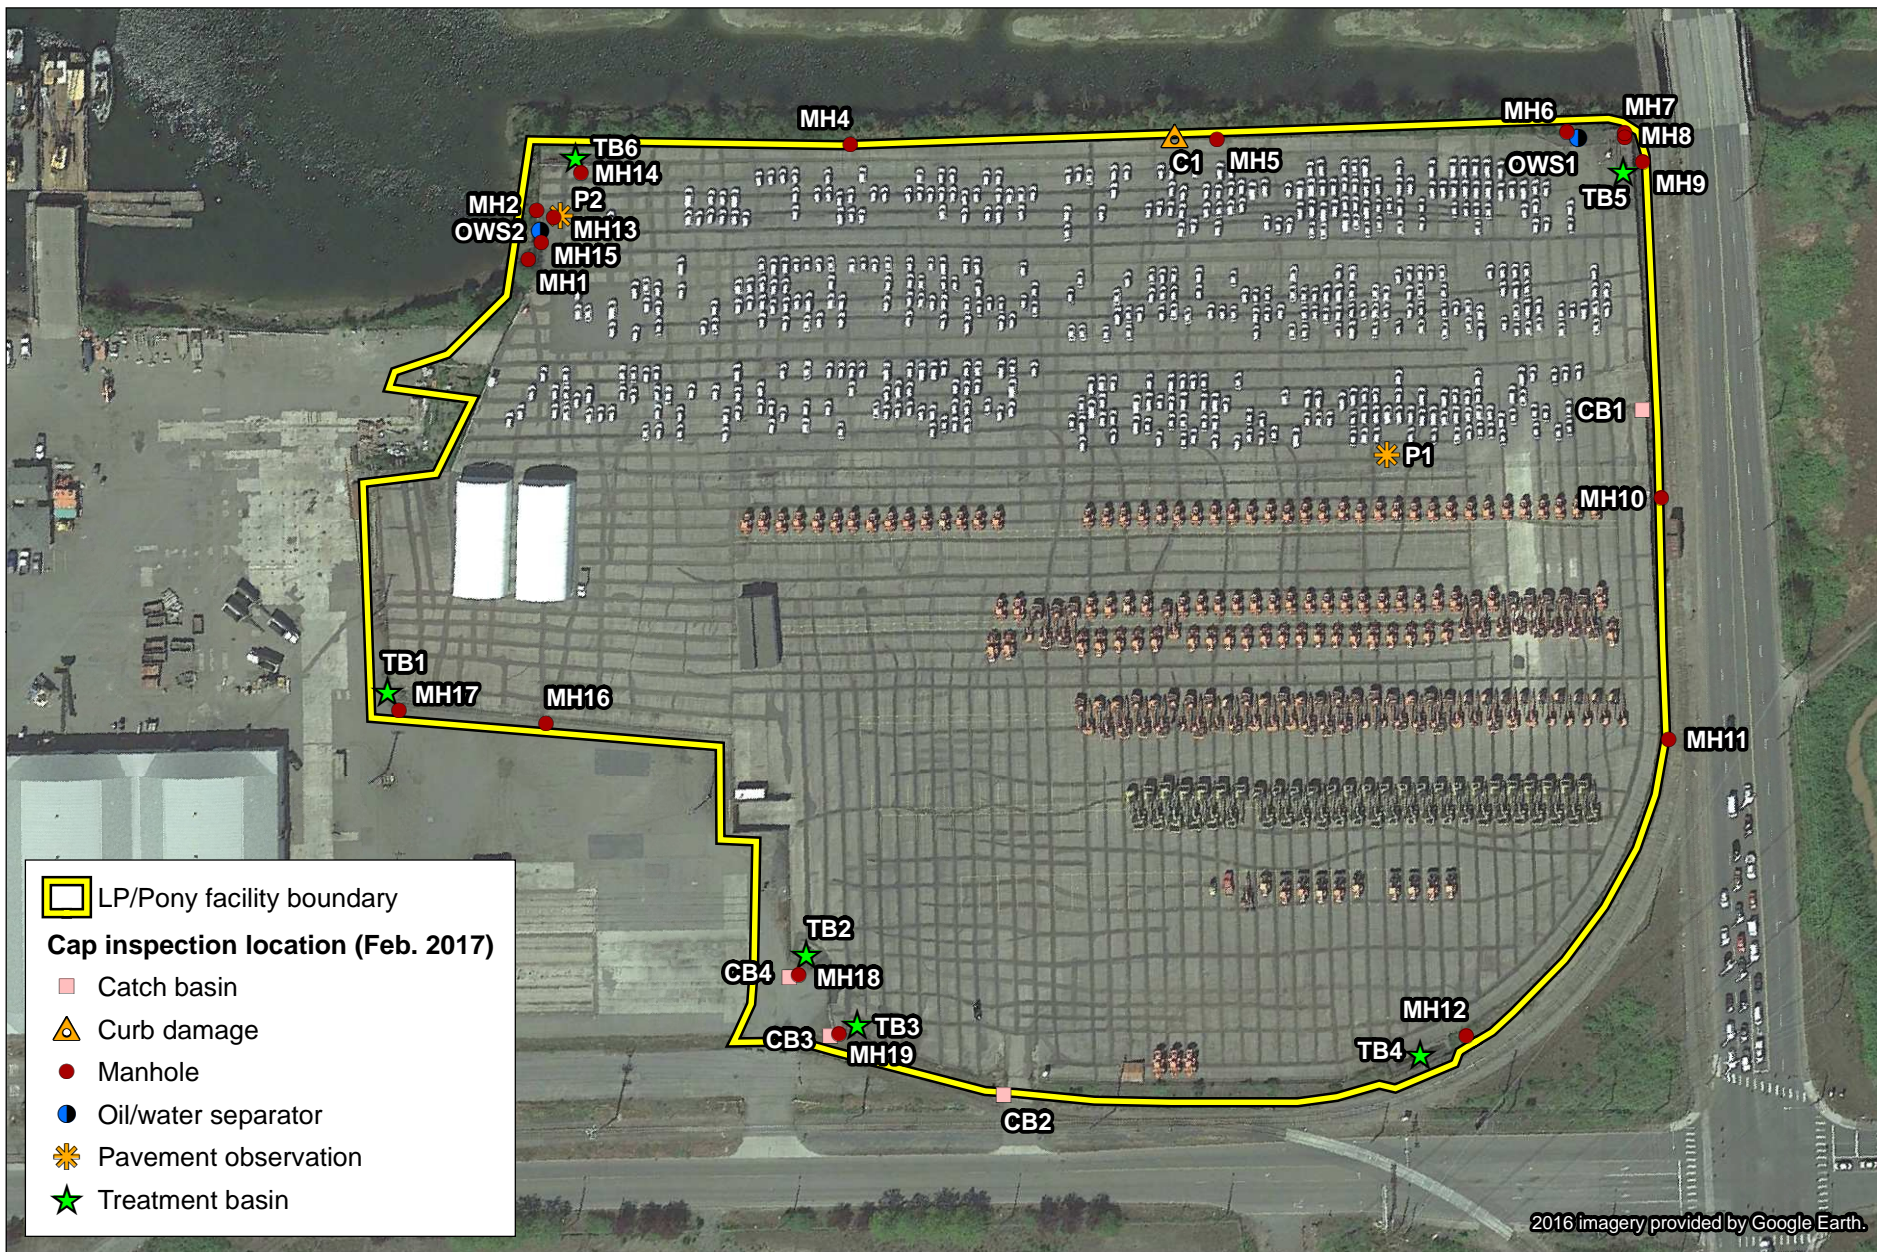
**Figure 2. LP/Pony field observations**

As described in Table 1 and shown on Figure 2, one crack wider than 1/8 in. was observed and should be repaired (P1 on Figure 2). An area of curb degradation approximately 4 ft long was also observed (C1 on Figure 2). This condition is described further in Table 2. The curb damage does not extend to the pavement surface and the curb continues to direct stormwater flow. It is recommended that the curb be monitored and evaluated for repair during the next inspection cycle.

An area of pavement deterioration was observed in the vicinity of treatment basin TB6. This area is marked on Figure 2, and recommended actions are described in Table 2. Table 2 lists cap condition-related issues observed during the inspection, which are also shown on Figure 2.

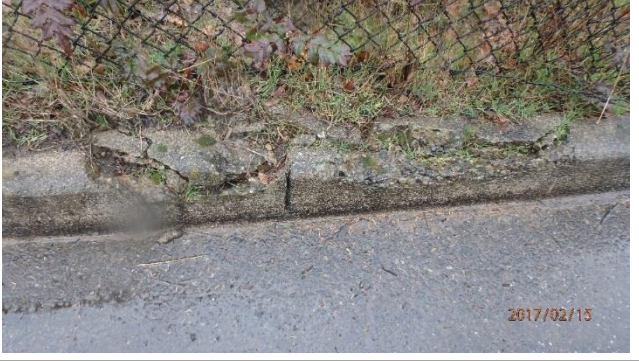
Location ID <sup>a</sup>	Observations	Recommended Actions	Photos
C1	curb damage extending approximately 4 ft	Monitor and reevaluate for repair during next inspection cycle.

- ◆ A damaged section of curb approximately 4 ft long was observed along the eastern fence line and should be monitored and reevaluated for repair during the next inspection cycle (location C1 on Figure 2).

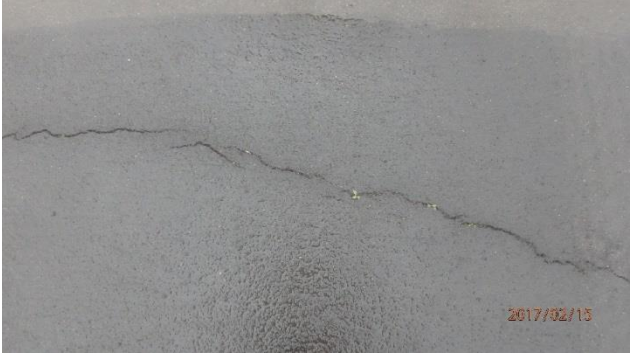
P1	crack wider than 1/8 in. extending approximately 12 ft	Repair.

- ◆ One crack wider than 1/8 in. and approximately 12 ft long was observed at location P1 (Figure 2). This crack should be repaired.
- ◆ An area of pavement deterioration was observed in the north corner of the facility at location P2 (Figure 2). The deterioration should be patched.

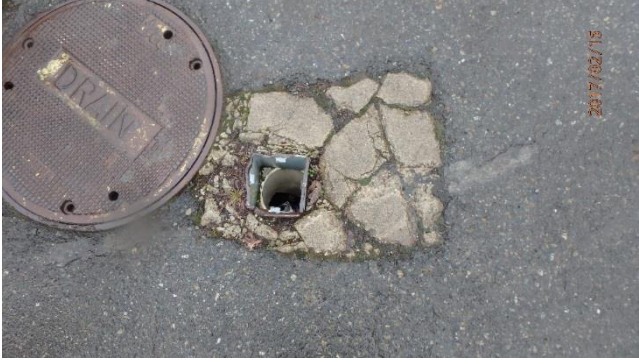
P2	damaged concrete near manhole	Repair pavement near manhole.

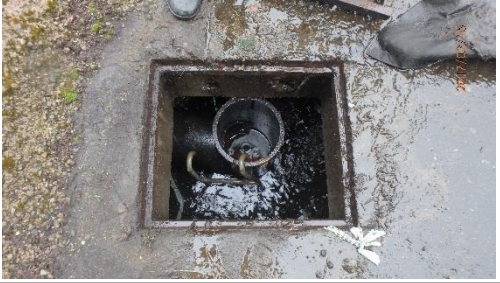
Location ID <sup>a</sup>	Type of Structure	Observed Condition	Sediment Accumulation (inches)	Additional Observations	Recommended Actions	Photos
CB1	catch basin	structurally sound, functioning normally	4	insert in catch basin; insert full of sediment; structure has a T-outlet; vault full of water to outlet invert; sediment accumulation around grate; some debris in catch basin	Clean or replace insert; remove accumulated sediment from around grate; remove debris from catch basin in accordance with stormwater maintenance requirements.

Debris should be removed from manholes MH13, MH14, and MH15, and accumulated sediment should be removed from the vicinity of catch basins CB1 and CB2.

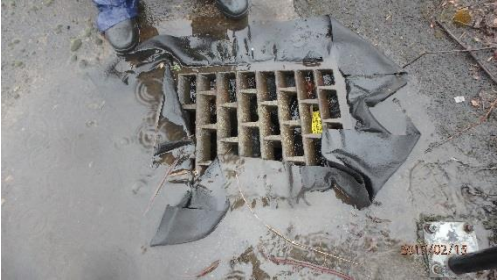
CB2	catch basin	structurally sound, functioning normally	0	insert in catch basin; no sediment in insert; did not pull grate/insert because of large amount of accumulated sediment in vicinity of grate	Remove accumulated sediment from around grate.

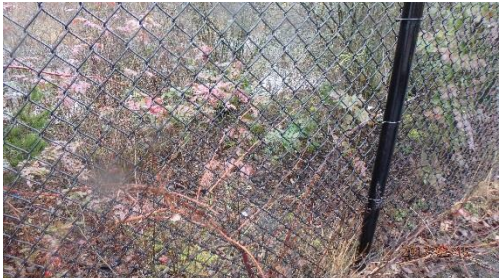
MH6	manhole	inaccessible and unsafe to observe due to vegetation and slope erosion	nm	none	Clear vegetation so that structure is accessible from gate on northeast side of facility fence; observe during next inspection.

It is also recommended that vegetation be cleared from the vicinity of manhole MH6 so that the structure is accessible from the gate on the east fence during future inspections, and from around manhole MH3 so that the structure can be located during future inspections.

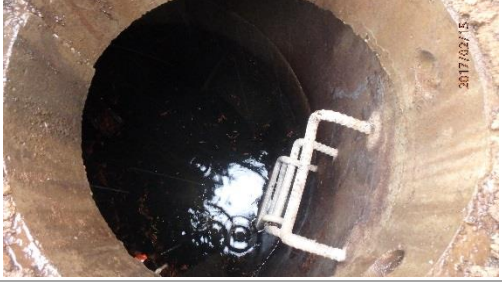
A photograph of a manhole opening. The concrete cover is partially open, revealing water flowing into the structure. The surrounding area is covered with dry leaves and twigs. A date stamp '2017/02/13' is in the bottom right corner.
MH13	manhole	structurally sound, functioning normally	structure too deep to measure	small amount of floating organic debris	Remove organic debris from structure in accordance with stormwater maintenance requirements.

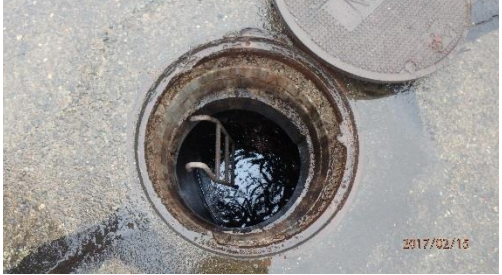
MH14	manhole	structurally sound, functioning normally	structure too deep to measure	organic debris in structure	Remove organic debris from structure in accordance with stormwater maintenance requirements.

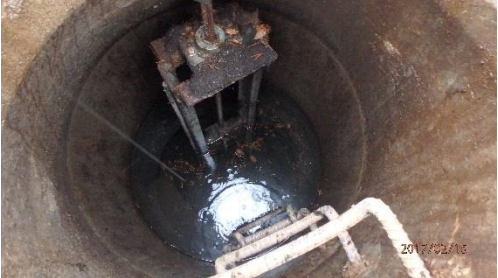
Location ID <sup>a</sup>	Type of Structure	Observed Condition	Sediment Accumulation (inches)	Additional Observations	Recommended Actions	Photos
MH15	manhole	structurally sound, functioning normally	structure too deep to measure	organic debris in structure	Remove organic debris from structure in accordance with stormwater maintenance requirements.

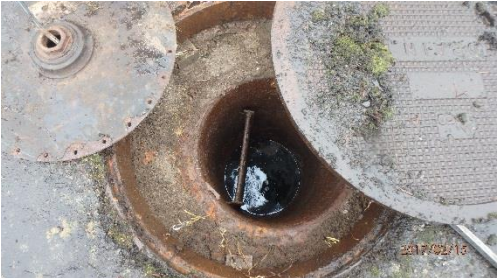
OWS1	oil/water separator	structurally sound, functioning normally	0	metal structure	Pump out the oil/water separator for inspection and check for corrosion.

The Port should consider pumping out the oil/water separators during the dry season to enable a full inspection of these structures, particularly for corrosion.

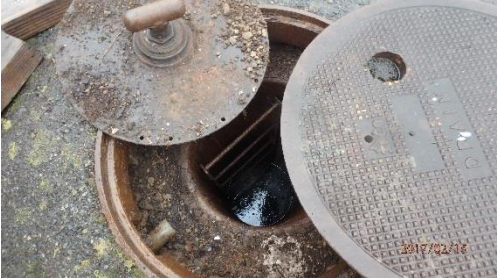
OWS2	oil/water separator	structurally sound, functioning normally	0	metal structure	Pump out the oil/water separator for inspection and check for corrosion.

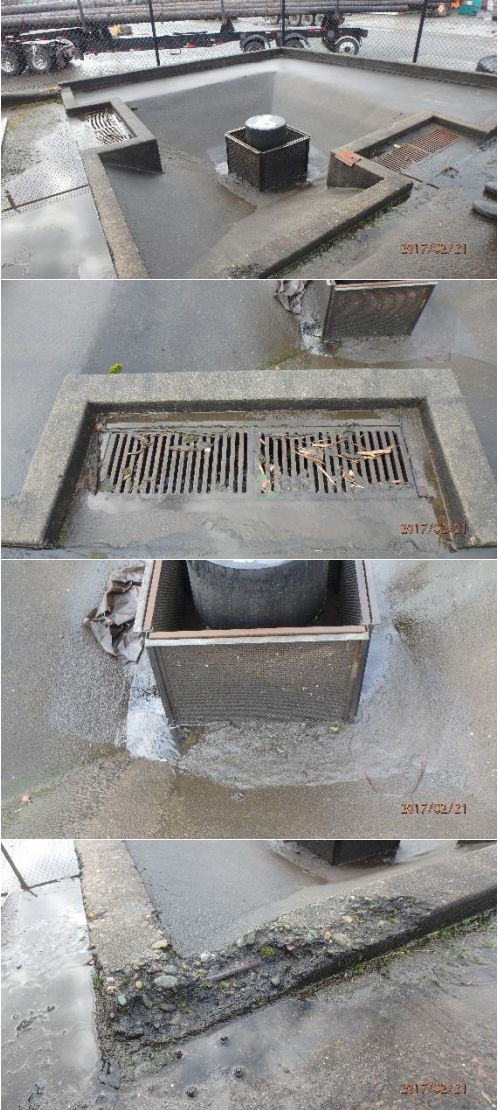
Location ID <sup>a</sup>	Type of Structure	Observed Condition	Sediment Accumulation (inches)	Additional Observations	Recommended Actions	Photos
TB1	treatment basin	structurally sound, functioning normally	1-2	no screens; some organic debris on grates; some deterioration of pavement curb on east corner of basin	Replace screens; remove accumulated organic debris and sediment in accordance with stormwater maintenance requirements; repair deteriorated pavement curb if condition worsens.

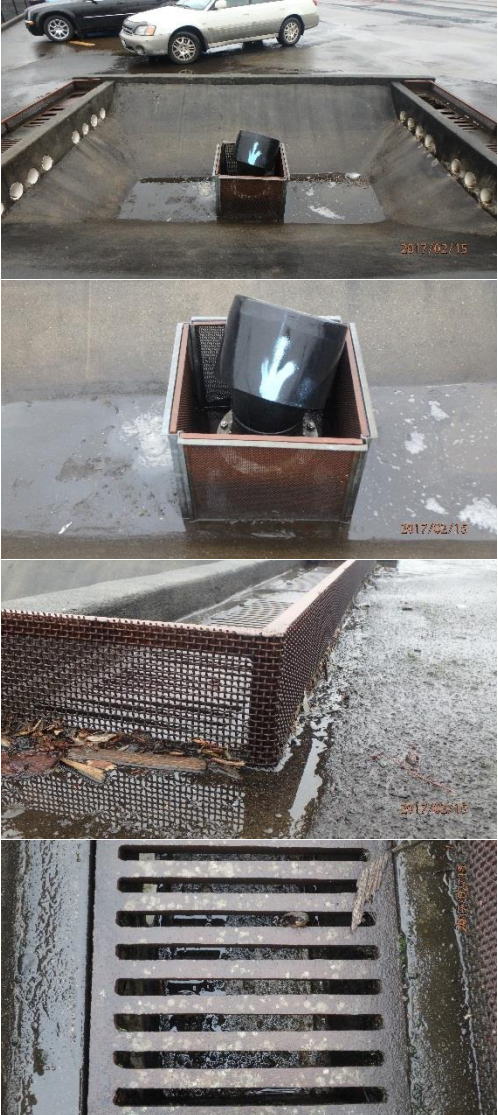
Location ID <sup>a</sup>	Type of Structure	Observed Condition	Sediment Accumulation (inches)	Additional Observations	Recommended Actions	Photos
TB2	treatment basin	structurally sound, functioning normally	1	small amount of sediment in west grate; some organic debris around screen	Remove accumulated sediment from southwest grate in accordance with stormwater maintenance requirements; remove organic debris from screen.

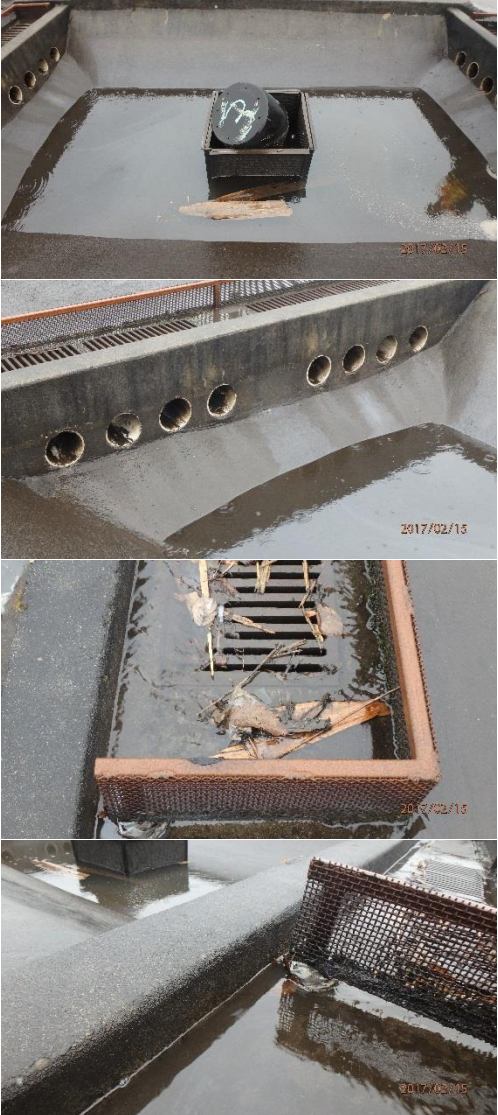
Location ID <sup>a</sup>	Type of Structure	Observed Condition	Sediment Accumulation (inches)	Additional Observations	Recommended Actions	Photos
TB3	treatment basin	structurally sound, functioning normally except for some flow bypassing screen	0	organic debris in basin and on grates; small amount of mud around basin; moss accumulated on screen; flow bypassing screen	remove organic debris and mud from grates and basin in accordance with stormwater maintenance requirements

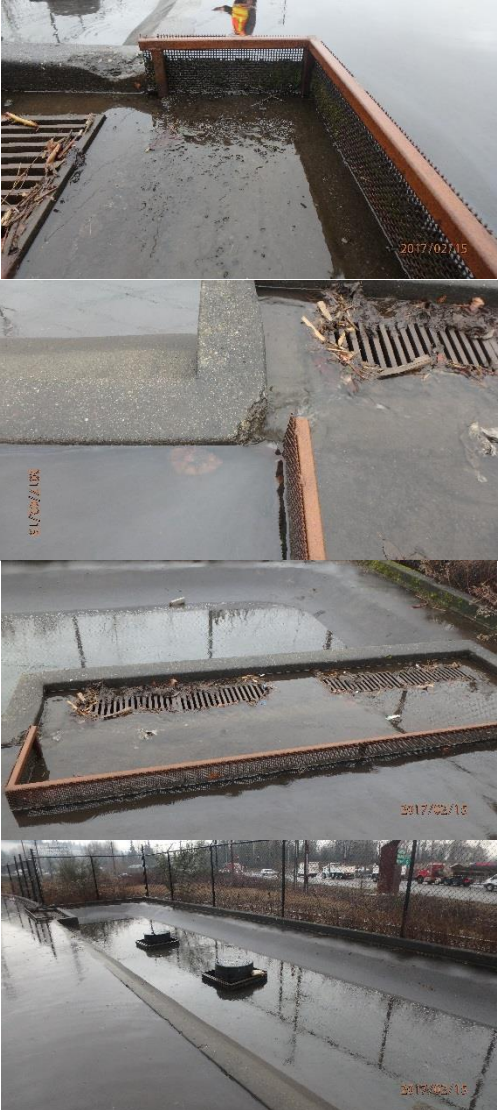
Location ID <sup>a</sup>	Type of Structure	Observed Condition	Sediment Accumulation (inches)	Additional Observations	Recommended Actions	Photos
TB4	treatment basin	structurally sound; flow bypassing screen	0	1–4 in. of mud accumulated on screen preventing flow from passing through screen and causing large amount of standing water up to 2 in. deep in vicinity of treatment basin; flow bypassing screen has caused some erosion of concrete curb on the north side of basin; organic debris on grates	Remove organic debris from grates; repair deteriorated pavement curb if condition worsens.

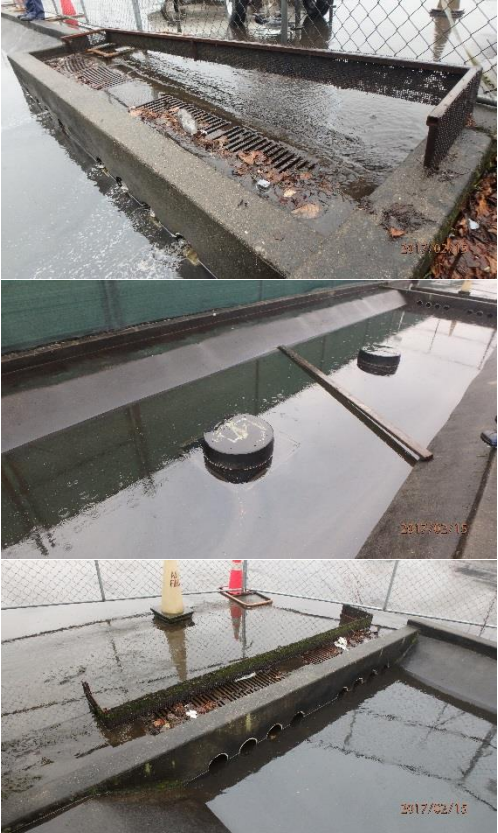
Location ID <sup>a</sup>	Type of Structure	Observed Condition	Sediment Accumulation (inches)	Additional Observations	Recommended Actions	Photos
TB5	treatment basin	structurally sound; flow bypassing both screens	2-3	organic debris and trash on grates; one screen pulled up so that stormwater flows under it; other screen moved so that stormwater flows around it	Remove organic debris and trash from grates; remove accumulated sediment from basin in accordance with stormwater maintenance requirements; clean screens.

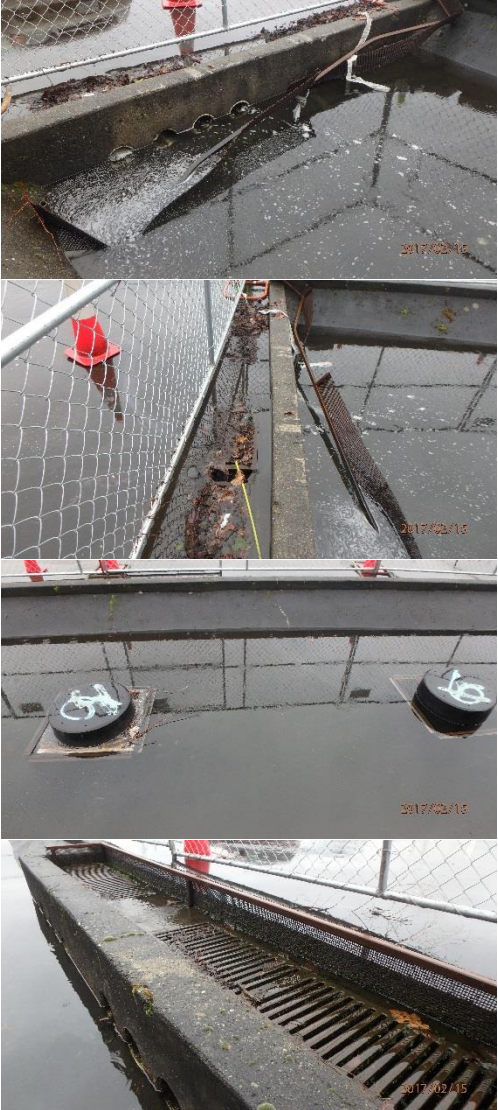
Location ID <sup>a</sup>	Type of Structure	Observed Condition	Sediment Accumulation (inches)	Additional Observations	Recommended Actions	Photos
TB6	treatment basin	structurally sound; screens not functioning	0	east screen moved to inside basin; 3–4 in. of sediment accumulated on south screen preventing flow; organic debris on grates; high water level in basin; standing water in vicinity of basin	Removed accumulated organic sediment in accordance with stormwater maintenance requirements.
