ENVIRONMENTAL CAP INSPECTION REPORT

FORMER MURRAY PACIFIC No. 2 LOG SORT YARD

Consent Decree No. 94-2-099227 (September 16, 1994)
Washington State Department of Ecology Facility ID # 1211
Inspection Dates: February 21 and March 1, 2017

April 17, 2017

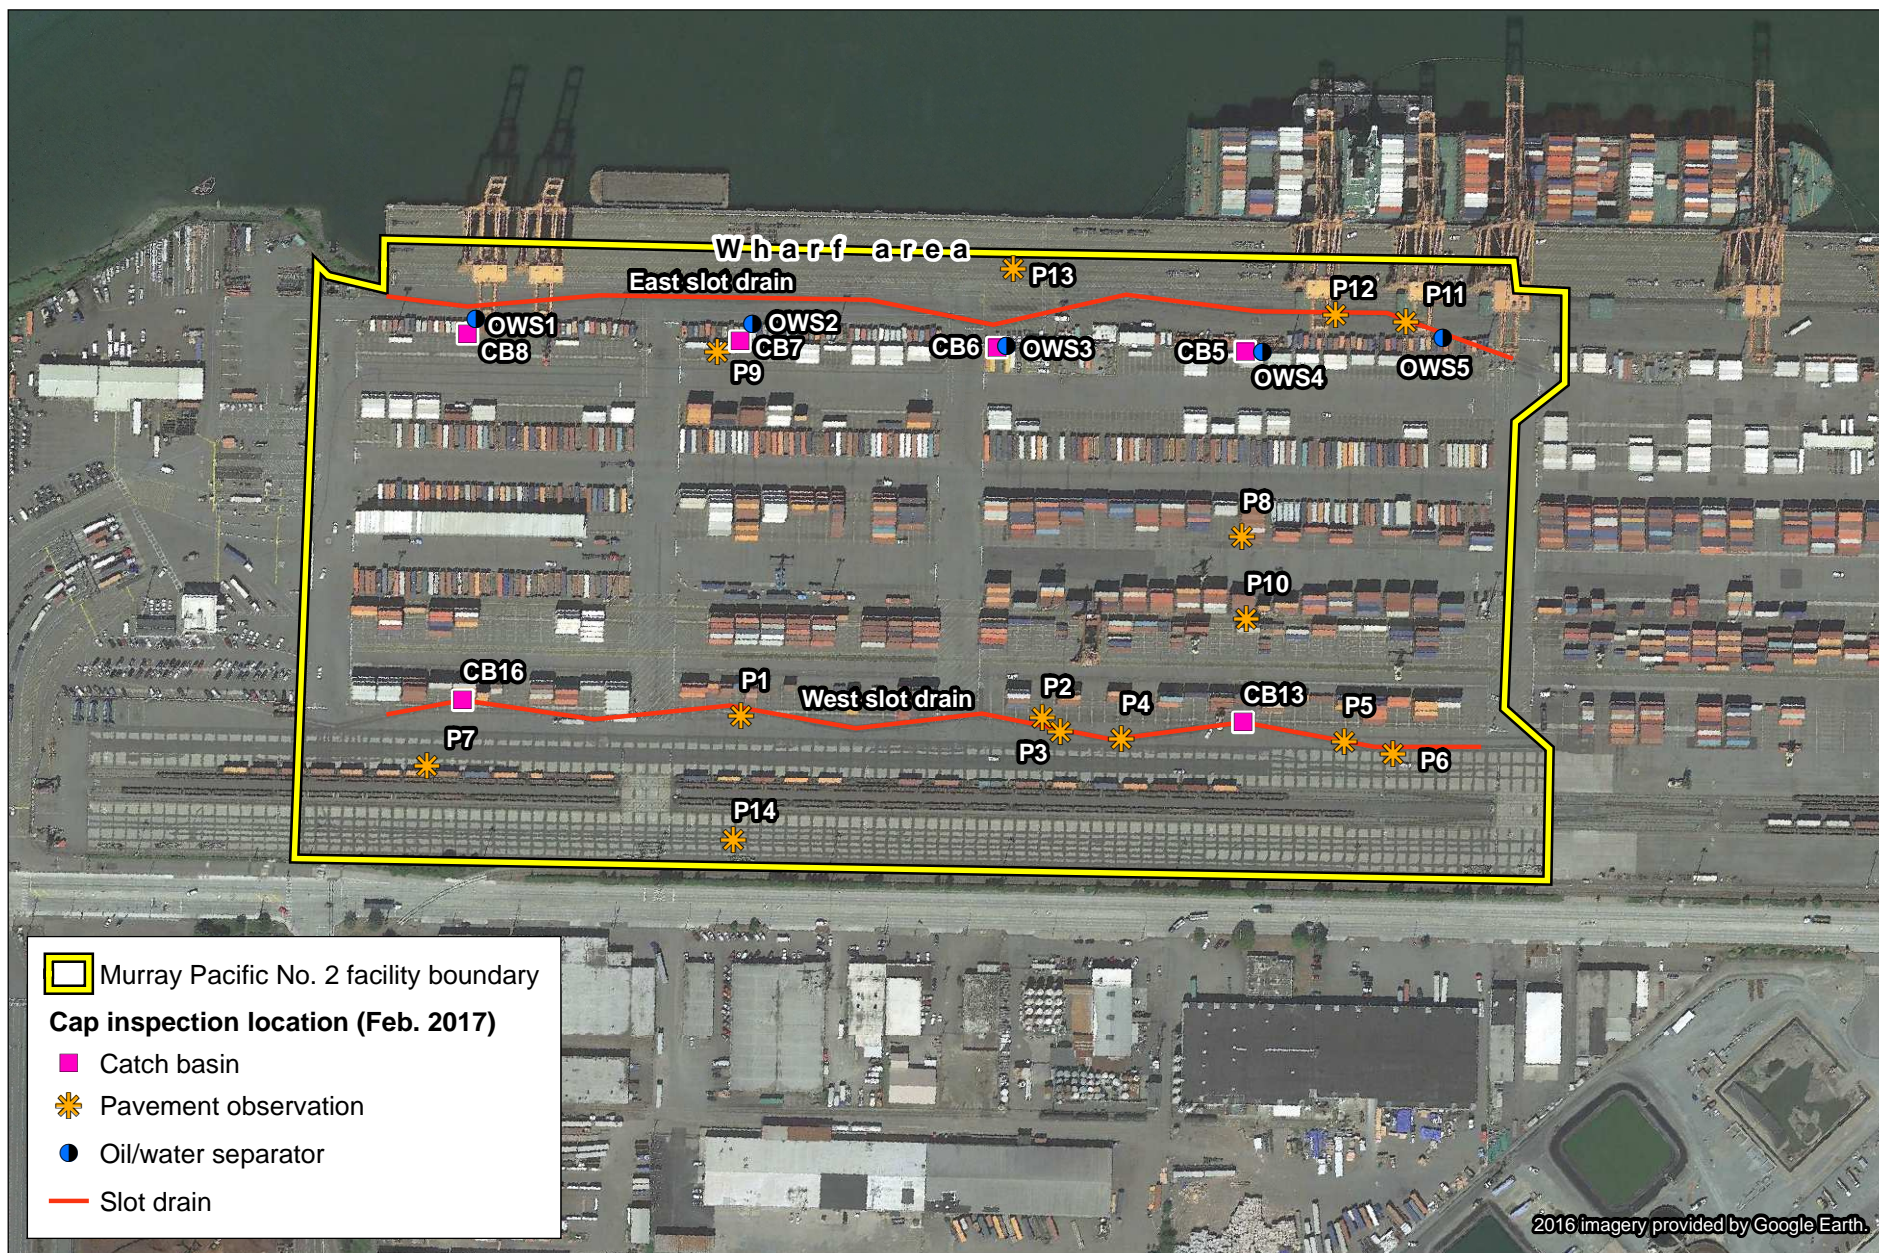
Figure 2. Murray Pacific No. 2 field observations

Divots were also observed at locations within the wharf area (Figure 2). These divots were shallower and smaller than those observed in the container storage area, and did not appear to be impacting the integrity of the cap.

Appendix A lists specific items observed on the environmental cap that require repair; these items are also shown on Figure 2.

All cracks wider than 1/8 in. and areas of pavement deterioration (Figure 2) should be repaired as described in Appendix A.

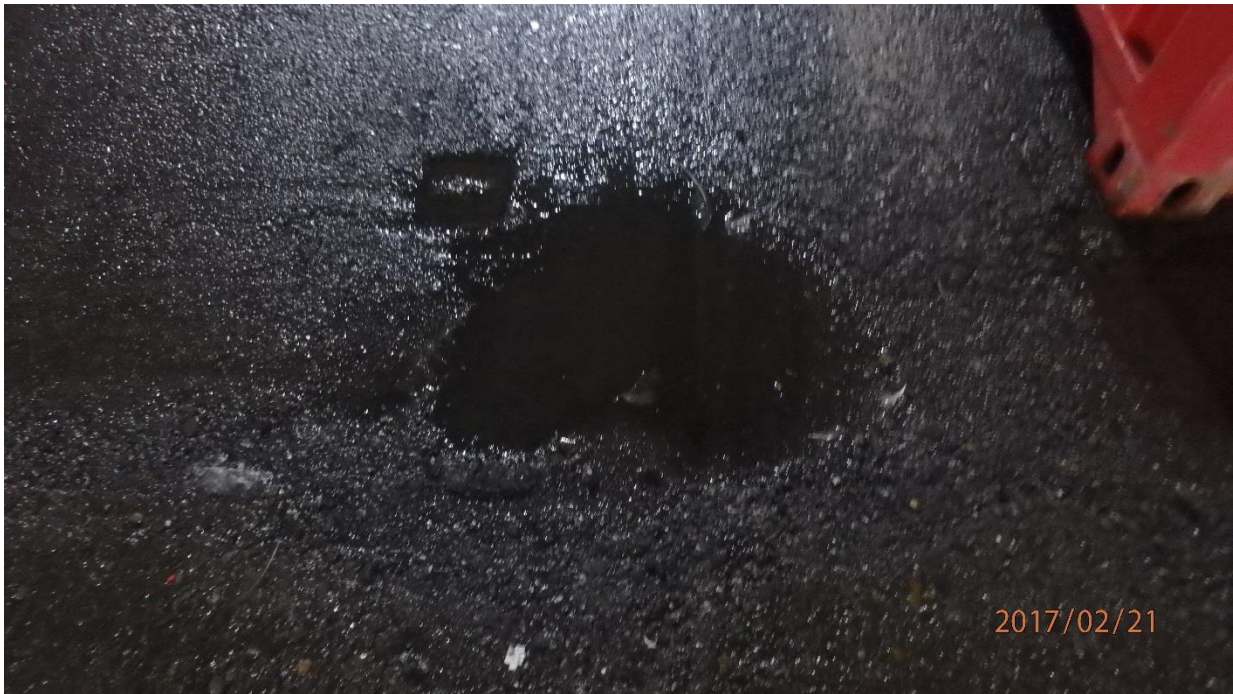
Figure 3. Single representative divot

The environmental cap at Murray Pacific No. 2 covers approximately 49.5 ac (Figure 2). The cap was observed to be showing some signs of wear caused by the presence of containers and heavy equipment. Container divots (i.e., small depressions in the pavement surface caused by container corner fittings) were observed throughout portions of the cap used for container storage. The divots were generally shallow and did not appear to extend deeply into the cap cross section, or to impact the integrity of the cap. Loose gravel was often observed in the vicinity of the divots and may have been the result of raveling (i.e., dislodging of aggregate) (USACE 2009). Photos of representative divots are included as Figures 3 and 4.

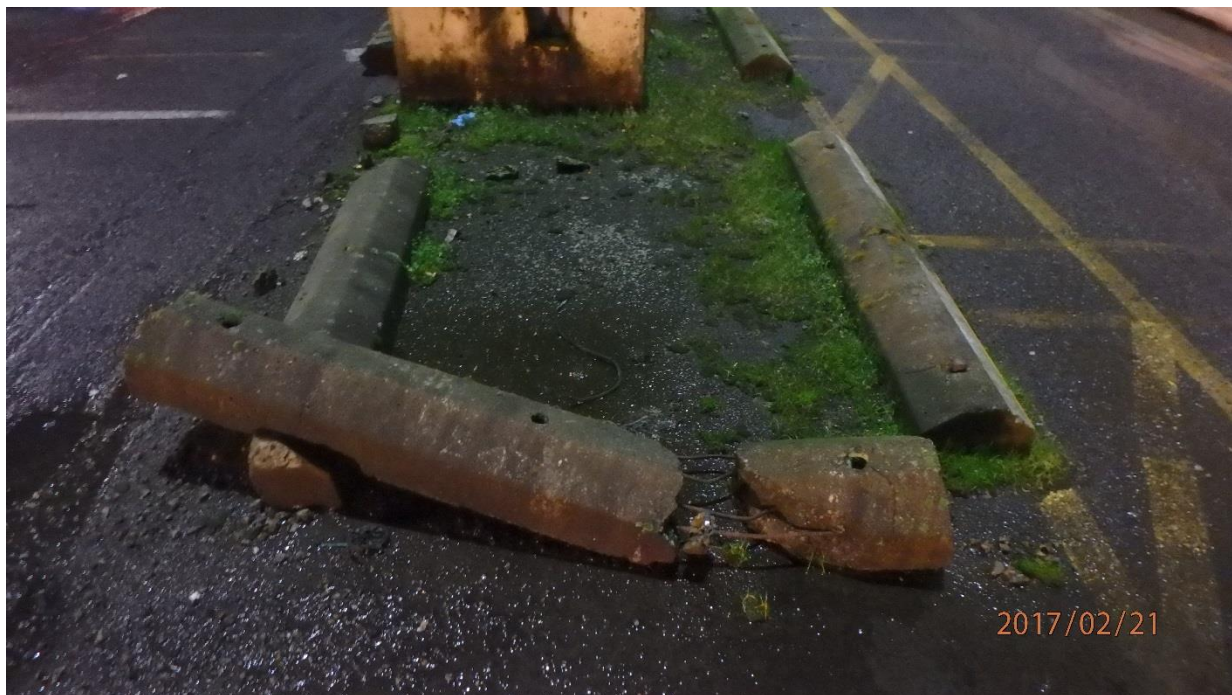
Figure 5. Example of deteriorated wheel stops

Deteriorated, broken, and relocated wheel stops were observed in multiple locations. Examples of such wheel stops are shown in Figure 5. In the previous inspection report (Hart Crowser 2014), 111 wheel stops were reported as damaged. Based on observations during the Windward inspection, it did not appear that the wheel stops had been repaired. However, the damaged wheel stops do not appear to be impacting the cap's integrity, as they are mounted on the cap surface with steel pins. Where the wheel stops were observed to be broken or dislodged, the pins remained intact.

As discussed in Section 2.1, it does not appear that the concrete wheel stops have been repaired, replaced, or removed. However, the condition of the concrete wheel stops does not appear to be affecting the integrity of the environmental cap.

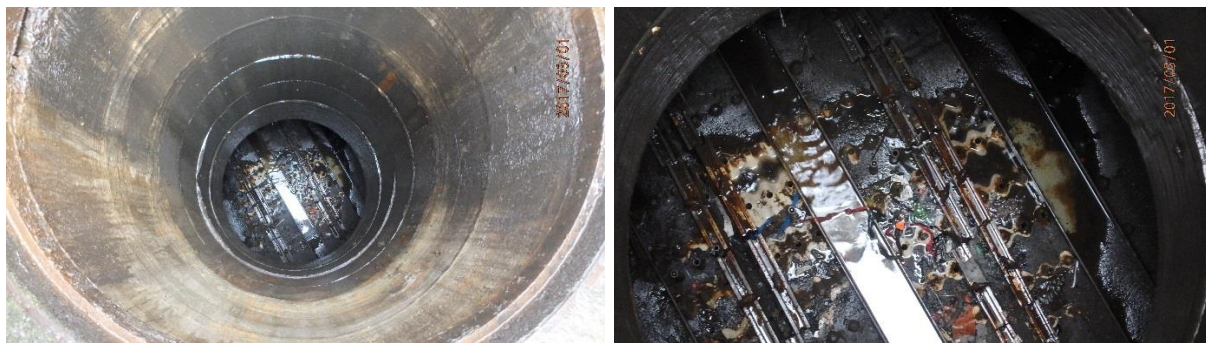
Figure 6. Representative views of sediment accumulation on the coalescing plate oil/water separators

Appendix B summarizes the observations made at each accessible stormwater structure. Overall, the structures were in good condition and required only minor servicing (e.g., removal of accumulated debris from catch basin inserts), which can be accomplished during the next stormwater system servicing event. Some sediment was observed on the tops of the coalescing separator plates in the oil/water separators (Figure 6), possibly indicating the need for separator cleaning. The O&M plan states that the oil/water separators should be cleaned annually, by October of each year, and when the accumulated sediment depth reaches 10% of the chamber depth, or 8 in. (HLA 1997). The Port should verify that these maintenance events are occurring. It is also recommended that the plates of the oil/water separators be checked and cleaned, and that any accumulated oil be pumped out during the next servicing event in order to help ensure the efficiency of the separators.

It is recommended that the insert in catch basin CB6 be cleaned or replaced, and that the insert in catch basin CB13 be repositioned (Figure 2; Appendix B). It is also recommended that the coalescing separator plates in the oil/water separators be cleaned and/or serviced to remove accumulated sediment and oil from the plates (Figure 6).

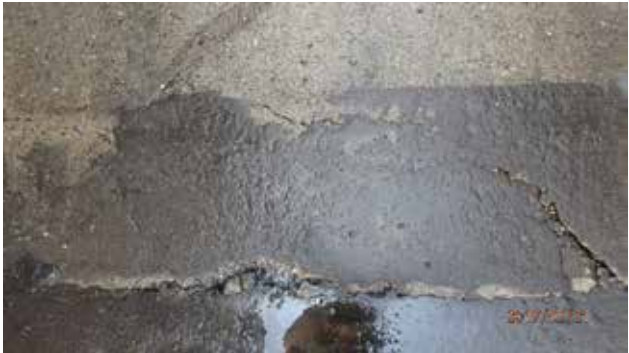
Location ID ^a	Observations	Recommended Actions	Photos
P1	pavement deterioration with cracks wider than 1/8 in.; area of damage approximately 25 by 5 ft; damage may extend under containers	Repair damaged pavement.

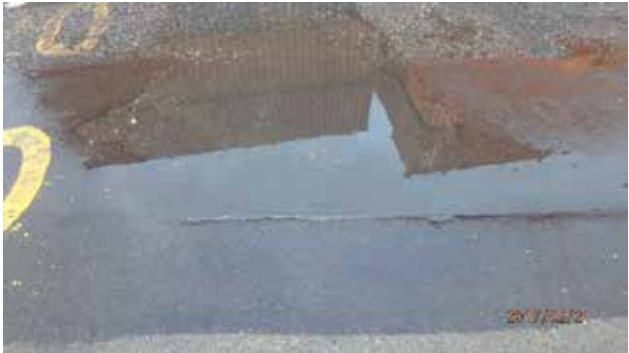
P2	pavement deterioration with portions of slurry overlay broken out; standing water up to 2 in. deep	Repair slurry overlay.

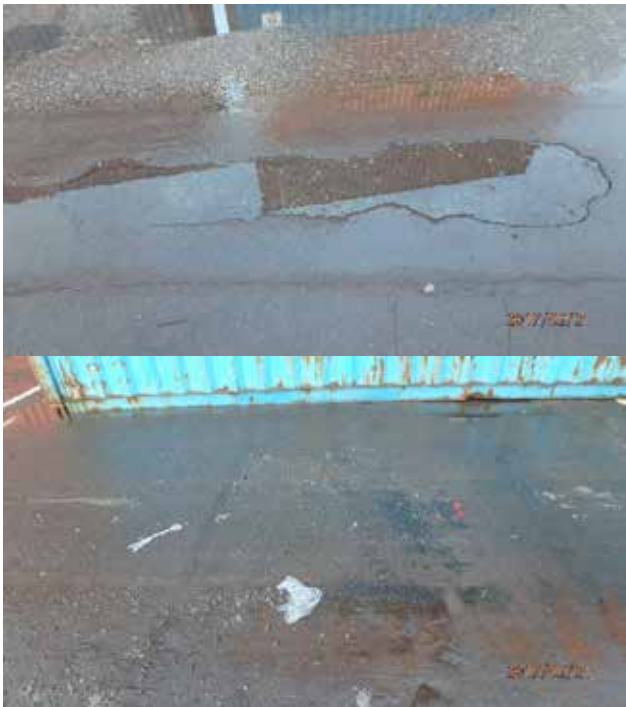
Location ID ^a	Observations	Recommended Actions	Photos
P3	pavement deterioration with portions of slurry overlay broken out; standing water 1–2 in. deep; three areas of damage in vicinity; loose gravel in vicinity	Repair pavement; remove loose gravel.

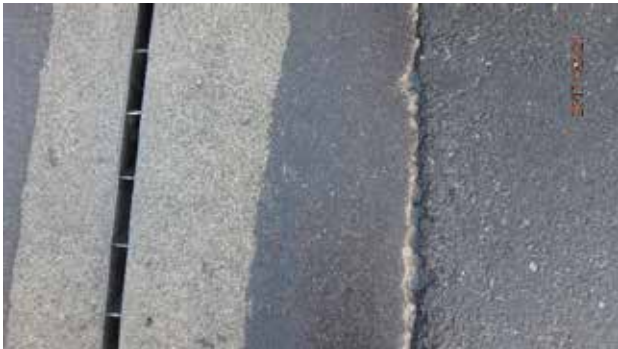
P4	separation between slot drain pavement and asphalt wider than 1/8 in.; extends at least 50 ft	Repair separation.

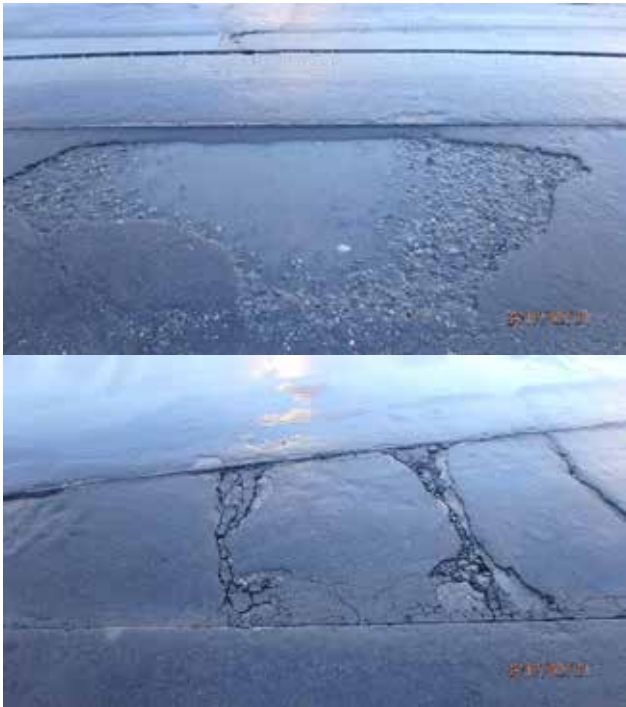
Location ID ^a	Observations	Recommended Actions	Photos
P5	pavement deterioration with portions of slurry overlay broken out; standing water up to 2 in. deep; numerous areas of damage in vicinity; loose pavement and gravel in vicinity; damage located adjacent to slot drain	Repair pavement; remove loose gravel.

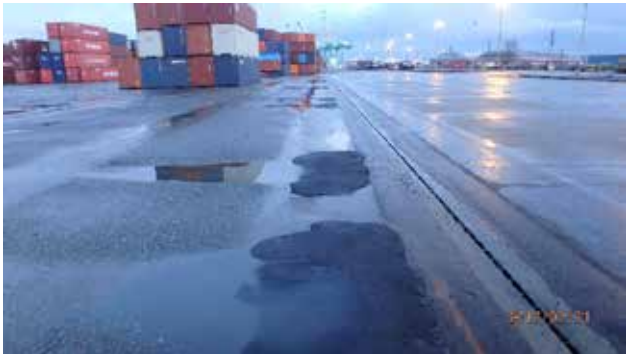
P6	patches adjacent to slot drains performing adequately; loose gravel in vicinity	Remove loose gravel.

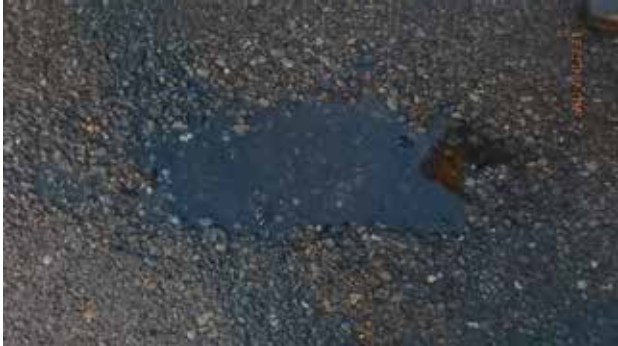
P7	deterioration causing divot in pavement surface; 1–2 in. of standing water in area approximately 2 ft by 8 in.	Repair pavement.

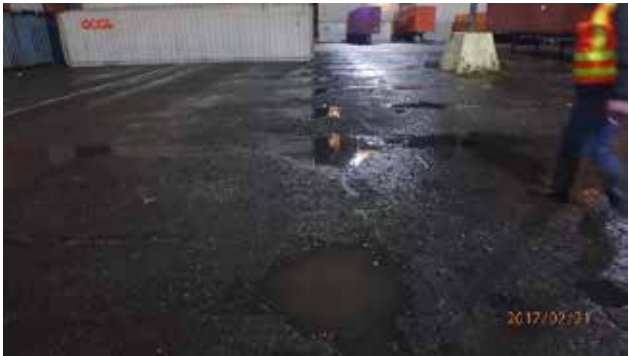
Location ID ^a	Observations	Recommended Actions	Photos
P8	divots in pavement caused by corners of containers; standing water up to 3 in. deep; loose gravel in vicinity	Repair pavement; remove loose gravel.

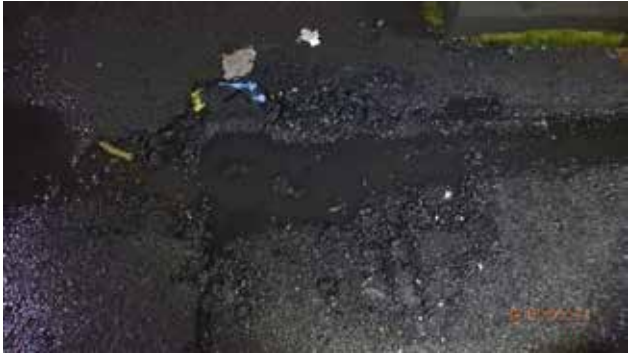
A photograph showing a dark, wet asphalt surface with several deep, rectangular divots. In the background, white and red shipping containers are visible. A person in a high-visibility vest is partially visible on the right. A timestamp '2017/02/21' is in the bottom right corner.
P9	pavement deterioration; loose gravel in vicinity	Repair pavement; remove loose gravel.

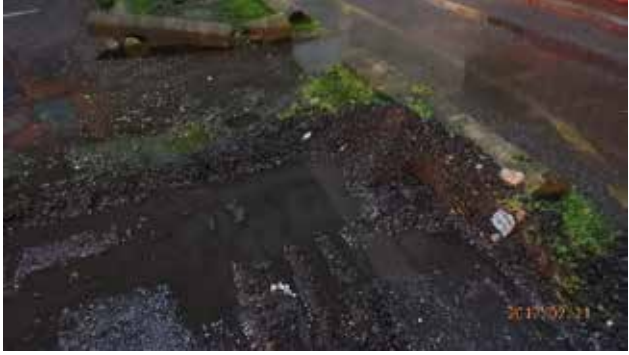
A close-up photograph of the asphalt surface showing significant cracking and crumbling. Loose gravel and debris are scattered around the damaged area. A timestamp '2017/02/21' is in the bottom right corner.
P10	area of gravel and mud accumulation and standing water	Remove accumulated mud and gravel; evaluate presence of underlying pavement and repair as necessary.

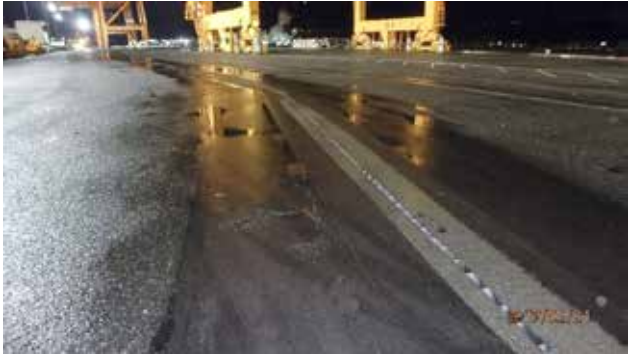
Location ID ^a	Observations	Recommended Actions	Photos
P11	pavement deterioration with portions of slurry overlay broken out; multiple areas of damage in vicinity; standing water in damaged areas; damage adjacent to slot drain	Repair pavement.

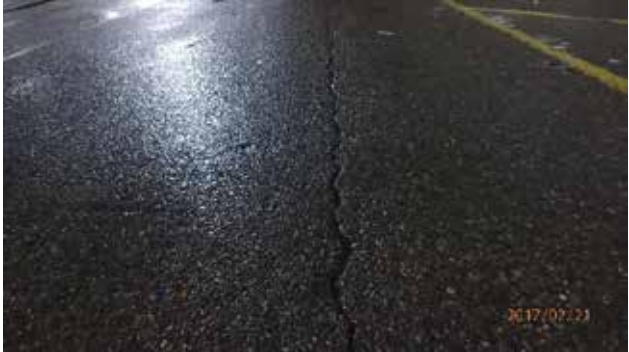
P13	crack wider than 1/8 in. extending several hundred feet	Repair pavement.

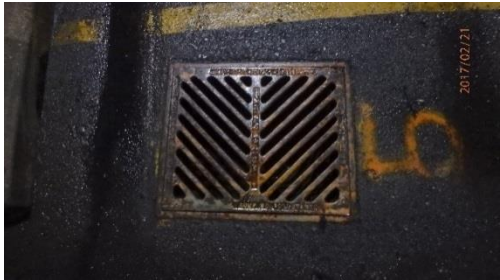
Location IDa	Type of Structure	Observed Condition	Sediment Accumulation (inches)	Additional Observations	Recommended Actions	Photo
CB5	catch basin	functioning normally	< 1	insert in catch basin	none

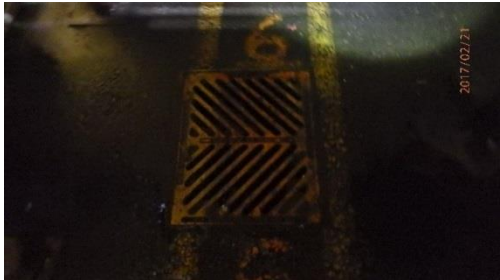
CB6	catch basin	functioning normally	4–5	insert in catch basin; moss growing on grate; did not open because of large volume of sediment in insert	Clean or replace insert as part of tenant's stormwater permit compliance program; remove vegetation from grate.

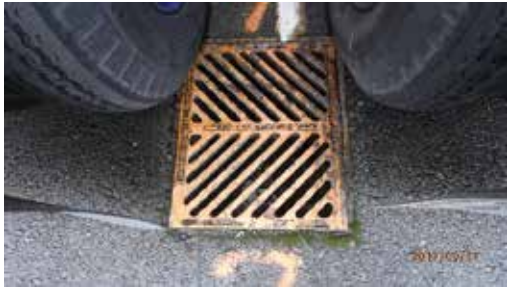
Location IDa	Type of Structure	Observed Condition	Sediment Accumulation (inches)	Additional Observations	Recommended Actions	Photo
CB7	catch basin	did not open because of equipment parked on grate; functioning normally	nm	insert in catch basin; debris in insert; did not open because of trailers parked on grate	Remove accumulated debris from insert as part of tenant's stormwater permit compliance program; observe interior structure during next servicing.

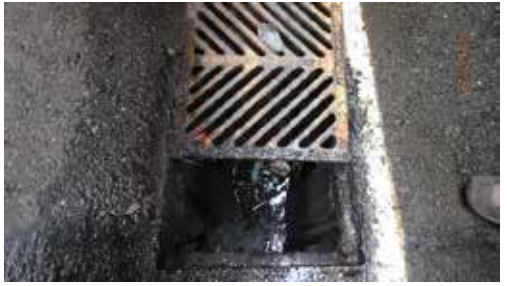
CB8	catch basin	functioning normally	5	insert in catch basin; did not remove because of large volume of sediment in insert	Clean or replace insert during next servicing under tenant's stormwater permit compliance program.

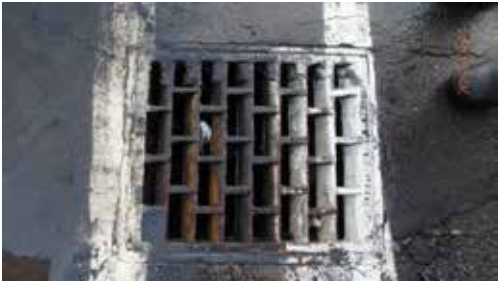
Location IDa	Type of Structure	Observed Condition	Sediment Accumulation (inches)	Additional Observations	Recommended Actions	Photo
CB13	catch basin	functioning normally	1-2	insert in catch basin; insert partially falling into structure; did not open due to insert position	Reposition insert during next servicing under tenant's stormwater permit compliance program.

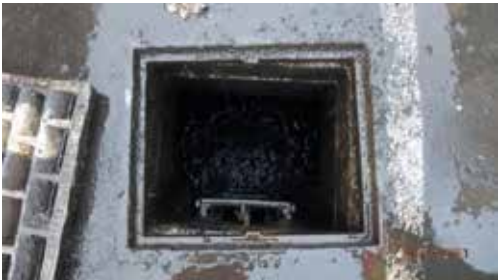
CB14	catch basin	not observed	nm	inaccessible; located under containers	Observe during next inspection.	not observed
CB15	catch basin	not observed	nm	inaccessible; located under containers	Observe during next inspection.	not observed
CB16	catch basin	functioning normally	1	insert in catch basin	none

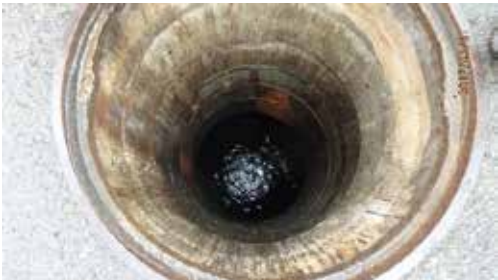
OWS1	oil/water separator	functioning normally	slight accumulation on top of separator plates	concrete structure	Service oil/water separator during next servicing under tenant's stormwater permit compliance program to remove any accumulated sediment or debris in structure and on plates.

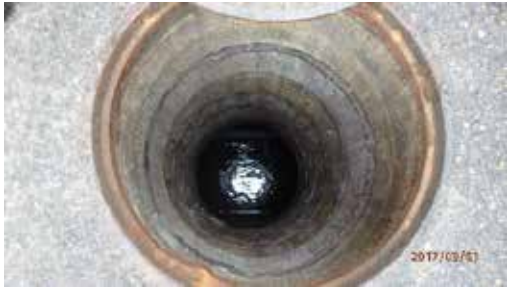
Location IDa	Type of Structure	Observed Condition	Sediment Accumulation (inches)	Additional Observations	Recommended Actions	Photo
OWS2	oil/water separator	structurally sound, functioning normally	slight accumulation on top of separator plates	east lid paved over; concrete structure	Service oil/water separator during next servicing under tenant's stormwater permit compliance program to remove any accumulated sediment or debris in structure and on plates.

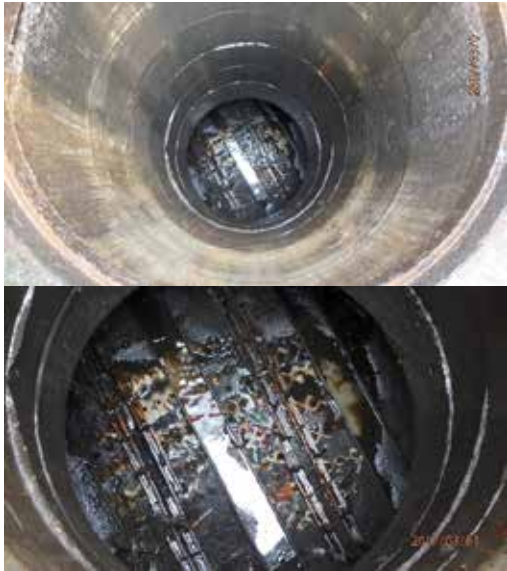
OWS3	oil/water separator	functioning normally	slight accumulation on top of separator plates (see photo)	debris and sediment accumulation on plates; concrete structure	Service and clean structure during next servicing under tenant's stormwater permit compliance program to remove debris and sediment from plates.

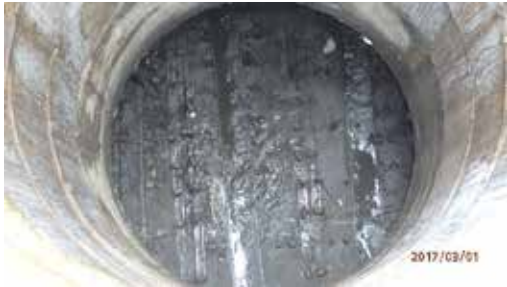
Location IDa	Type of Structure	Observed Condition	Sediment Accumulation (inches)	Additional Observations	Recommended Actions	Photo
OWS4	oil/water separator	functioning normally	slight accumulation on top of separator plates (see photo)	east vault inaccessible (located under equipment); sediment accumulated on plates in west vault; concrete structure	Service and clean structure during next servicing under tenant's stormwater permit compliance program to remove sediment from plates.

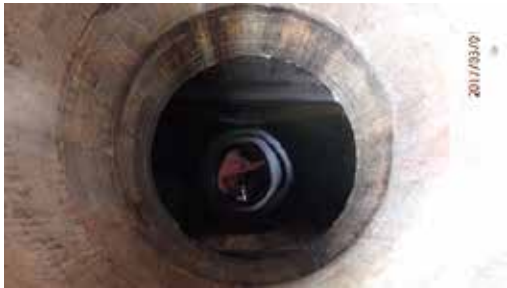
A photograph looking down into a circular concrete structure. The bottom of the structure is covered with a layer of dark, silty sediment. The concrete walls are visible on the sides. A date stamp '2017/03/01' is in the bottom right corner.
OWS5	oil/water separator	structurally sound, functioning normally	slight accumulation on top of separator plates	concrete structure	Service oil/water separator during next servicing under tenant's stormwater permit compliance program to remove any accumulated sediment or debris in structure or on plates.

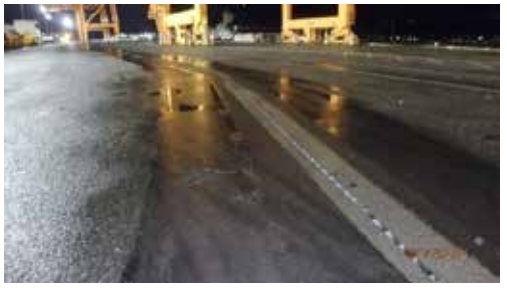
East slot drain	slot drain	structurally sound, functioning normally	< 1	minimal sediment accumulation	none

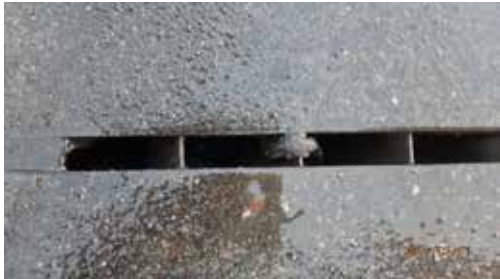
Location IDa	Type of Structure	Observed Condition	Sediment Accumulation (inches)	Additional Observations	Recommended Actions	Photo
West slot drain	slot drain	structurally sound, functioning normally	< 1	minimal sediment accumulation	none
