PHOTOGRAPH LOG

Environment and Infrastructure, Inc.
7376 SW Durham Road
Portland, Oregon 97224

PROJECT NAME: Pasco Landfill Cap Project - Cap Construction Project

Project No: 4-61M-10705-1 P-02

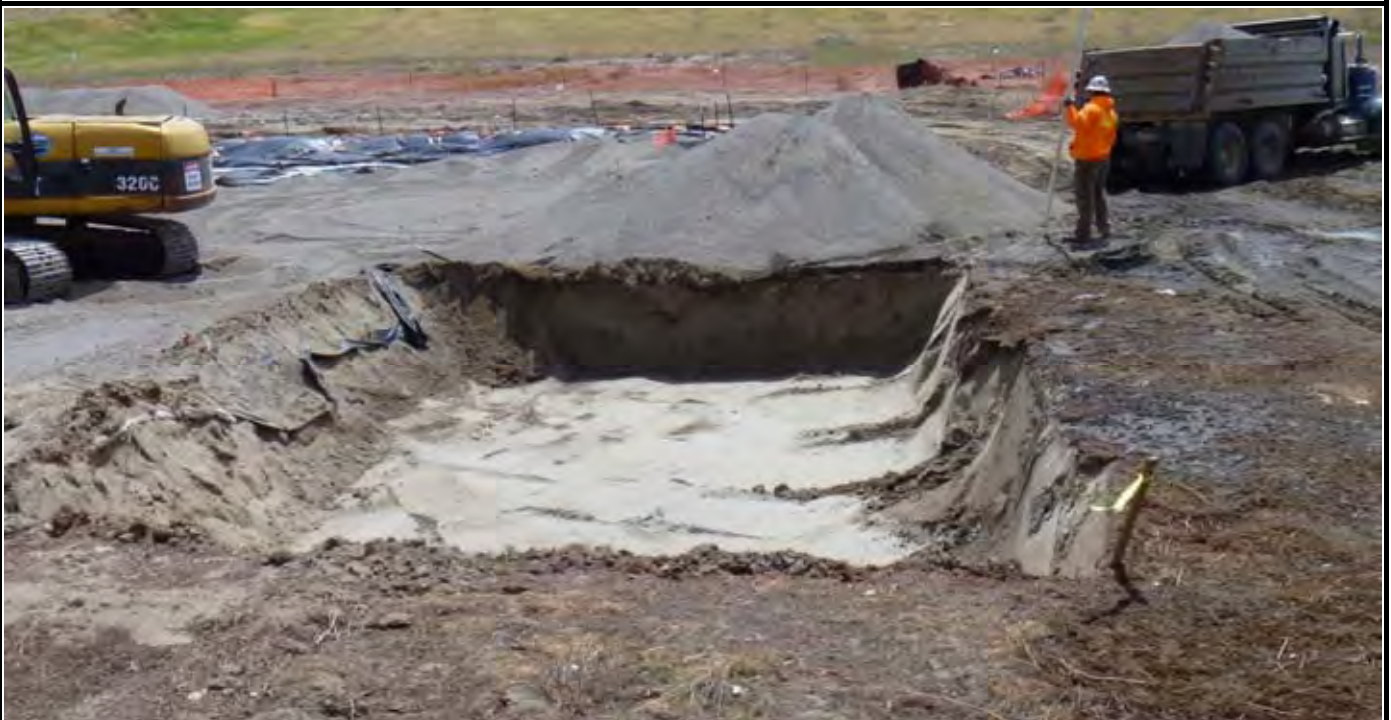
Photo 6: View of AE-2 after final 5-ft bgs excavation work. Note gravel stockpiles that will be used for backfilling AE-1 and AE-2. View looking south from north side of AE-2.

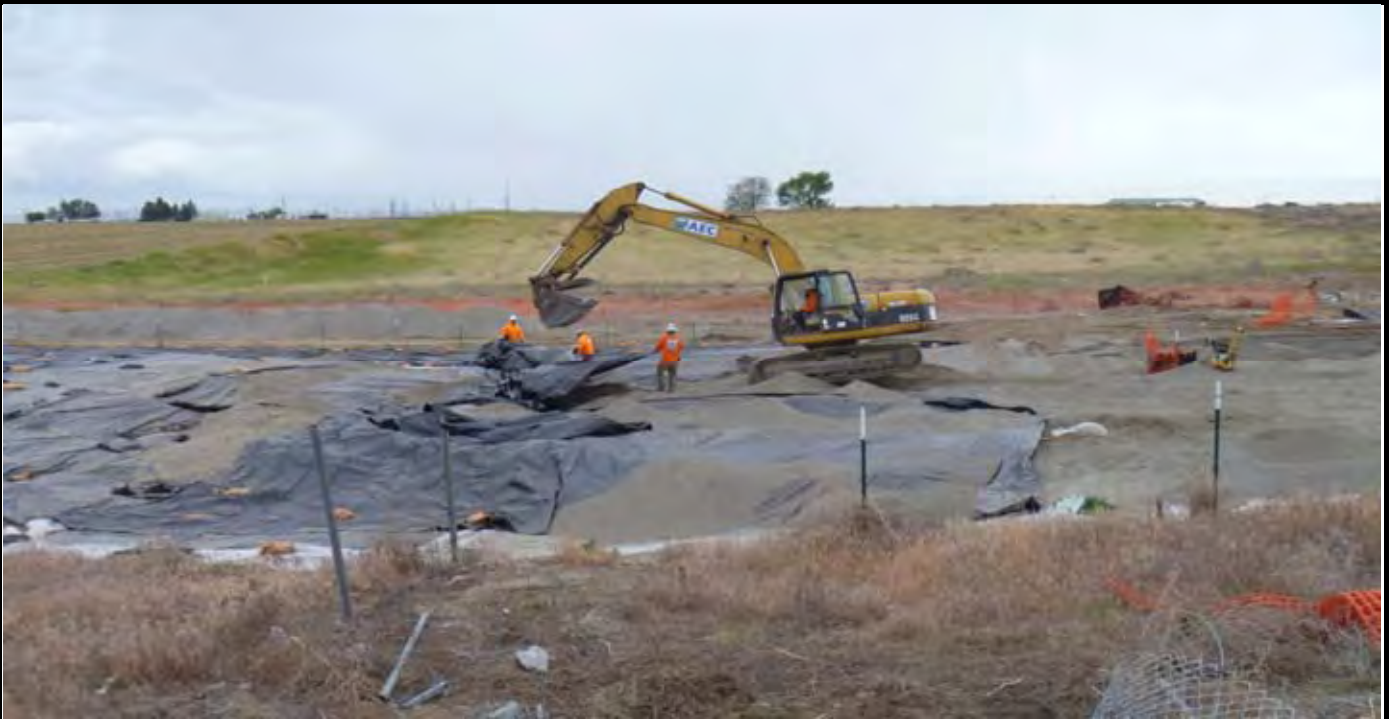
Photo 9: AEC laying out 12-mil liner over the AE-1 and AE-2 excavated soils. AEC uses clean gravel to hold down the edges and middle of the liner. View looking south from north side of the site.

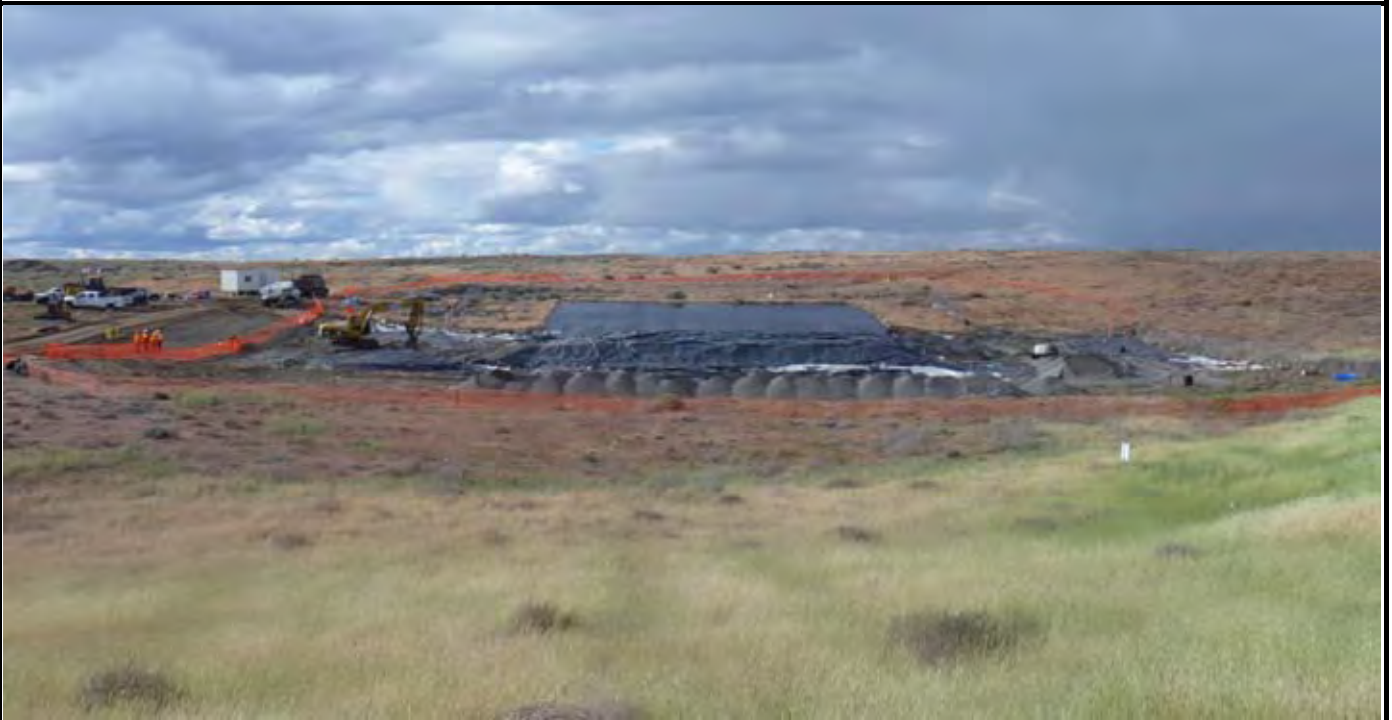
Photo 10: View of the site at the conclusion of work for the day. Orange construction fence is up around the site and gravel is stockpiled for next day's excavation and backfilling work at AE-4 and AE-5. View looking north from hill south of the southern end of the site.

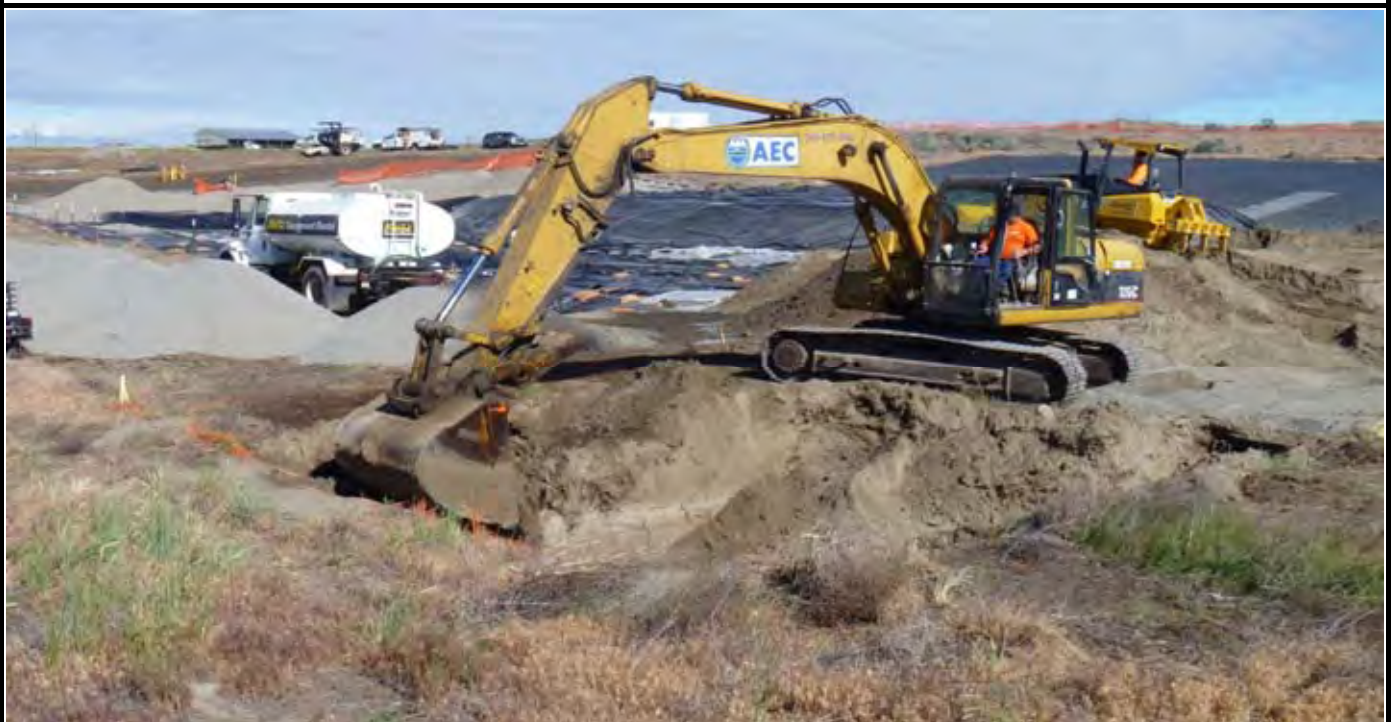
Photo 4: AEC begins the excavation of AE-5 down to 4-ft bgs. View of AE-5 looking to the north/northwest.

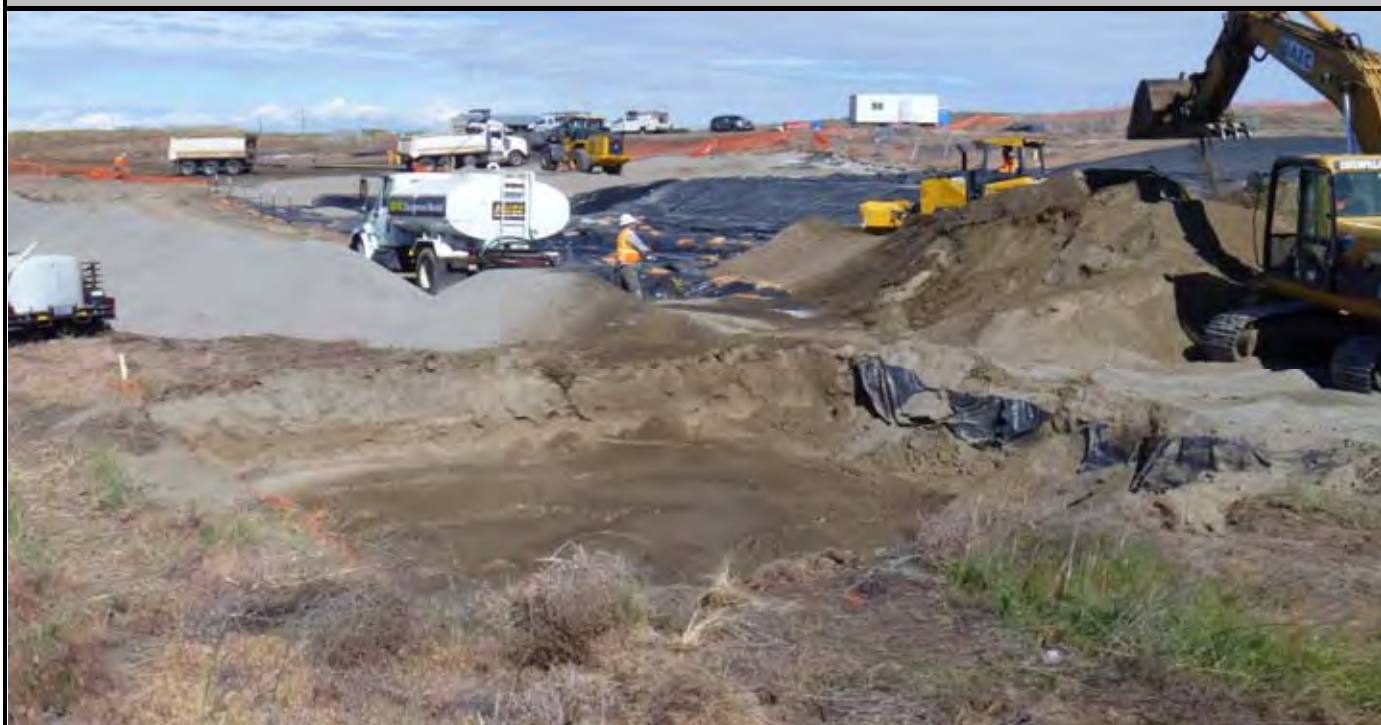
Photo 5: View of excavation AE-5 down to 4-ft bgs. Stockpiled soils from AE-5 shown on the right side of photo.

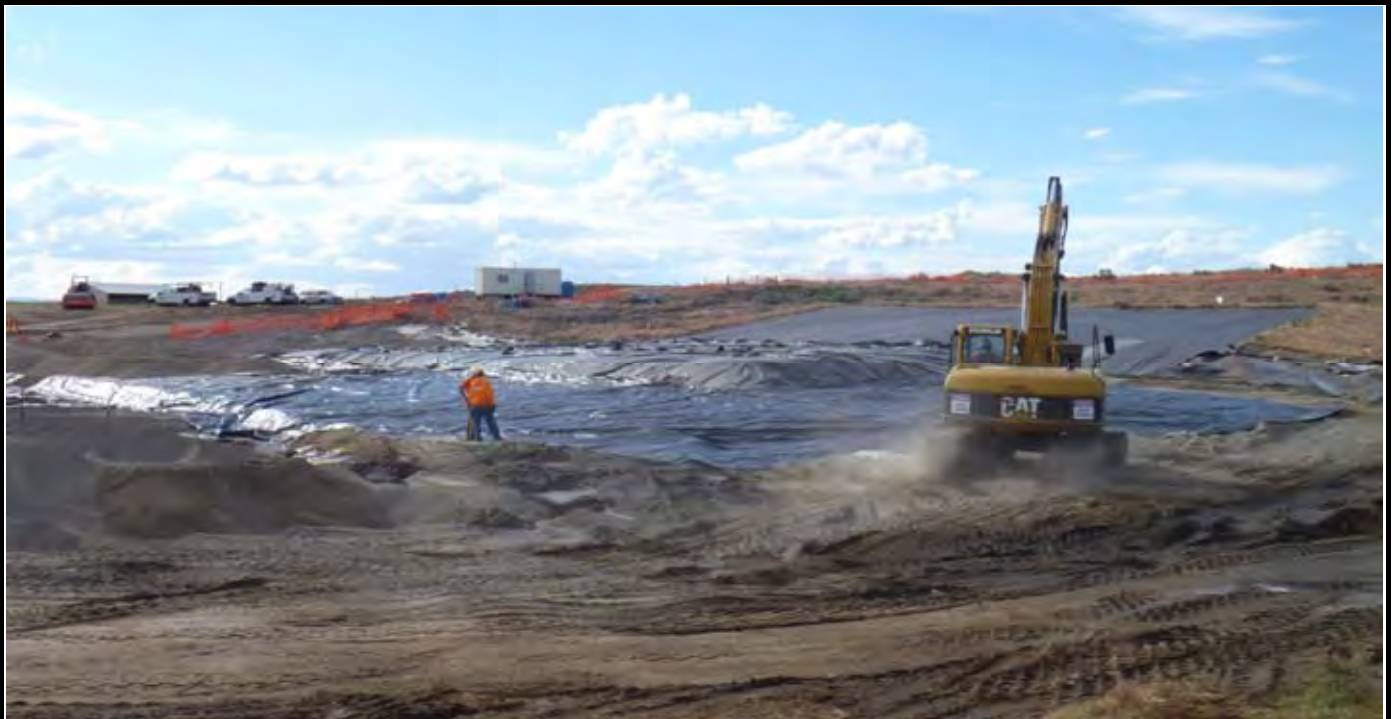
Photo 9: View of the area of soils from AE-4 and AE-5 under the 12-mil plastic liner. Note trackhoe spreading gravel over the cover liner. View looking to the north/northwest.

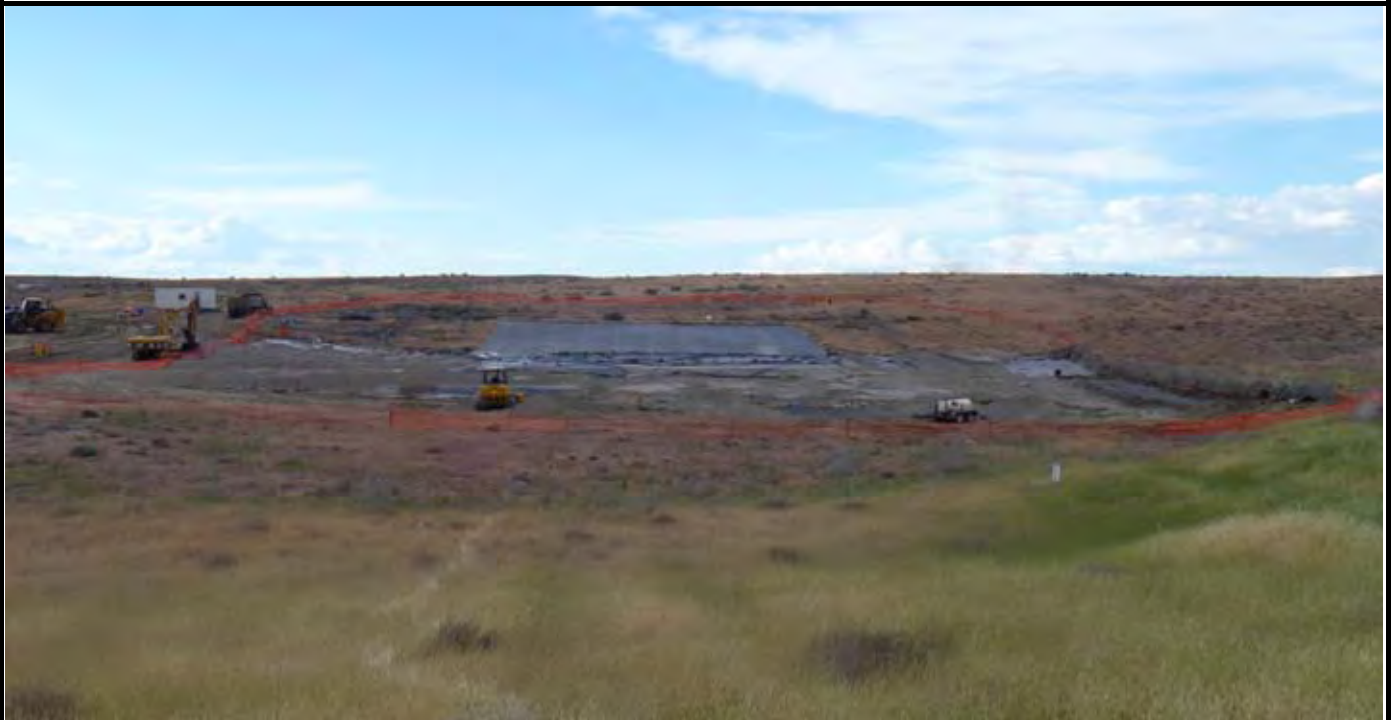
Photo 10: View of the site at the conclusion of work for the day. Orange construction fence is up around the site and the 12-mil tarps covering the excavated soils is covered mostly with gravel. View of the site looking north.

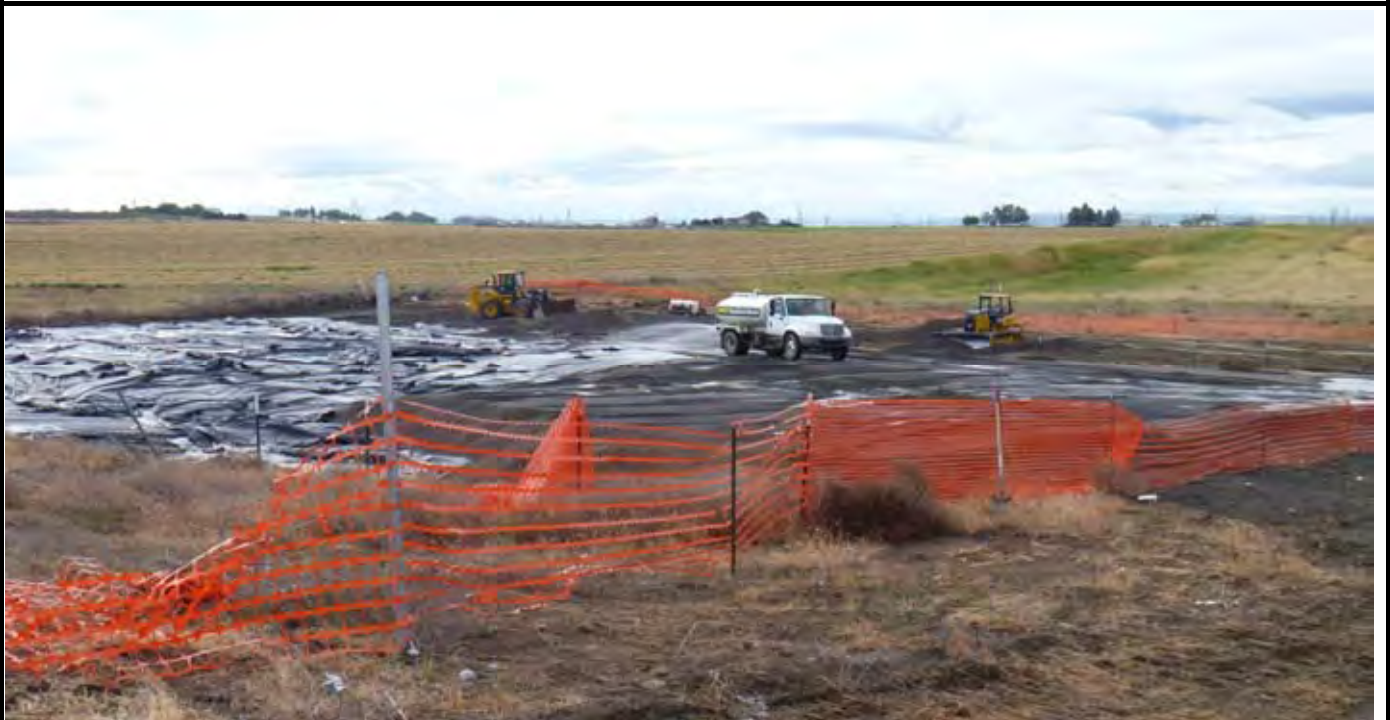
Photo 4: View of AEC water truck wetting down G-layer materials on cap. View looking to the southeast.

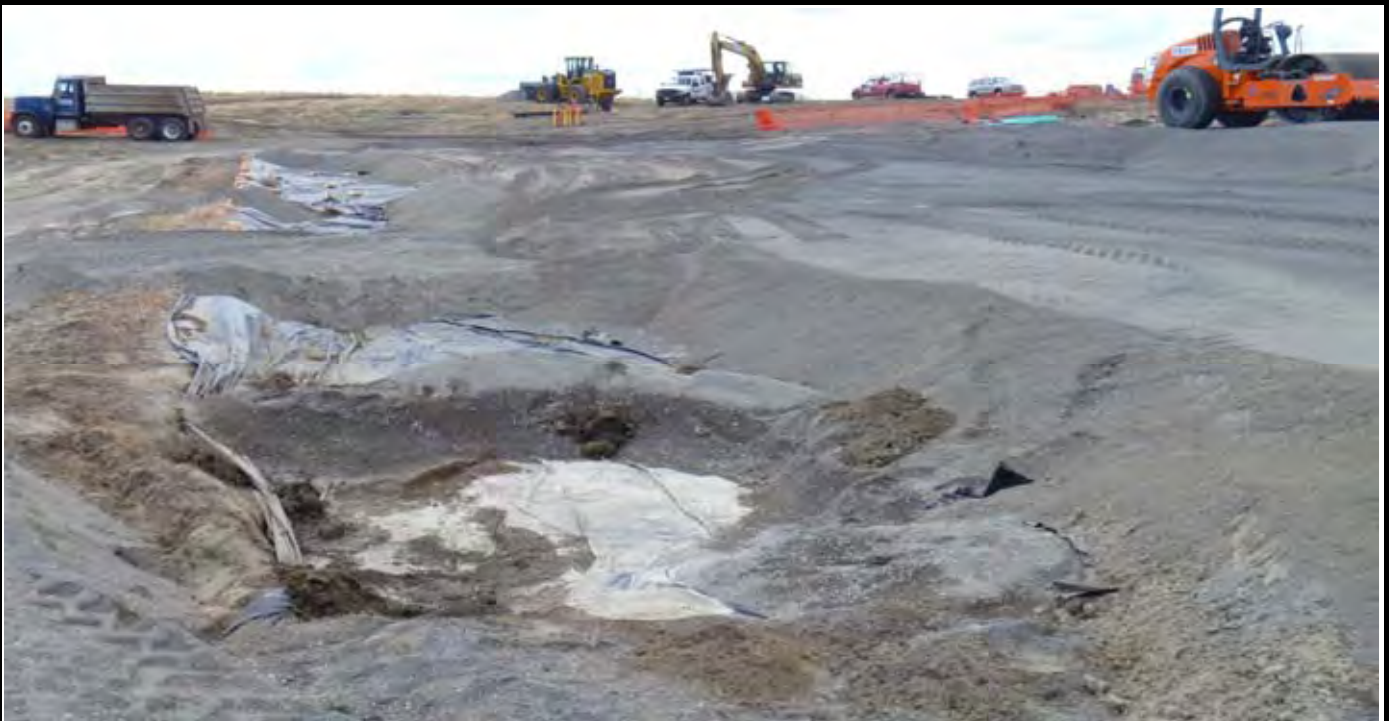
Photo 3: View of the decon pond after decon water has evaporated from the pond. AMEC authorizes burying the pond under the G layer material. View looking west from the SE corner of the CAP.

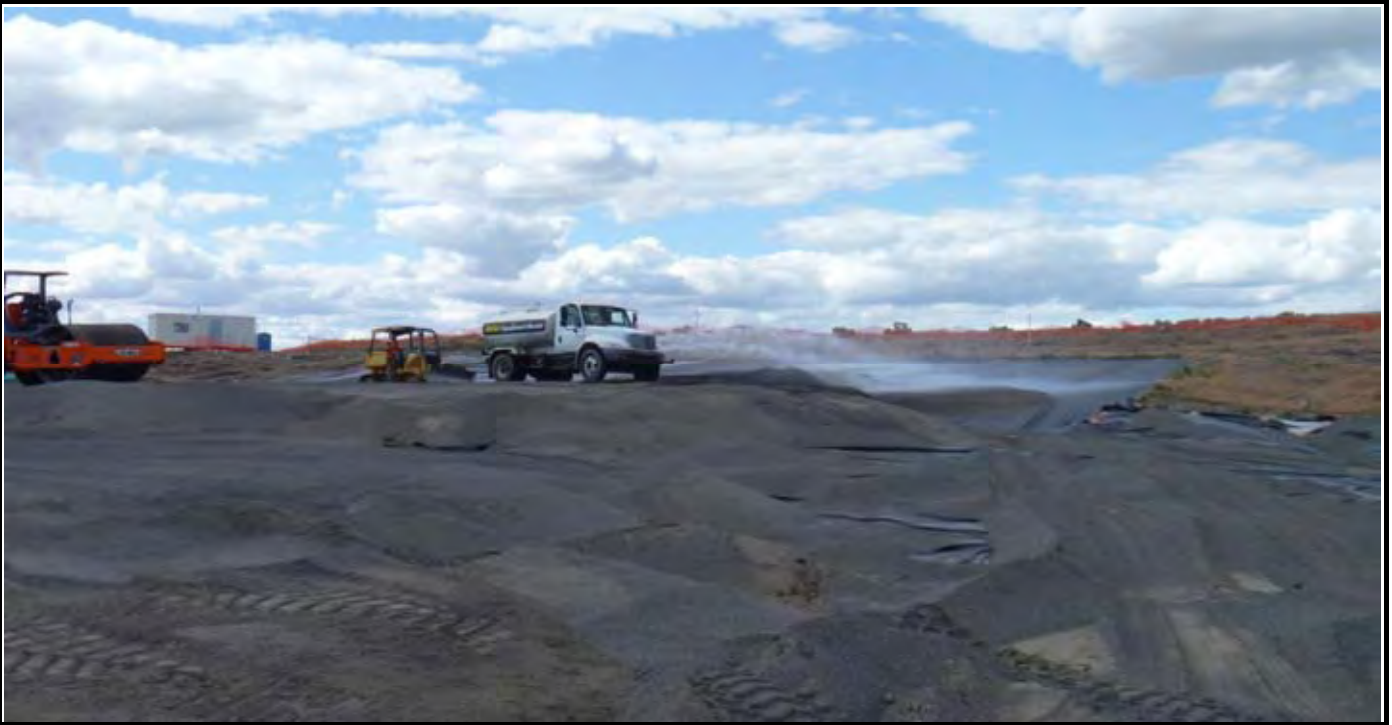
Photo 4: View of AEC water truck watering down G layer gravel that is spread over original cap liner. View looking to the North/Northwest from the SE corner of the site. Note the water truck is on top of the covered "Hump".

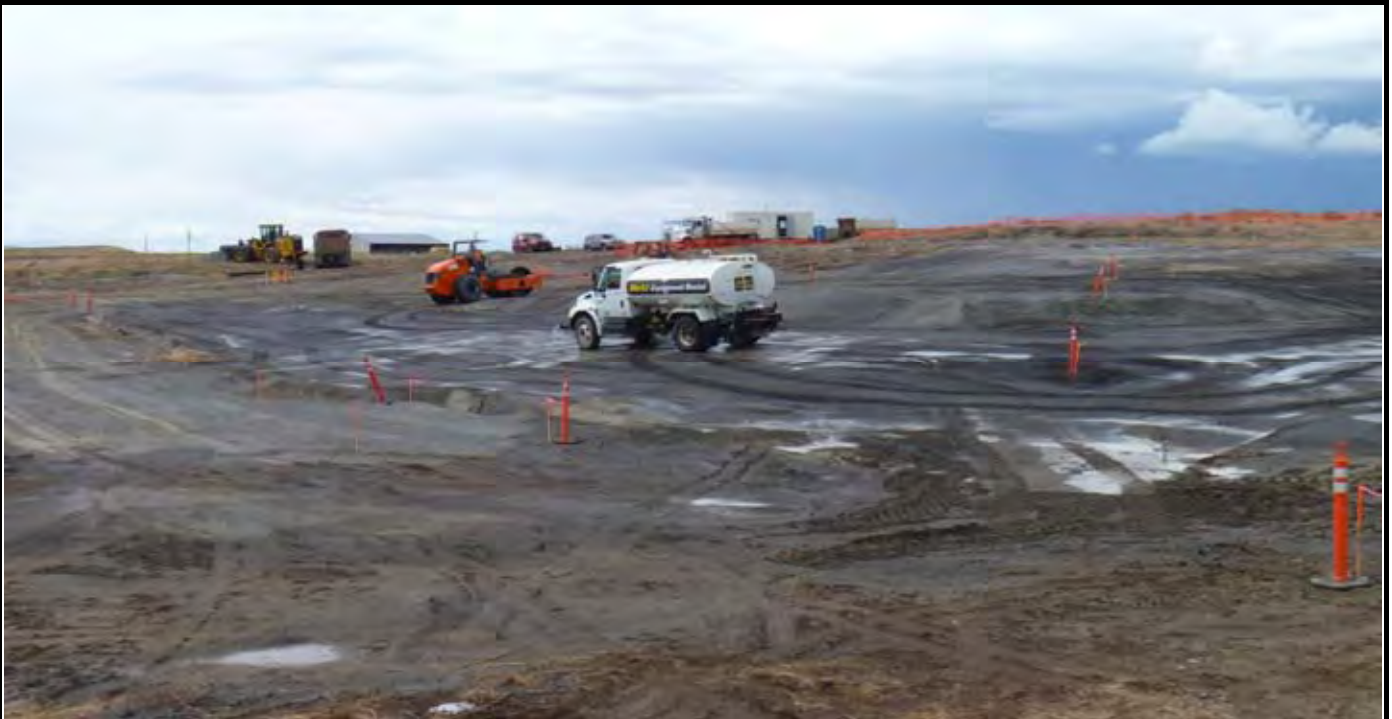
Photo 5: View of the southern edge of G-layer near end of the day with watering truck and roller. Note that former holes in Photo 4 have been backfilled and compacted. View looking west/northwest from AE-5.

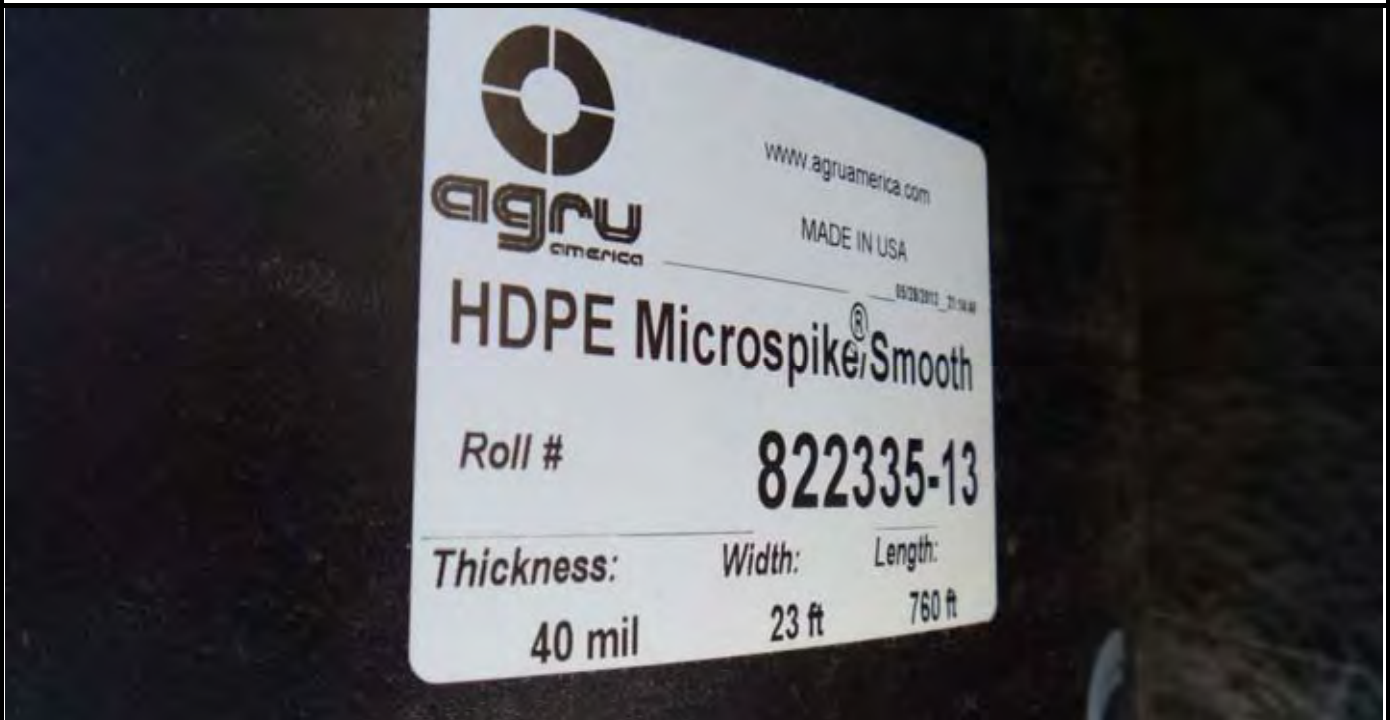
Photo 6: View of label on second roll of 40-mil HDPE Microspike / smooth geomembrane. Roll # = 822335-13
Thickness = 40-mil, Width = 23-ft, Length = 760-ft for a total area of roll = 17,480-sf
Microspike side is considered "textured".

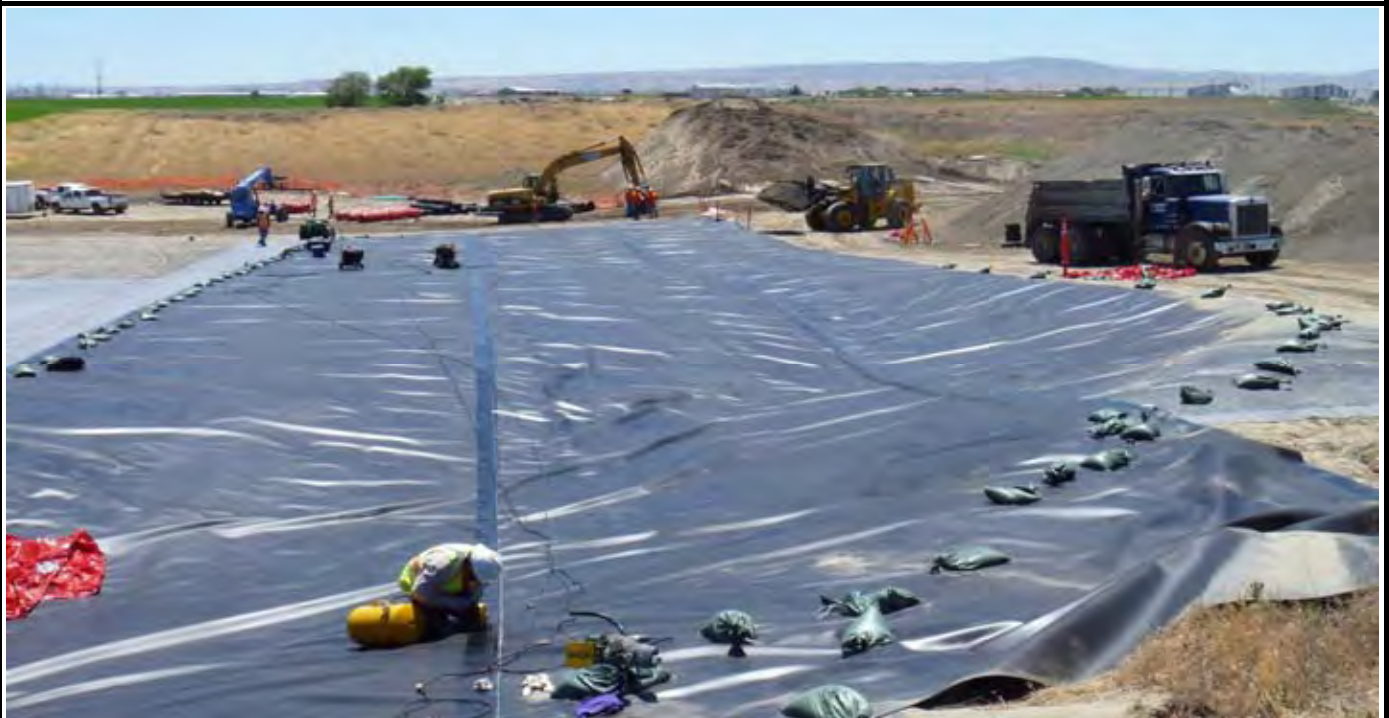
Photo 12: View of NWL worker conducting air test on small section of the weld (S-2) between passes 2 and 3 (P-2/P-3). Seam S-2 failed and NWL conducted several air tests to find the leak. Leak was found on the northern end of the weld and patched by NWL. View looking south from northern end of EOL.

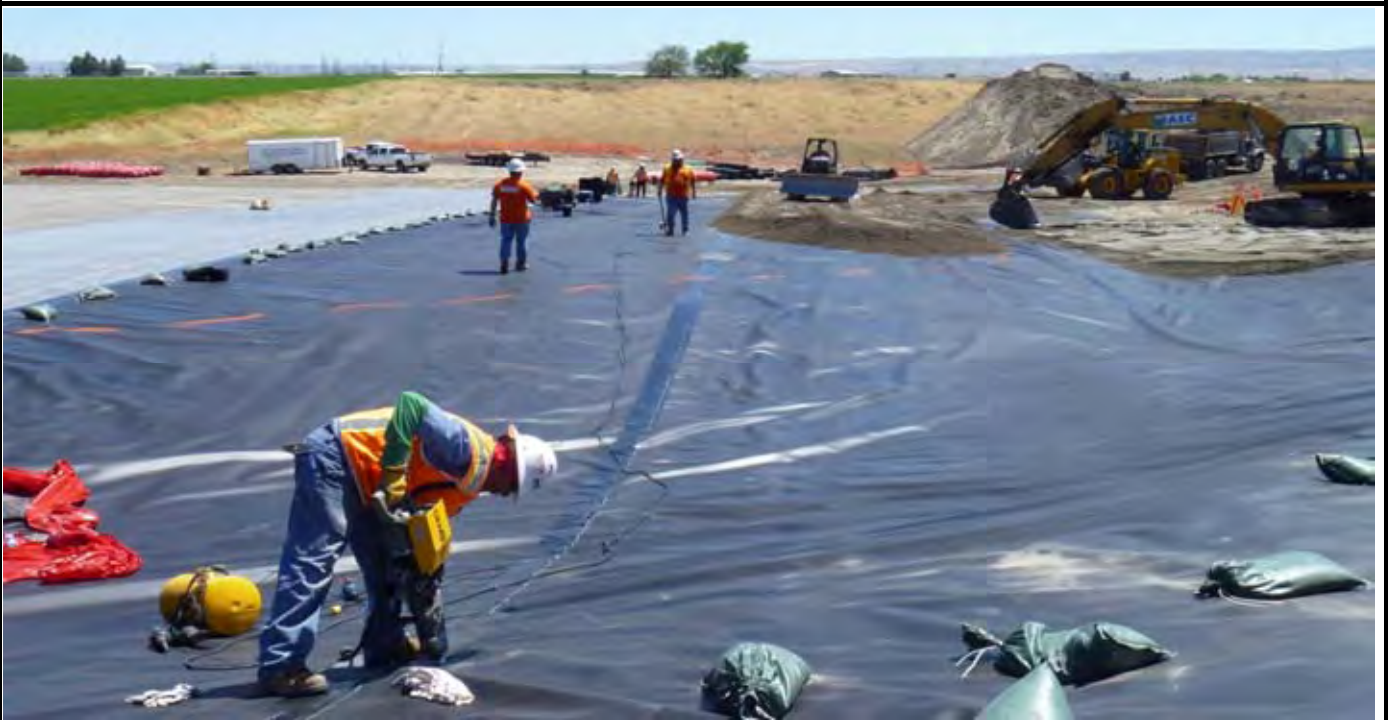
Photo 14: View of NWL worker patching the leak area on seam S-2. Note AEC in the background is beginning to cover the geomembrane with a 1-ft thick layer of sand. See orange dashed line that shows the EOC. View looking south from northwest corner of EOL.

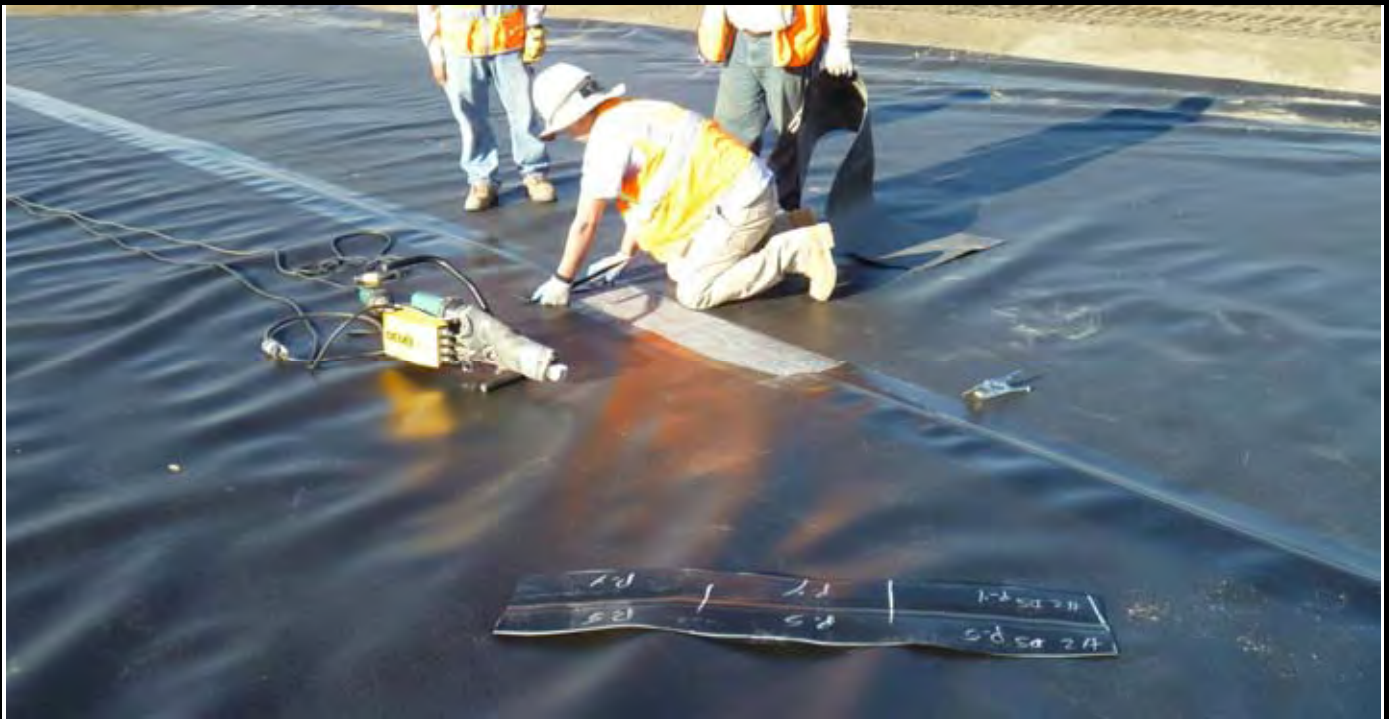
Photo 3: View of NWL crew cutting out destructive test sample DS-2 along seam S-4 for field testing. View looking southwest towards SW corner of CAP.

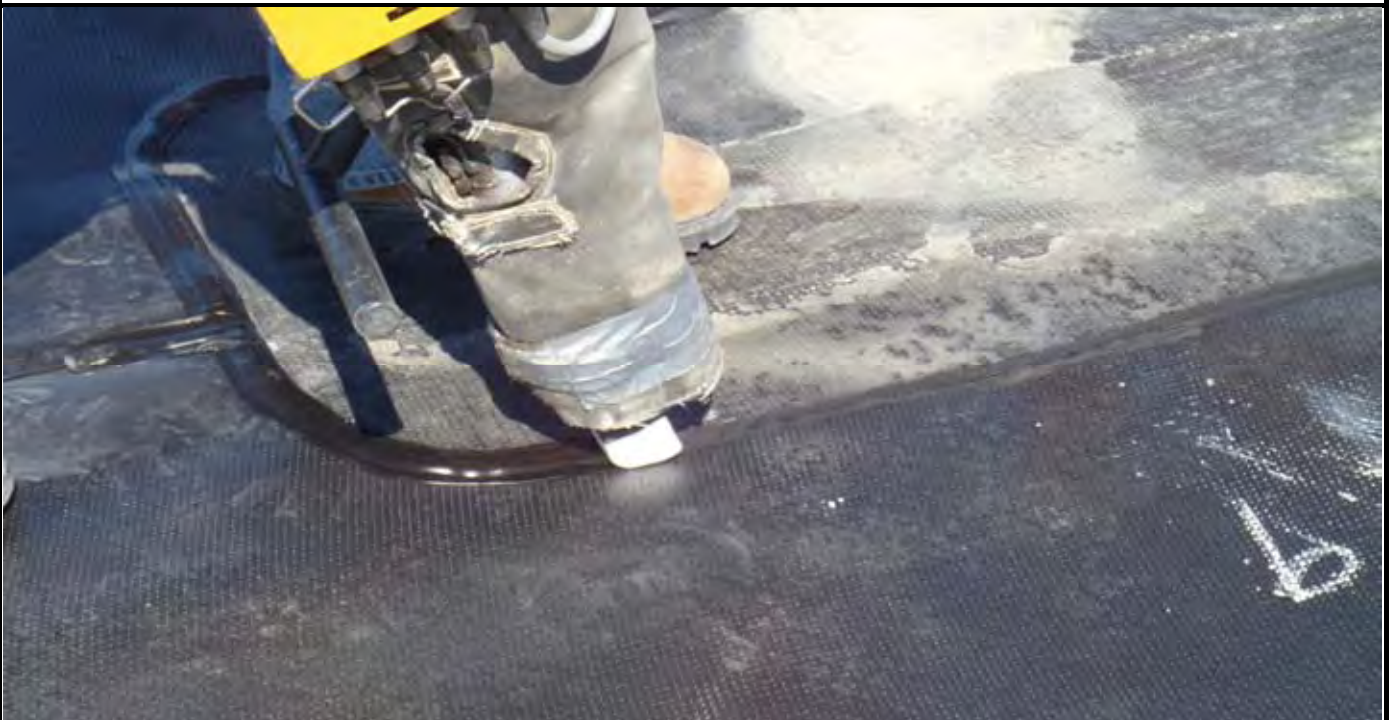
Photo 6: Close-up view of the patch welding machine welding an HDPE seam along patch for seam sample DS-4.

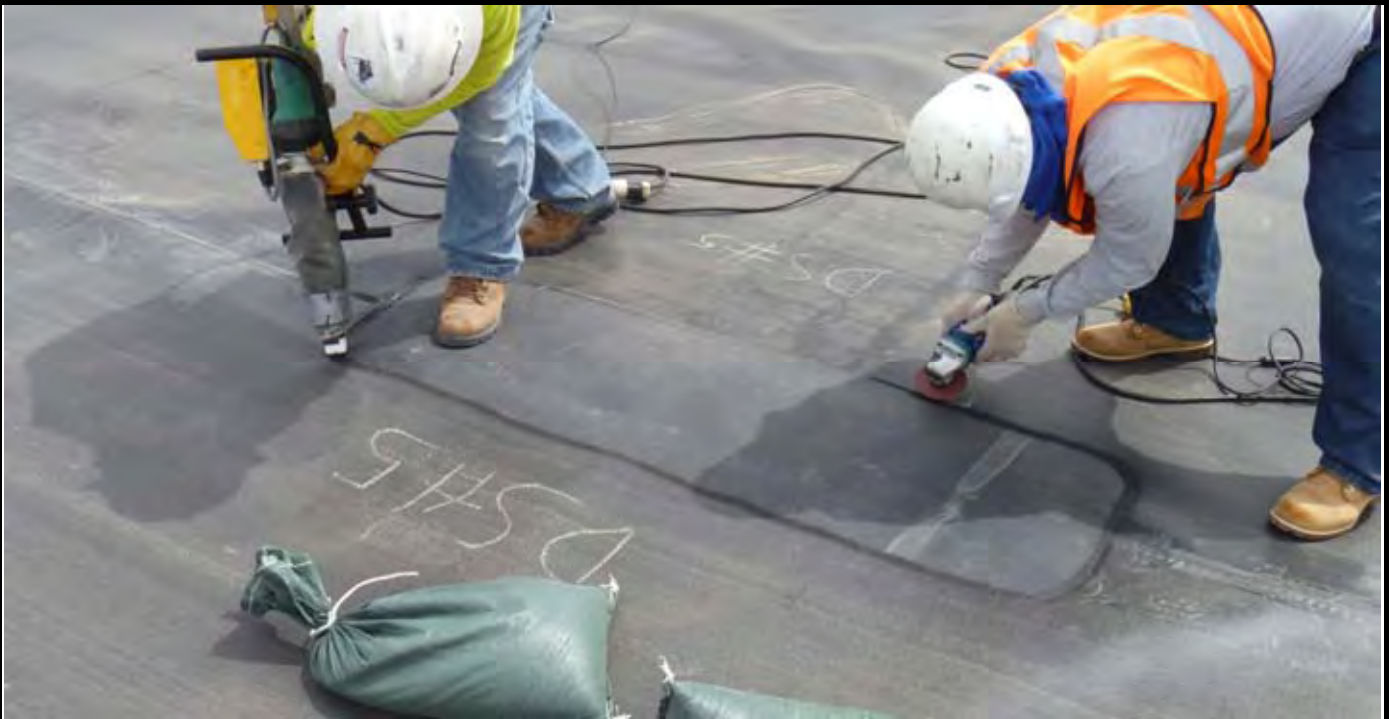
Photo 5: View of NWL patching the seam sample DS-5. Note worker with grinder (right) roughing up new patch seam and worker welding seam (left). View looking east from geomembrane panel P-10.

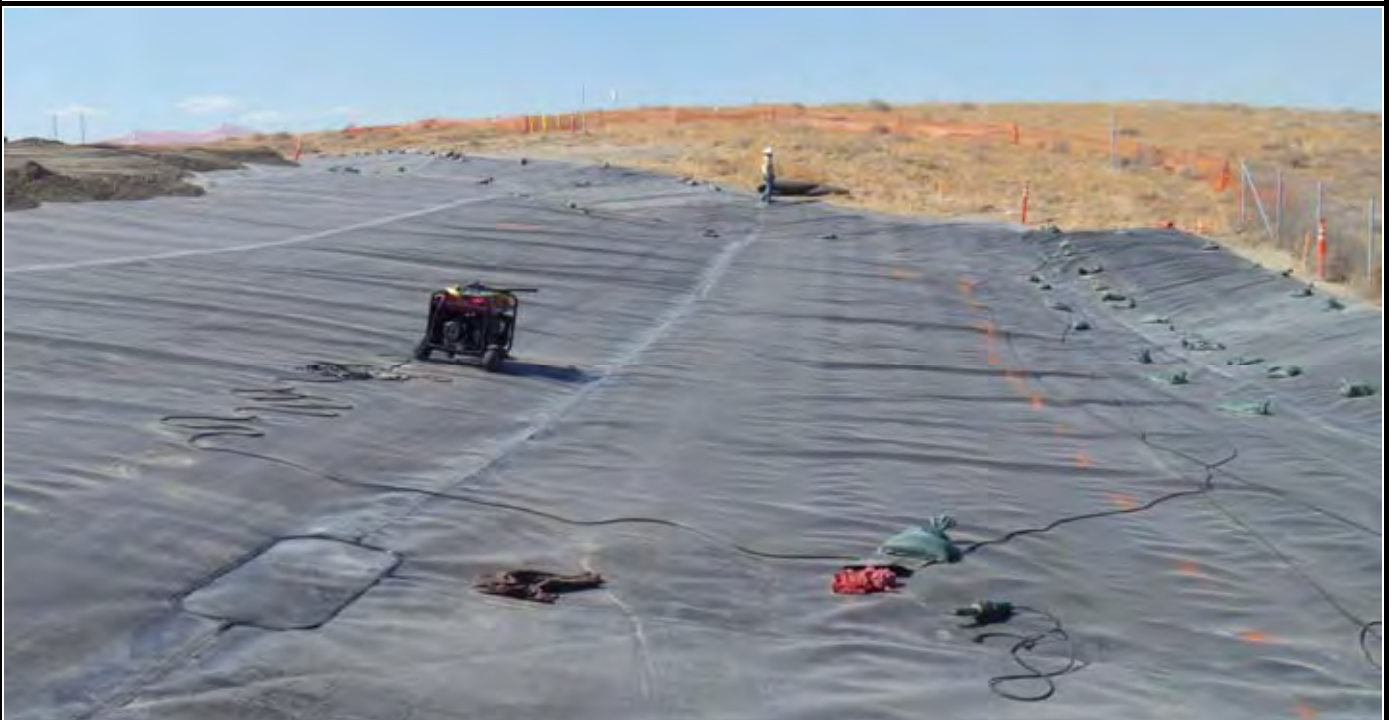
Photo 8: View of the NE corner of the completed geomembrane area (showing NE and east swale area between the EOC and EOL. Note patch for seam sample DS-6 between panels P-12 and P-13. Orange dashed line is the EOC. View looking north from center of the eastern side of the EOC.
