Pasco Sanitary Landfill: Managing a Subsurface Fire at a MTCA Cleanup Site

Washington State LEPC-Tribal Conference
Chelan, WA, May 16, 2017

Chuck Gruenenfelder & Jeremy Schmidt, site managers
Toxics Cleanup Program, Eastern Region

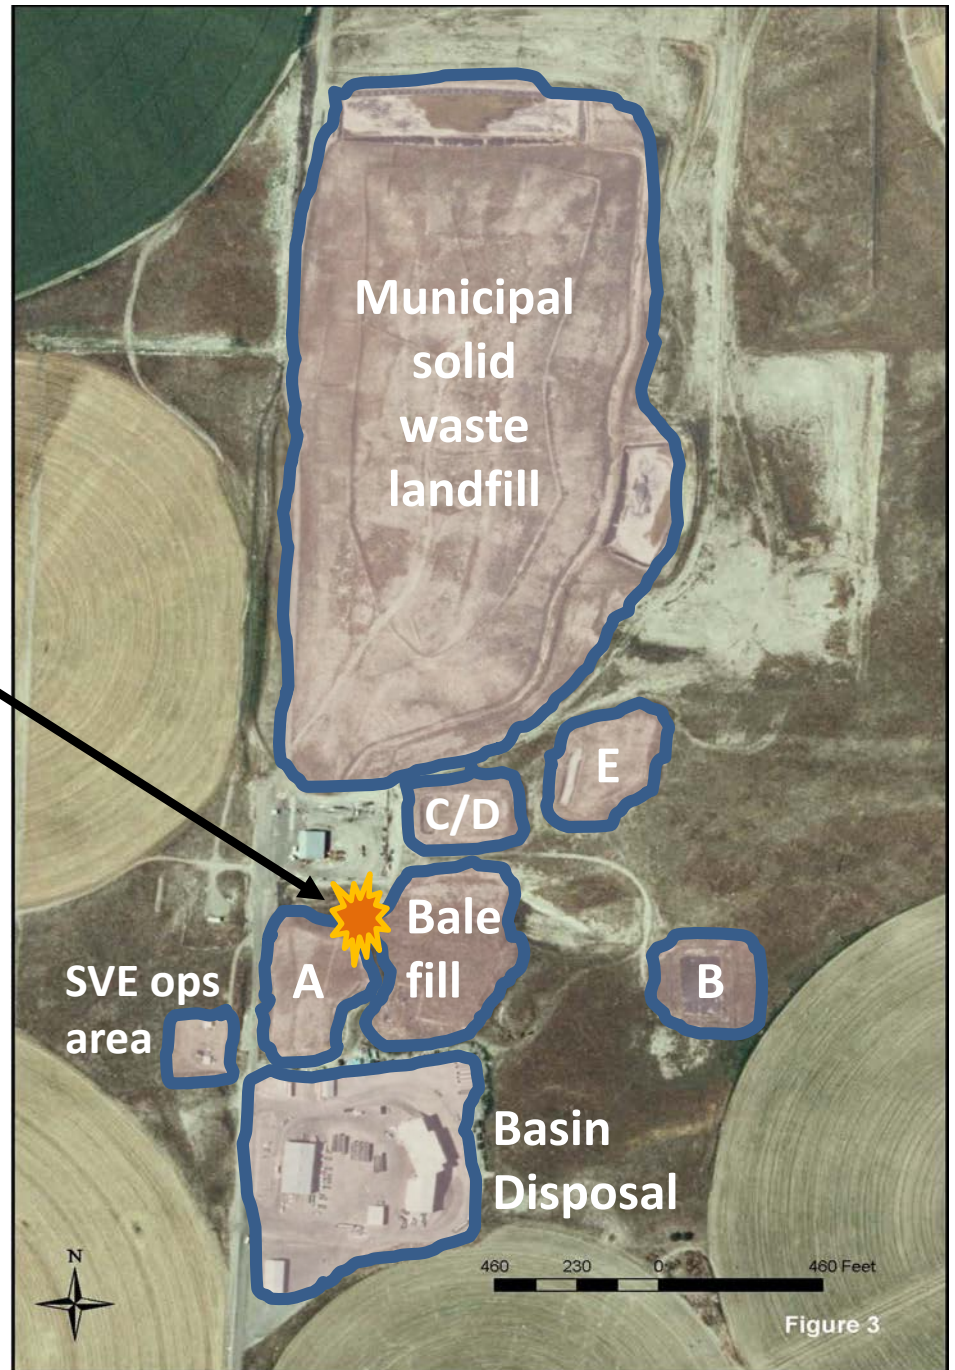
November 2013

A landfill fire is suspected and reported in Balefill area following a routine visual inspection

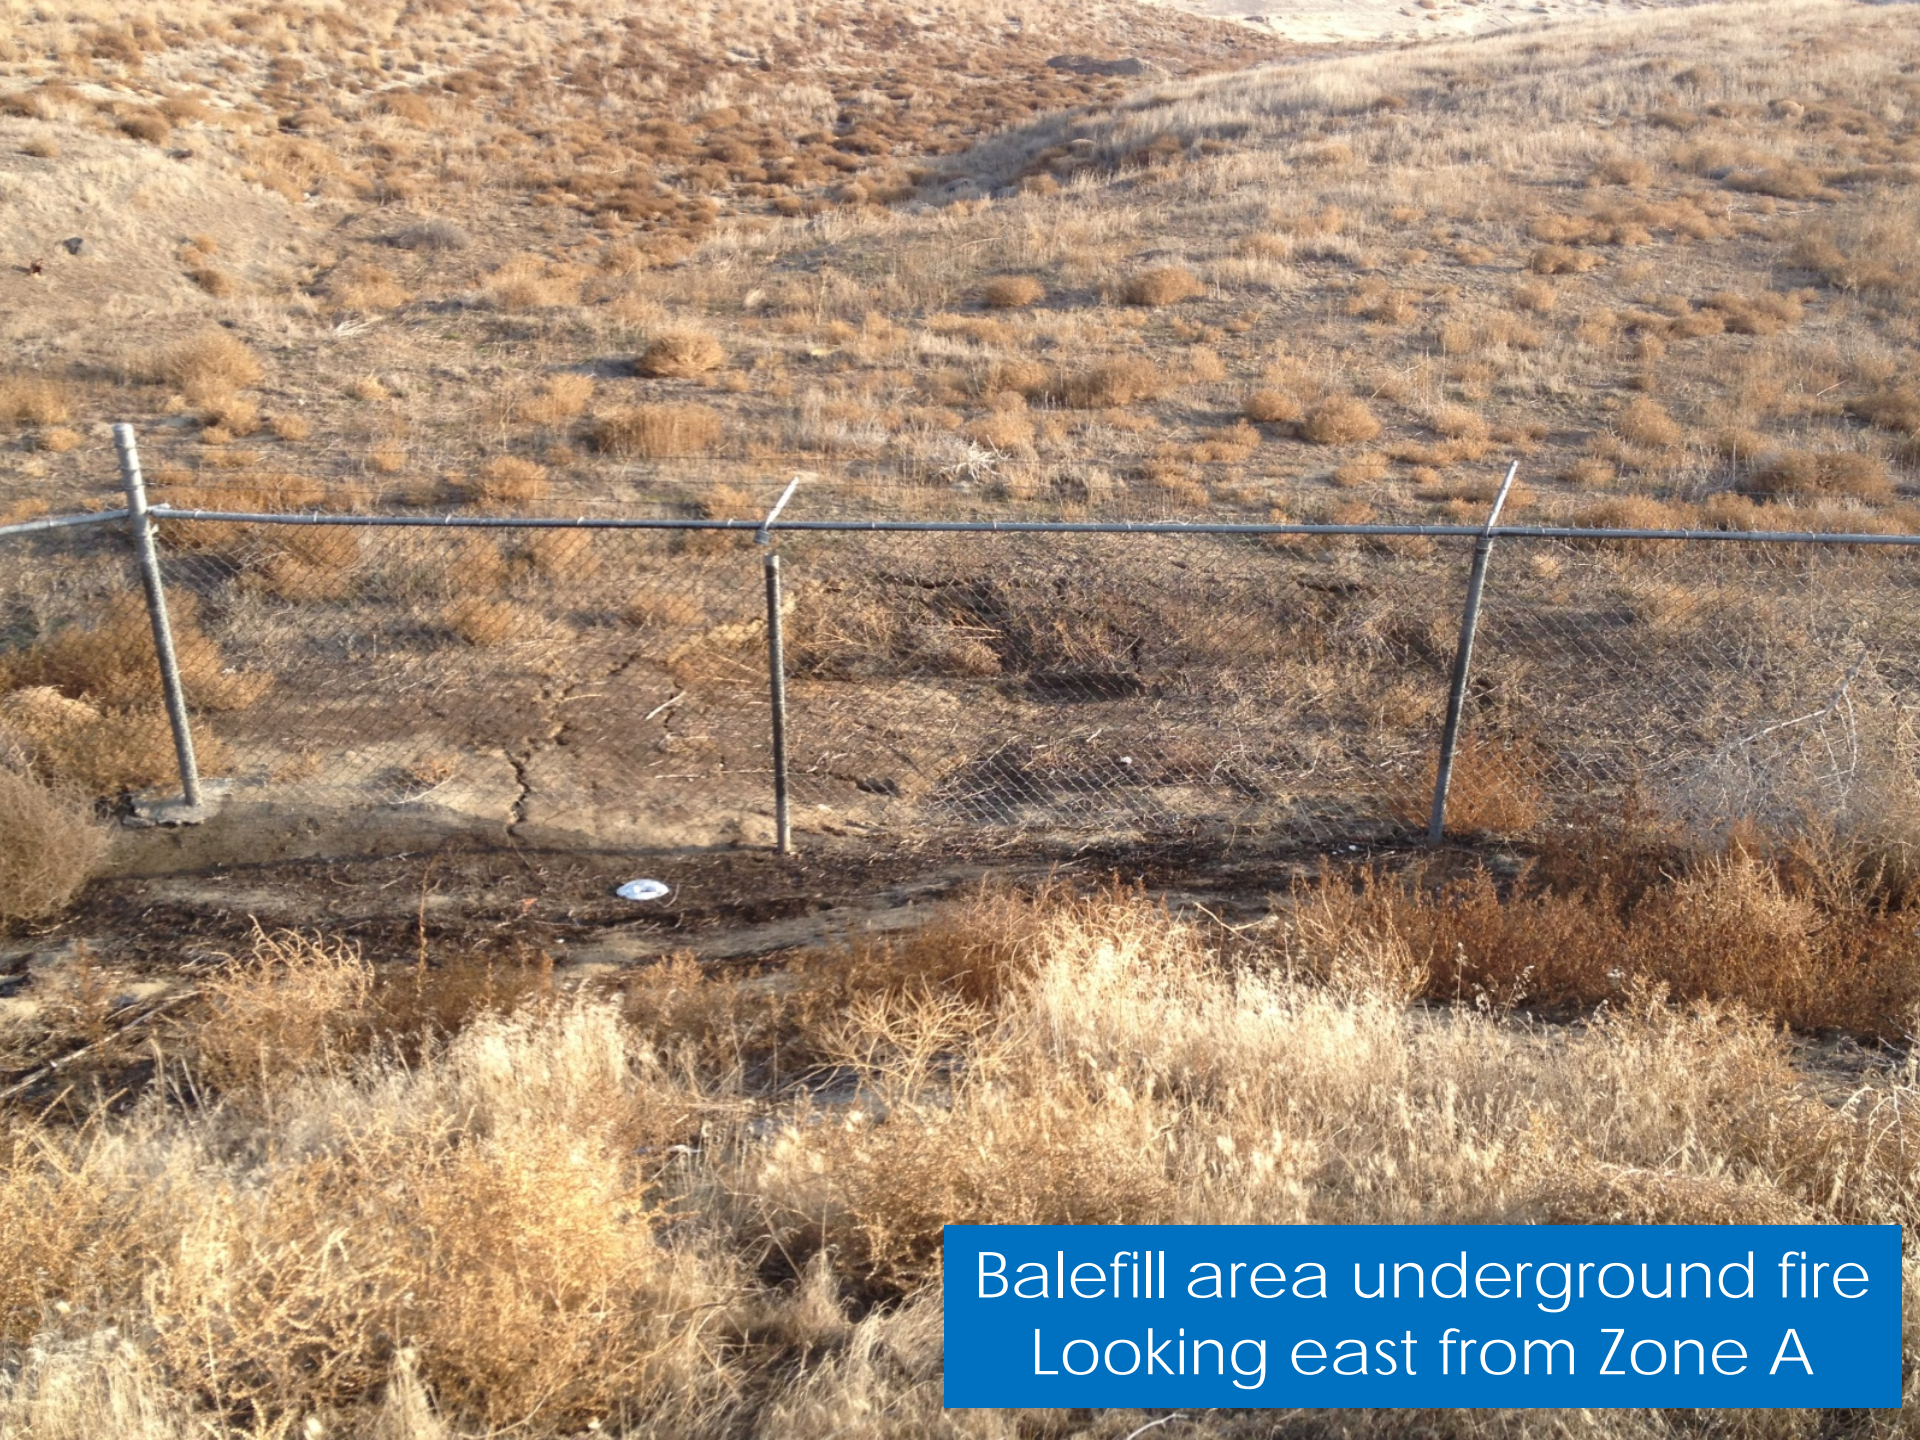
Balefill area underground fire
Looking east from Zone A

- Smoke
- Soil cracking
- Ground settlement
- Stressed vegetation
- Heat
- Carbon monoxide

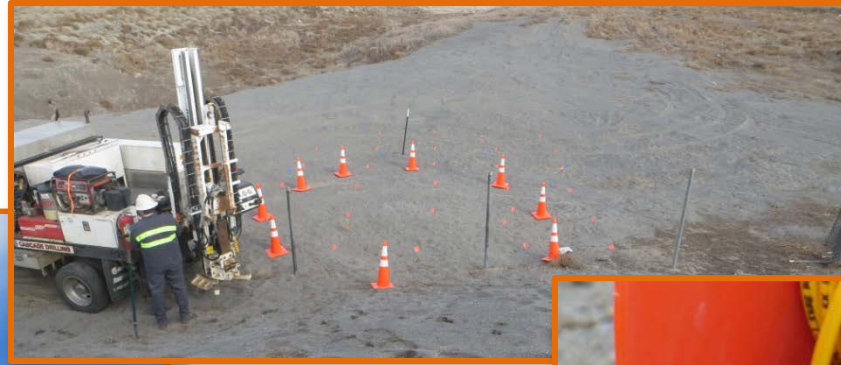
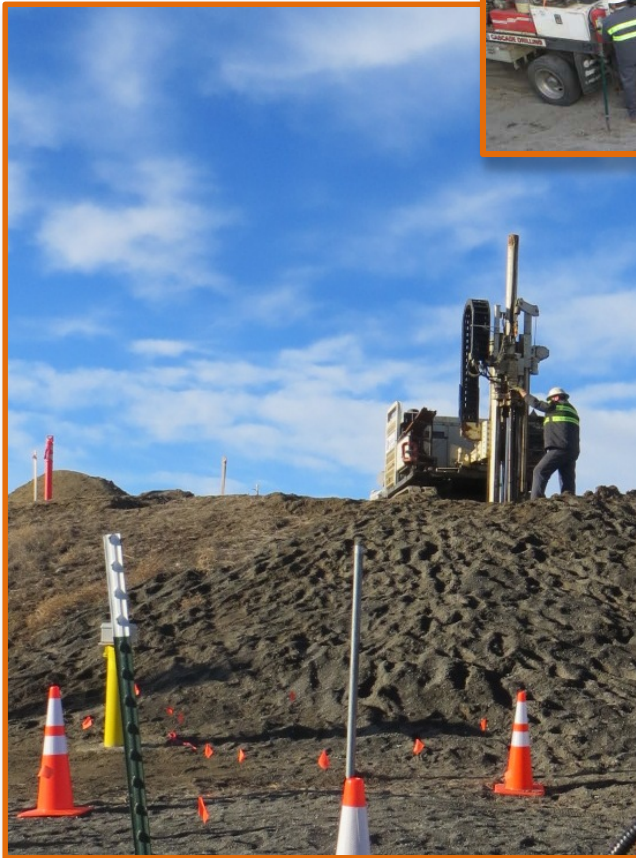
Geoprobe temperature evaluation

How **BIG**?

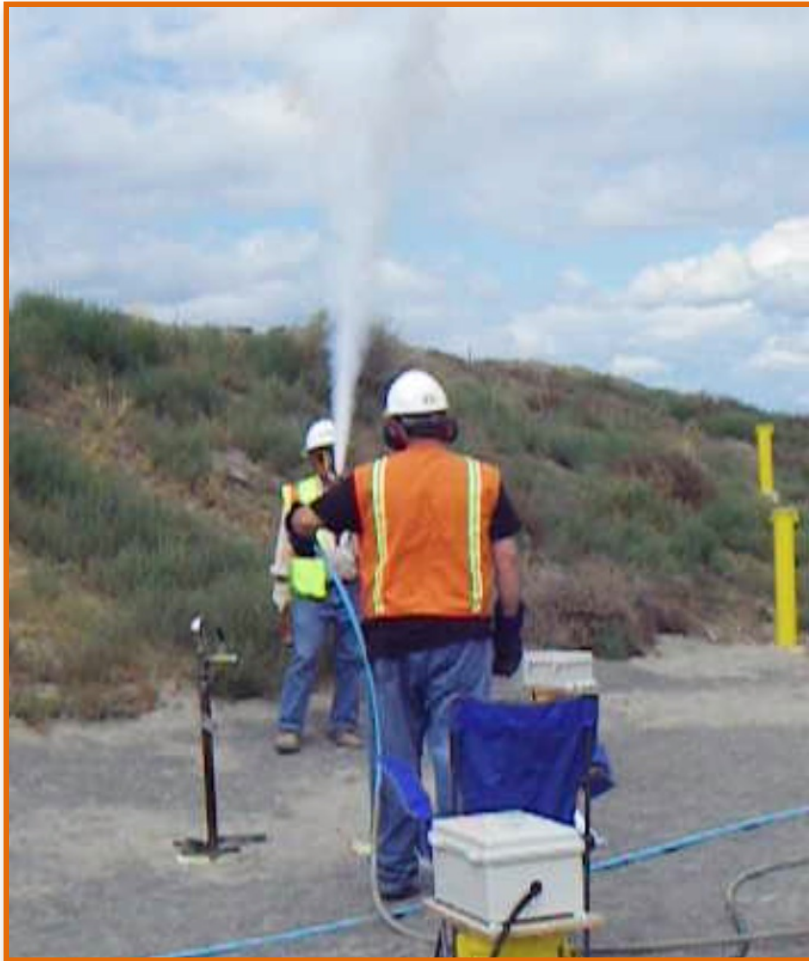
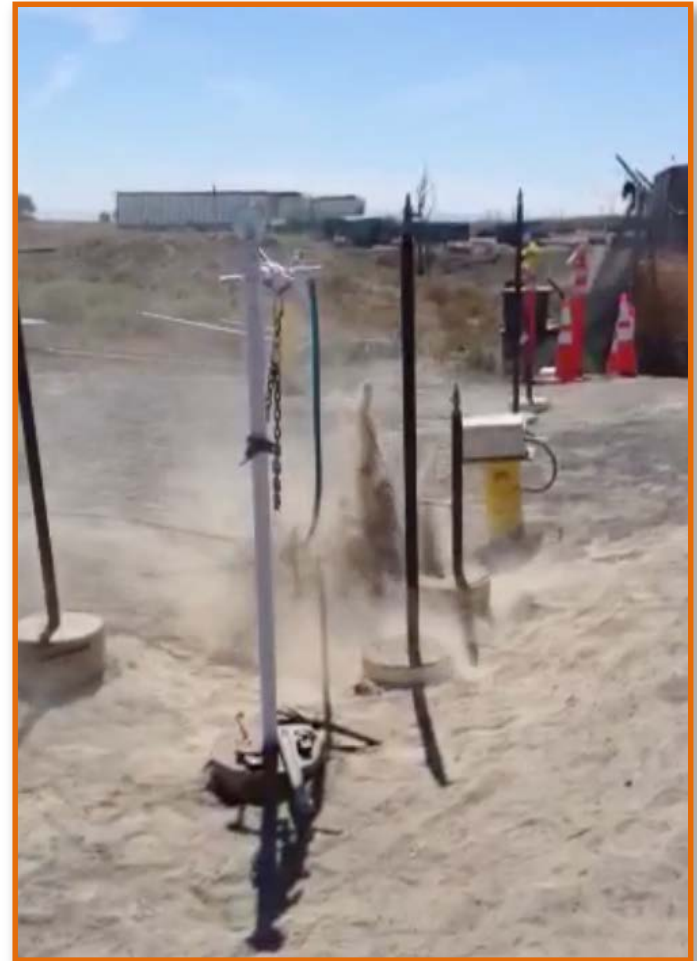
Carbon dioxide refusal & short-circuiting

Injecting liquid carbon dioxide until probe won't transmit it or short-circuiting occurs

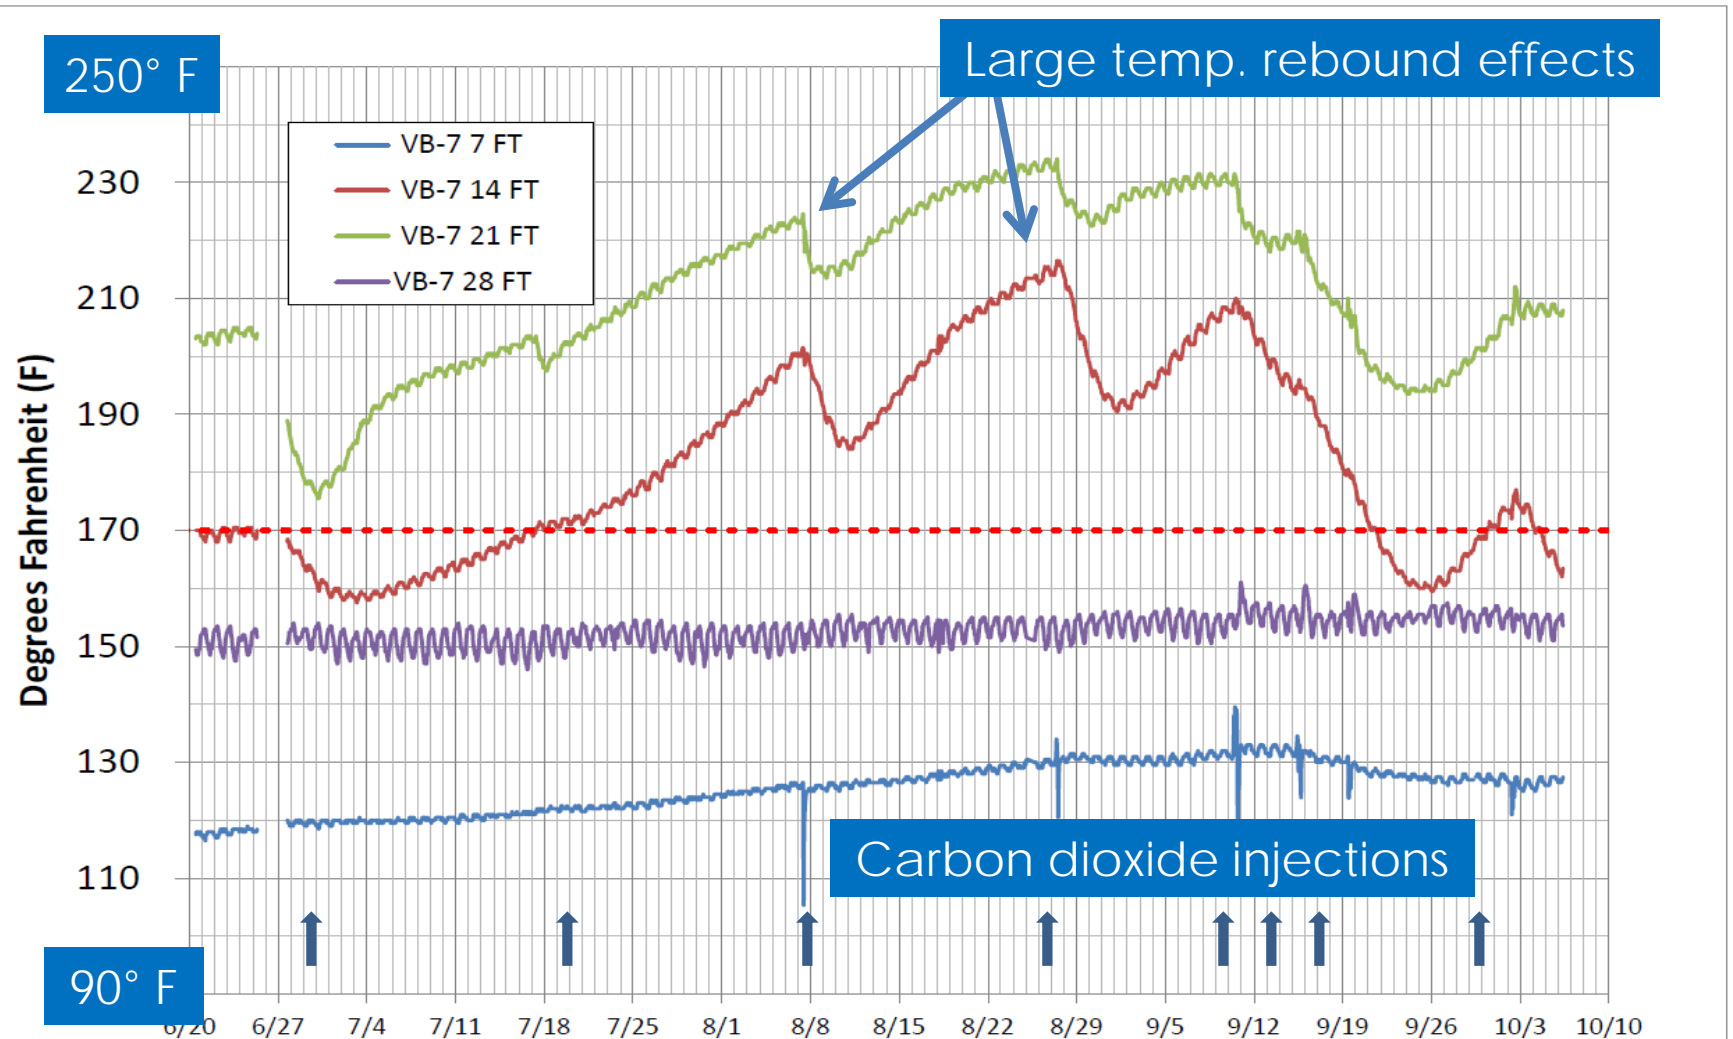
Station ID VB-7 ALL DEPTHS

Large temp. rebound effects

----- Subsurface temperature greater than 170°F is one indicator of possible subsurface combustion (FEMA 2002).

- 21 injection events (June 2014–March 2015)
- 5,000 to 23,000 pounds of liquid carbon dioxide injected per event (6–15 probes per event)
- Total quantity injected: 255,000 pounds
- Carbon dioxide residence time ~1 week or less
- Oxygen intrusion and uneven gas dispersion appears to limit overall effectiveness
