Construction Quality Assurance Certification Report for Sudbury Road Landfill Remedial Action Walla Walla, Washington

April 14, 2017

Construction Quality Assurance Certification Report Sudbury Road Landfill Remedial Action Walla Walla, Washington

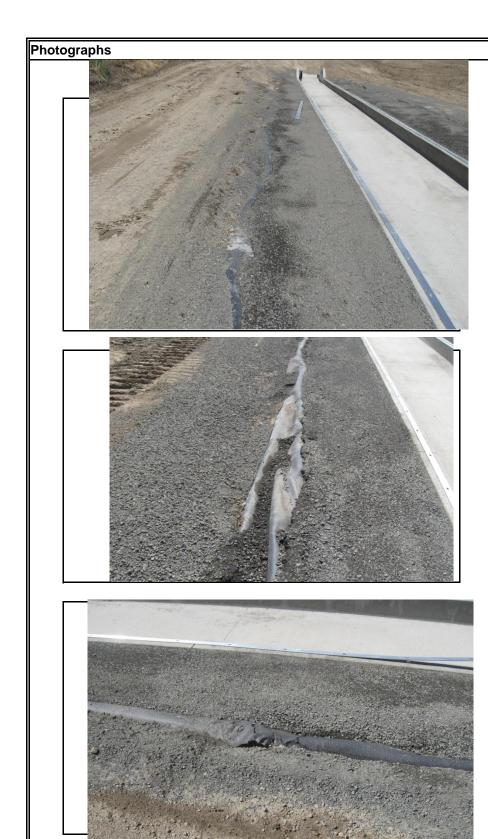
Tear in HDPE No liner to be repaired when top liner welded to bottom

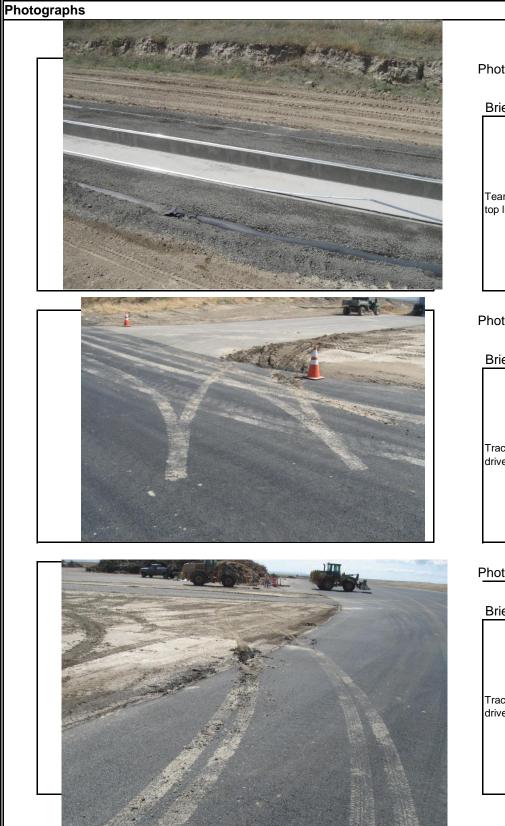
Tear in So HDPE liner to be repaired when top liner welded to bottom

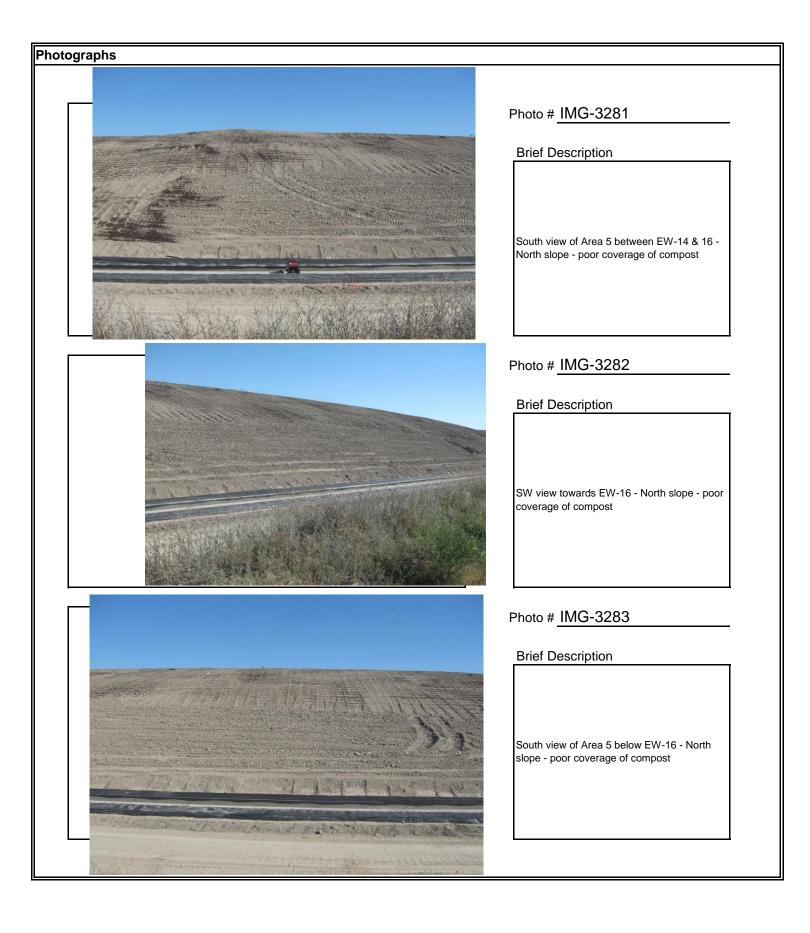
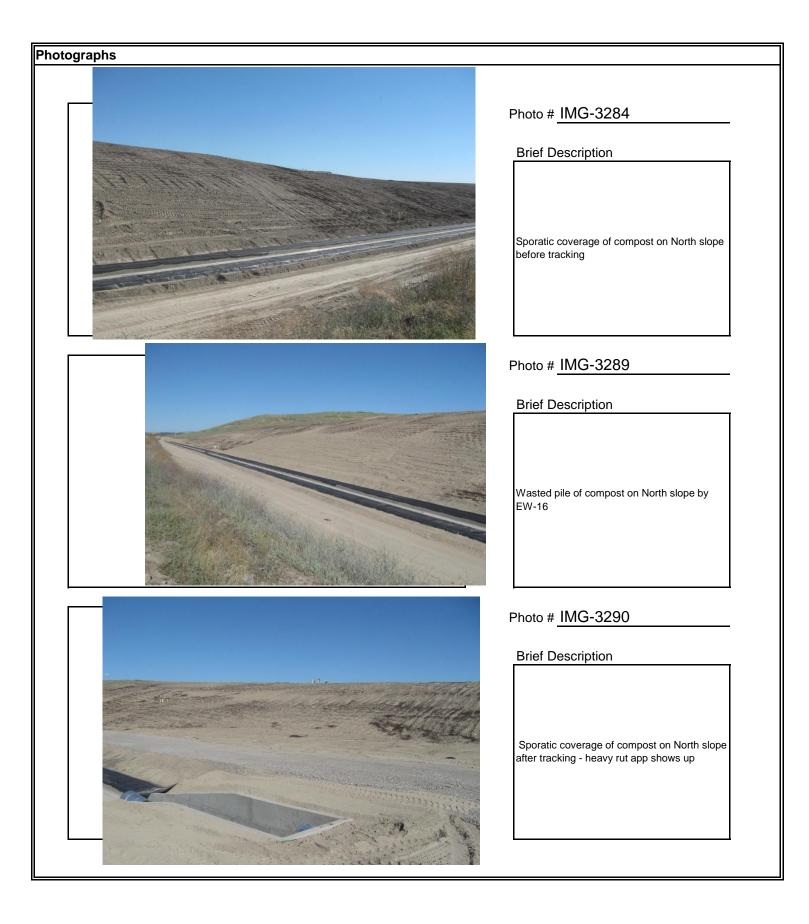
Photographs	
	Photo # IMG-3278 Brief Description
	South view of NE corner Area 5 by EW-12 - North slope - poor coverage of compost
We the second seco	
	Photo # IMG-3279
	Brief Description
	SW view of north slope - poor compost coverage towards EW-14
	Photo # IMG-3280
	Brief Description
	Welded HDPE cover lapping

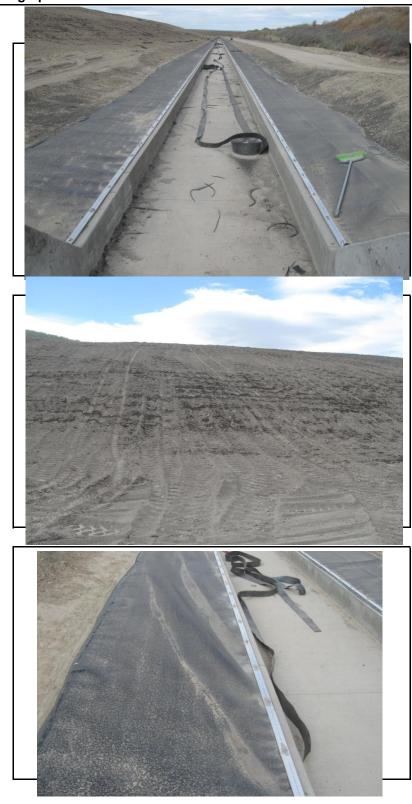
Photographs				
	Photo # IMG-3315 Brief Description Conduit to flare for frost proof heat tape			
	Photo # IMG-3316			
THE THE	Brief Description			
	Welding of HDPE liner completed - waiting for neoprene gasket material to complete			
	Photo # IMG-3317			
	Brief Description			
	Welding of HDPE liner completed - meandering seams with variable finish elevati

Photo # IMG-3319	
Brief Description	
Finish seam on north - south side still nead neoprene gasket - both sides need butyl rubber sealant	S

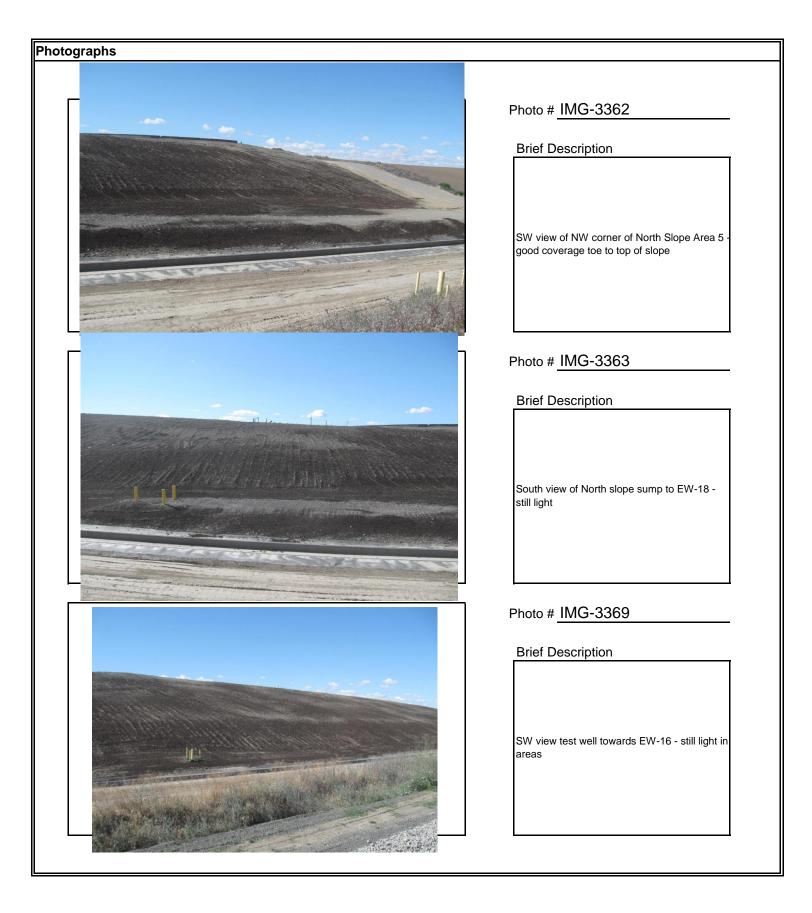
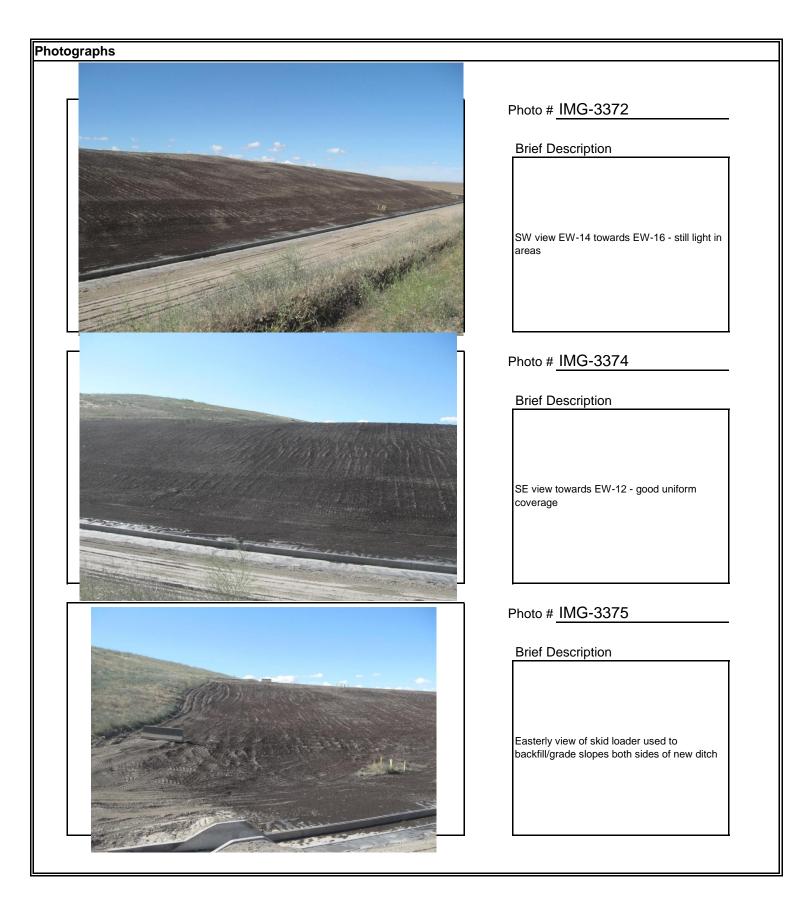
Photo # IMG-3377
Brief Description
West view of North slope - compost blew into ditch heavy coverage at toe of slope

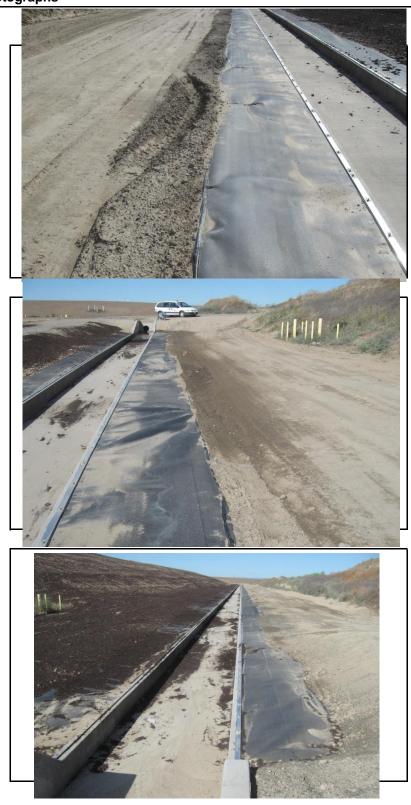
East view of north side of ditch - water flows along liner into drain under structure - needs repaired

Photo # IMG-3401	
Priof Description	
Brief Description	
Vehicle track along liner shows lack of	
compaction in HDPE liner anchor
