INITIAL INVESTIGATION FIELD REPORT

OLL HAL OLLINA	ION					
Site Name (Nam	ne over door):	Site Address (including City, State and Zip):	Phone (360) 428-1598			
Anacortes Former Water Treatment Plant		14549 River Bend Road Mount Vernon, WA 98273	<u>Email</u>			
Site Contact, Titl Fred Buckenmeyer, City of Anacortes	e, Business: Director of Public Works	Site Contact Address (including City, State and Zip): PO Box 457 Anacortes, WA 98221	Phone (360) 293-1943 Email fredb@cityofanacortes.org			
Site Owner, Title	, Business:	Site Owner Address (including City, State and Zip):	Phone (360) 293-1919			
City of Anacortes		PO Box 457 Anacortes, WA 98221	<u>Email</u>			
Site Owner Cont	act, Title, Business:	Site Owner Contact Address (including City, State and Zip):	Phone			
same as above			<u>Email</u>			
Previous Site Ov	wner(s):	Additional Info (for any Site Information Item):				
		ENL to Mr. Fred Buckenmeyer				
Alternate Site Na	ame(s):

On April 24, 2017 the Remedial Investigation Report, Anacortes Water Treatment Plant, MWH Americas, Inc., April 2017 was submitted to the Ecology NWRO. The report documented PCB contamination in shallow soils exceeding MTCA Method A in 7 locations near t

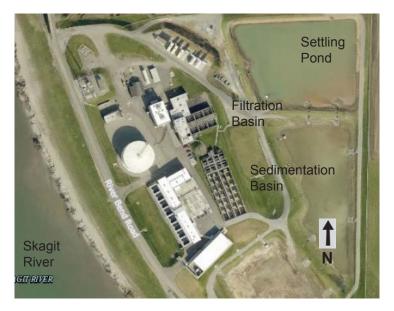
Sedimentation Basin east side

I conducted a site visit with Fred Buckenmeyer, Public Works Director, City of Anacortes, on May 5, 2017. I found conditions at the site as described above and as diagrammed in Remedial Investigation, 2017. The decommissioned structures and surrounding soils were undisturbed the the time of the visit. The lawn is mowed routinely around the structures but no other activity is taking place at this time. A 2015 aerial image from the site along with photos from the site visit of the area around the decommissioned sedimentation basin and filtration basin are below.
