Westmoreland Property  
23019 192<sup>nd</sup> Ave SE  
Renton WA 98058

ERTS # 614667/628570

ICT visits by Debra Oliver & Sue Hamilton, HEI III, King County Hazardous Waste Management Unit; Initial Investigation on behalf of Ecology TCP.

First visit: 18 August 2011:

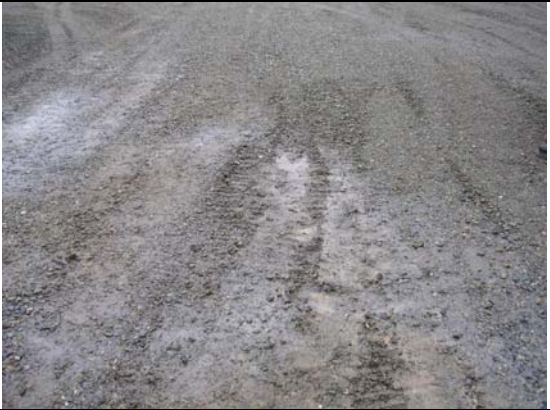
We observed two areas of discolored gravel. Mr. Westmoreland stated that he normally poured Dawn dish soap on spills and followed that with water from the hose. We explained that using Dawn dish soap was not an option for cleaning up

<p>This area of discolored gravel (approximately 4' by 2') with sheen is on the north side of the looped drive that begins at the entrance to the property. Mr. Westmoreland stated that he normally pours Dawn dishwashing liquid on areas like this to remedy oil spills.</p>

oil spills on the ground. We instructed him to remove the discolored gravel and soil and dispose of it, which he agreed to do as he planned on taking the debris from the three buildings he'd demolished to the Rabanco Transfer Station and would add the soil and gravel to the haul. He agreed to call me after doing this so that I could re-photograph the area.

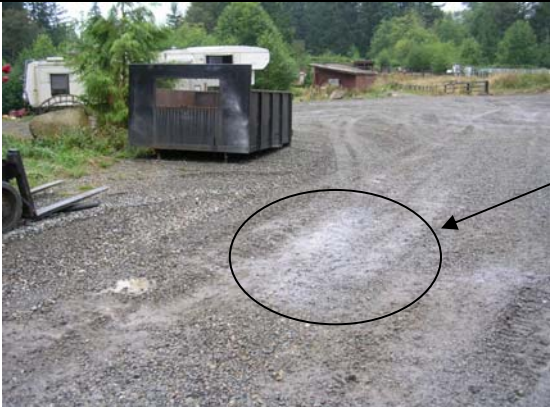
<p>This is the same area of discoloration, capturing the tines of the red forklift to provide an idea of the location of the area.</p>

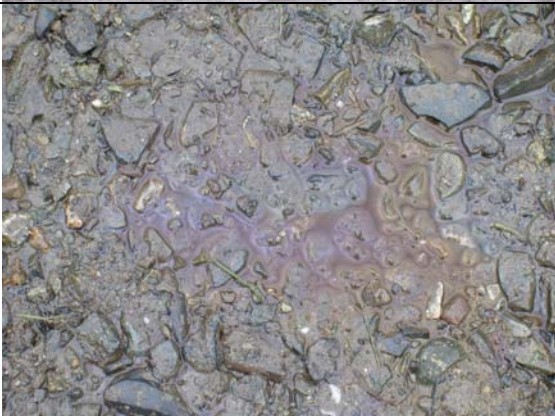
<p>Sheen on gravel in this area (approximately 1' by 1') – on the gravel drive approaching the horses.</p>

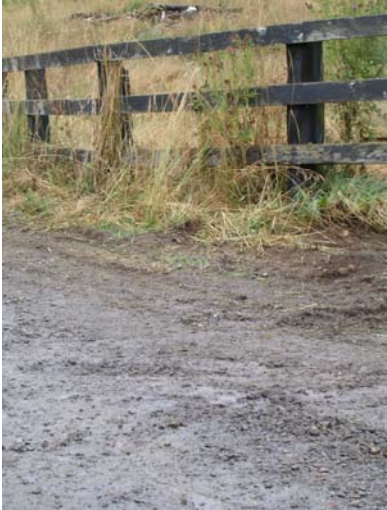
<p>Location of second sheen: near drive to horse pasture, before demolished building remains – on the NNW section of the property.</p>

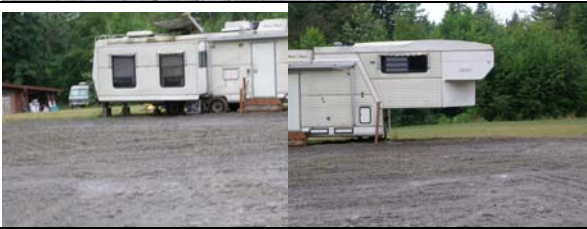
<p>An RV on the property (looking west). It did not appear to have electricity hooked up to it.</p>

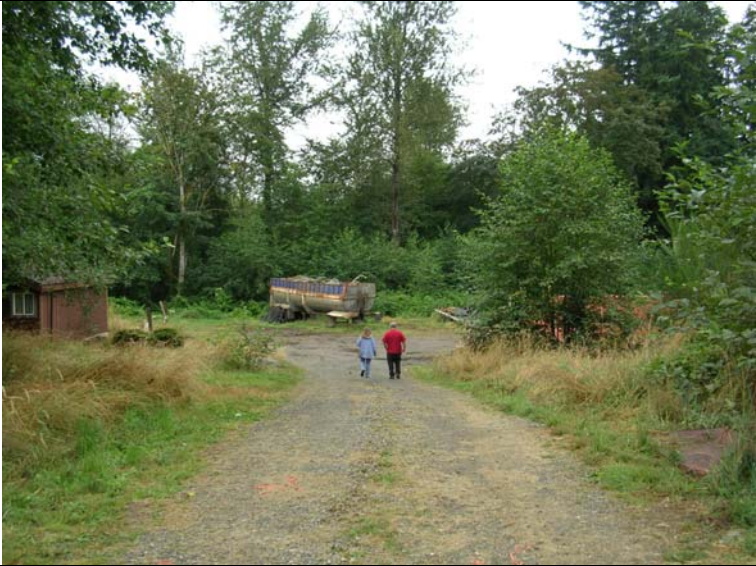
<p>Walking south on the west side of the property to a large parking area. Mr. Westmoreland stated that the building on the left side of the photo with curtains in the windows and steps leading to a door is a playhouse for children. He denied that anyone lived there. On the right behind the tree is a sealed semi container Mr. Westmoreland stated belongs to his brother. Also near the tree behind the semi container is another pile of debris from a building Westmoreland recently demolished. In the center of the photo is the semi-trailer containing tires and scrap metal.</p>

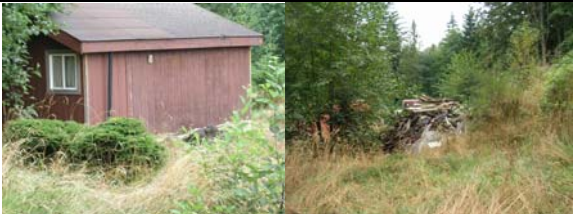
<p>Children's playhouse on the left; demolition debris pile on the right.</p>

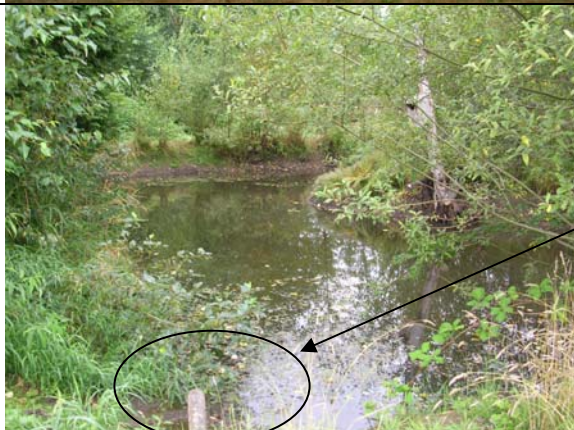
We observed two areas where we noticed odors. We detected a metallic-like odor near the pond where the pipe discharged storm water (similar to the odor of a metal shop) and near the NW corner of the house we detected a solvent-like odor (similar to spray paint) that would come and go.

The SE section of the pond, near the barn. Notice the pipe emptying into the pond on the bottom center of the photo. According to Mr. Westmoreland, the drain pipe comes from the storm drain at the NW corner of the house, where he stated rain has historically puddle up and presented problems. (We ran out of memory on the camera and were unable to capture images of the storm drain by the house.)

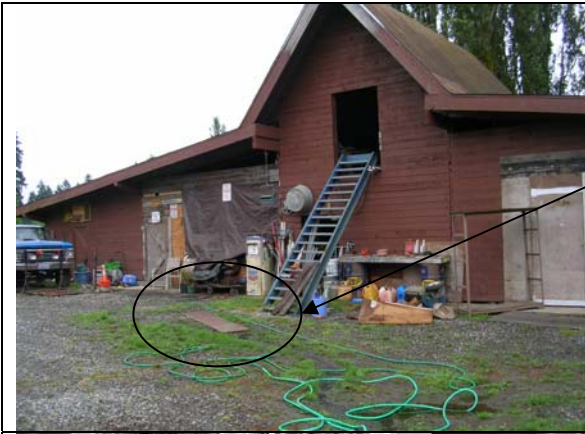
The “barn.” The plank lying on the ground in the center of the photo is to protect the broken drain pipe from further vehicle damage.

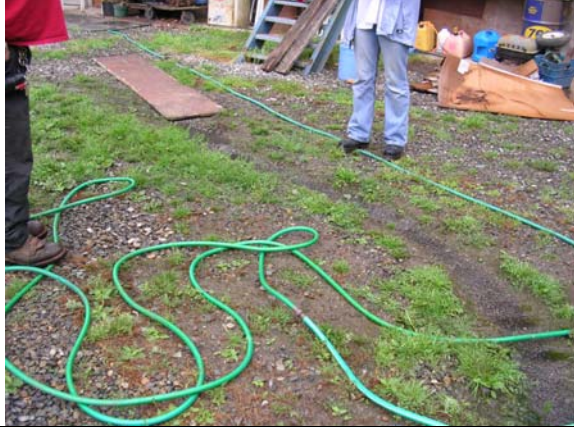
Discharge from the broken drain pipe on the surface of the ground.

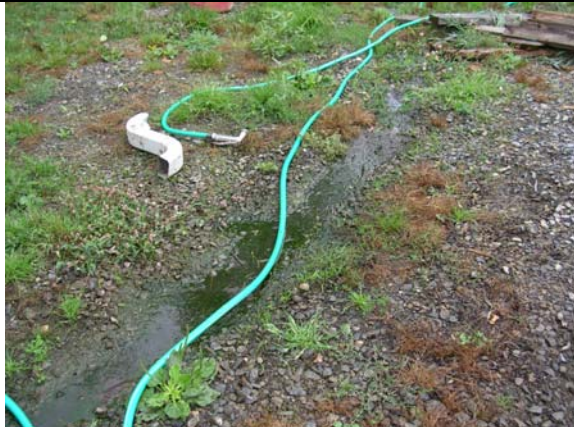
Shows that the discharge from the broken drain pipe also empties at the pond.

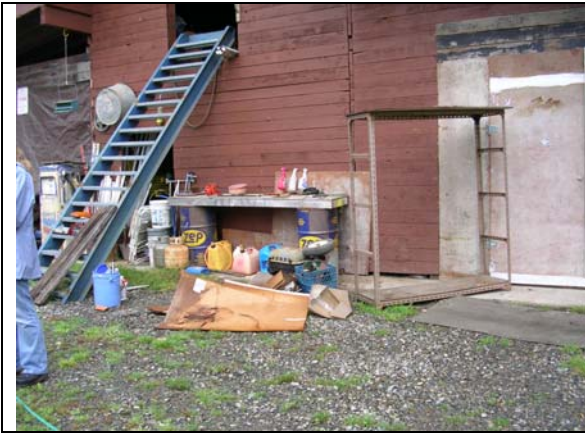
Containers stored outside.
