## **PERIODIC REVIEW**

**Renton Shopping Center  
Facility Site ID#: 26515148**

**351 Hardie Avenue SW  
Renton, WA**

**June 2017**

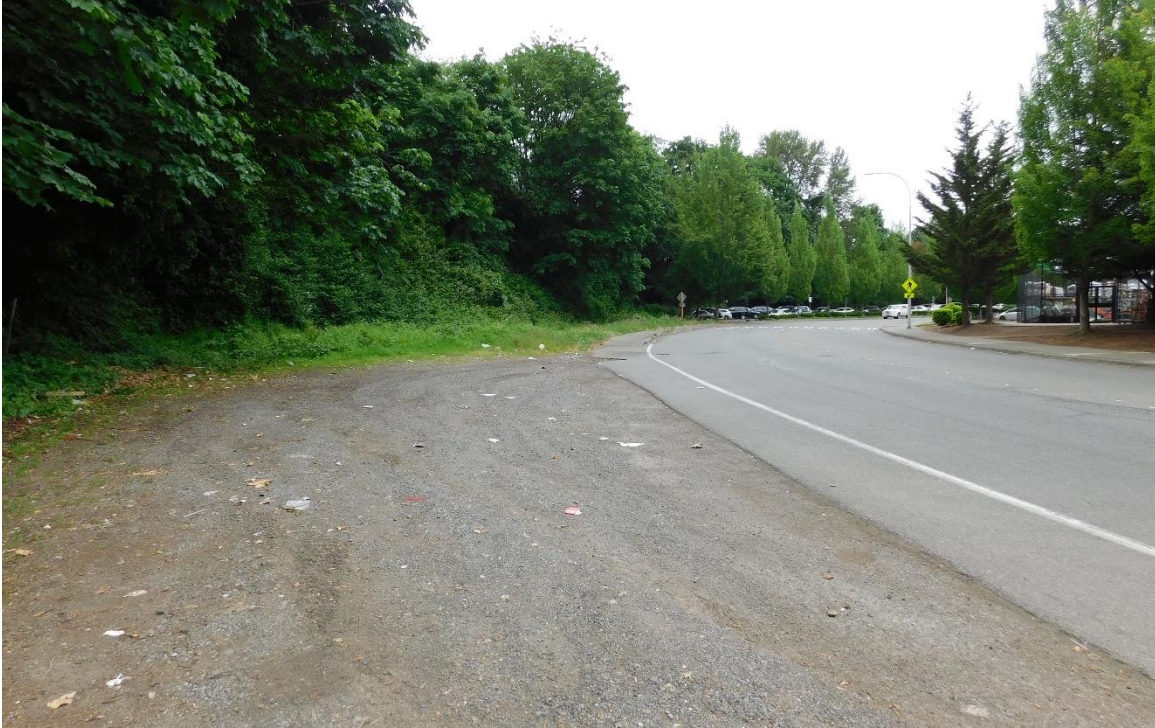
Photo 1: The eastern portion of the Site is located on the left of Hardie Avenue SW – from the south

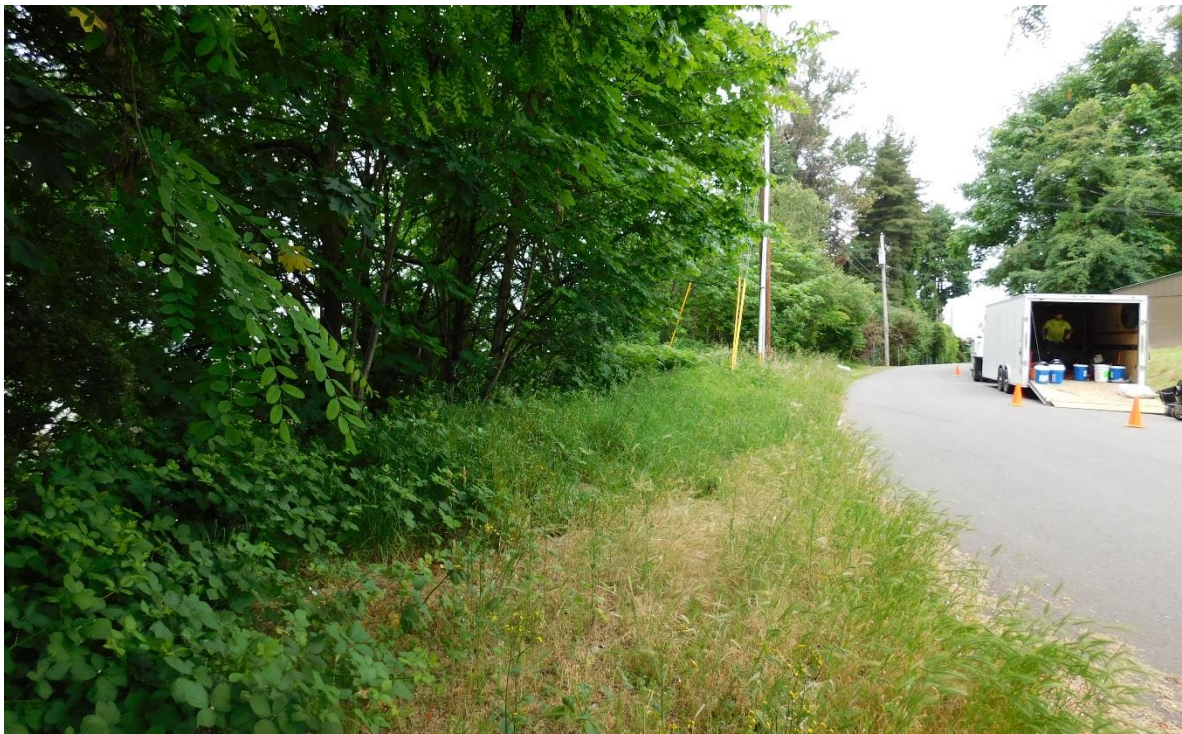
Photo 2: The western portion the Property over the cliff is located on the left of Maple Avenue SW – from the northwest

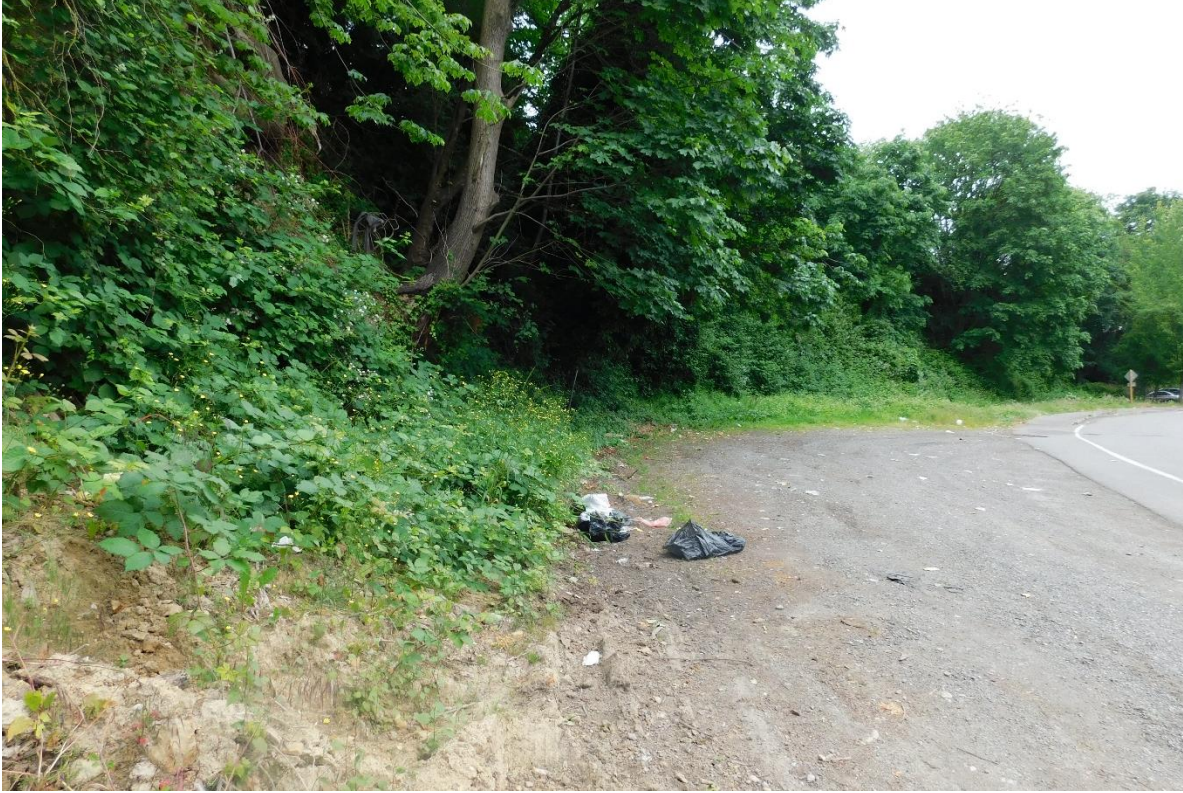
Photo 3: The Cliff on the southwestern portion of the Property – from the southeast

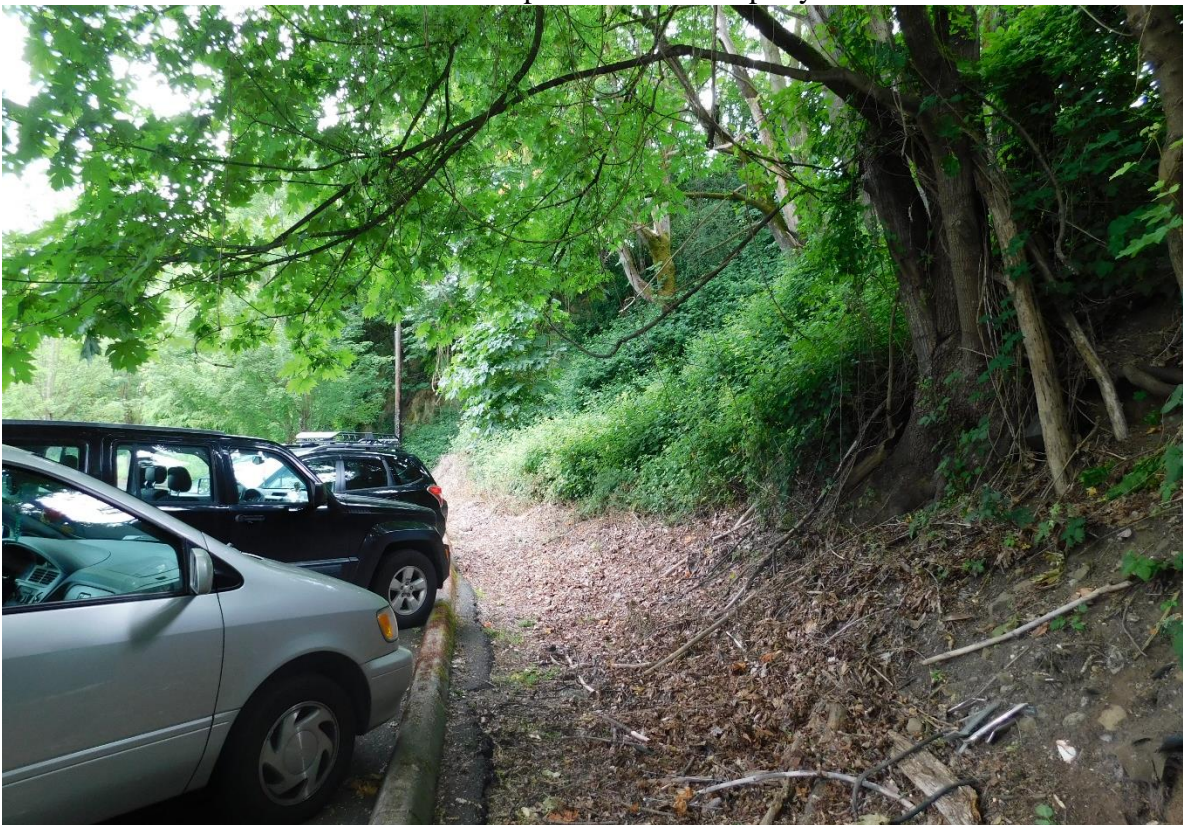
Photo 4: The Cliff on the northwestern portion of the Property – from the northeast

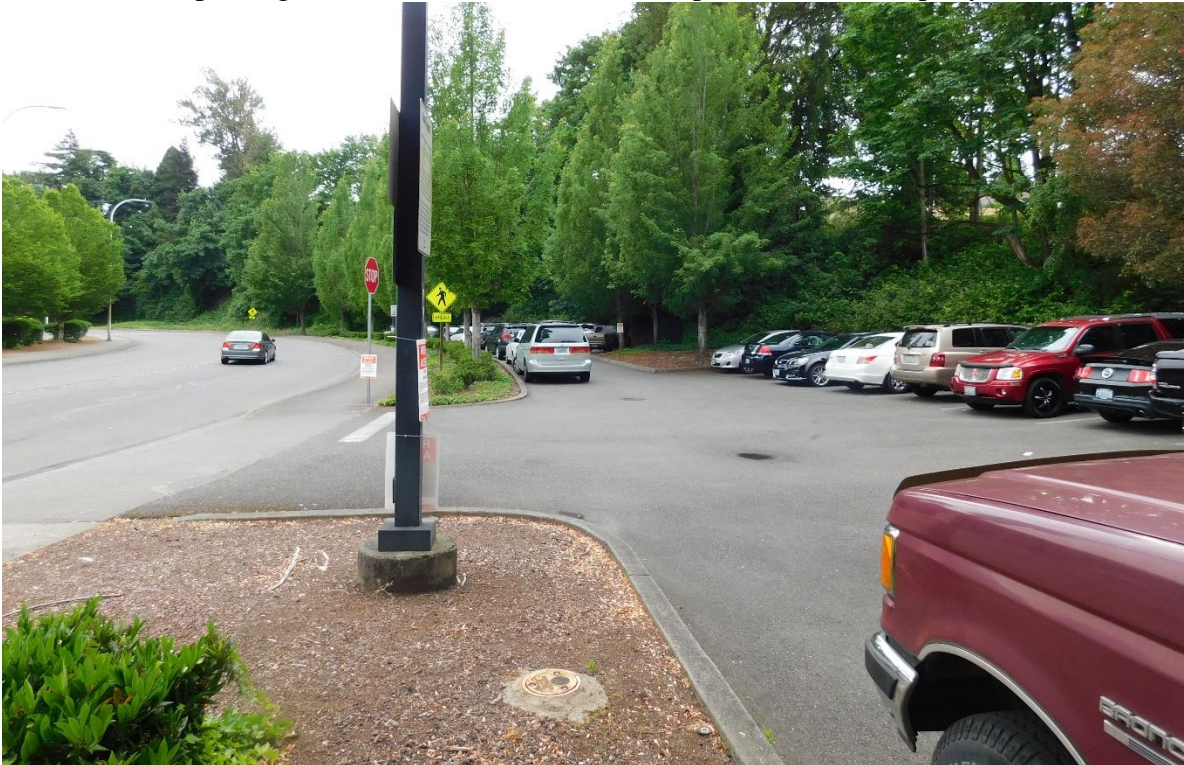
Photo 5: The parking lot located on the northeastern portion of the Property – from the north

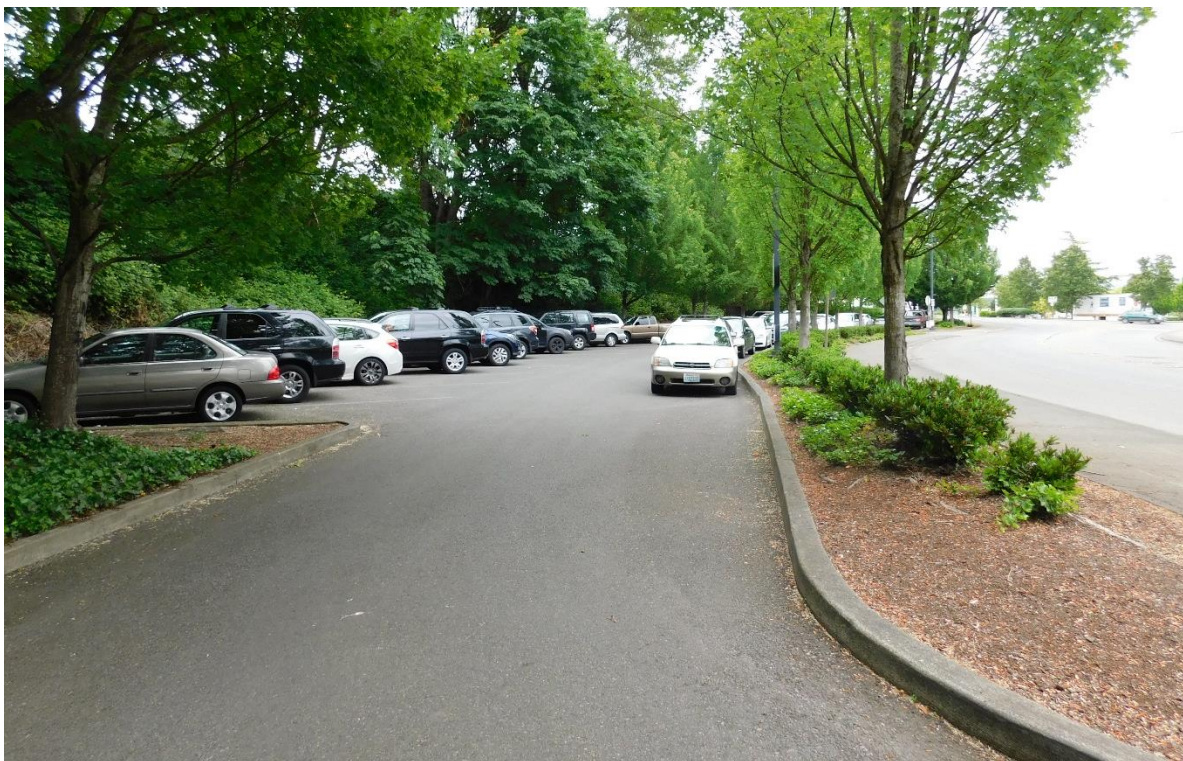
Photo 6: The parking lot located on the northeastern portion of the Property – from the south

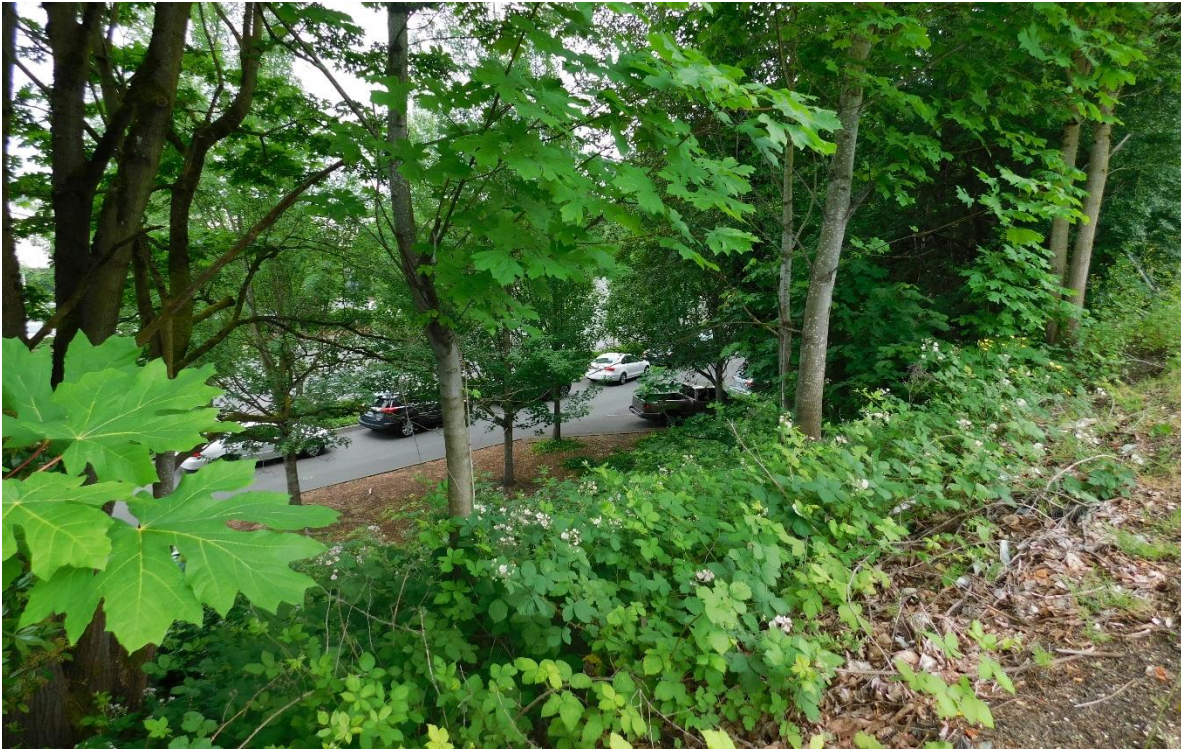
Photo 7: The parking lot located on the northeastern portion of the Property – from the northwest on the cliff

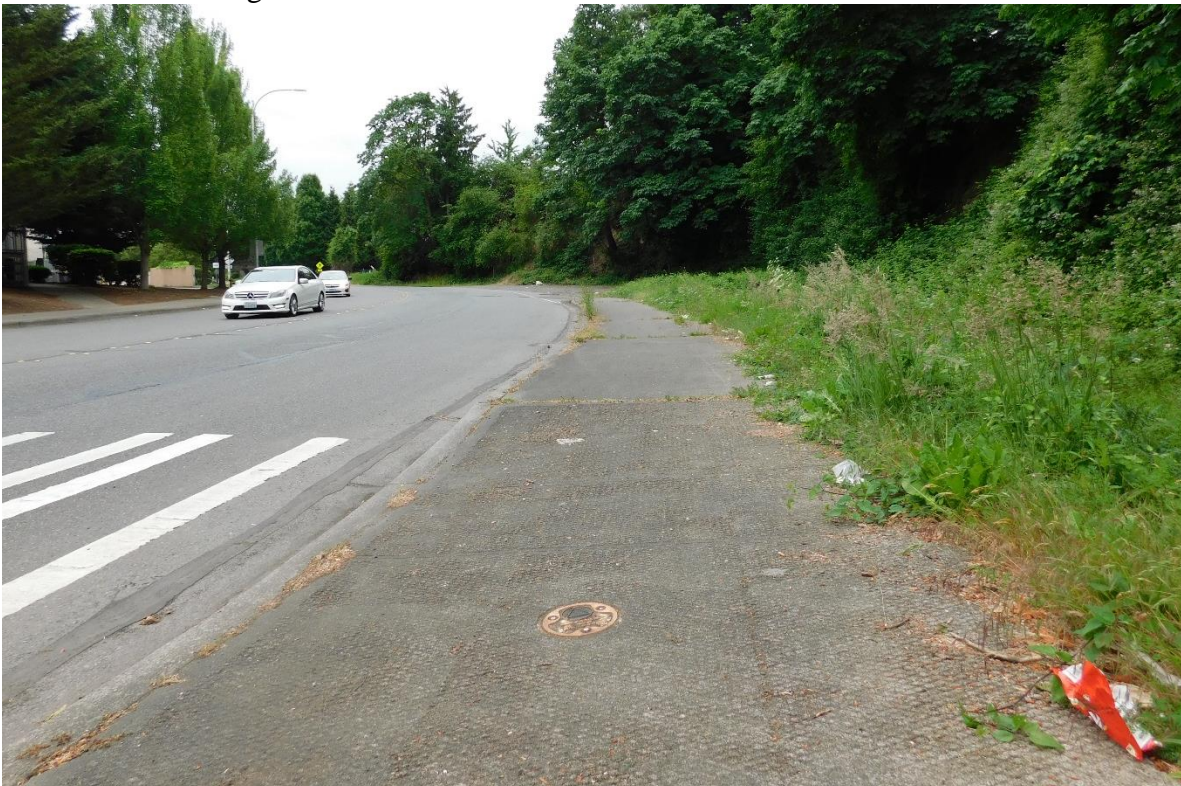
Photo 8: Monitoring well MW-17 – From the north
