Subject: Submittal of Reports for Semi-Annual Inspections of SPL Cap and Asphalt Areas and Related Drainage Features – Tasks 8 & 9

**KAISER MEAD NPL SITE
SPL CAP AND ASPHALT AREA INSPECTION RECORD**

May 2016

**KAISER MEAD NPL SITE
DRAINAGE FEATURES INSPECTION RECORD**

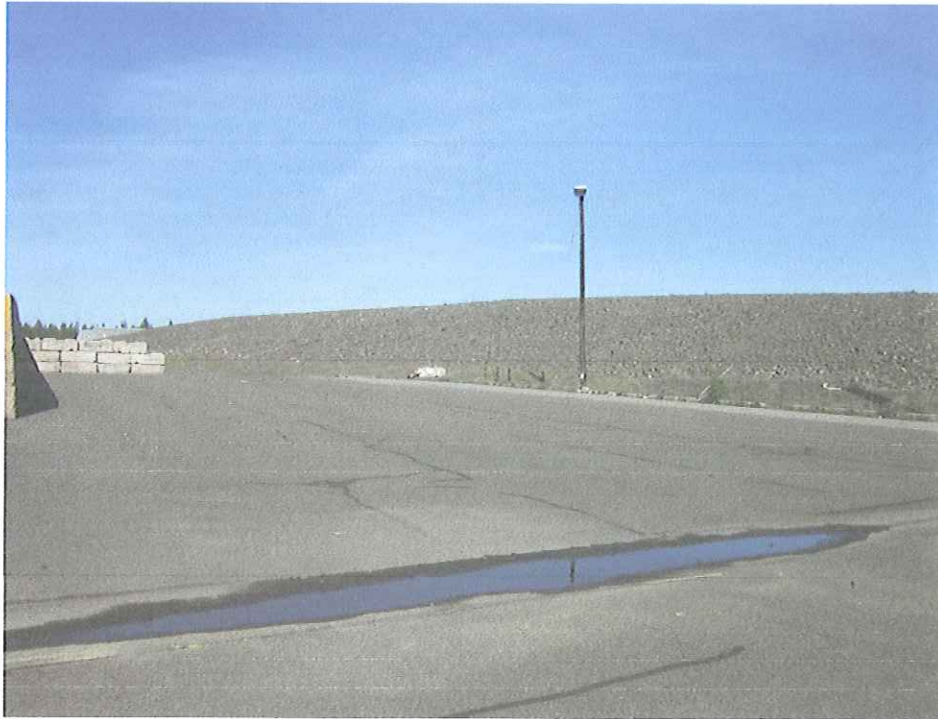
Photo 1: Photograph of asphalt area southeast of SPL Pile showing ponding.

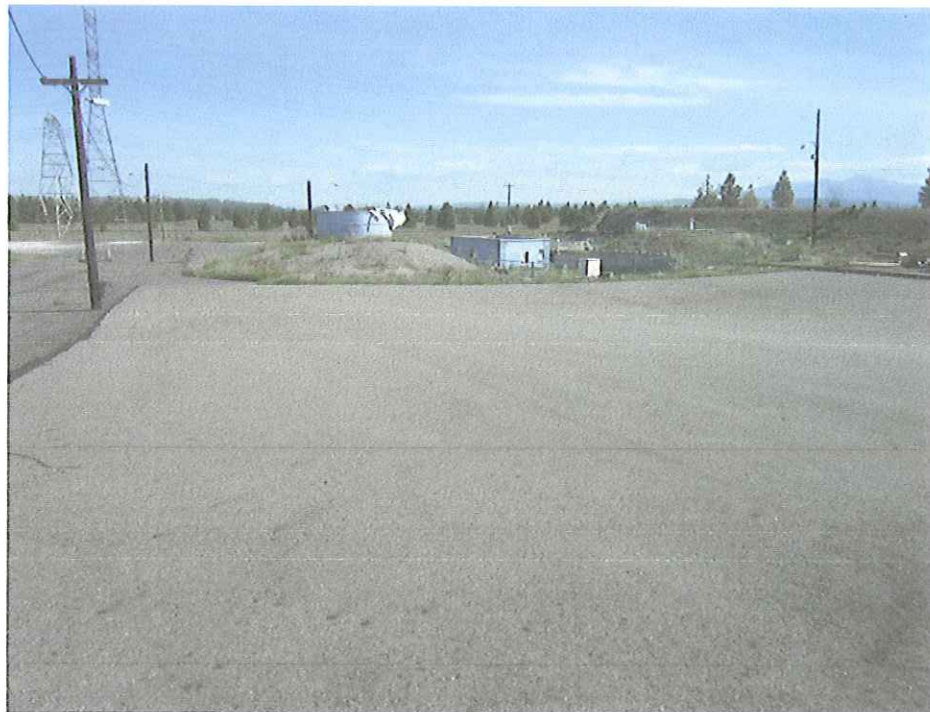
Photo 2: Photograph of asphalt area east of SPL Pile (Area 2) looking north showing good condition.

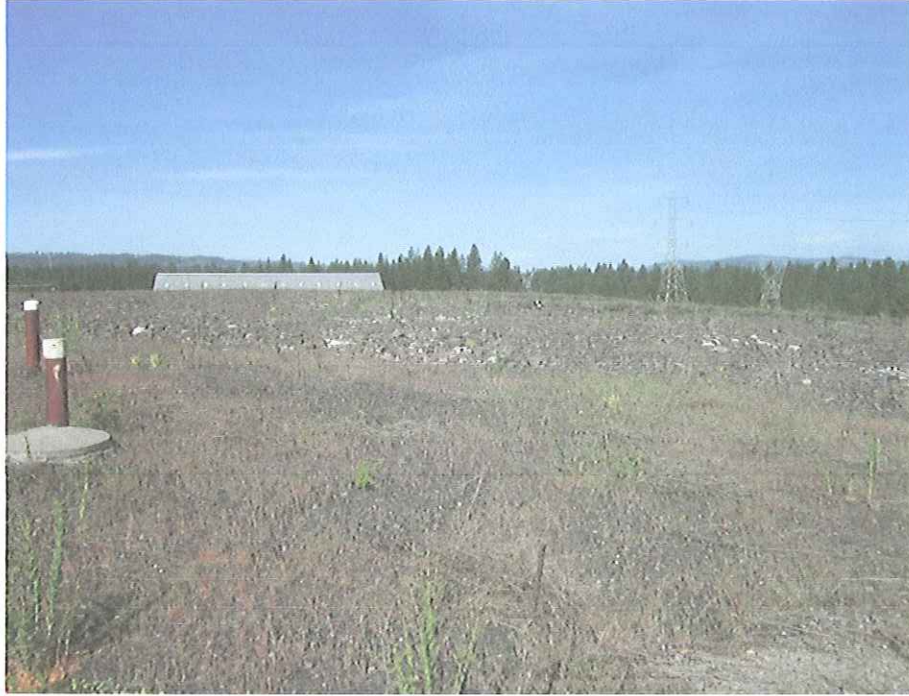
| Rock Covered Surfaces: Overall in good condition. <ul style="list-style-type: none">▪ Failures or areas of concern: None. The rock areas are in good shape with no evidence of movement on the slopes. See attached photos.▪ Comments: Some weeds and grasses have invaded. At least one type of weed is noxious (dalmation toadflax) and Hydrometrics will contact a weed control contractor for a bid to eradicate the noxious weeds. | | |

Photo 7: Showing top of of SPL Pile cap looking west.

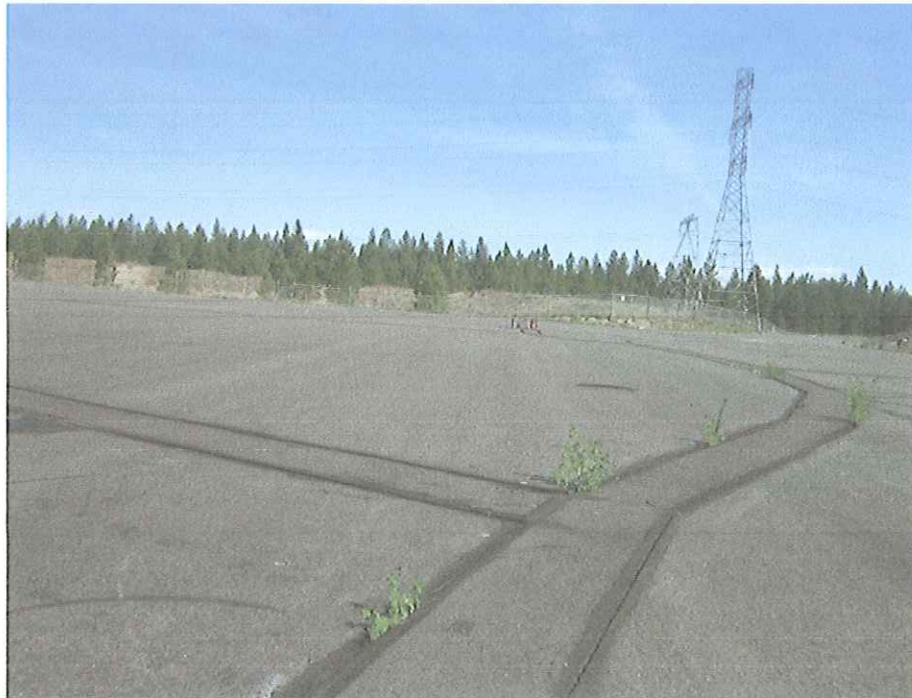
The asphalt cap is in good condition. There are cracks in the asphalt on the west side of the SPL Pile. We will schedule filling with the asphalt contractor we have used in the past.

| Asphalt Covered Surfaces: Overall in good condition. <ul style="list-style-type: none">▪ Failures or areas of concern: Cracks on west side of SPL pile will require filling this year. See attached photos.▪ Comments: Hydrometrics will schedule crack filling this year. | | |

Photo 8: Showing asphalt cracks west of SPL Pile cap looking north.

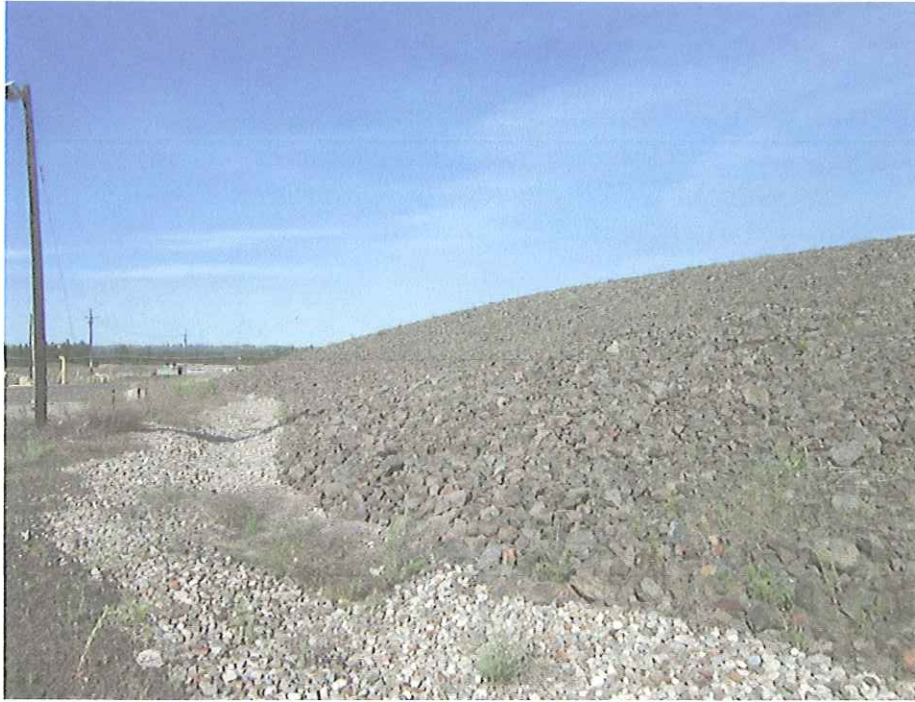
Photo 1: Photograph showing ditch along southeast corner of SPL Pile looking west.

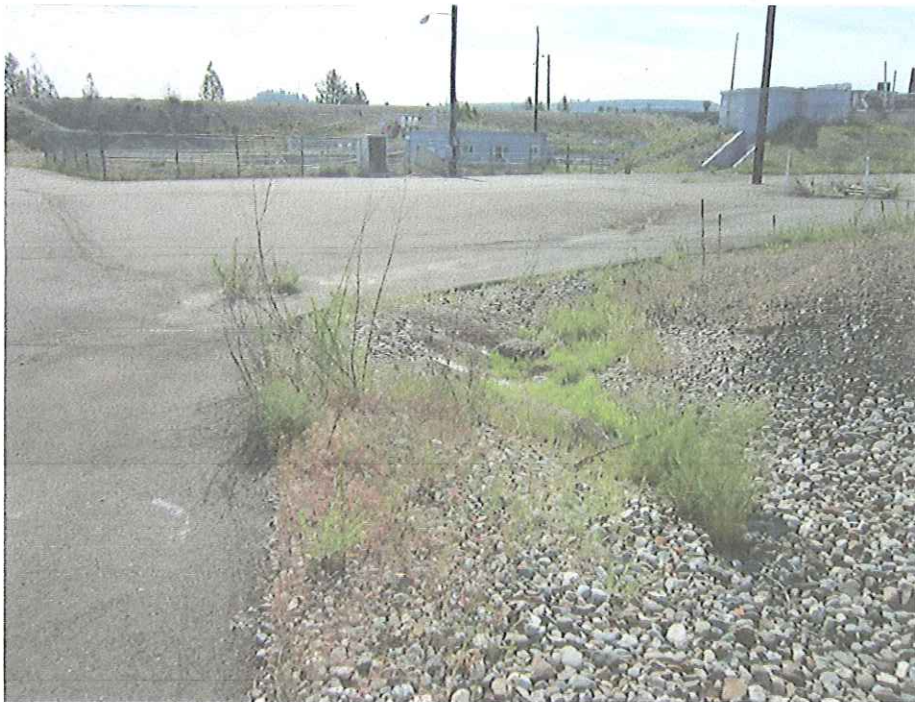
Photo 2: Photograph of perimeter ditch drainage into northeast storm water drain looking east. Vegetation is not impeding flow.

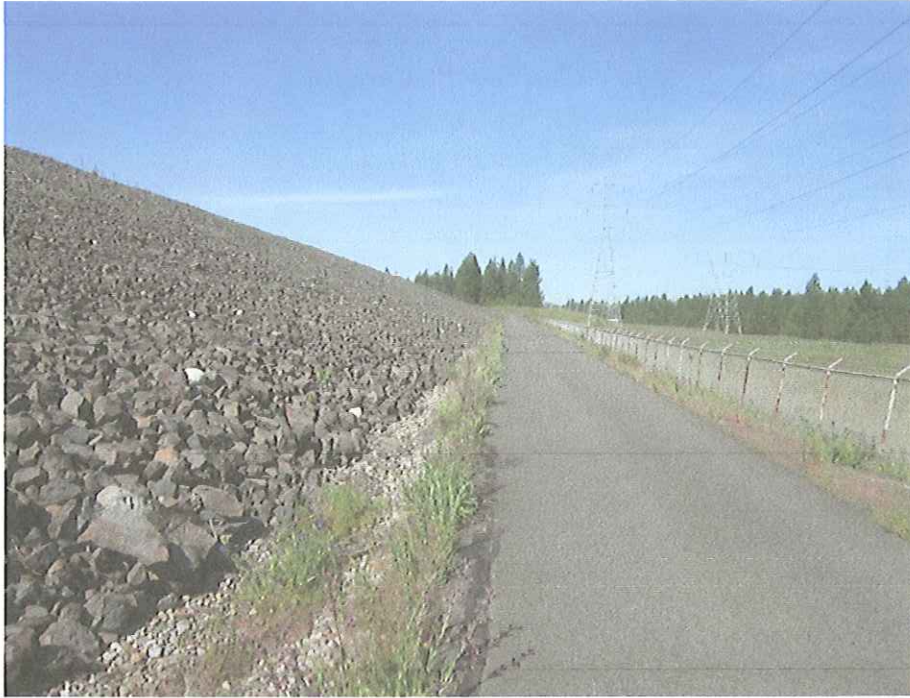
Photo 3: Photograph showing SPL Pile perimeter ditch along north perimeter road looking west.

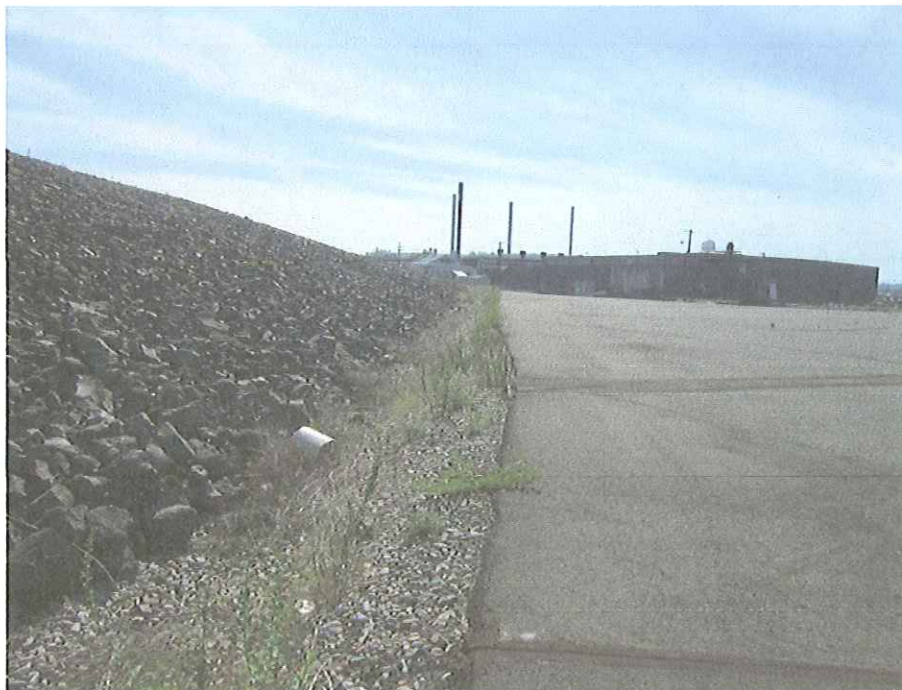
Photo 4: Photograph of SPL west perimeter ditch looking south.
