SUBJECT: Semi-Annual Cap and Asphalt Inspection Reports

**Subject: Submittal of Reports for Semi-Annual Inspections of SPL Cap and Asphalt Areas
and Related Drainage Features – Tasks 8 & 9**

**KAISER MEAD NPL SITE
SPL CAP AND ASPHALT AREA INSPECTION RECORD**

October 2016

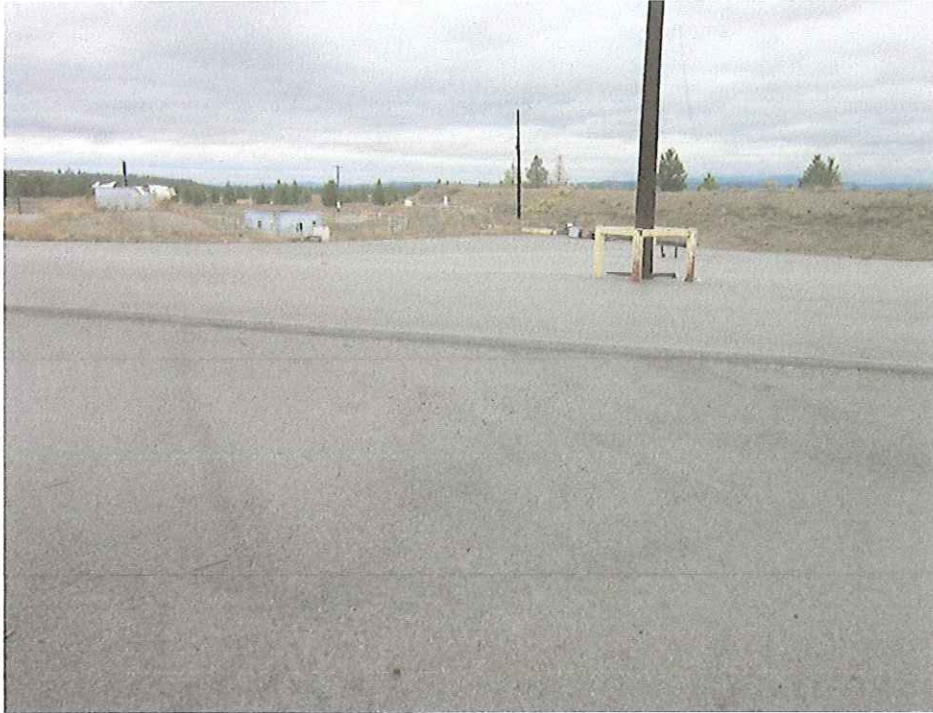
Photo 1: Photograph of asphalt covering Area 2, between the SPL Pile and the sludge pond.

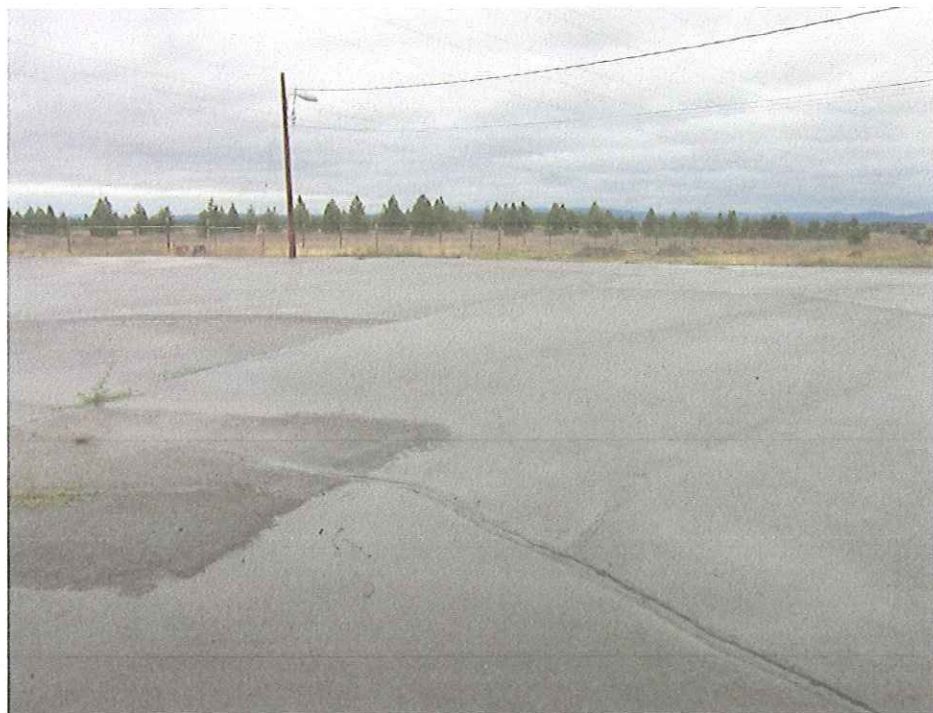
Photo 2: Photograph of asphalt area northeast of SPL Pile looking northeast showing good condition.

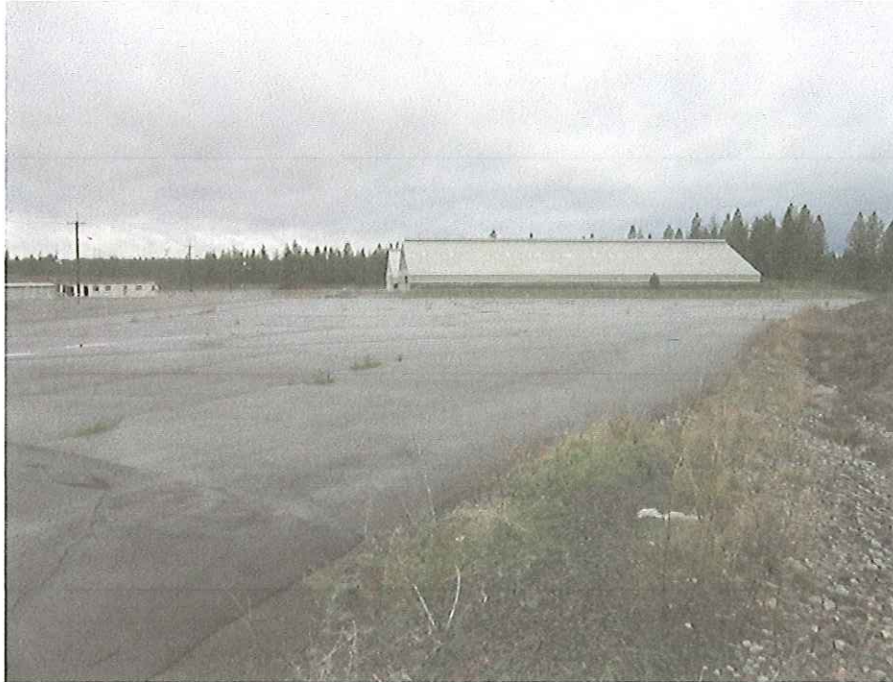
The asphalt cap is in good condition. There are cracks in the asphalt on the west side of the SPL Pile. We will schedule filling with the asphalt contractor we have used in the past.

Photo 3: Photograph of asphalt area west of SPL Pile looking west showing some cracks.

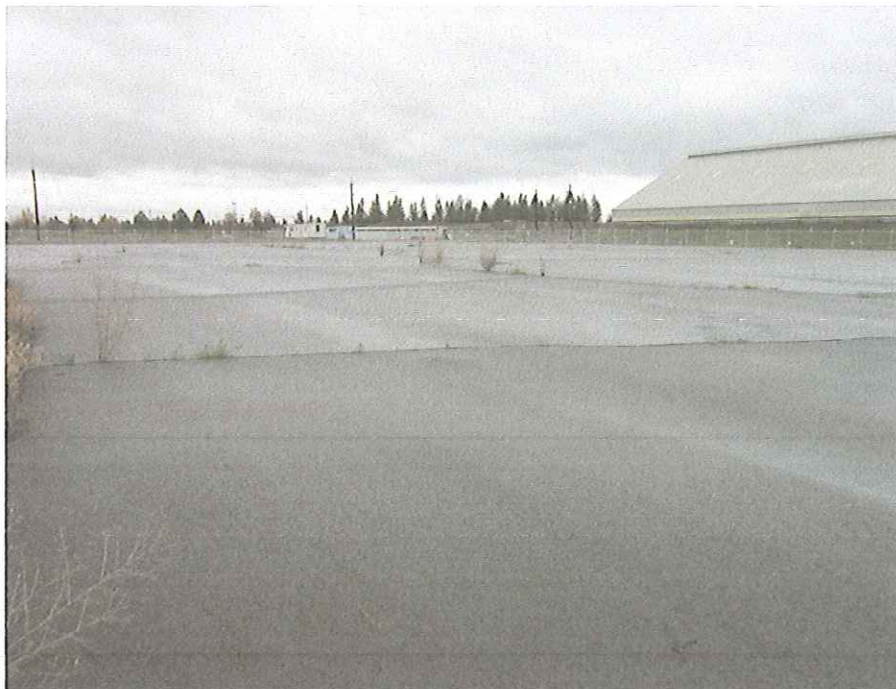
Photo 4: Photograph showing asphalt west of SPL pile looking southwest, showing cracks.

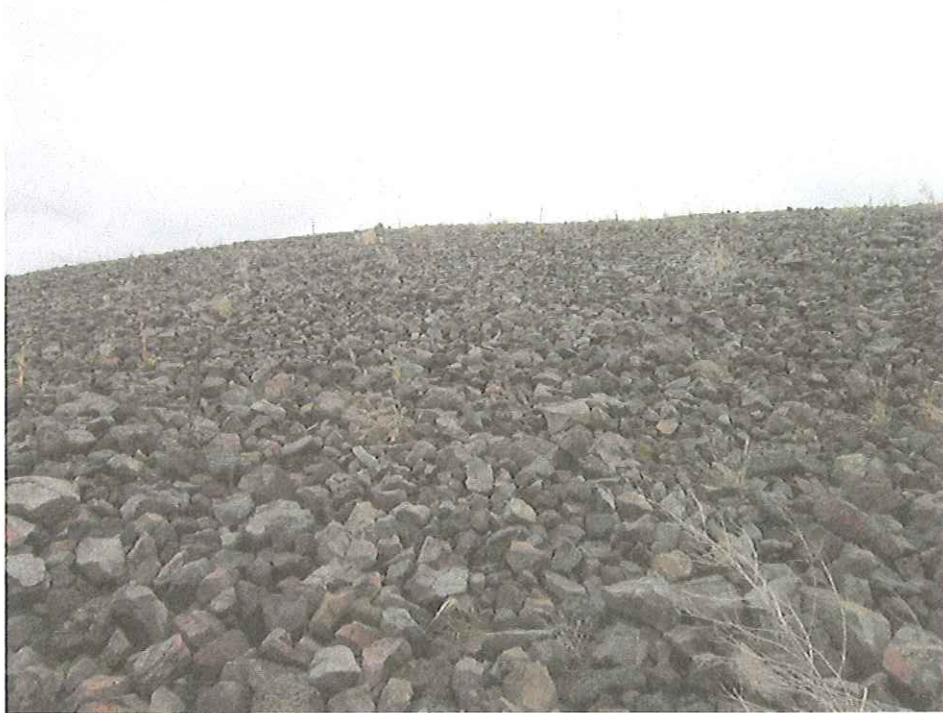
Photo 5: Showing northwest slope of SPL Pile cap.

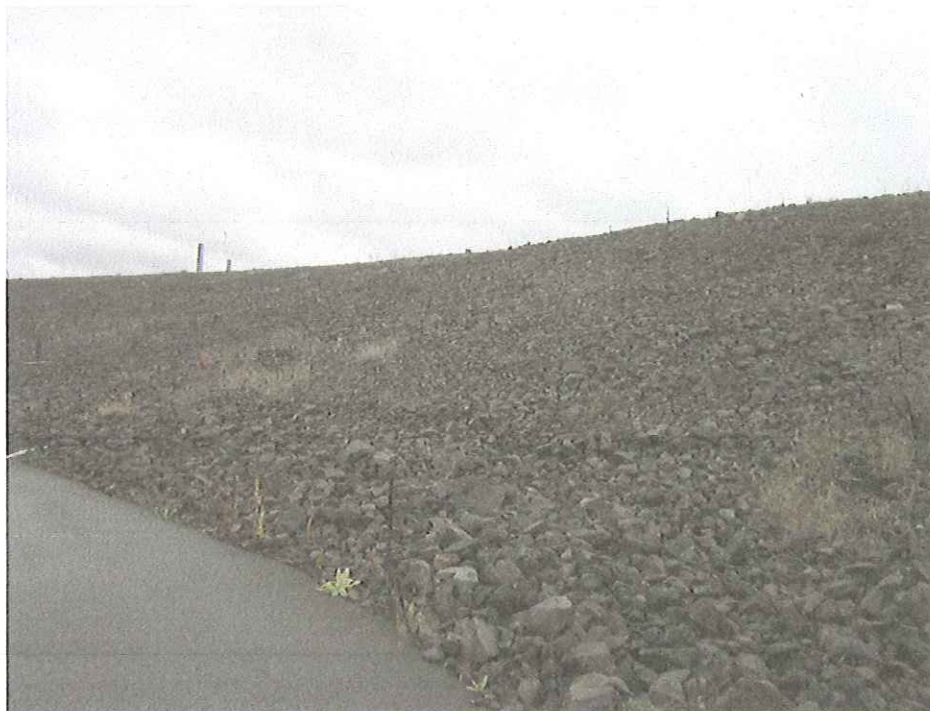
Photo 6: Showing eastern portion of north slope of SPL Pile cap looking southeast.

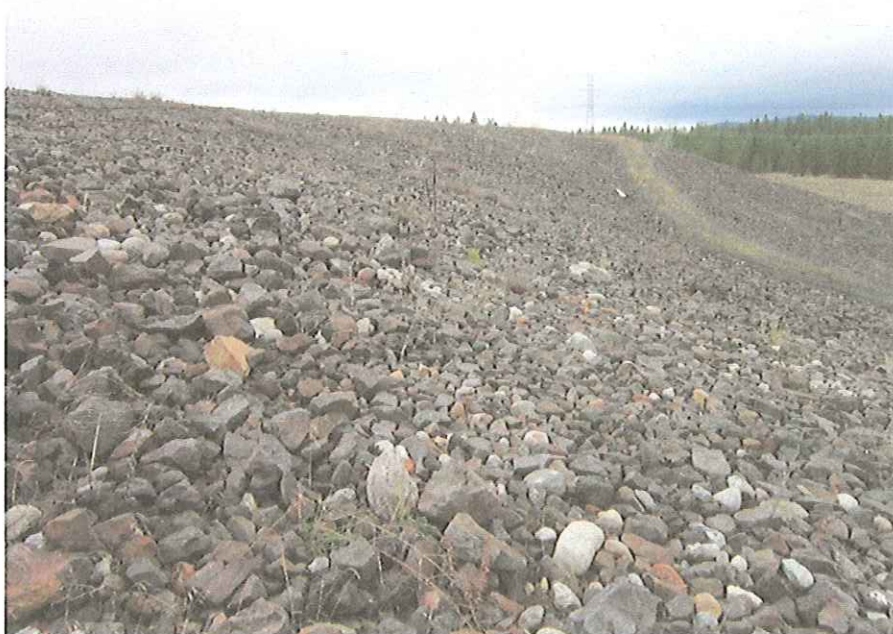
Photo 7: Showing north slope of SPL Pile cap and access road looking west.

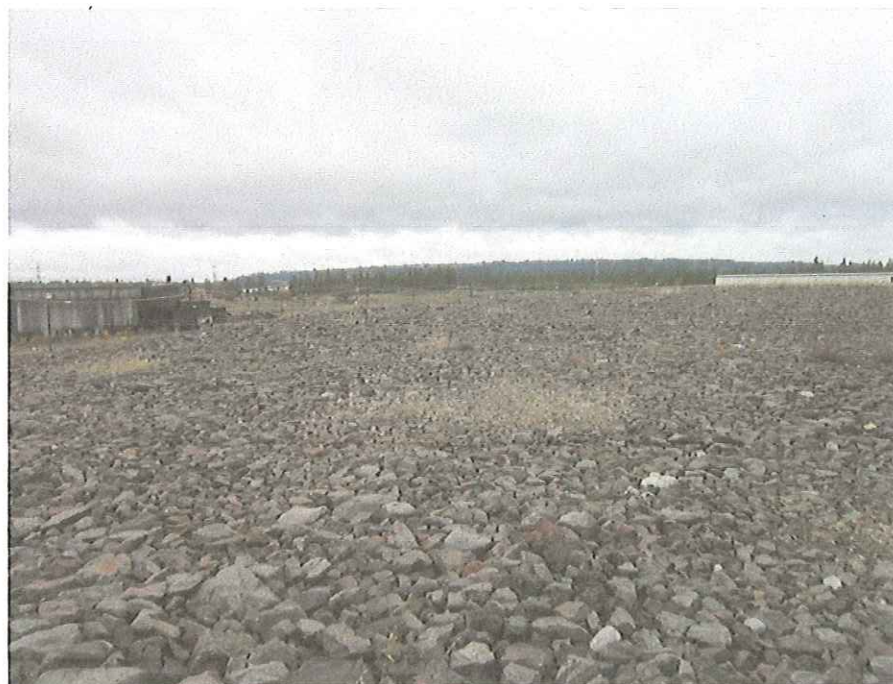
Photo 8: Showing top of SPL Pile cap looking west from east side.

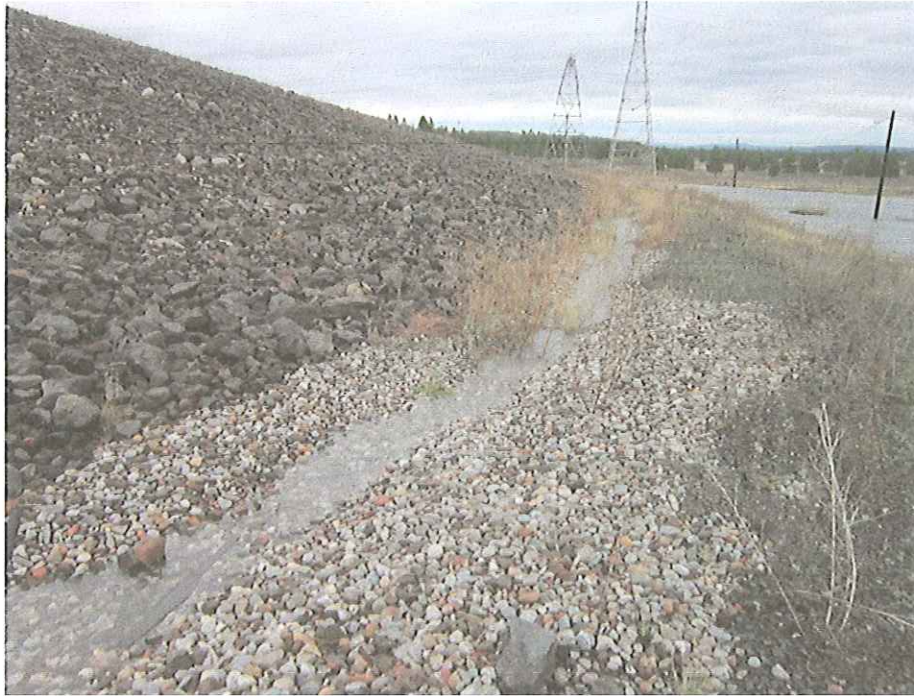
Photo 1: Photograph showing flowing ditch along southeast corner of SPL Pile looking north.

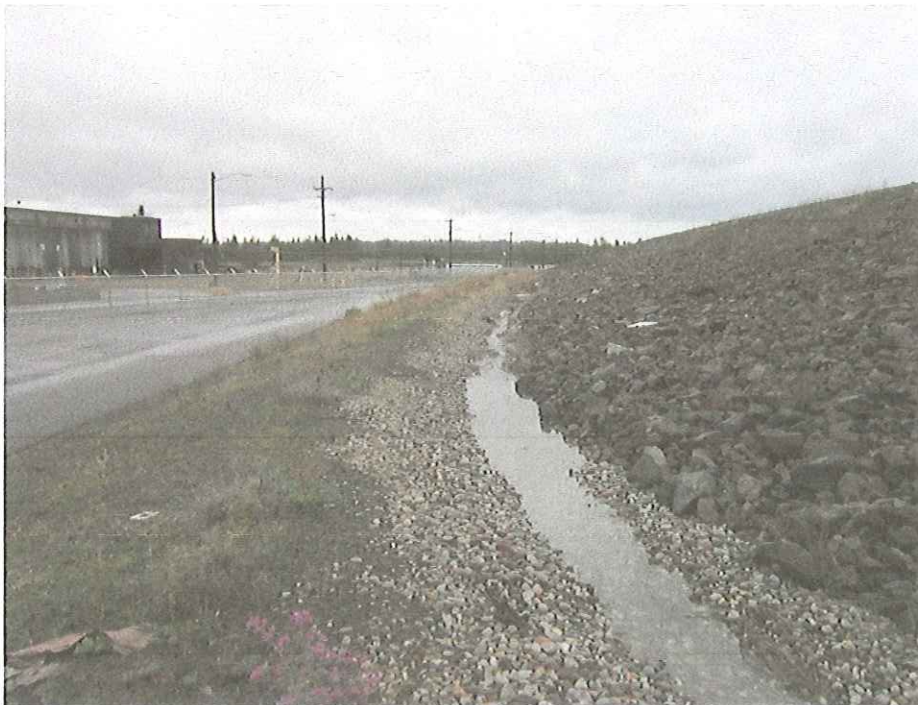
Photo 2: Photograph of perimeter ditch drainage flowing west along south side of SPL pile.

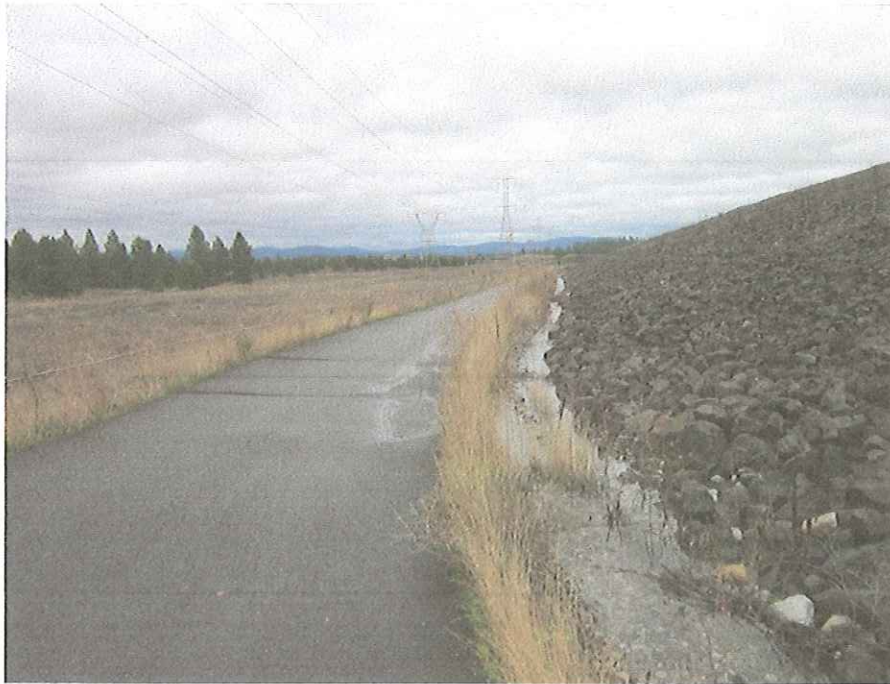
Photo 3: Photograph showing SPL Pile perimeter ditch flowing along north perimeter road looking east.

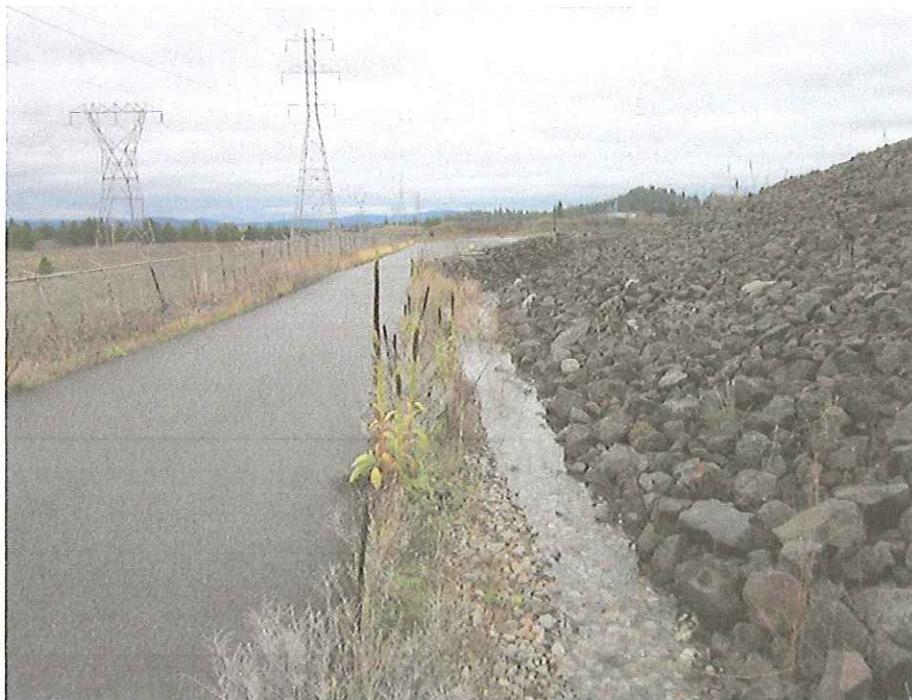
Photo 4: Photograph of end of SPL north perimeter ditch just before entering subsurface drain pipe.
