STATE OF WASHINGTON
DEPARTMENT OF ECOLOGY

August 2, 2010

Re: Opinion pursuant to WAC 173-340-515(5) on Proposed Remedial Action for the following Hazardous Waste Site:

- Name: Mr. Sudsy Car Wash Kent
- Address: 209 South Central Avenue
- Facility/Site No.: 58168724
- VCP No.: NW2267

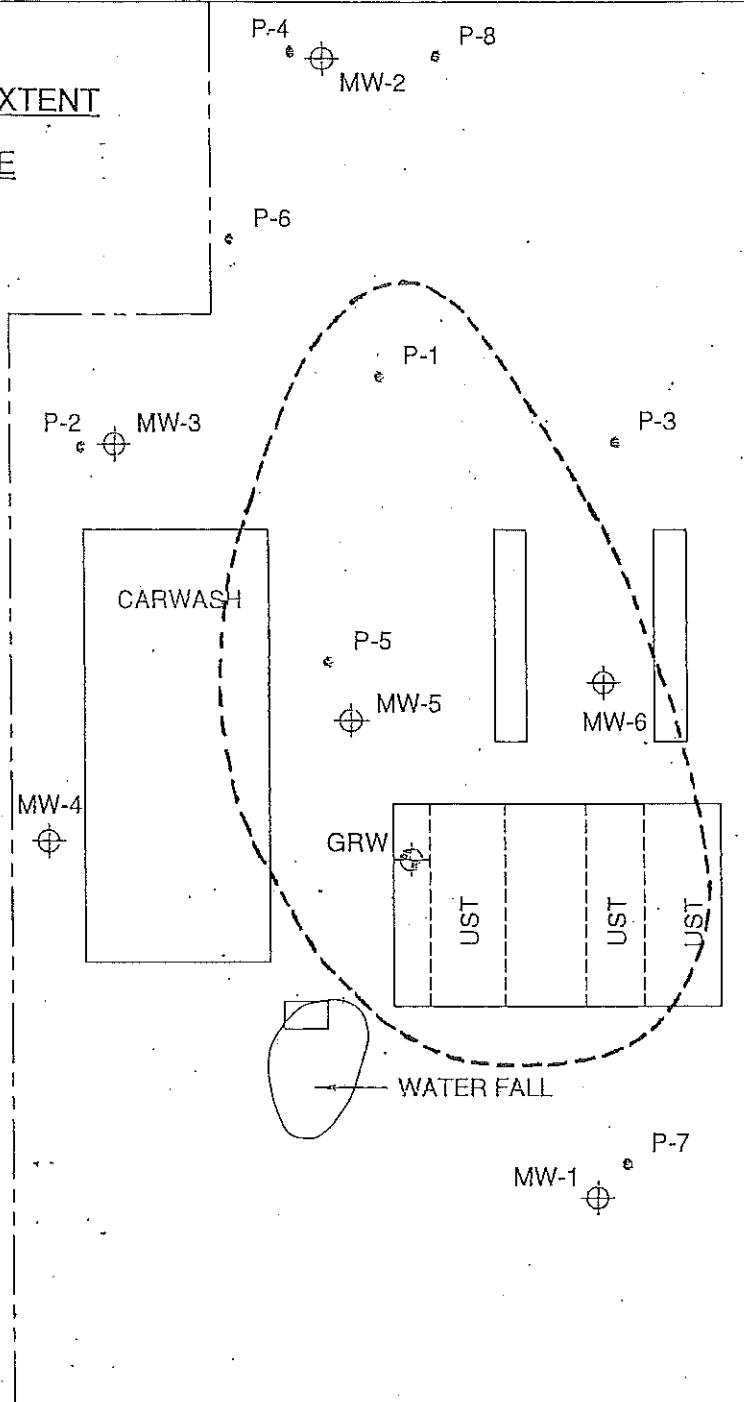
FIGURE 2 - Site and Exploration Plan

APPROXIMATE EXTENT
OF THE SITE
