STATE OF WASHINGTON
DEPARTMENT OF ECOLOGY

April 18, 2017

Subject: Van Stone Mine, Tailings Pond Dam; Dam Safety file no. ST 61-0608
Dam Safety Inspection, summary findings and required remedial actions

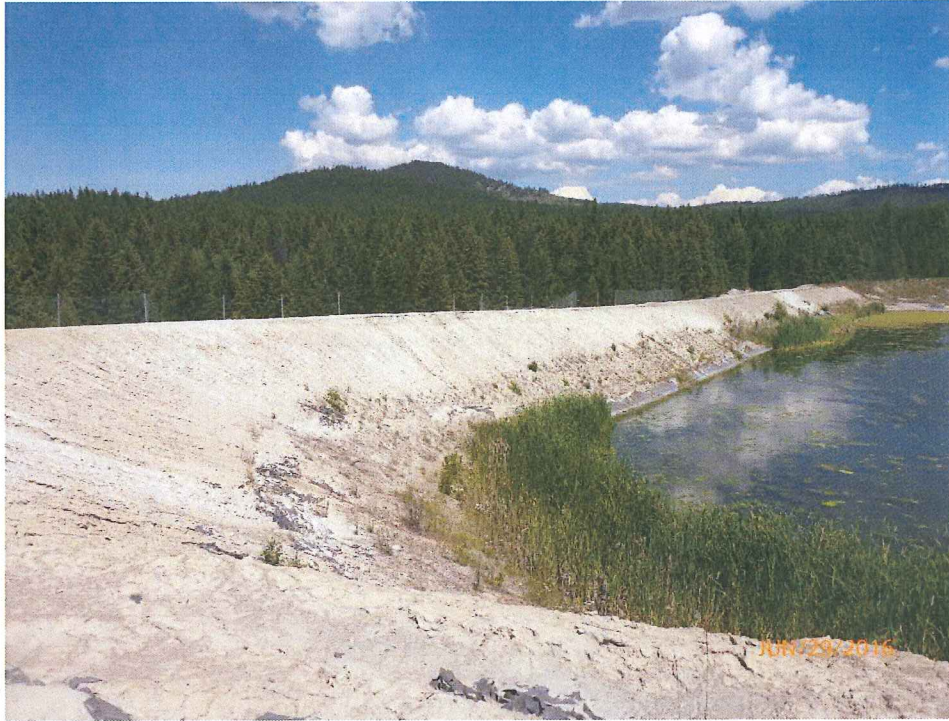
The embankment appears to be in similar condition as described in these previous reports, with similar deficiencies. The erosion damage to the embankment slopes should be repaired, and the slopes re-graded to a stable, smooth, even slope. In conjunction with this, an erosion-resistant cover or surface should be established or installed on the embankment slopes.

1. East Cell north berm upstream face, looking right (east).

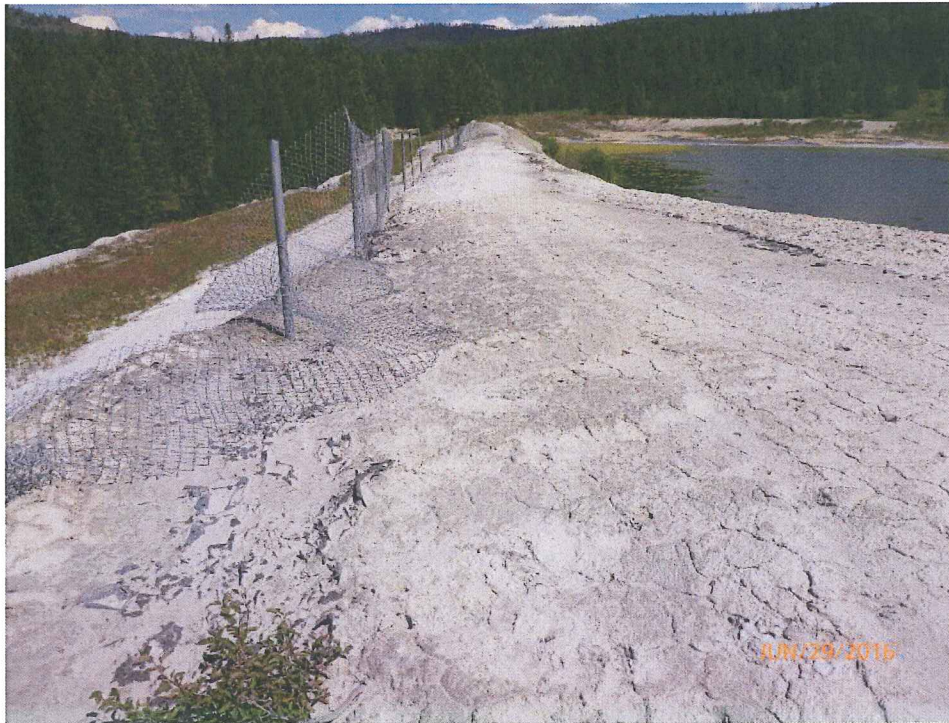
2. East Cell north berm dam crest, looking right (east).

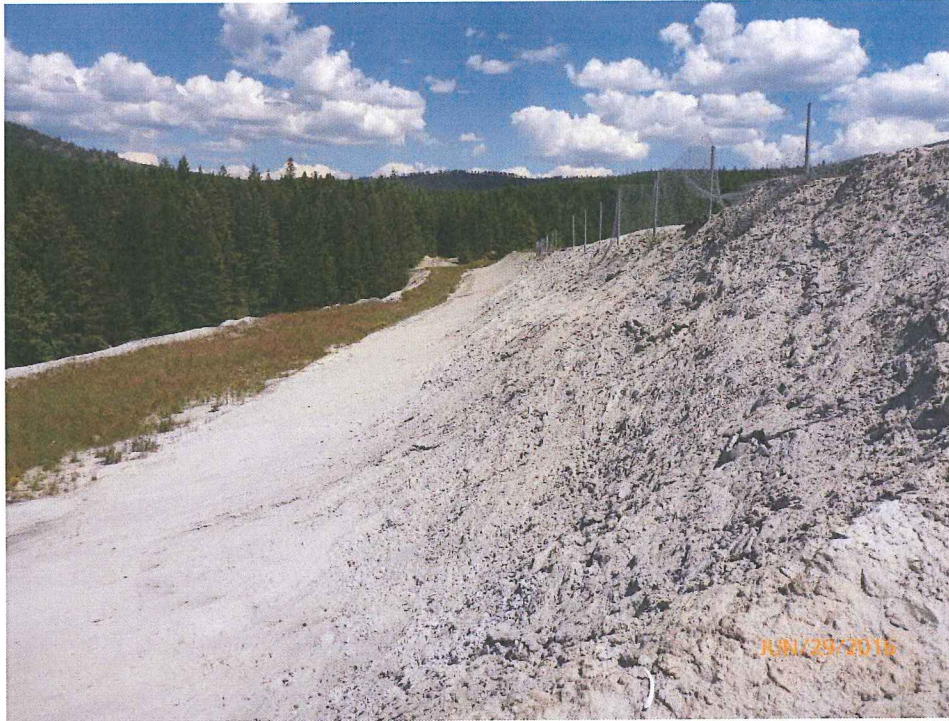
3. East Cell north berm downstream face, looking right (east).

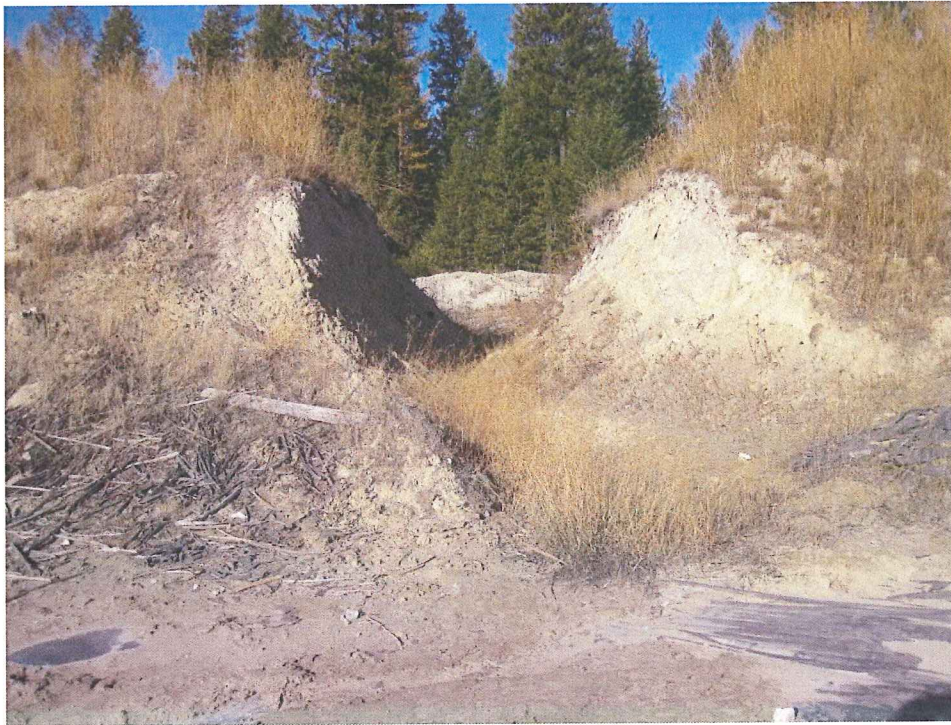
From a review of inspection photos from 2006, 2011 and 2016, it appears that sediment may have slumped into the spillway channel such that the spillway is no longer 6 feet wide at elevation 2694 feet. Any accumulated sediment should be removed to restore the spillway to the design geometry and overflow elevation. From elevation data for the East Cell north berm, it appears that the notch through the embankment may be around 9 feet deep at the spillway

4. East Cell overflow spillway, looking downstream (north) (2011 photo)

location. From elevation data for the north berm, the notch through the berm needs to be at least 5.5 feet lower than the lowest elevation on the north berm. The overflow spillway should also overflow at the same or lower elevation than the equalizing spillway. After the spillway is reopened, the erosion-resistant channel lining should be restored.

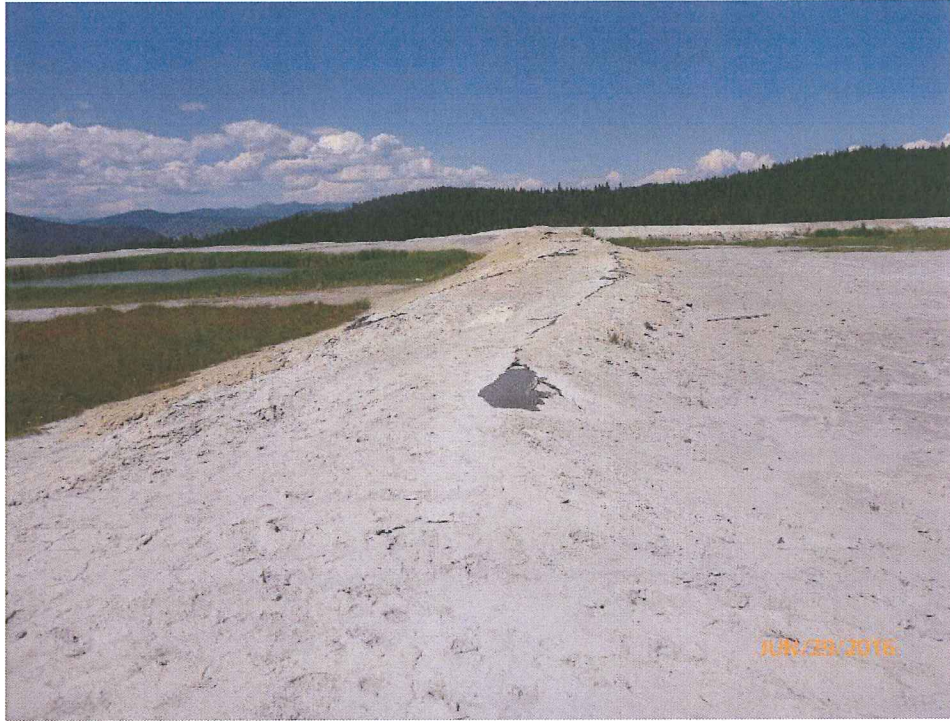
5. Center divider berm, looking north.

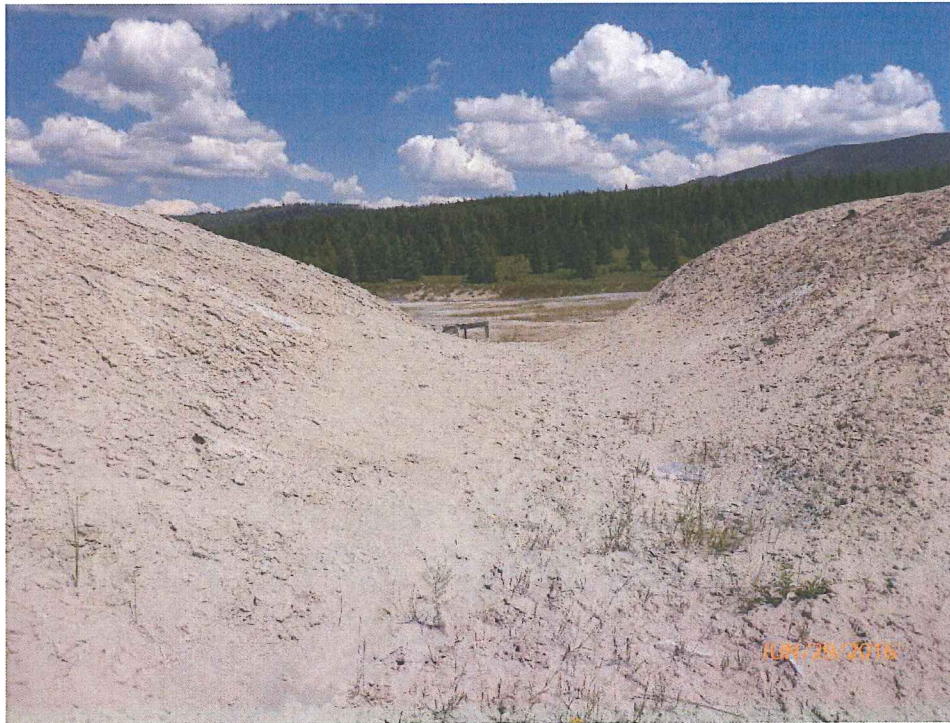
From a review of inspection photos from 2006, 2011 and 2016, it appears that sediment may have slumped into the spillway channel such that the spillway is no longer 6 feet wide at elevation 2694 feet. Any accumulated sediment should be removed to restore the spillway to the design geometry and overflow elevation. From elevation data for the center berm, it appears that the notch through the embankment may be around 13 feet deep at the spillway location. From elevation data for the west berm, the notch through the center berm needs to be at least 3.5 feet lower than the lowest elevation on the west berm. After the spillway is re-opened, the erosion-resistant channel lining should be restored.

6. Center berm equalizing spillway, looking east.

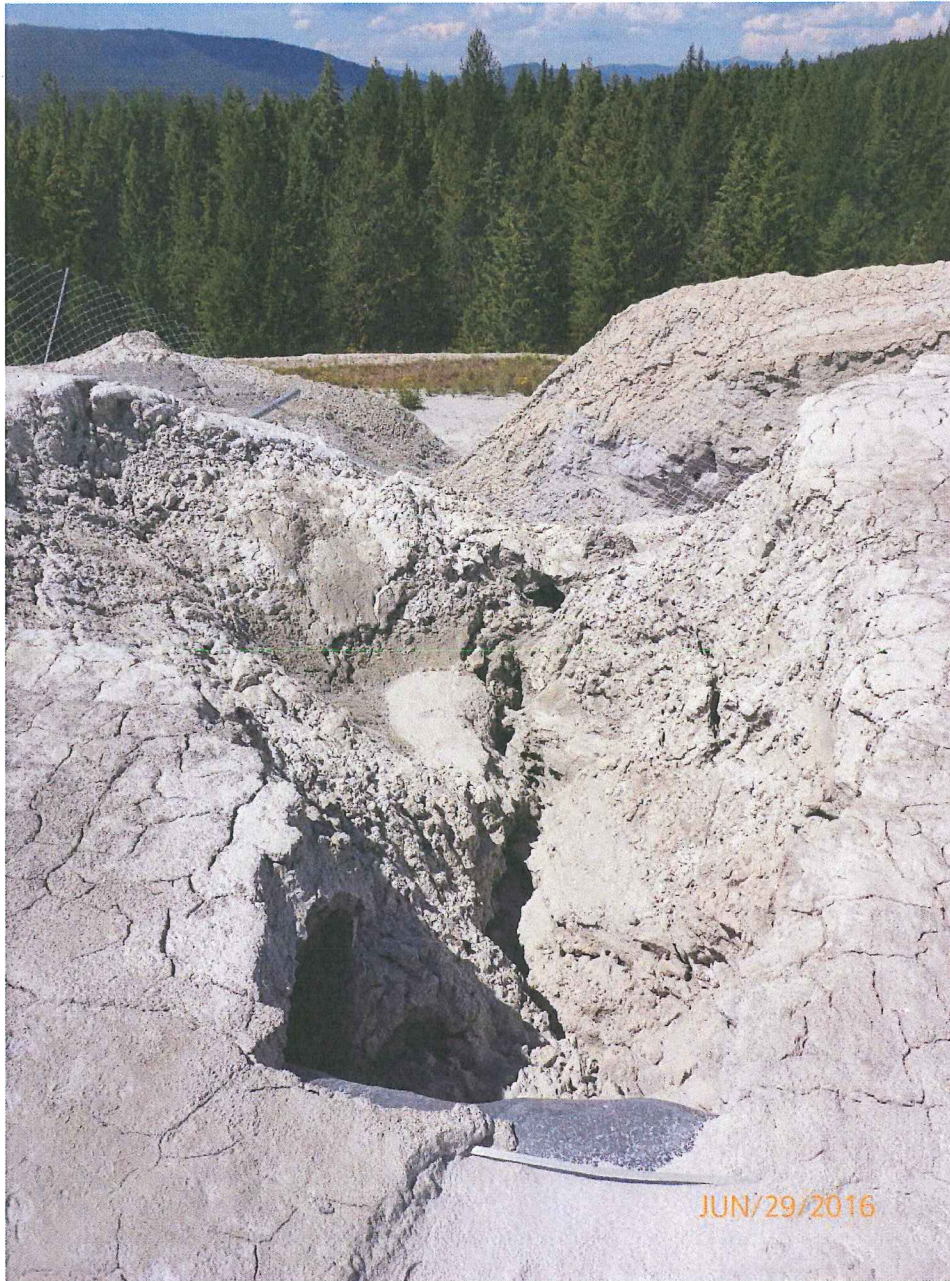
The previous inspection report (Ma and Blacklaw, 2008) on page 2 notes that the upper portion of the tailings pond is lined with a geo-synthetic liner, where the “upper portion” is interpreted to mean the upper 25 feet of the tailings pile constructed since 1991 (see Hart Crowser, Appendix F, 2013, page F-1). Damage to the PVC liner from exposure to sunlight was the subject of correspondence from Dam Safety in 1998, with a directive that the free water pool should be reduced to an elevation below that of the intact (undamaged) liner. The 2013 Remediation Investigation by Hart Crowser (2013, see section 4.4 on page 34) noted that cracking and weather damage was visible in exposed sections of the PVC liner, confirming the 1998 observations by Dam Safety and also indicating that repairs have not yet been made to the PVC liner. Until this situation is corrected, the pond should be configured to hold only a minimal volume of water.

7. West Cell north side dam crest, looking downstream. Erosion damage above PVC liner.

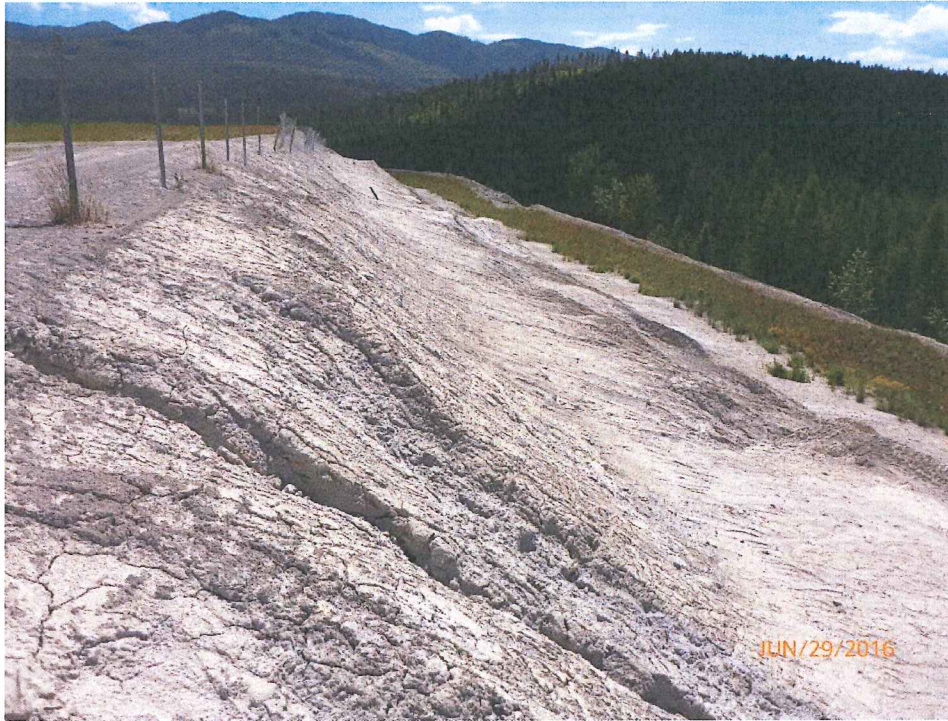
8. West Cell NW side downstream face, looking left.

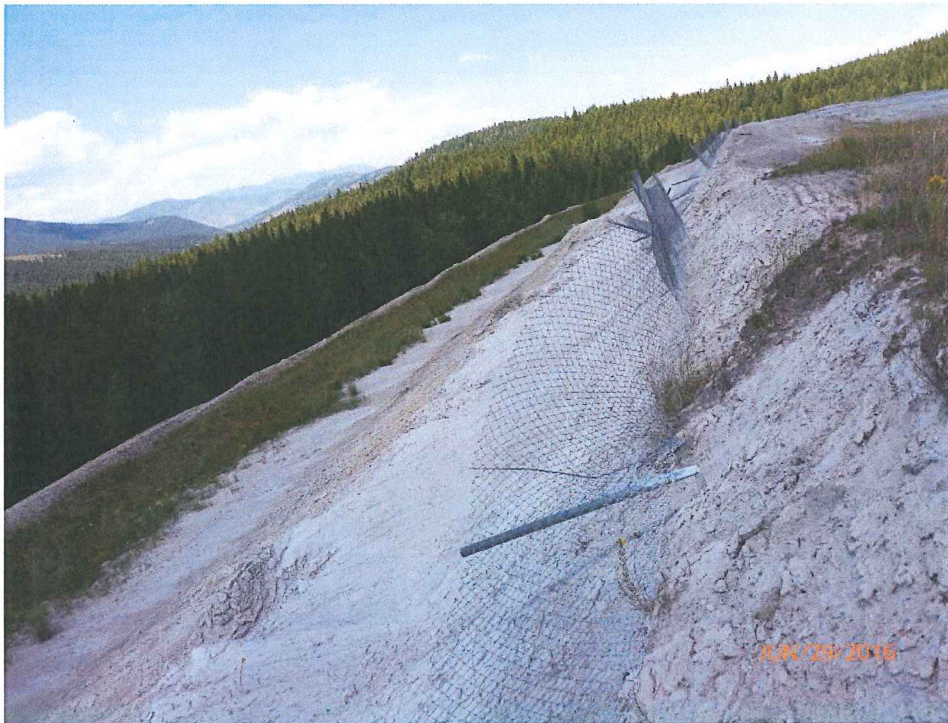
9. West Cell west side downstream face, looking right. Soil movement (slumping).

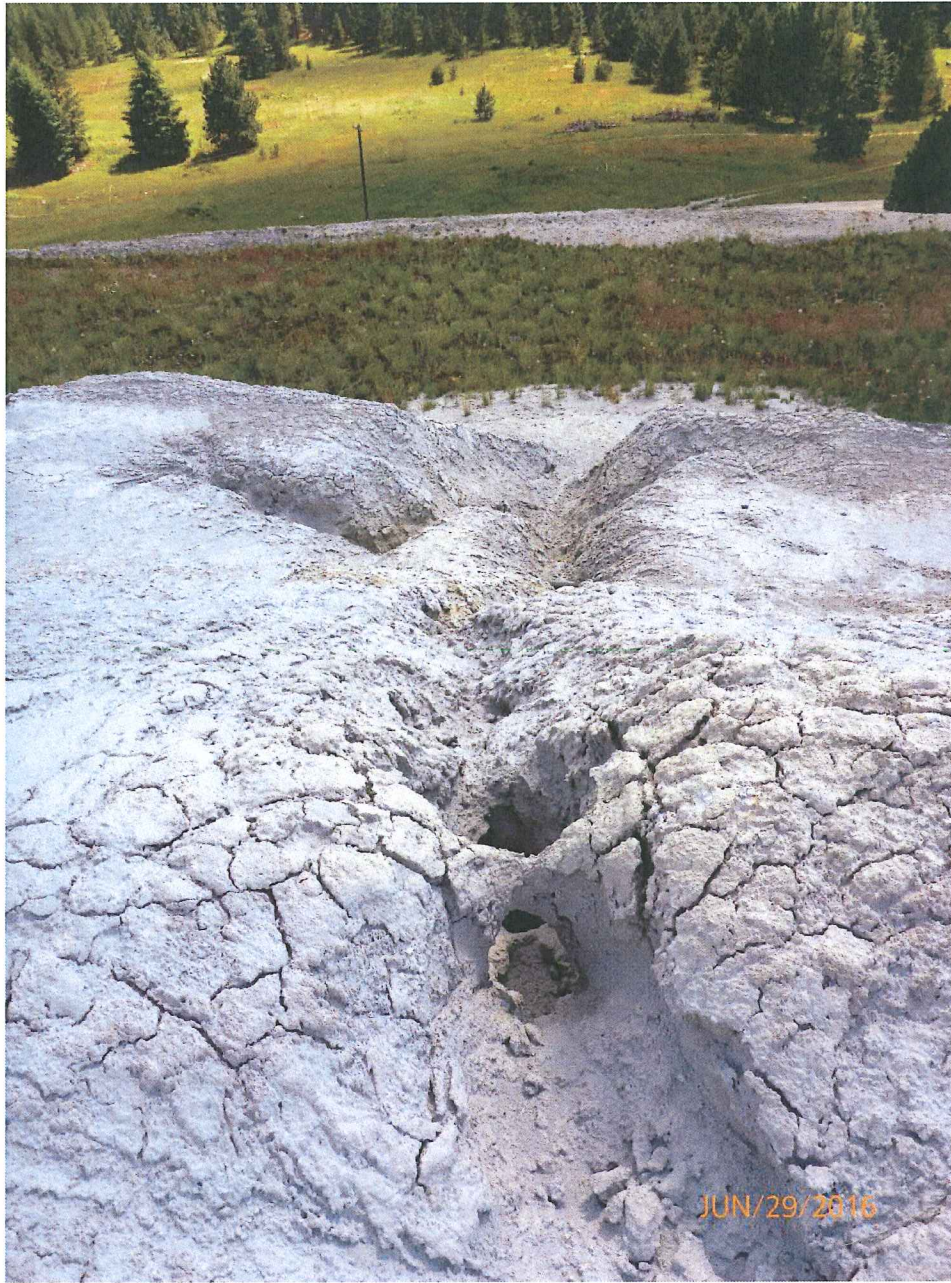
10. West Cell south side downstream face, looking downstream. Erosion damage includes piping.

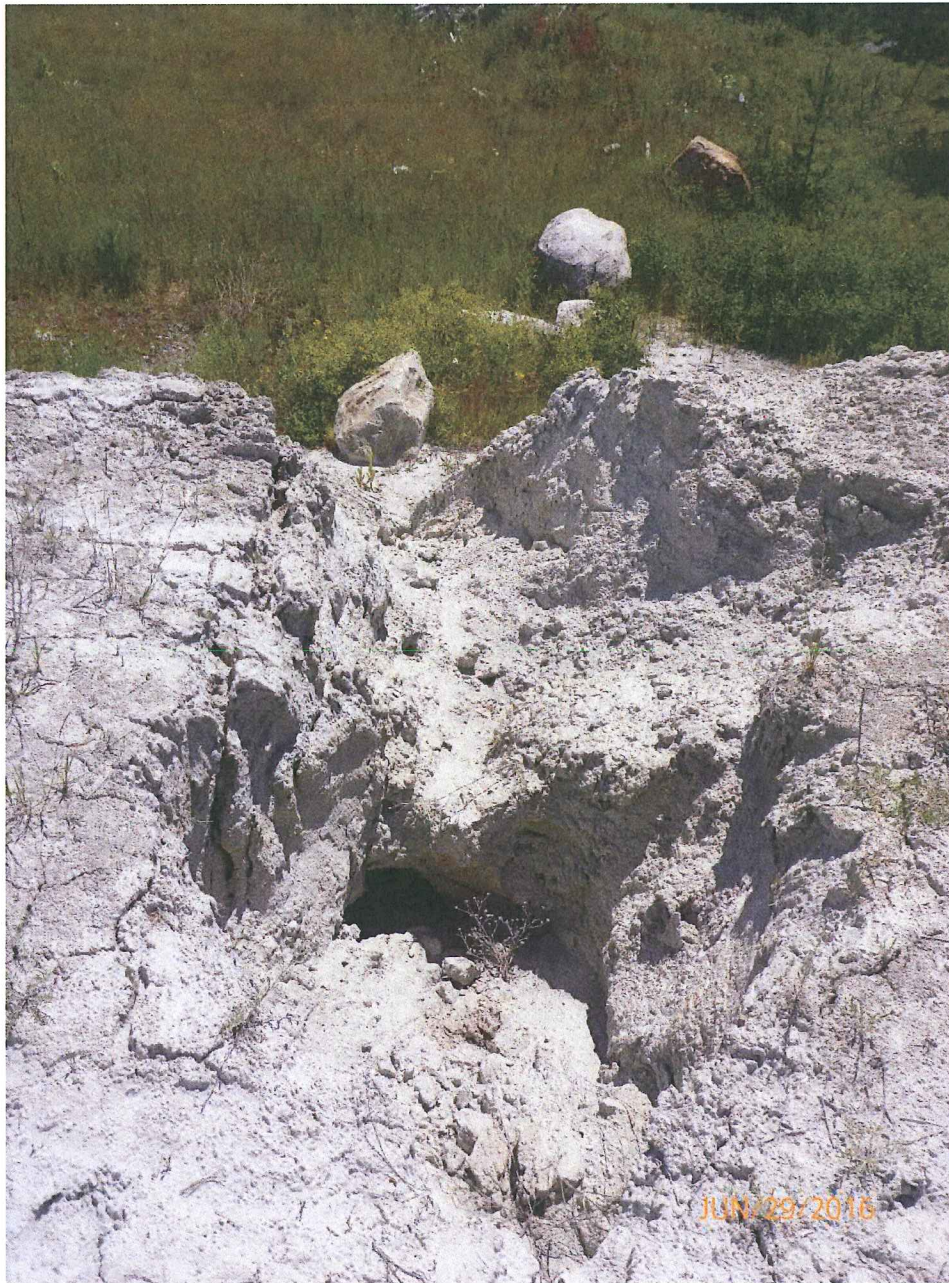
11. West Cell south side downstream face, looking downstream. Erosion damage includes piping.

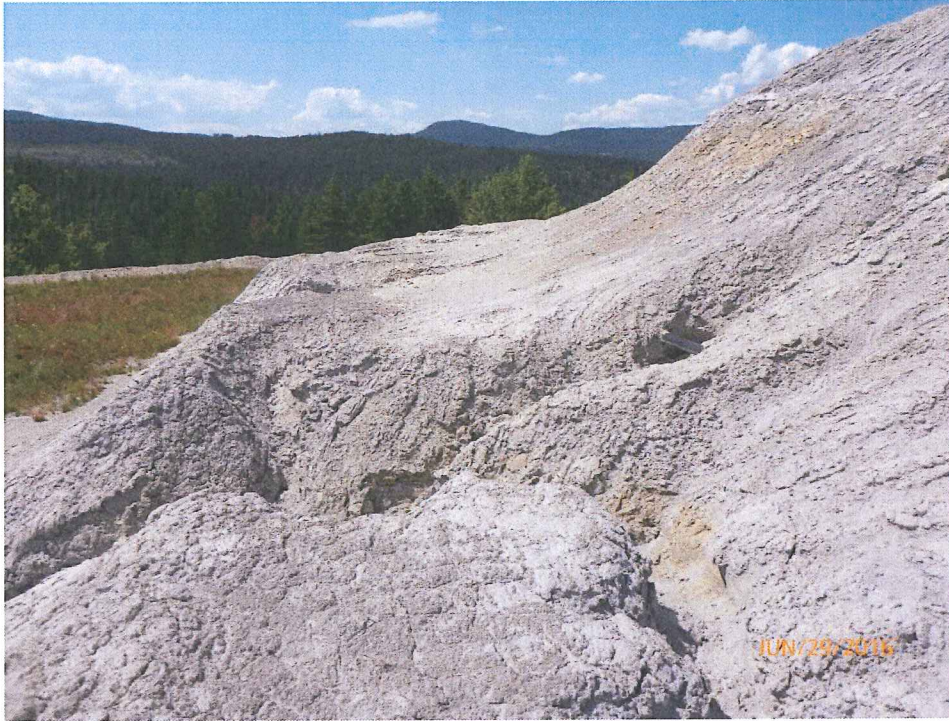
12. West Cell south side downstream face, looking right. Erosion.

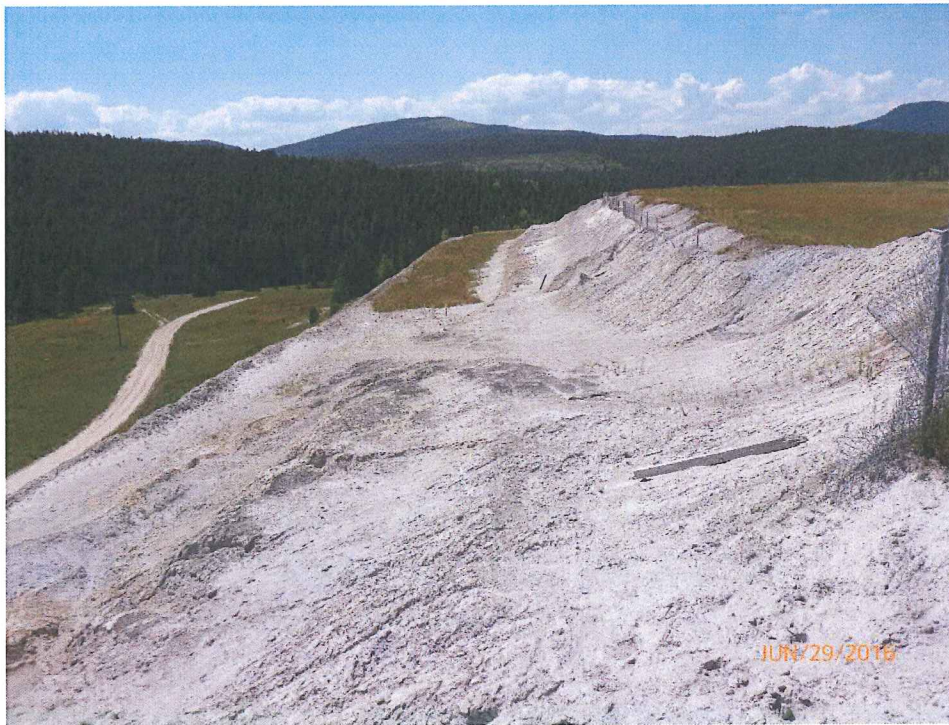
13. West Cell south side downstream face, looking right (west).

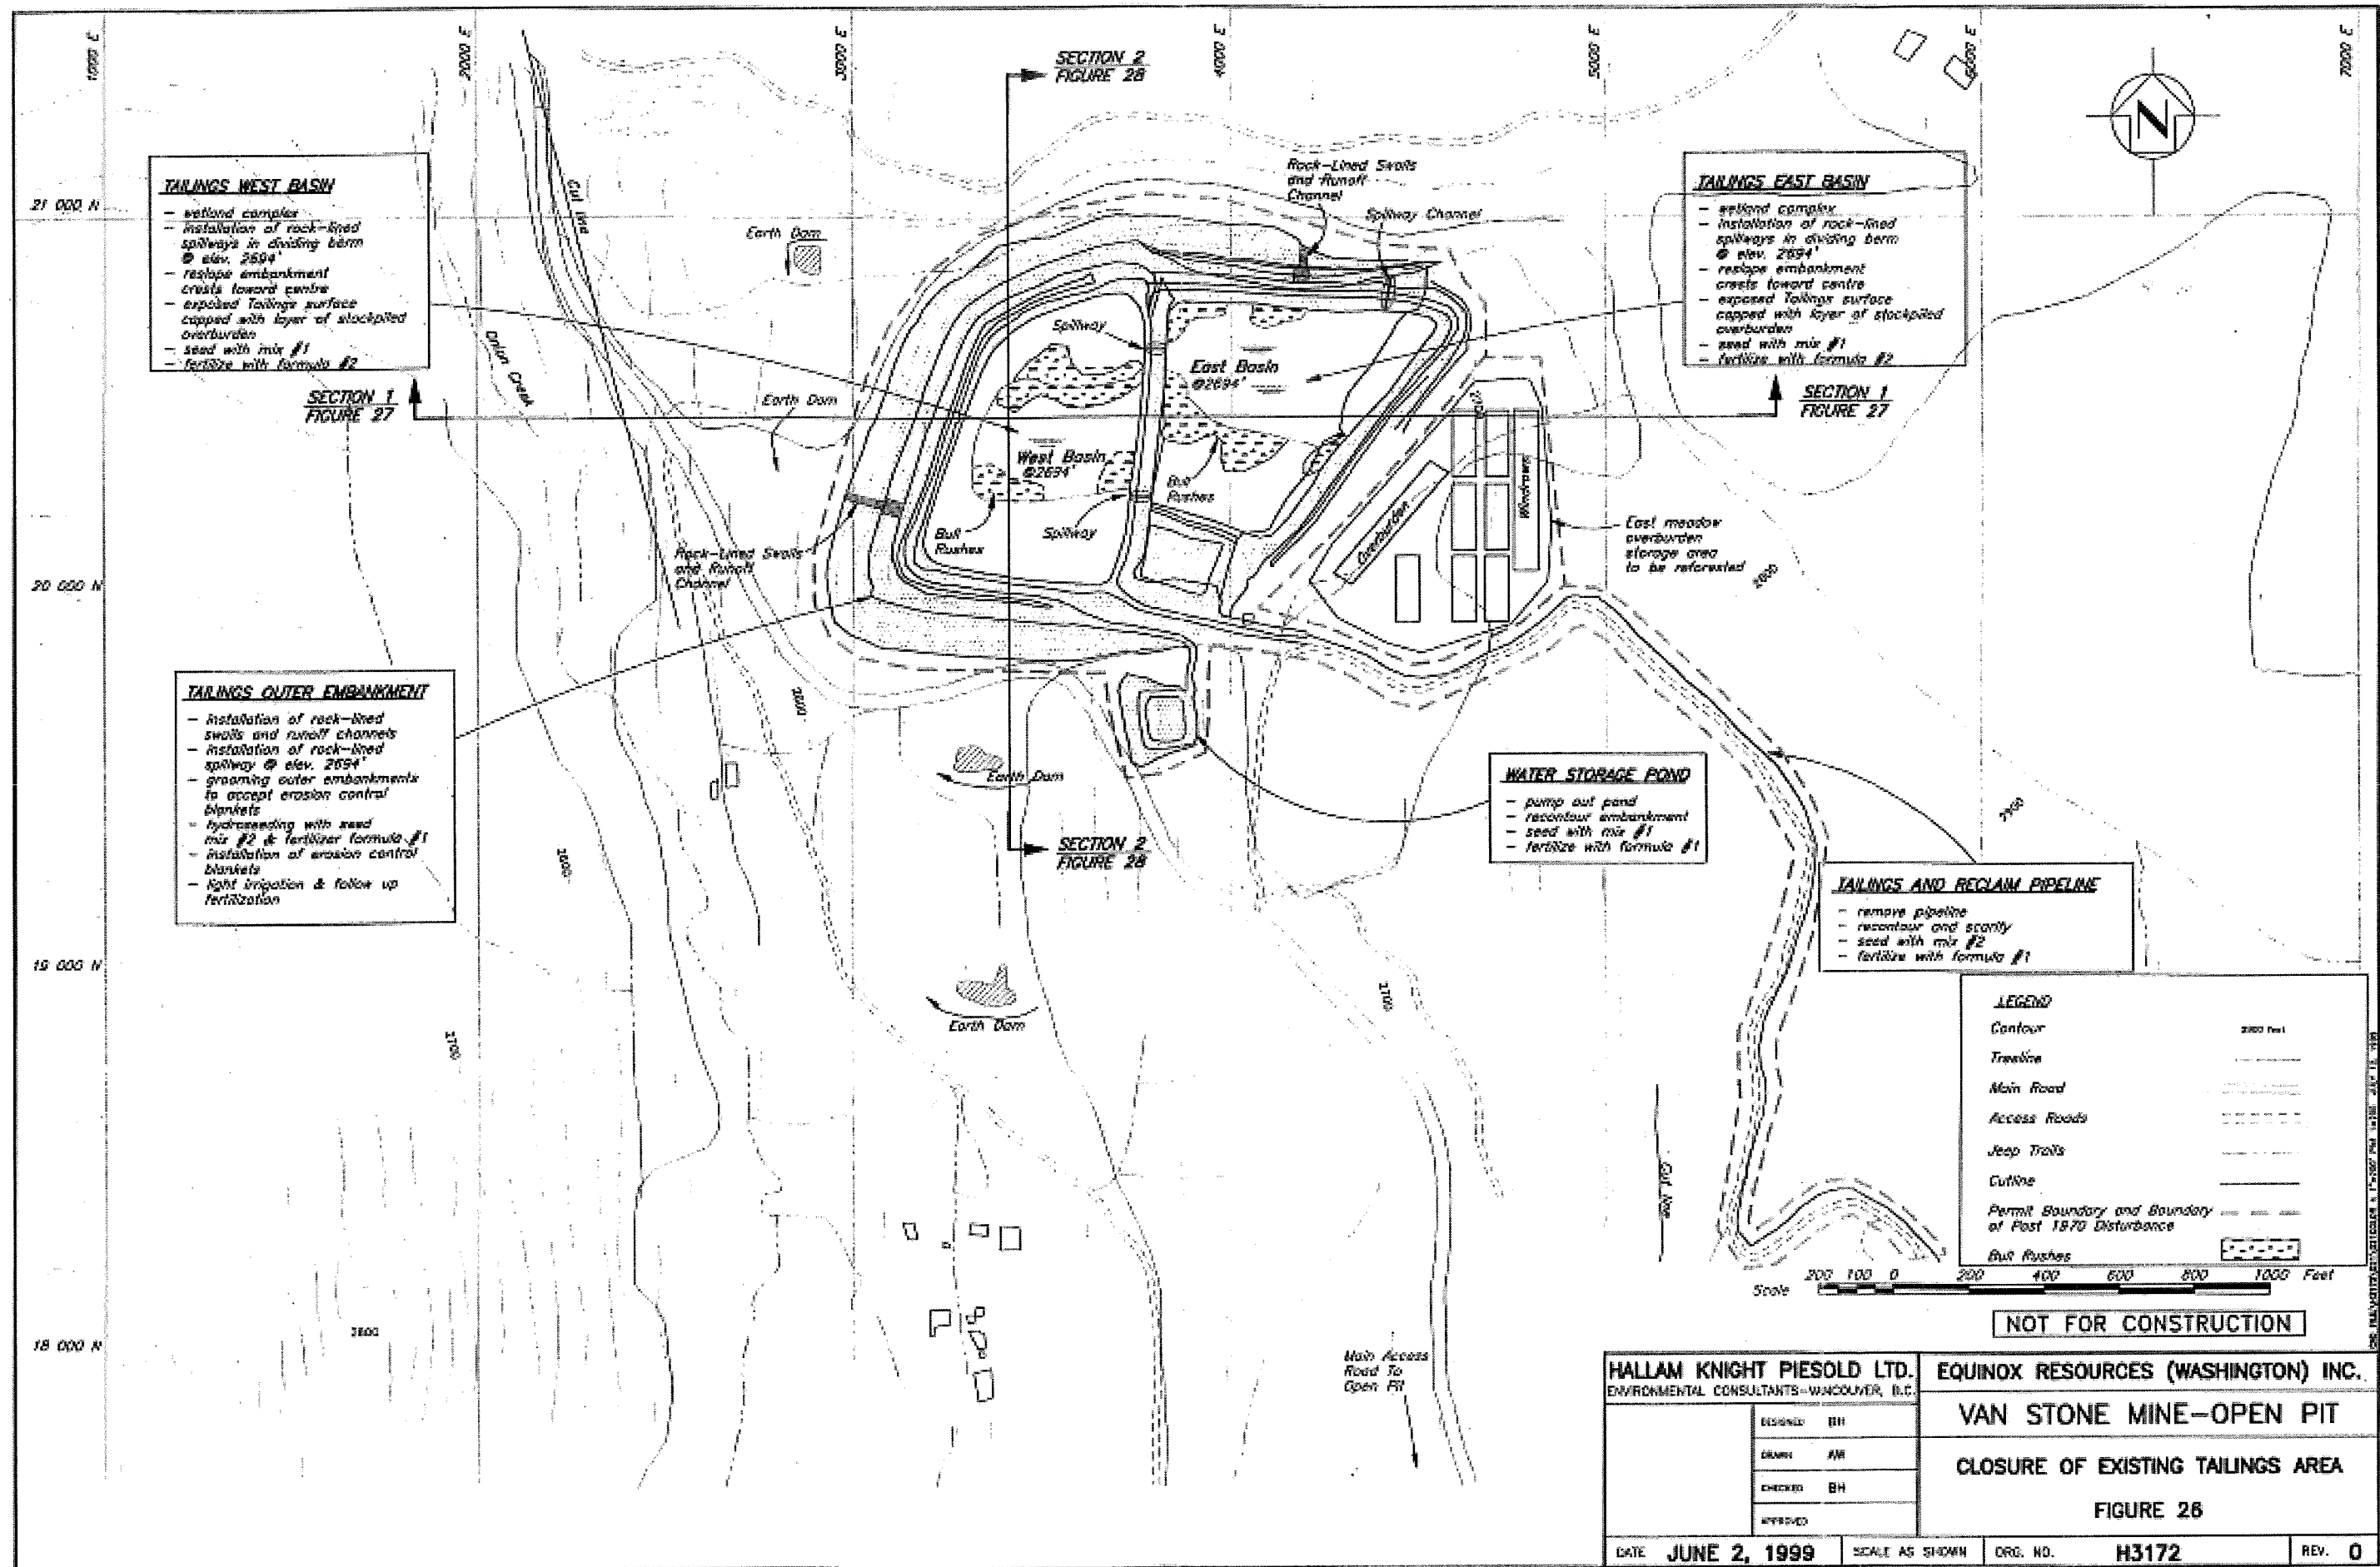
The Reclamation Plan by Beacon Hill Consultants (1999) in section 6.3.2 on page 16, and on Figure 26 by Hallam Knight Piesold Ltd, notes that the spillway should overflow at elevation 2694 feet. The previous inspection report (Ma and Blacklaw, 2008), on the project data sheet on page 6, lists a spillway base width of 6 feet.

The Reclamation Plan by Beacon Hill Consultants (1999) in section 6.3.2 on page 16, and on Figure 26 by Hallam Knight Piesold Ltd, notes that the spillway should overflow at elevation 2694 feet. Apparently only one of the two proposed equalizing spillways was actually installed. The previous inspection report (Ma and Blacklaw, 2008), on the project data sheet on page 6, lists a spillway base width of 6 feet, specifically for the overflow spillway but presumed to apply to the equalizing spillway also.
