**Former Hardel Mutual Plywood Site  
1210 West Bay Drive NW  
Olympia, Washington**

**Interim Action Closure Report**

**December 2010**

**GREYLOCK CONSULTING LLC**

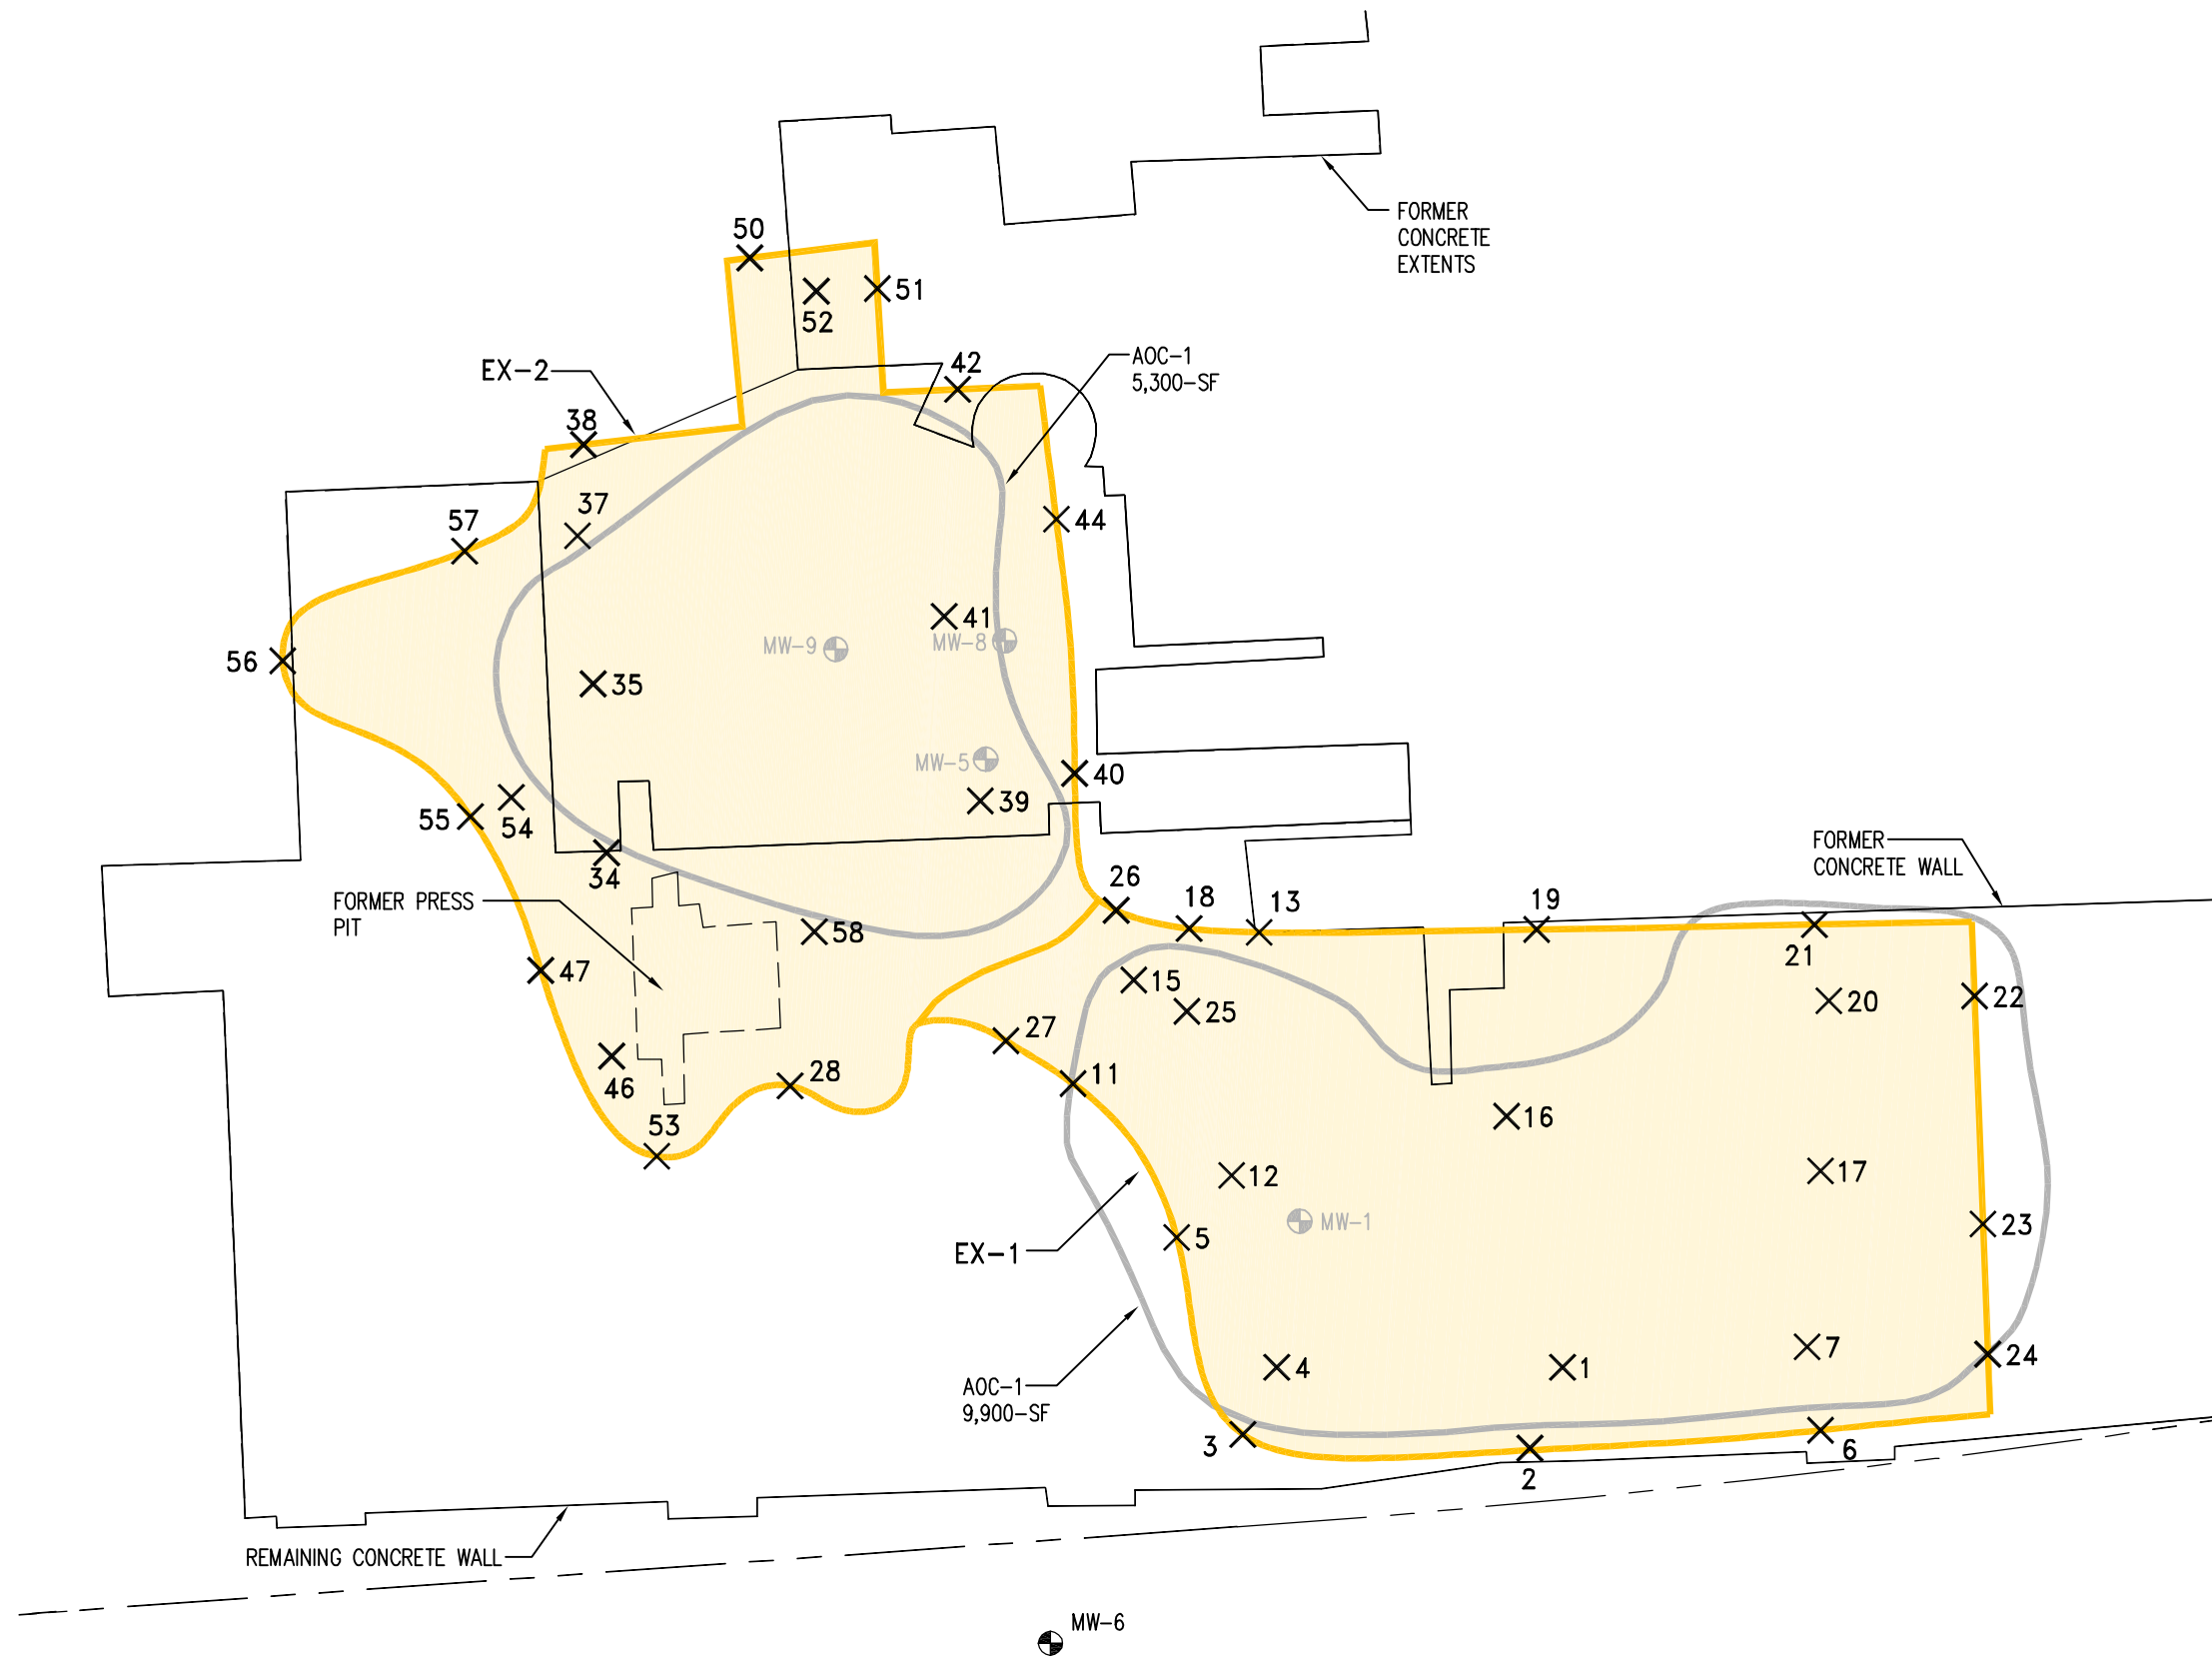
FIGURE 4 : EXCAVATION EXTENTS DETAIL - NORTH

Excavation EX-1 (Figure 3 and Figure 4) was excavated to depths ranging from approximately 9-to-13 feet below the ground surface (bgs), with an average depth of approximately 10 feet bgs. The deeper areas of the excavation were in the western portion of EX-1. A photograph taken during soil excavation activities in the northwestern portion of EX-1 is included as “Photo 3” in Appendix 2.

Excavation EX-2 (Figure 3 and Figure 4) was excavated to depths ranging from approximately 9-to-16 feet below the ground surface (bgs), with most of the excavation at approximately 16 feet bgs. The shallower areas of the excavation were nearby to the north and west of the former “press pit”.

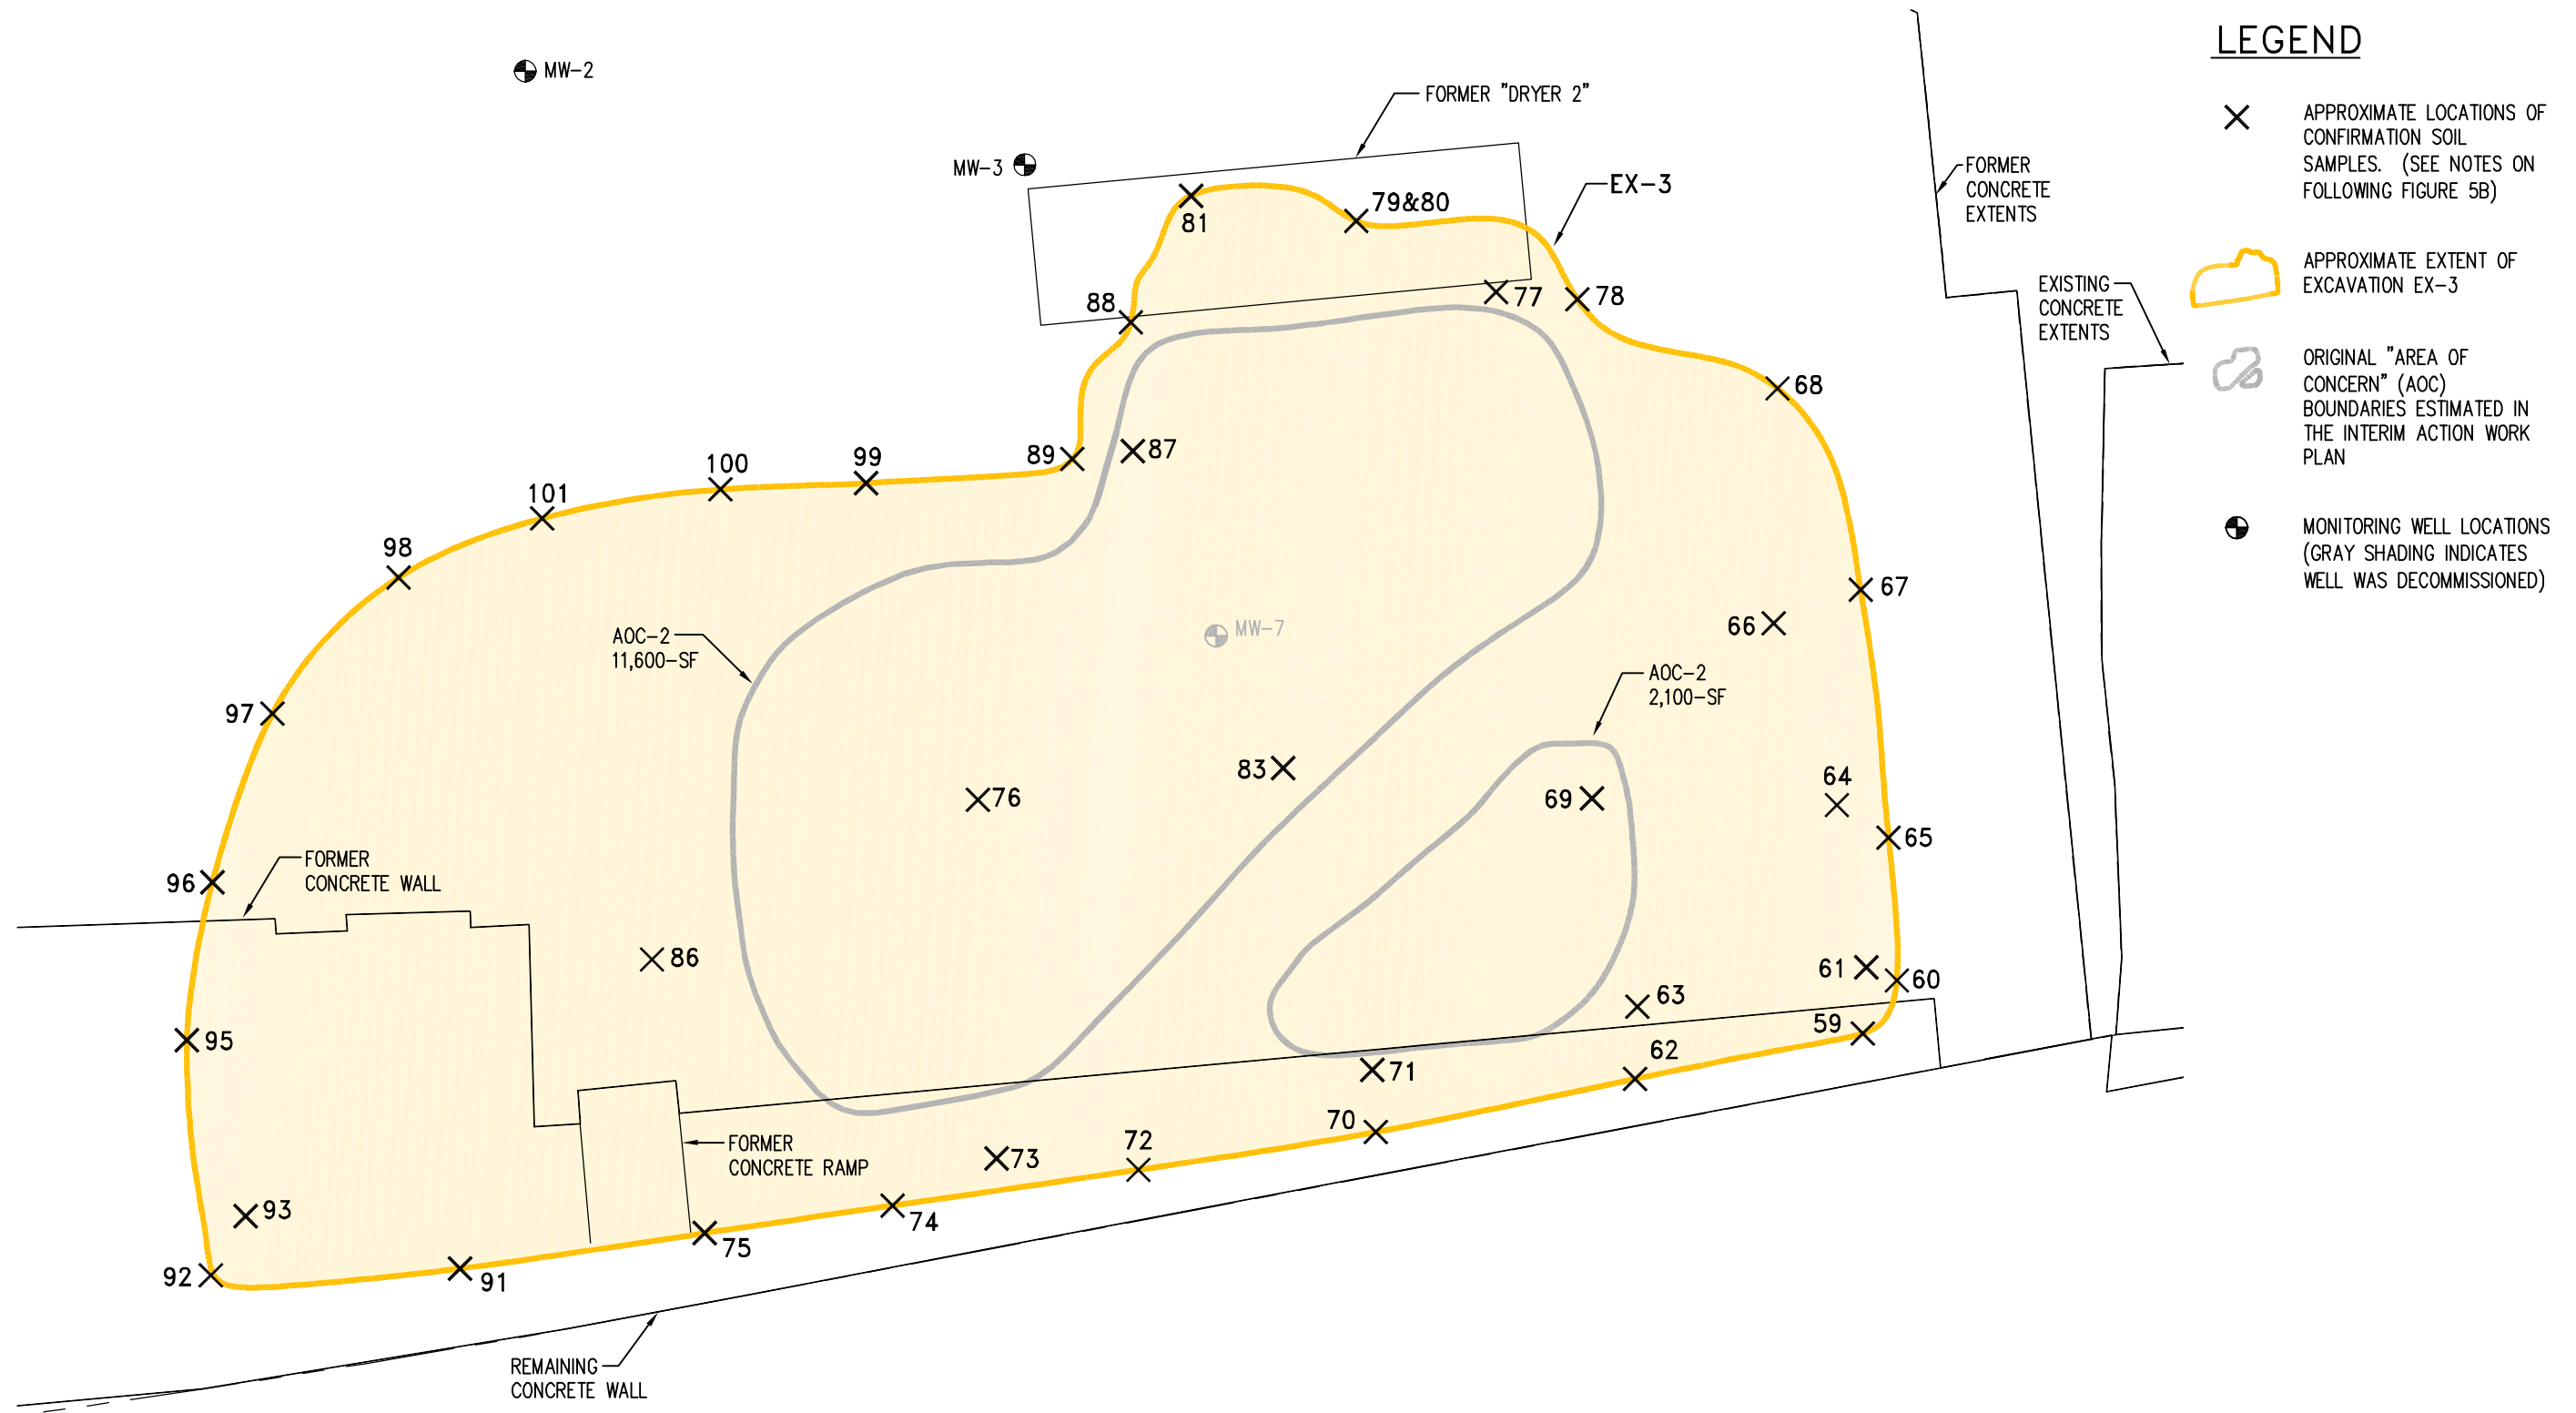
FIGURE 5 : EXCAVATION EXTENTS DETAIL - SOUTH

Much of excavation EX-3 (see Figure 3) was excavated to depths ranging from approximately 6-to-7 feet below the ground surface (bgs), with the exception of an area in the western portion of the excavation which averaged approximately 10 feet bgs.
