STATE OF WASHINGTON
DEPARTMENT OF ECOLOGY

Re: Opinion pursuant to WAC 173-340-515(5) on Remedial Actions for the following Hazardous Waste Site:

- **Name:** Conway Feed VCP (aka Conway Feed LUST)
- **Address:** 2110 Jones Road, Conway, WA
- **Facility/Site No.:** 5135 (Formerly F/S No.: 3194825)
- **VCP No.:** NW2185
- **Cleanup Site ID Nos:** 2524 & (7524)

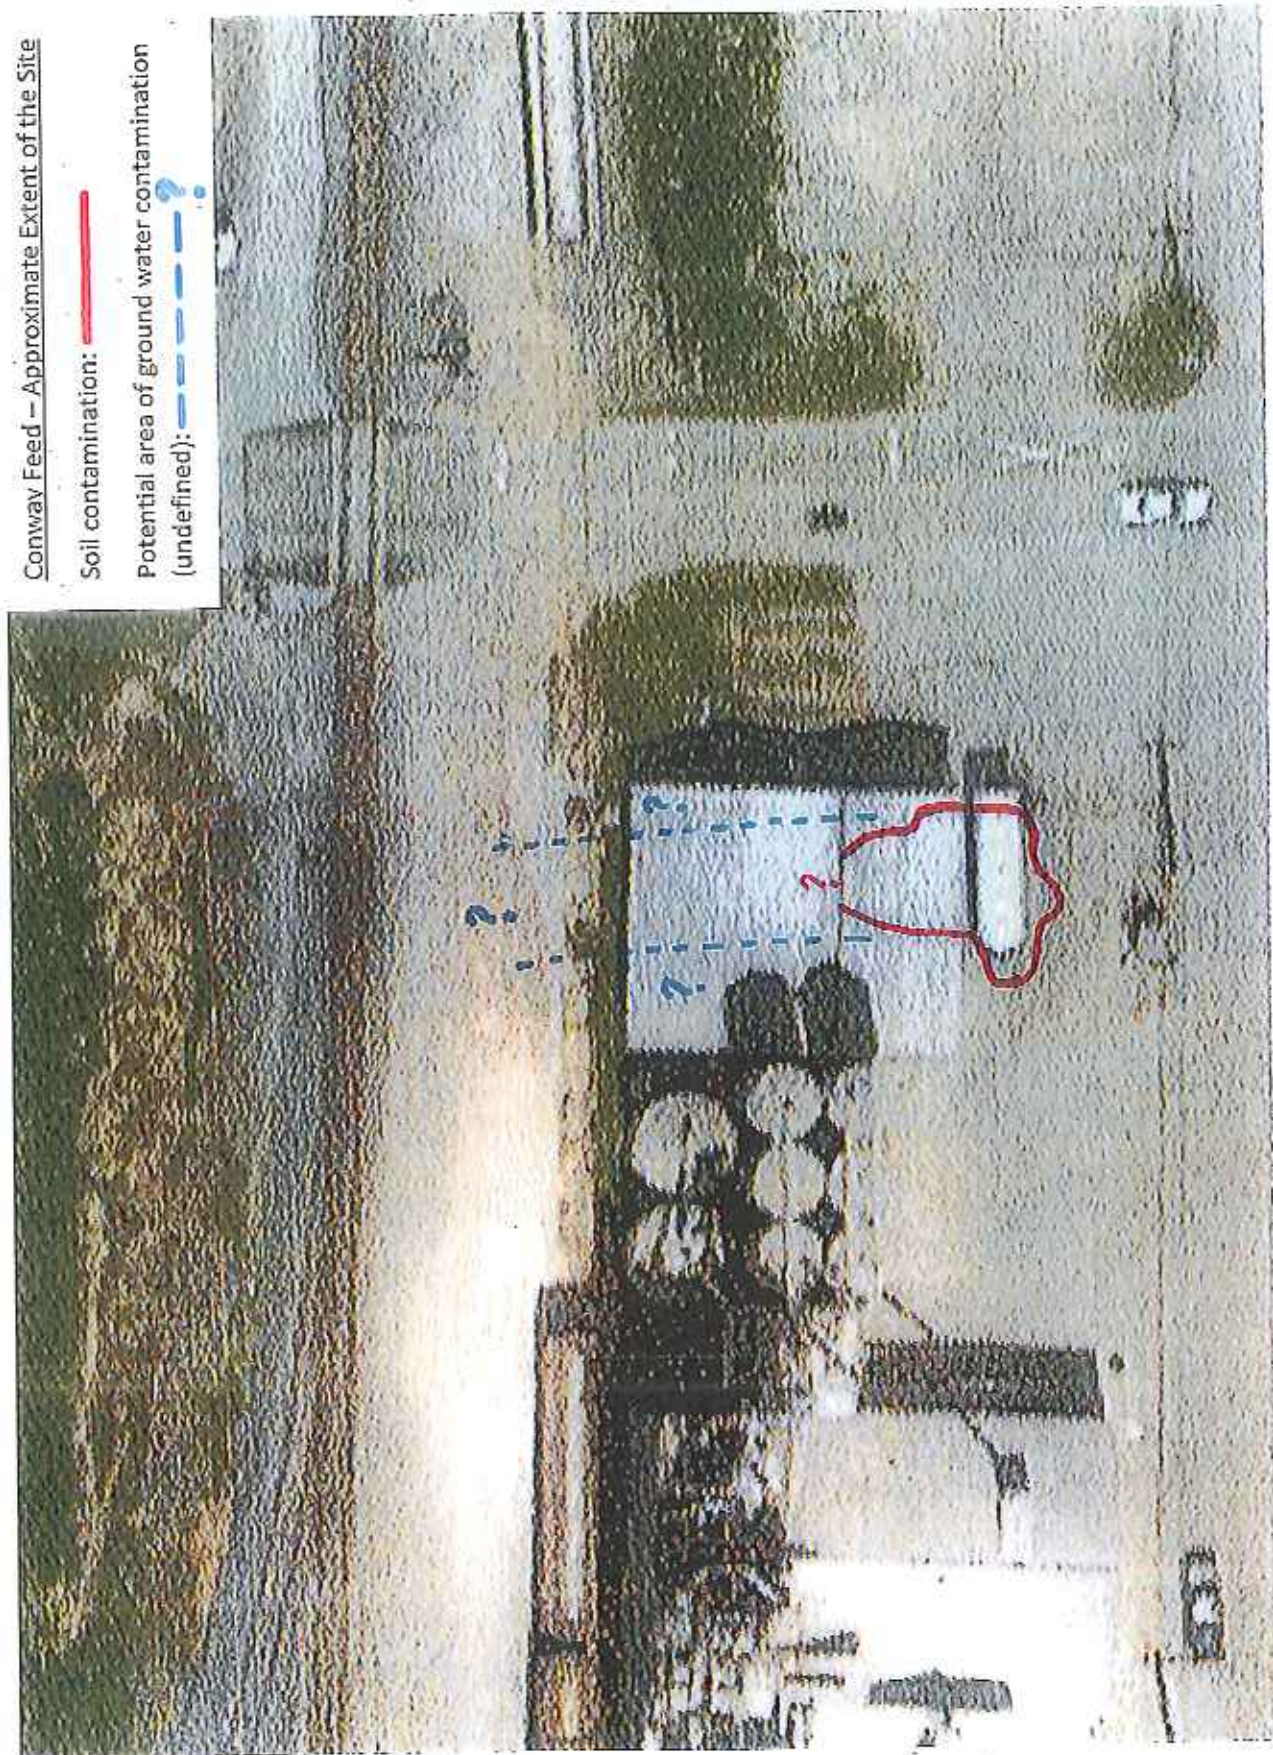
Conway Feed – Approximate Extent of the Site

Extent of Soil and Ground Water Contamination: The lateral extent of soil contamination was defined except to the west. The vertical extent was limited to approximately 6 feet bgs. The extent of possible ground water contamination on and potentially downgradient of the Property is unknown.

Soil contamination:

Potential area of ground water contamination
(undefined):

Additional soil and ground water sampling is required to demonstrate that the full extent of the soil contaminated above Method A was removed, and that ground water contamination above Method A cleanup levels is not present on the Property. This would initially require taking soil and ground water samples inside the warehouse building. There is limited-access "push probe" equipment available that can acquire soil and grab ground water samples from the shallow ground water (provided there is some room to work inside the building). There should be at least one ground water sample location as near to the railroad property to the west as possible.
