STATE OF WASHINGTON
DEPARTMENT OF ECOLOGY

Re: Opinion pursuant to WAC 173-340-515(5) on Remedial Action for the following Hazardous Waste Site:

- **Name:** Cascade Autovon Company
- **Address:** 12727 412th Ave SE, North Bend, WA 98045
- **Facility/Site No.:** 36296841
- **VCP No.:** NW3098
- **Cleanup Site ID No.:** 8879

Description and Diagrams of the Site

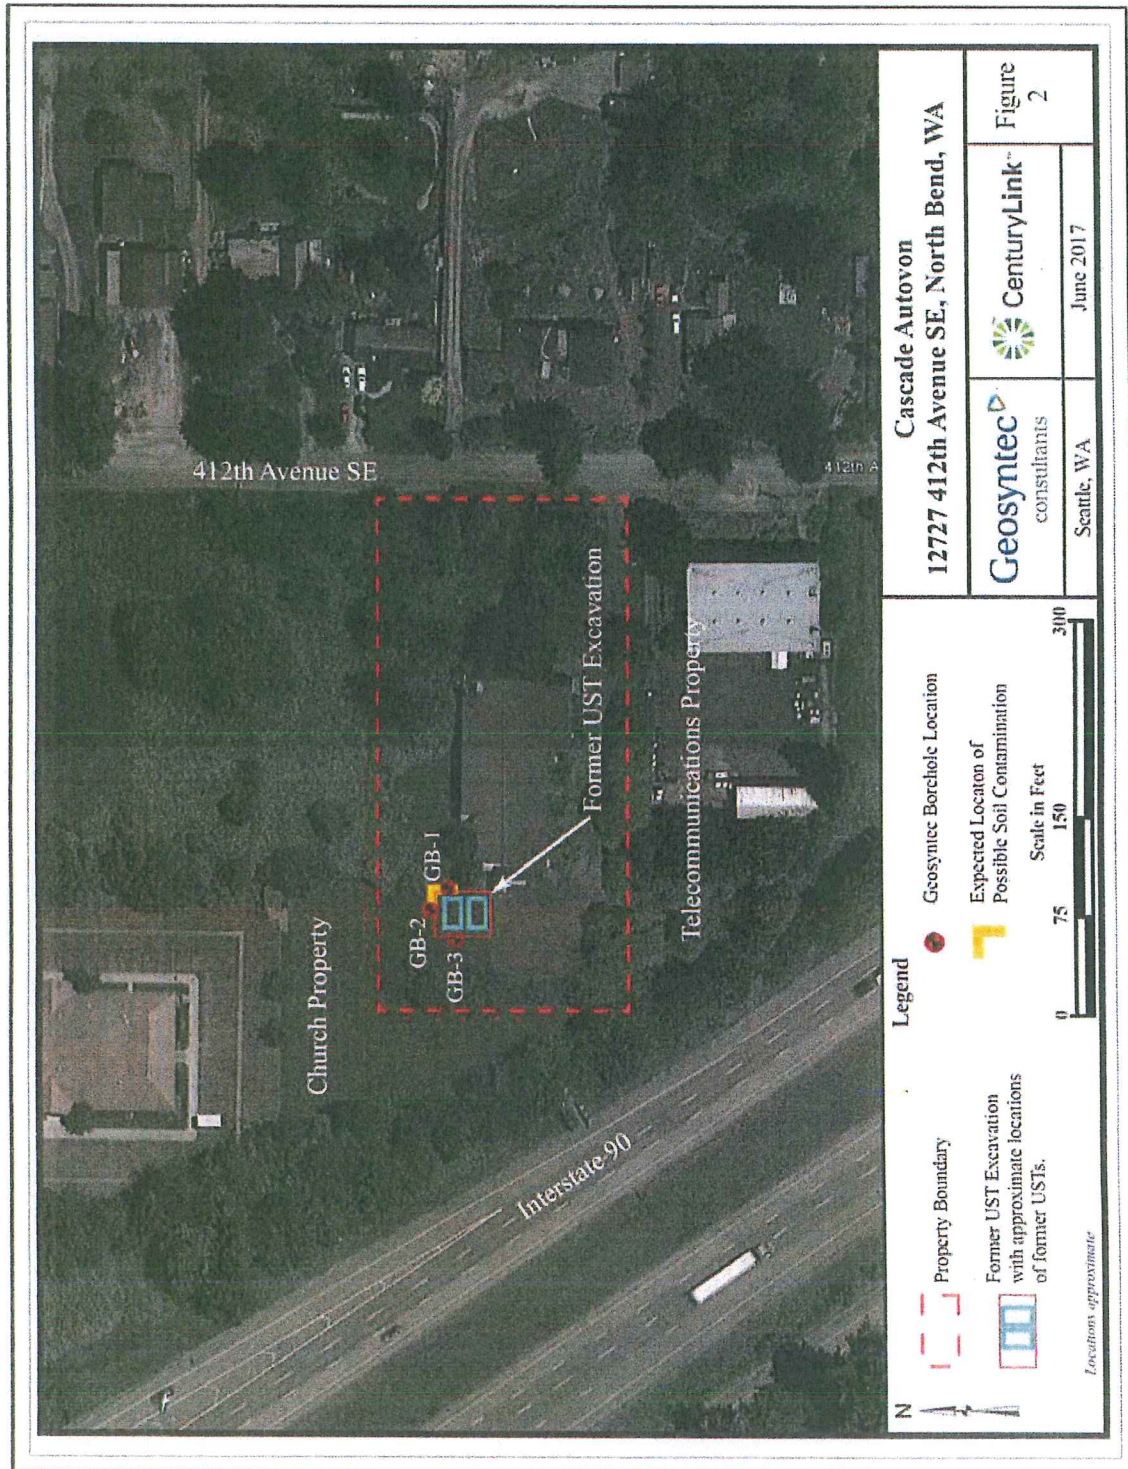
Enclosure A: Figure 1

Area and Property Description: The Property is located within a mixed commercial/residential area. The Property is bounded to the north by a church and a vacant lot with a Safeway grocery store beyond, to the east by 412th Avenue SE with single family residential houses beyond, to the south by a telecommunication switching facility and single family residential houses beyond, and to the west by Interstate 90 (I-90) with single family residential houses beyond. Current Property developments include a 10,000-square foot structural steel building located on the central portion of the Property. The southern portion of the Property is mostly paved with asphalt, while the northern portion is covered with grass and brush vegetation (Figure 1).

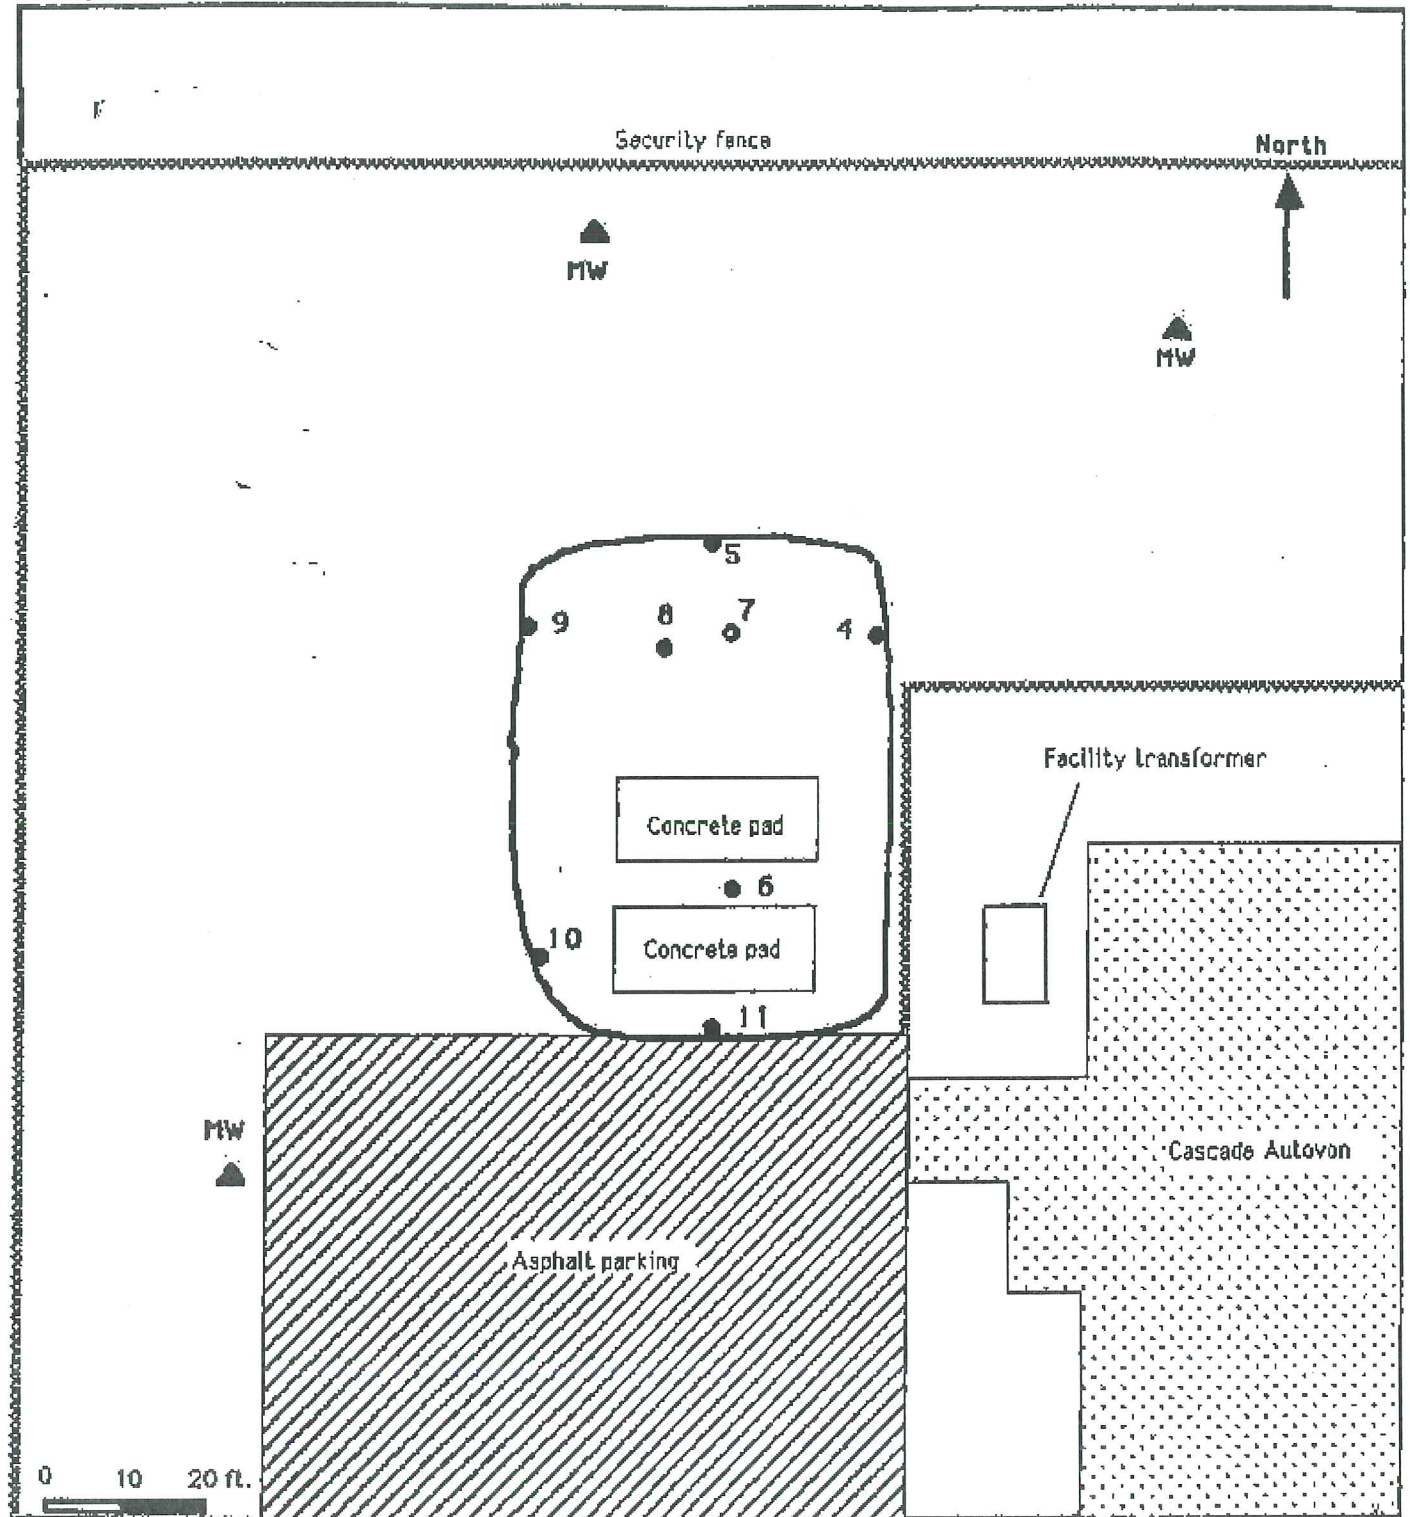
Enclosure A: Figure 2

- During 1991, following the diesel underground storage tank (UST) removal and associated soil excavation, soils containing TPHd concentrations above the MTCA Method A soil cleanup level remained at the northeast and southwest sidewalls of the excavation between 10 and 11 feet below ground surface (bgs). A southeast sidewall sample was not collected. Therefore, the southwest and east boundaries of the soil contamination were not fully defined at the time. During a Site investigation in 2016, soil samples were collected at the northeast, north, and northwest corner of the 1991 excavation which confirmed residual contaminated soils at the northern portion of the excavation have likely been remediated below the MTCA Method A soil cleanup levels. Additional soil sampling of native materials is required southwest, southeast, and east of the 1991 excavation to confirm current soil conditions in these areas.

Ground water was encountered at approximately 10.5 feet bgs in the excavation in 1991. A water sample was collected from the recharging water in the excavation, which contained a TPHd concentration of 8,500 micrograms per liter ($\mu\text{g/L}$), above the MTCA Method A ground water cleanup level. Approximately 10,000 gallons of recharging water was pumped into a 20,000-gallon Baker tank on the Site, and later treated using a carbon absorption treatment system and then released into a nearby drainage ditch in a northward direction toward a nearby vacant field. Hydrocarbon breakthrough was continuously monitored and one water sample collected from the discharge end of the treatment system did not contain concentrations of TPH and benzene, toluene, ethylbenzene and xylenes (BTEX) above laboratory detection limits. During the installation of a new 5,000-gallon diesel UST in January 1992, pumping water into the Baker tank was determined not feasible due to the large volume of water in the excavation and relatively fast recharging rate. A separate filter system was installed in the excavation using a drum filled with pea gravel, which pumped water to a depression located at the north end of the Site. Discharge water was continuously monitored for visual evidence of contamination (i.e. sheen) during the pumping activities. The soil and ground water sampling locations in the final excavation in 1991 are depicted on Figure 2 of the Site Diagrams.

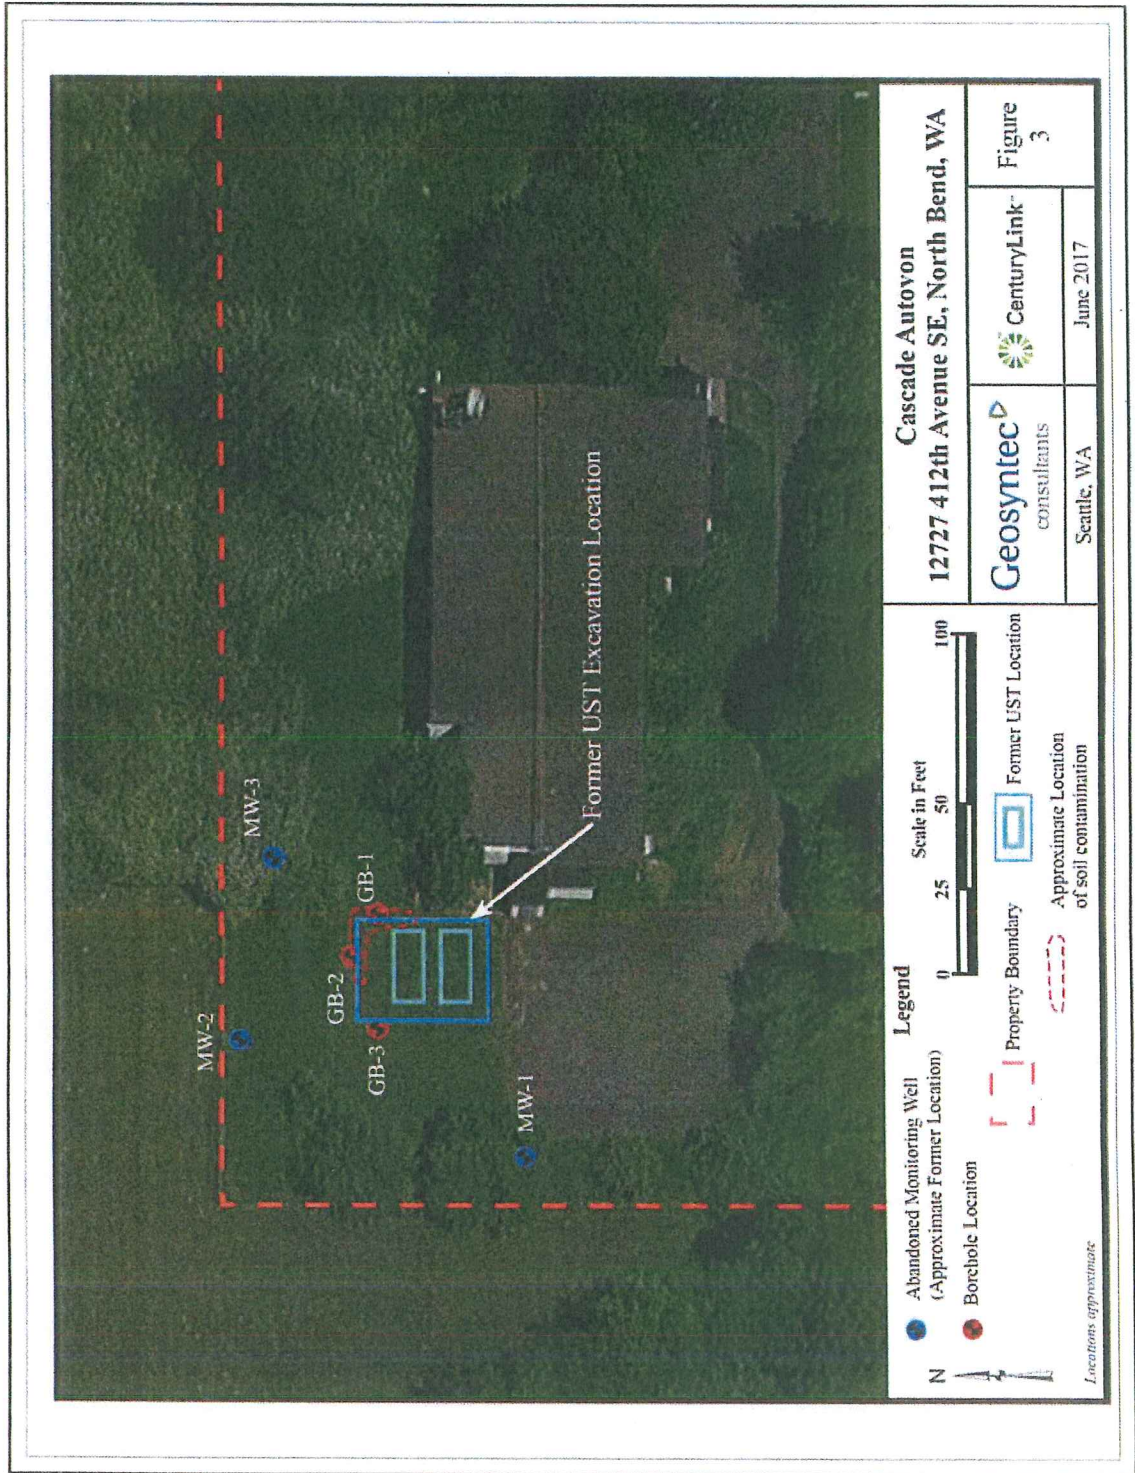
Enclosure A: Figure 3

In August 2016, three soil borings GB-1 through GB-3 were advanced to a total depth of 20 feet bgs on the north, northwest, and northeast corners of the 1991 excavation to investigate the current soil conditions. The soil boring locations are depicted on Figure 3 of the Site Diagrams. One soil sample was collected from each borehole at a depth between 12 and 14 feet bgs, just above the depth at which ground water was encountered, and the approximate depth that residual soil contamination was left in place. One ground water sample was also collected from each soil boring using a five-foot temporary well screen. All soil and ground water samples contained concentrations of TPHg, TPHd, TPHo, and BTEX below the MTCA Method A cleanup levels, indicating residual soil and ground water contamination northeast of the 1991 excavation has most likely degraded. However, soil and ground water contamination was also present at the southwest corner of the 1991 excavation, and may have extended downgradient to the southeast and east. Current soil and ground water conditions southwest, southeast, and east of the 1991 excavation have not been evaluated.
