INTERIM ACTION REPORT
ENNIS CREEK-FINISHING ROOM
FUEL OIL TANK NO. 2
MACHINE SHOP

FORMER RAYONIER PULP MILL SITE
PORT ANGELES, WASHINGTON

Integral Consulting, Inc.

March 2003

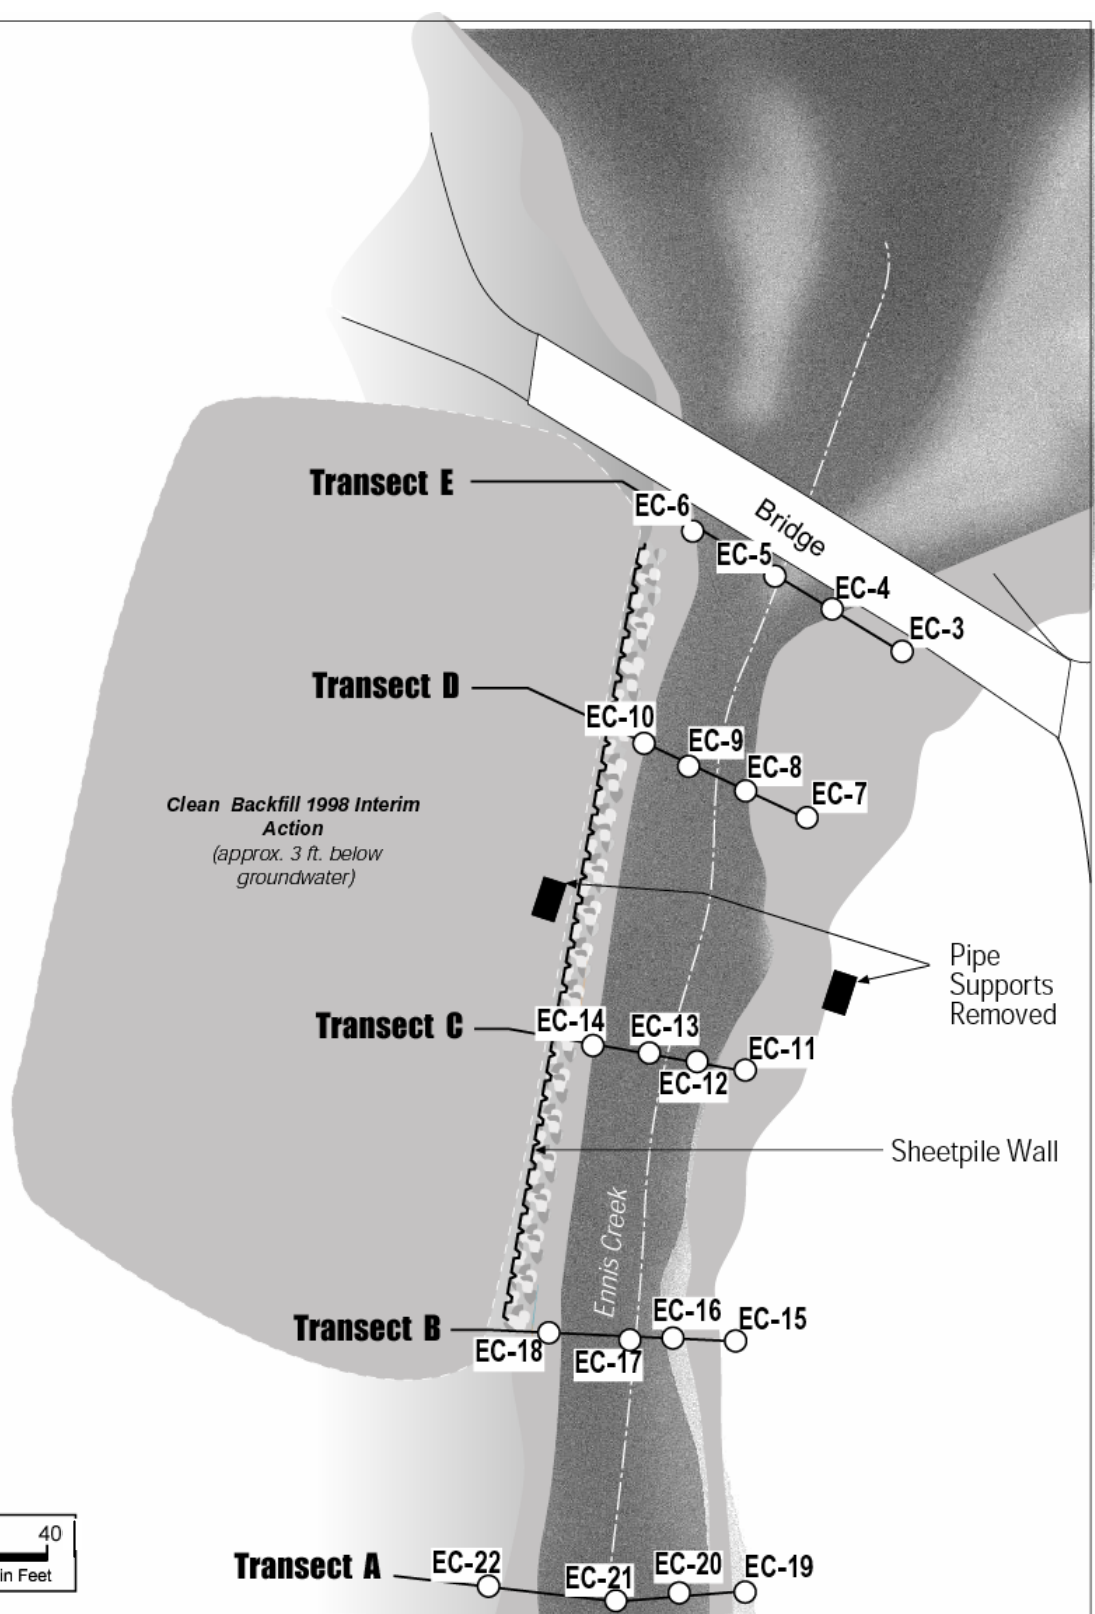
Figure 5-1.
Delineation Sample Locations for the Ennis Creek - Finishing Room Area

Chemical analysis of sediment samples EC-4/8/12/16/20 was not conducted because sediment samples closer to the source area (EC-5/9/13/17/21) did not show concentrations of TPH and PCBs greater than the cleanup levels.

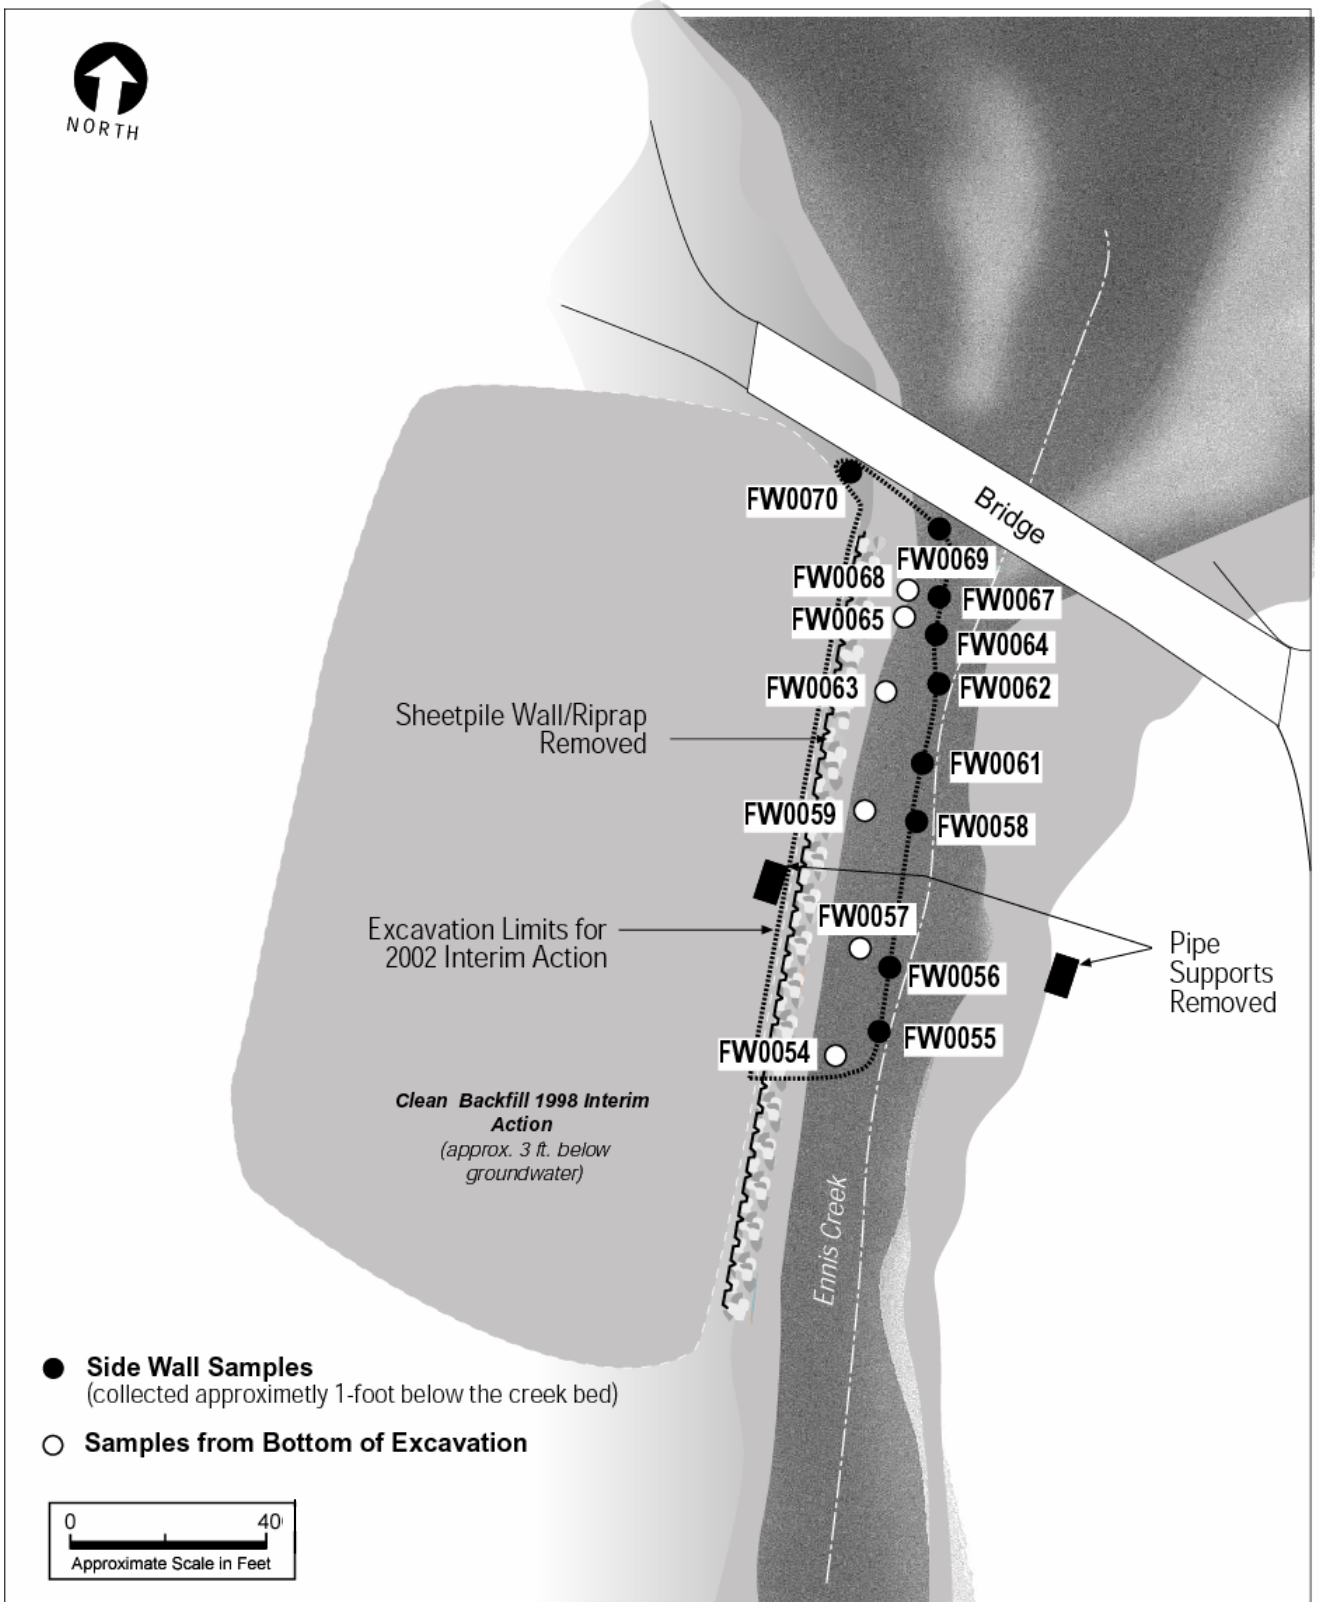
Figure 5-2.
Confirmation Sample Locations for the Ennis Creek -
Finishing Room Area

creek at an elevation approximately 1.5 to 1.0 foot below the centerline elevation of the creek bed. Excavation depths between the sheet pile wall and the center of the creek exceeded the planned excavation depth and averaged approximately 3.5 feet below groundwater. In some locations it was difficult to obtain the exact depths due to rapid infiltration of groundwater. Due to the infiltrating groundwater, it was necessary that the excavated area was backfilled each day to control sloughing of soils and movement of water accumulating in the excavation. Therefore, laboratory analytical results of the confirmation sampling were not available until the excavation and backfilling were completed. The excavation also went as far east as could occur without endangering the integrity of the creek bypass line.
