STATE OF WASHINGTON
DEPARTMENT OF ECOLOGY

Re: Opinion on Proposed Cleanup of the following Site:

- **Site Name:** Gig Harbor Transmission
- **Site Address:** 14610 Purdy Dr. NW, Gig Harbor, Pierce County, WA 98332
- **Facility/Site No.:** 11876
- **Cleanup Site No.:** 1952
- **VCP Project No.:** SW1590

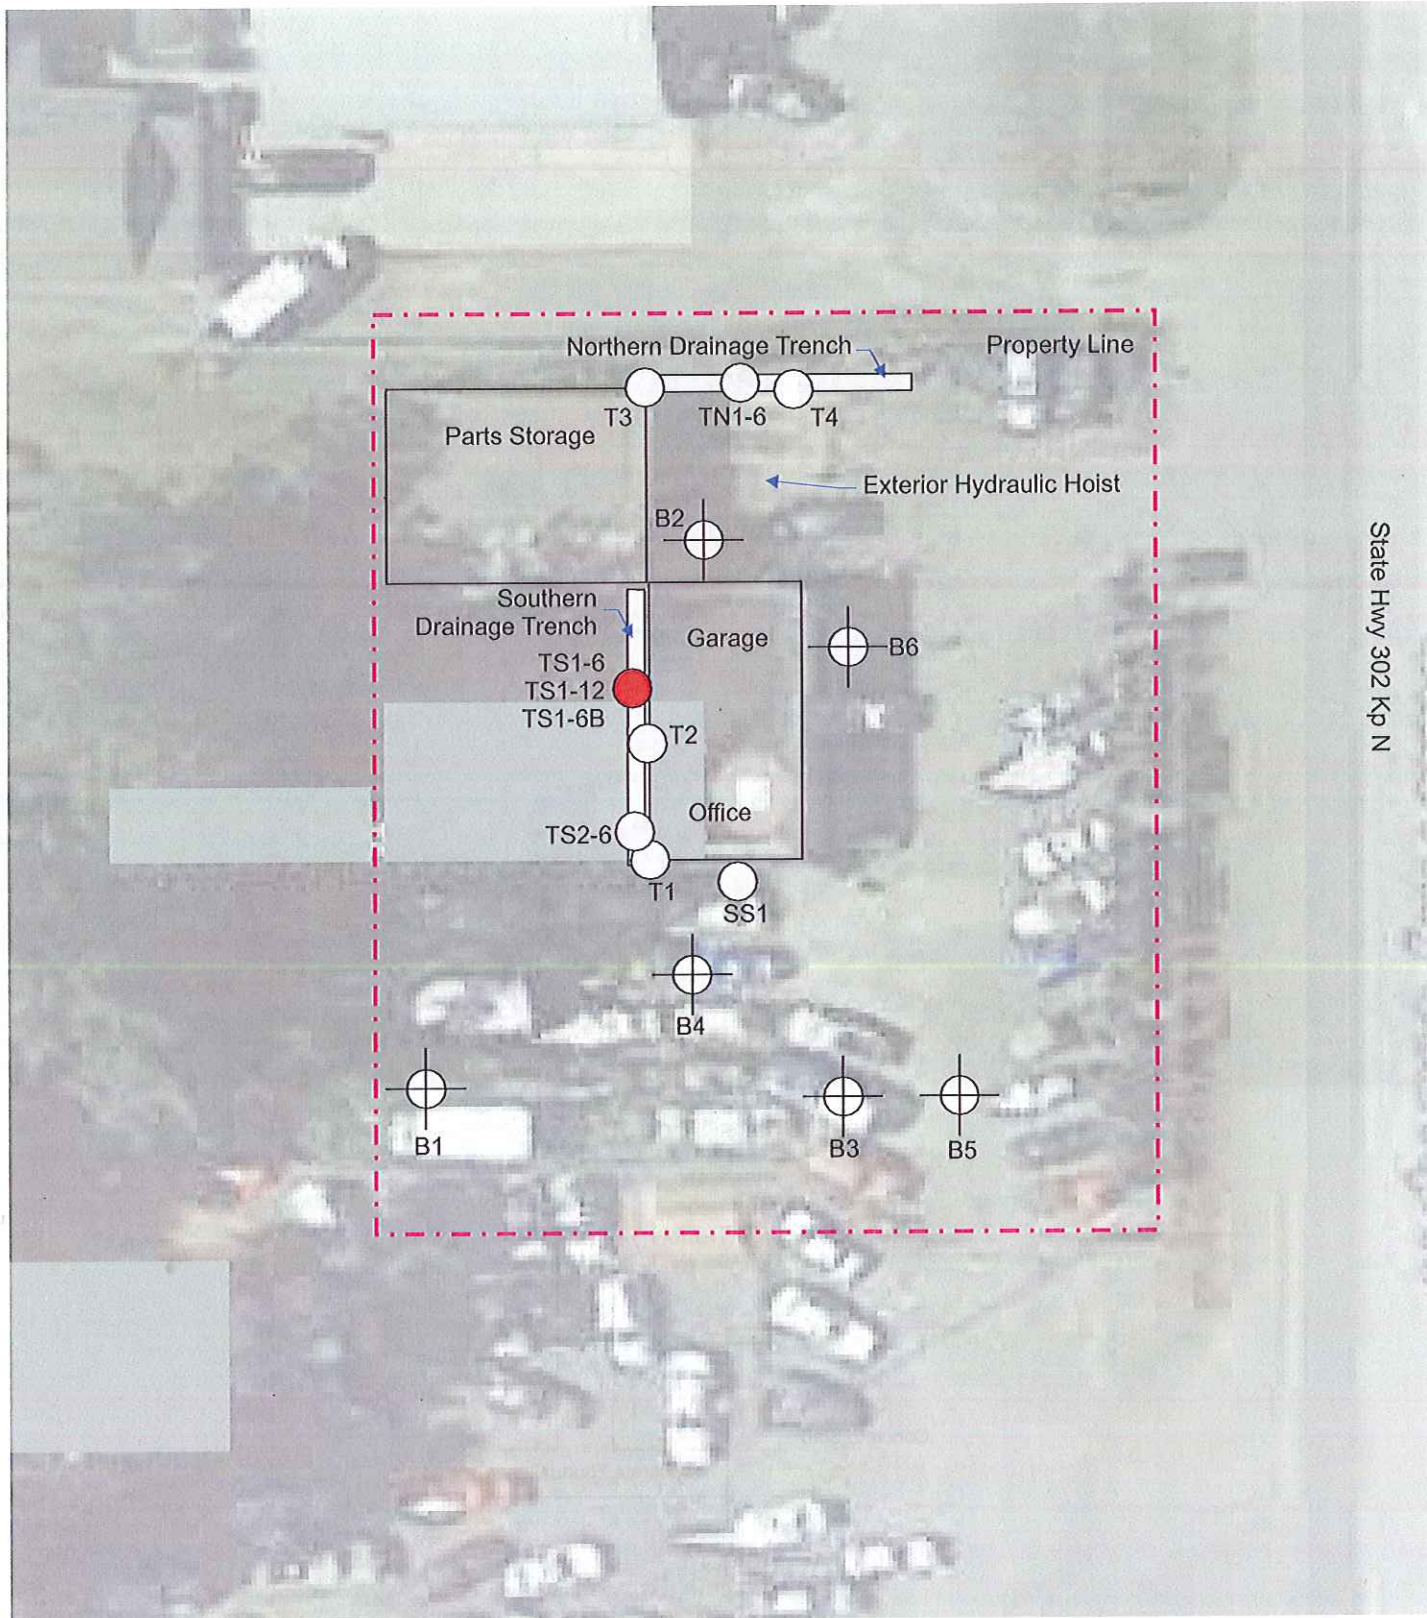
Historical Soil Sample Location Map
 Cleanup Action Report
 14610 Purdy Dr NW
 Gig Harbor, WA 98332

Based on the 2017 Phase I ESA findings, ECI sampled soil from the same trenches as completed in 2009. Concentrations of TPH-O, cPAHs, and lead exceeded the MTCA Method A cleanup levels in soil sampled from west trench. Cadmium was not sampled in soil collected from the western trench in 2017, though this contaminant exceeded the MTCA Method A cleanup level in soil sampled in 2009. The west trench is enclosed in concrete (see Figure 4). Petroleum contaminated soils (PCS) in both the west trench and the north trench were removed and disposed of off-Site by PRS Group, Inc.

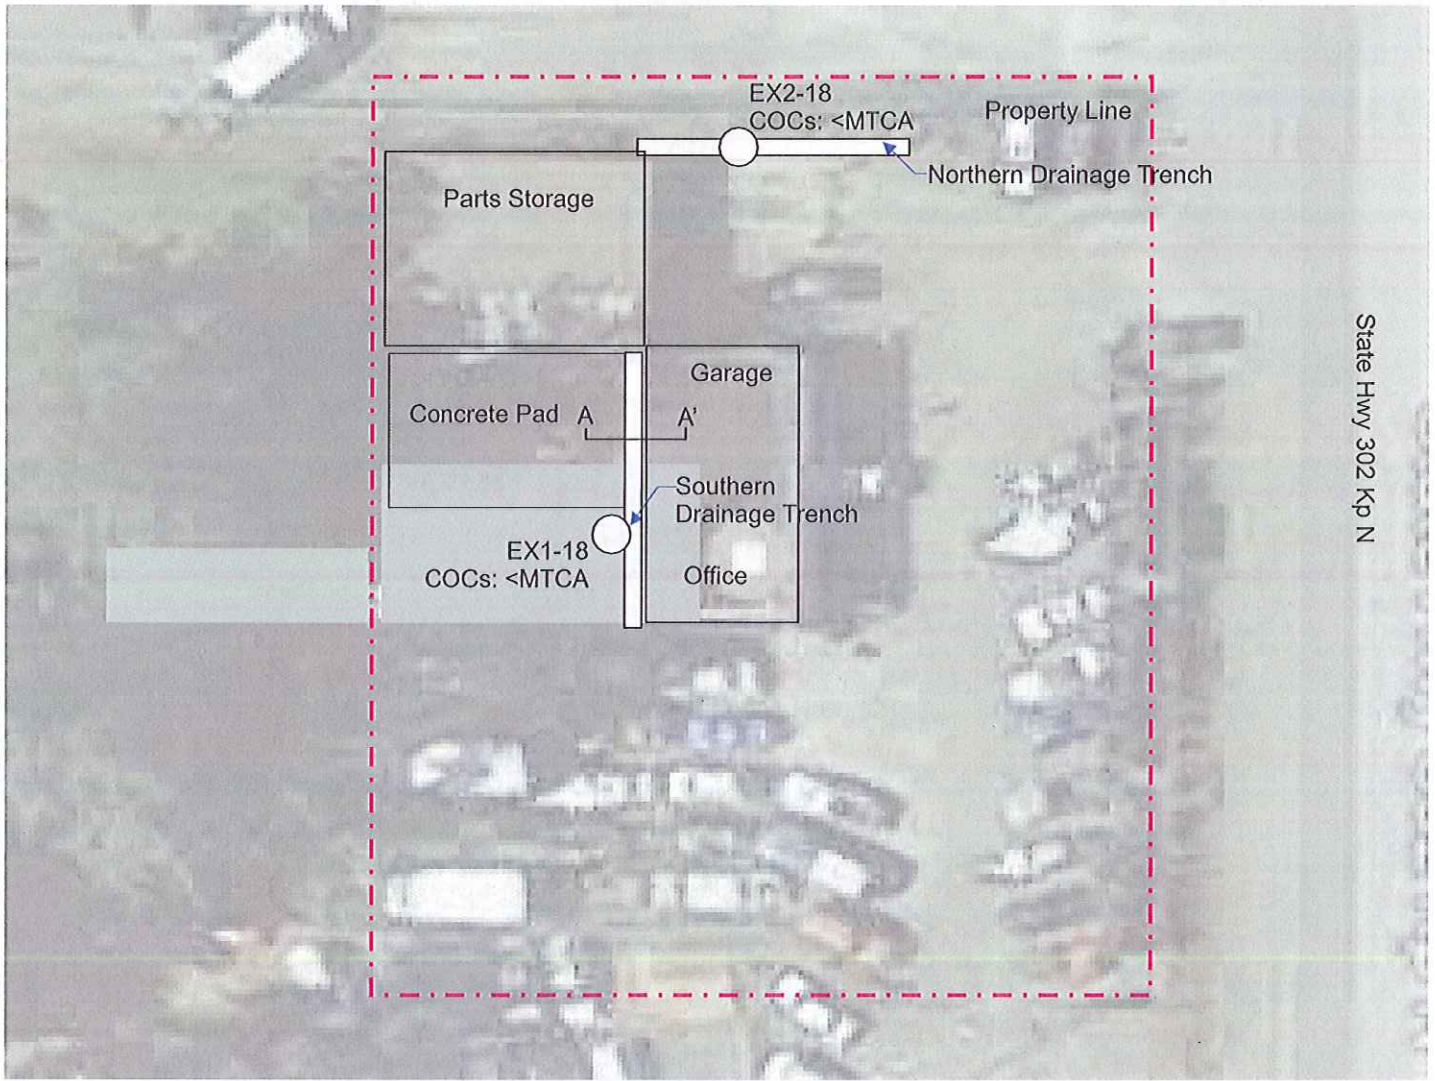
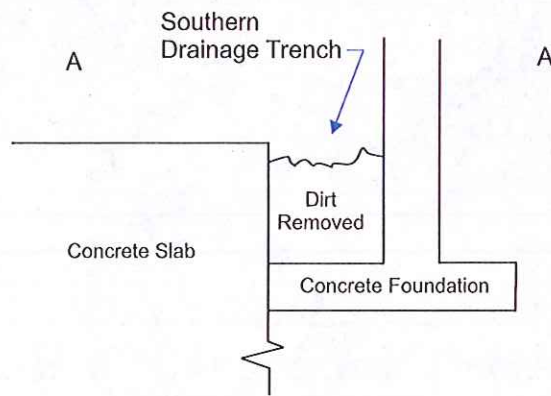
In 2017, concentrations of Site COCs in soil sampled from the concrete lined west trench¹ exceeded the MTCA Method A cleanup level. Ecology identifies the MTCA “Site” as an area encompassing those areas which have had concentrations of Site COCs in excess of the cleanup levels and where removal of potentially contaminated soils has occurred. In the MTCA Site, Ecology includes west trench and the north trench, and the area in the vicinity of boring B2. Ecology added the approximate MTCA Site boundary to figure 5 in **Enclosure A**. New data may alter the boundaries of the MTCA Site.
