**Area 1 Remedial Investigation and
Property Transfer
Boeing Auburn Facility
Auburn, Washington**

February 9, 2017

The Boeing Company
Seattle, Washington

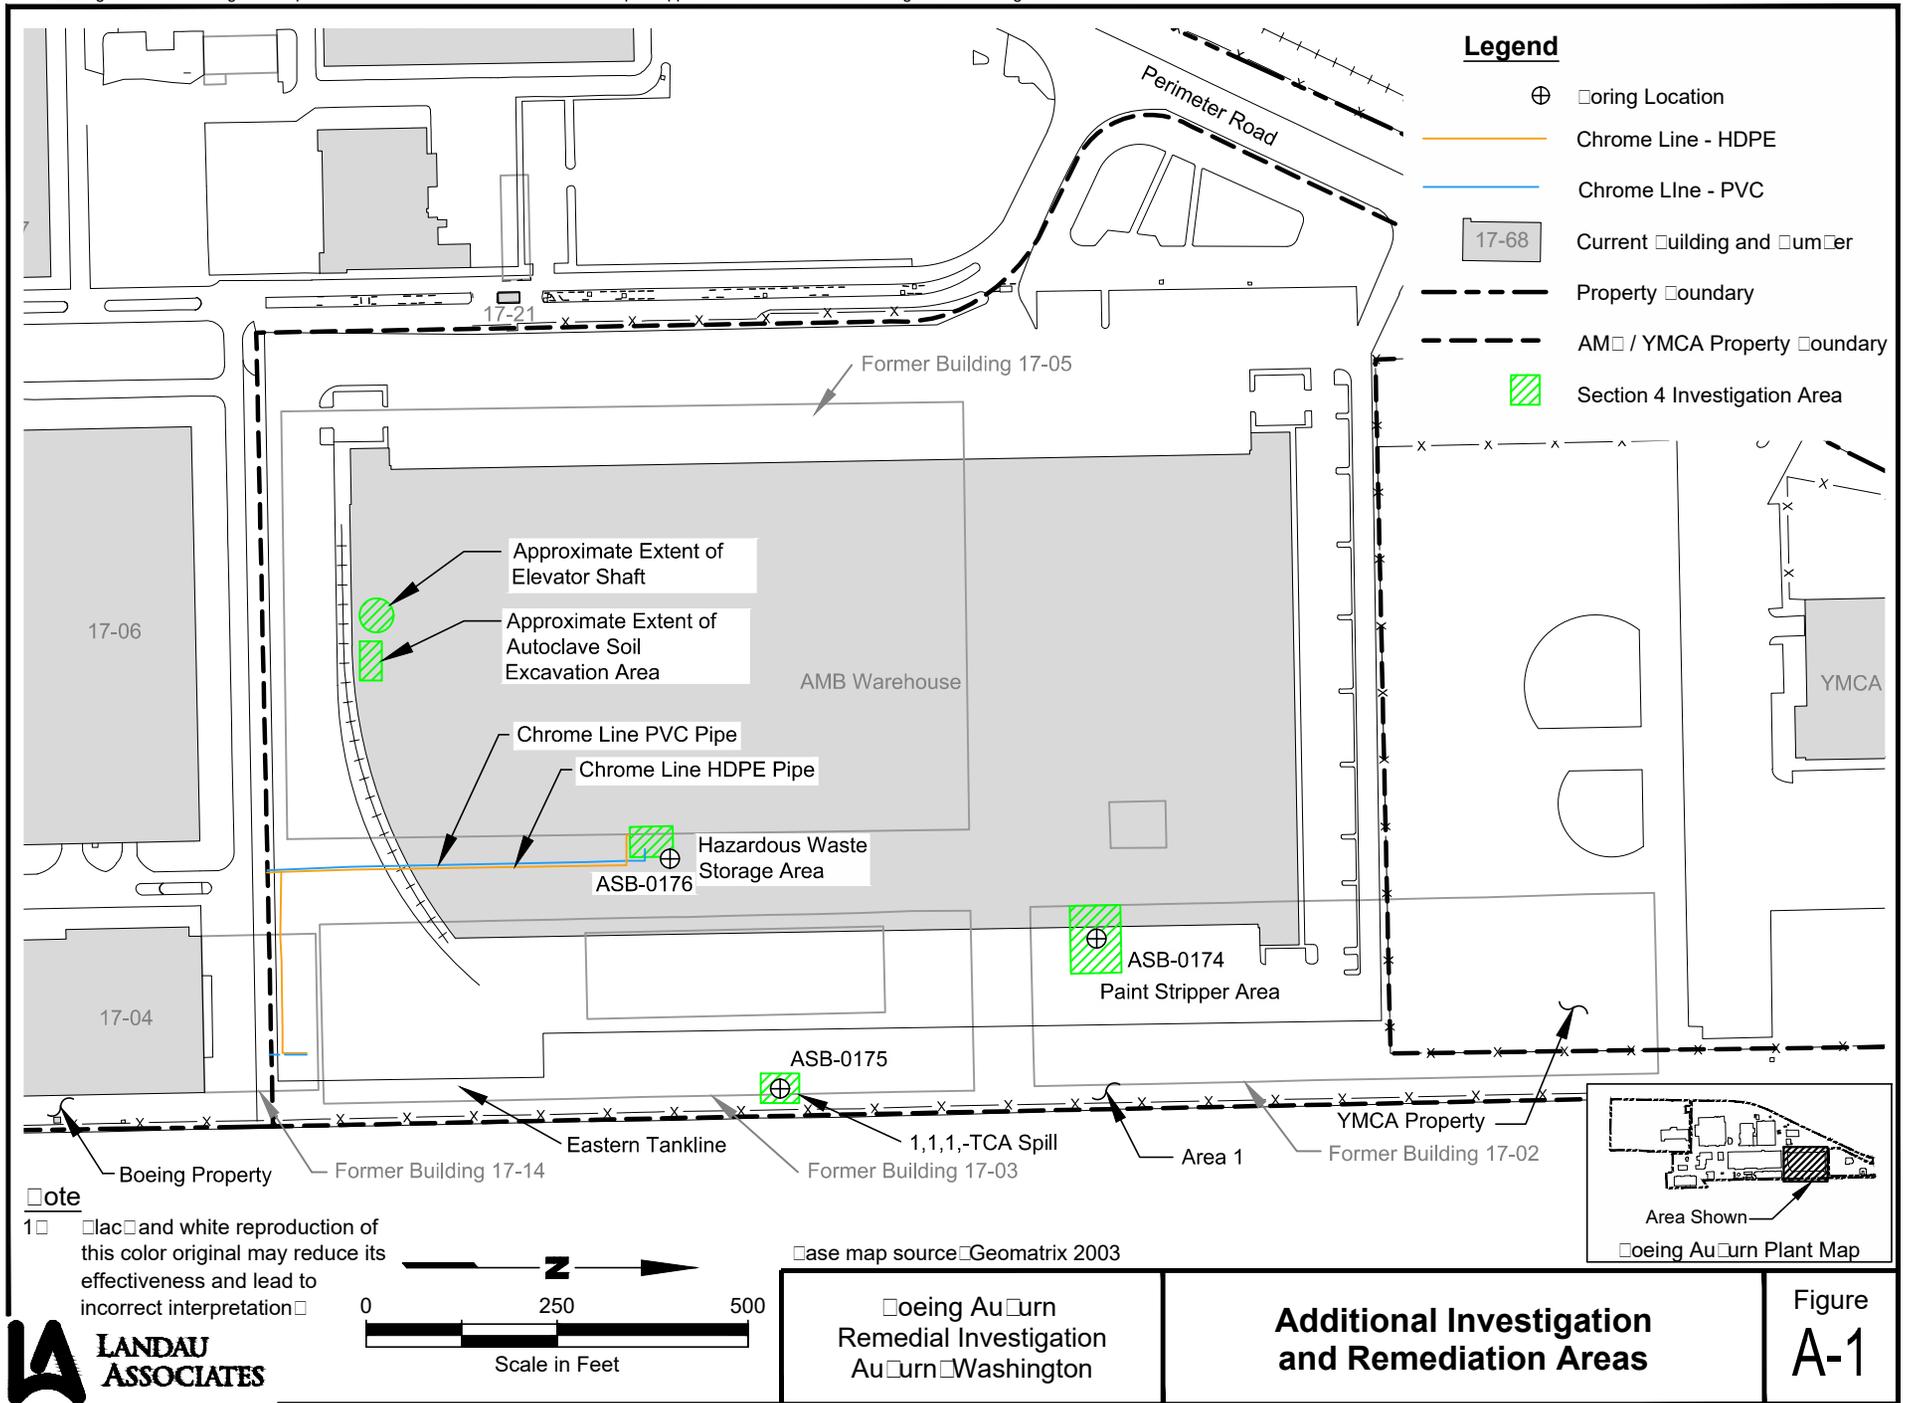
<u>Figure</u>	<u>Title</u>
A-1	Additional Investigation and Remediation Areas

As part of the Area 1 property sale agreement, Boeing agreed to remove two Area 1 chrome lines after the planned demolition of Building 17-05 and the Building 17-14 shed. The chrome lines reportedly transported wastewater from manufacturing operations in Area 1 to the treatment plant located on the eastern portion of the Boeing Facility near Building 17-15. Based on Facility drawings and previous investigations, each chrome line actually consisted of two separate lines: an older high-density polyethylene line and a newer PVC line. Samples of the lines and liquid in the lines were collected and analyzed for waste disposal purposes. None of the results from samples collected in Area 1 exceeded dangerous waste thresholds. However, results indicated that the lines might designate as listed hazardous or dangerous waste for disposal purposes. Consequently, the decision was made to remove the lines from Area 1. The liquid content of the lines was removed in October 2005 from discrete points accessed through backhoe excavations. The chrome lines were subsequently removed between June 12 and June 22, 2006. The former location of the lines is shown on Figure A-1.

During line removal, there was no visual indication of impacted soil anywhere along the lines. However, four areas were identified where the outside of the pipe was discolored. Soil in contact with discolored pipe (approximately 1 cubic yard at each location) was removed and disposed of with the pipe material. After soil removal, confirmation samples were collected from each location and analyzed for metals. Confirmation soil sampling results indicated that any potentially contaminated soil associated with the discolored pipe locations was removed.

An elevator and elevator shaft was present in the south end of the former Building 17-05. Previous samples of the hydraulic oil used to operate the elevator contained polychlorinated biphenyls (PCBs). Consequently, samples of concrete from the elevator shaft floor, an I-beam, and the concrete sump were collected and analyzed; wipe samples of concrete and painted surfaces were also analyzed. The maximum concentration was 53 milligrams per kilogram (mg/kg) from the sump concrete. Because the elevator shaft meets the criteria for a low occupancy area as defined in 40 Code of Federal Regulations (CFR) Section 761.2, a cleanup level of 25 mg/kg [40 CFR 761.61(a)(4)(i)(B)] was identified for the elevator shaft. The only sample that exceeded the cleanup level was the sample collected from the base of the concrete sump. The approximate location of the elevator shaft is shown on Figure A-1.

Demolition of Building 17-05 resulted in removal of the building superstructure, concrete slab, and shallow underground utilities. During excavation near the southern portion of the original building footprint, evidence of petroleum-impacted soil was observed. The impacted soil is located near a former autoclave racking system that was operated in Building 17-05. Initial sample results indicated the presence of diesel, motor oil, carcinogenic polycyclic aromatic hydrocarbons (cPAHs), and PCBs. Additional test pits were conducted on June 8 and 12, 2006 to delineate the extent of soil contamination. The location of the autoclave excavation is shown on Figure A-1.

Because there was a cleanup level exceedance, Boeing appropriately disposed of PCB-impacted surfaces and notified the U.S. Environmental Protection Agency (EPA) of their remediation plans under the Toxic Substances Control Act in a letter dated August 18, 2005 (Boeing 2005). EPA provided approval of the planned remediation in a letter to Boeing dated August 28, 2005 (EPA 2005). The cleanup action activities began on September 20, 2005 and were completed on September 23, 2005. All PCB-contaminated material removed from the elevator shaft during implementation of the cleanup action was disposed of at a Chemical Waste Management EPA-approved hazardous waste landfill in accordance with 40 CFR 761 (a)(5)(v). This included concrete removed during the scarification of the sump sidewalls and elevator shaft concrete floor, the concrete removed from the base of the sump, the concrete associated with the steel I-beam, and the steel I-beam. Following removal, confirmation samples were collected from the soil below the base of the concrete sump and the sidewalls. The PCB concentrations detected in the confirmation soil samples were below the cleanup level. The cleanup action was documented in a cleanup action report submitted to Ecology and EPA (LAI 2005b).

On June 21 and 22, 2006, excavation of contaminated soil was performed. Contaminated soil was excavated directly into trucks for disposal. Approximately 164 cubic yards of contaminated soil were disposed of offsite. During soil excavation, deeper soil contamination was found within the excavation at a depth of approximately 12.5 ft; however, the area of this deeper zone was limited to an area of about 15 ft by 15 ft. On June 29 and 30, 2006, the excavation was continued to a depth of approximately 20 ft; groundwater was encountered at a depth of approximately 16 ft. This additional excavation produced approximately 96 cubic yards of impacted soil, which was loaded into 8 roll-off boxes. The roll-off boxes were shipped offsite for disposal as soil with listed dangerous waste constituents on July 11 and 12, 2006.

Prior to backfilling, 18 buckets (approximately 450 pounds) of Regensis Advanced Oxygen Releasing Compound was mixed with exposed water at the base of the excavation to address the possibility of residual petroleum compounds in groundwater. The excavation was backfilled with quarry spalls, pit run gravel, and clean overburden material that had been segregated and stockpiled. Backfill activities were completed on July 6, 2006. A summary of the autoclave investigations and remediation were documented in an August 2006 memorandum to Ecology (LAI 2006).
