# Memorandum

**Date:** October 20, 2017

**Project No:** Weyer-Mill E

**Re: Pipe Exploration Summary for Storm Drain Associated with Outfall LLO-07**

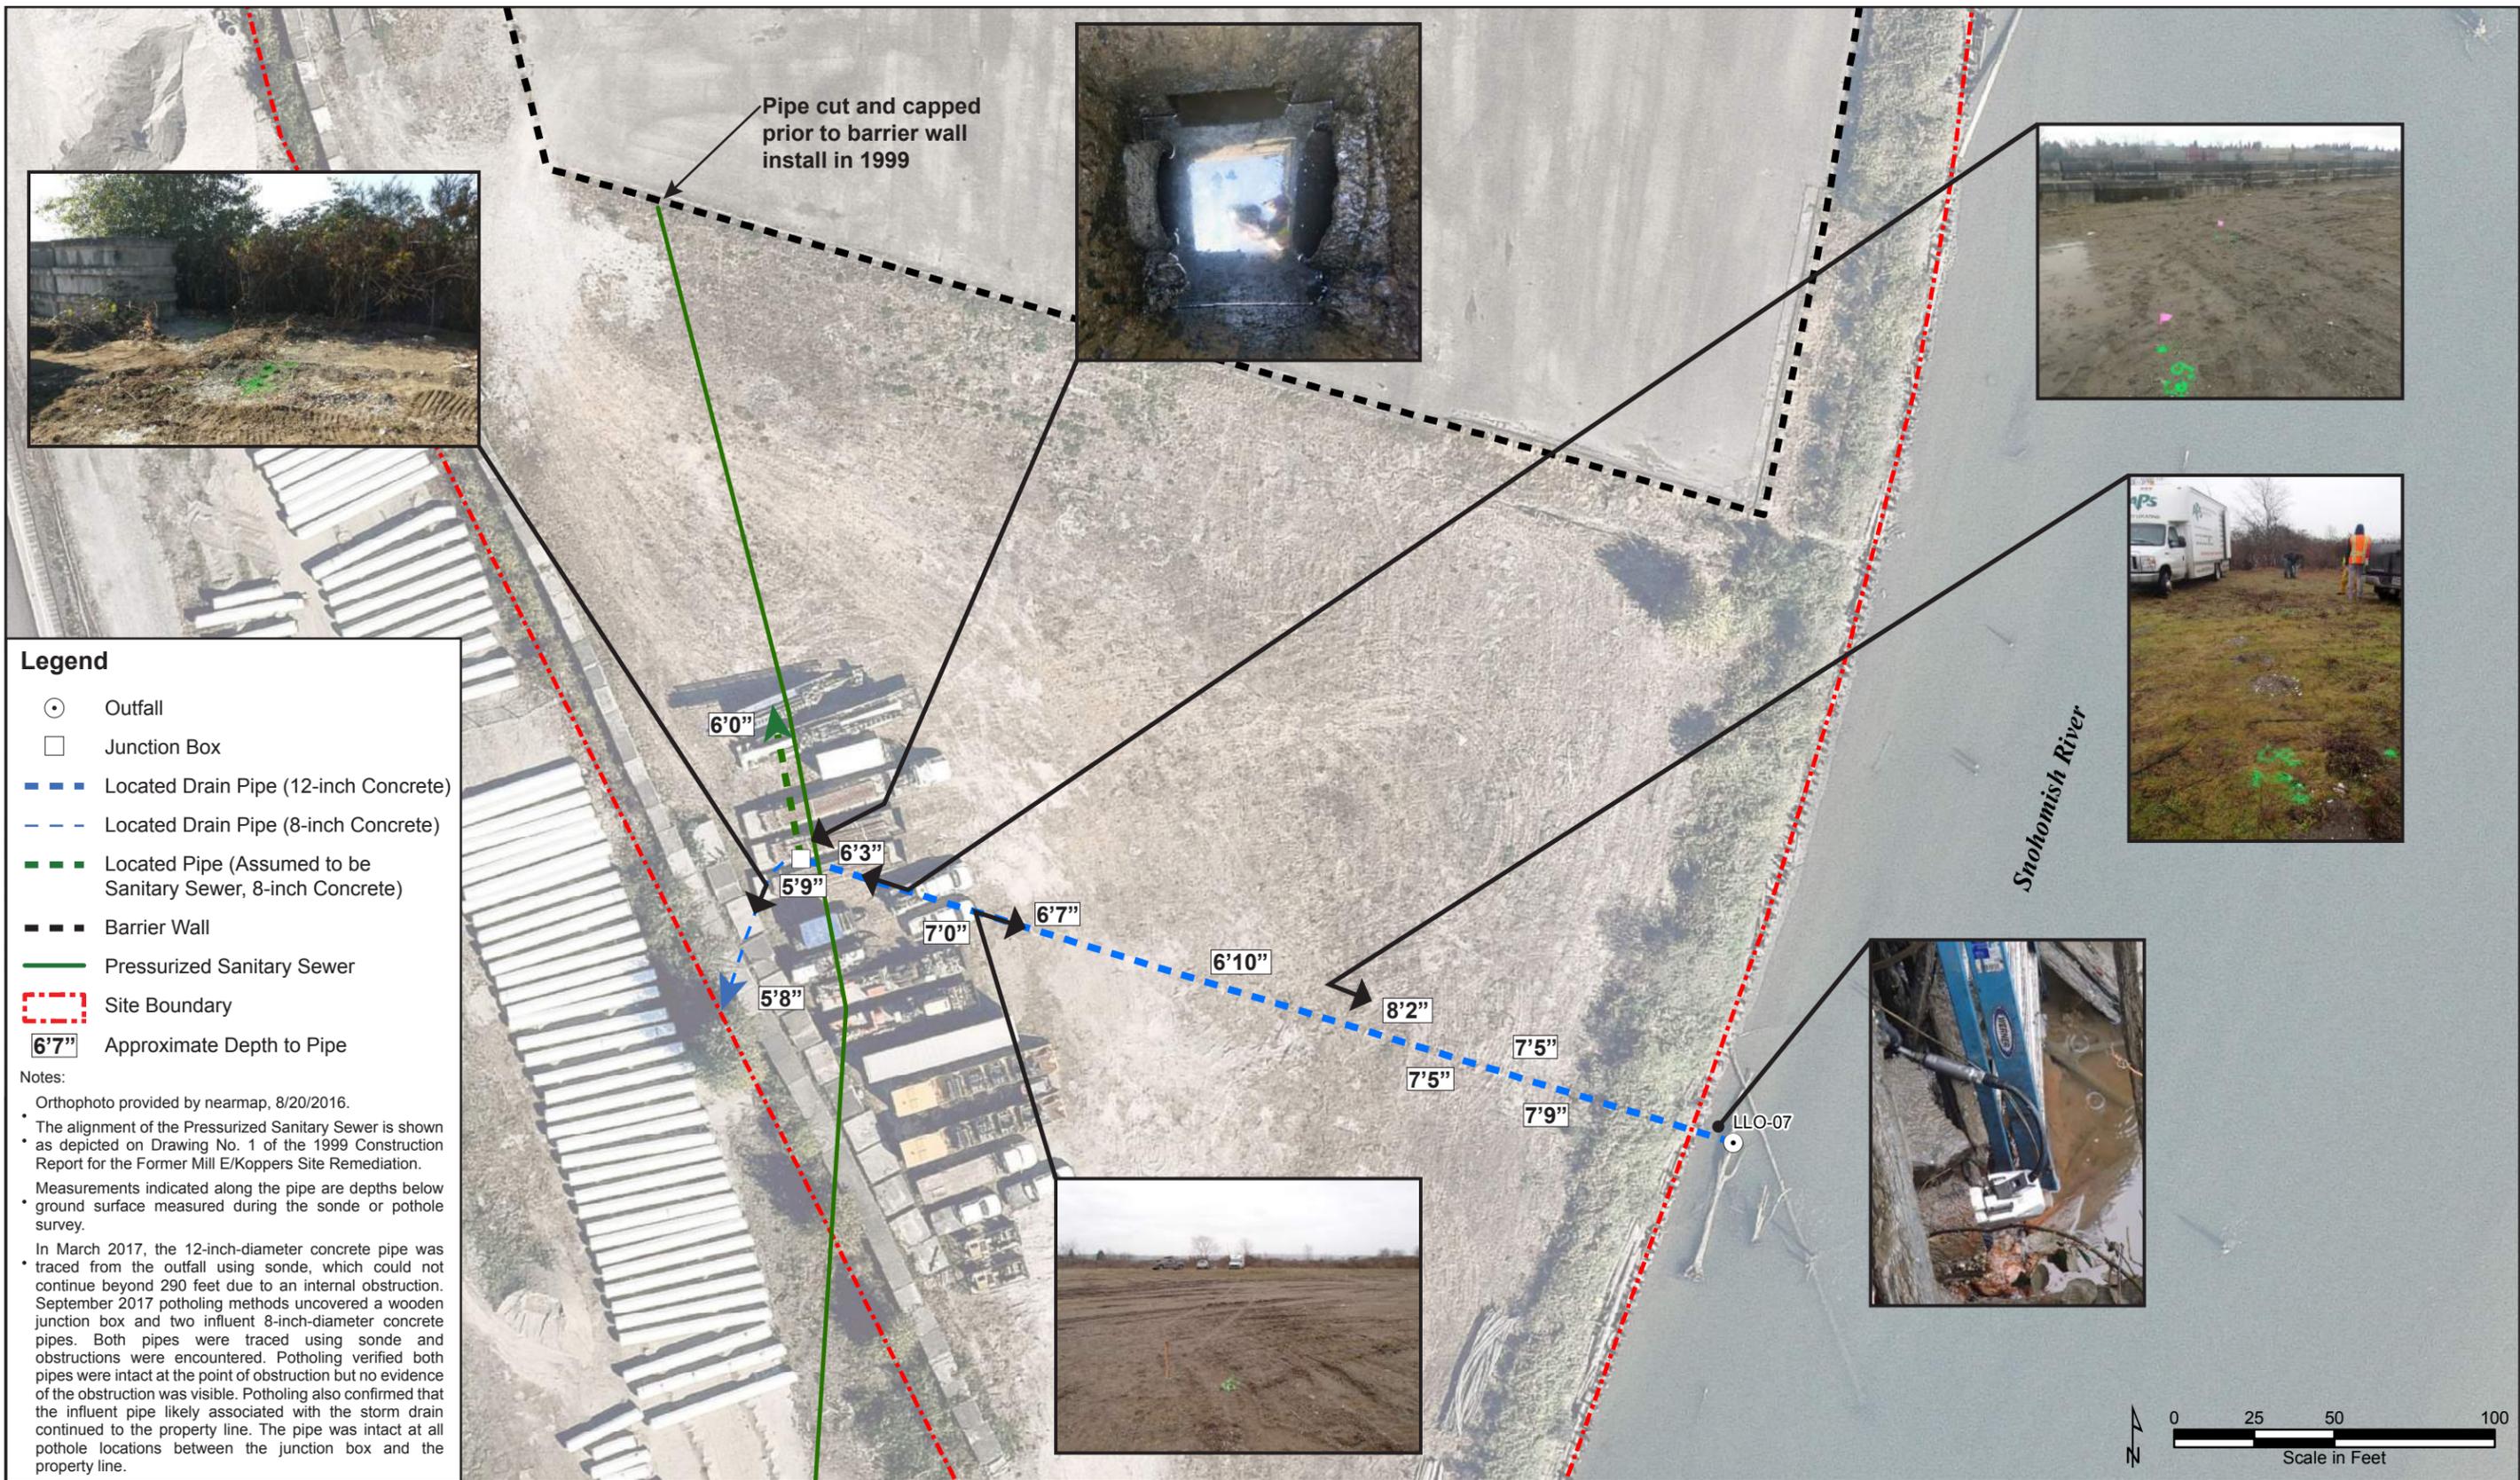
| Figure 3 | LLO-07 Outfall Pipe Survey Details |

The average water table in the area of the piping is between 5 and 6 feet below ground surface (bgs), but is tidally influenced by the Snohomish River. Because of this, both events were completed at low tide, with subsurface exploration targeted when the tide was below 3 feet mean lower low water (MLLW). Photographic documentation of both exploration events is included in Attachment 1 and the findings are depicted on Figure 3.

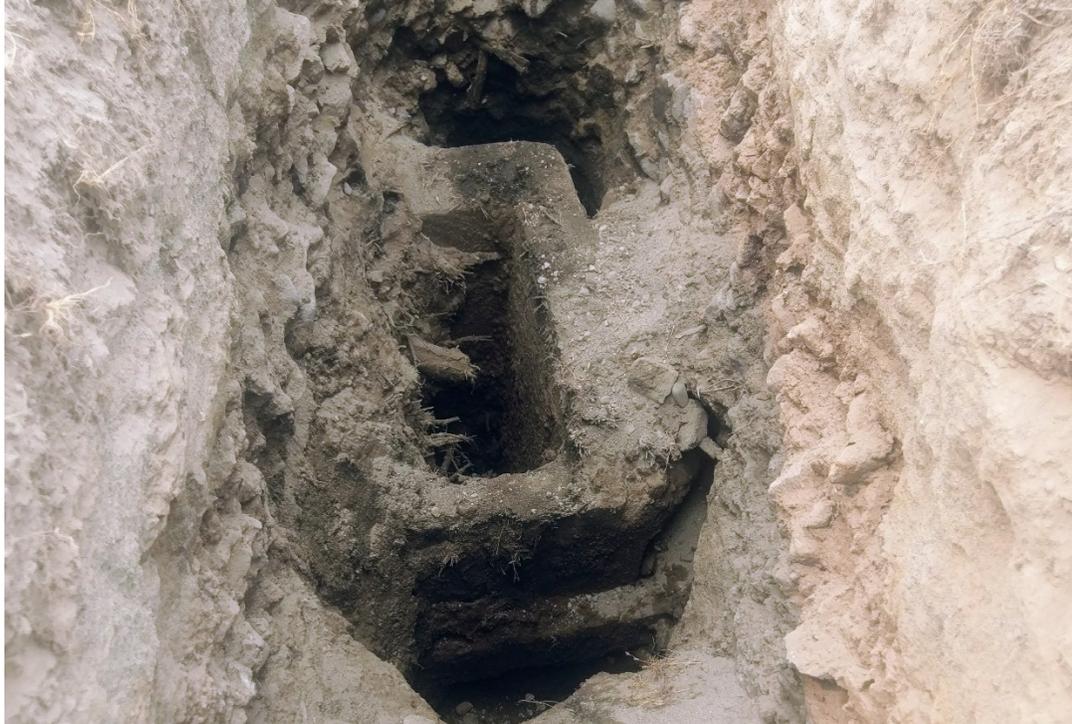
Photograph 1. The wooden junction box viewed looking northwest, in line with the 12-inch-diameter concrete outlet pipe (September 5, 2017).

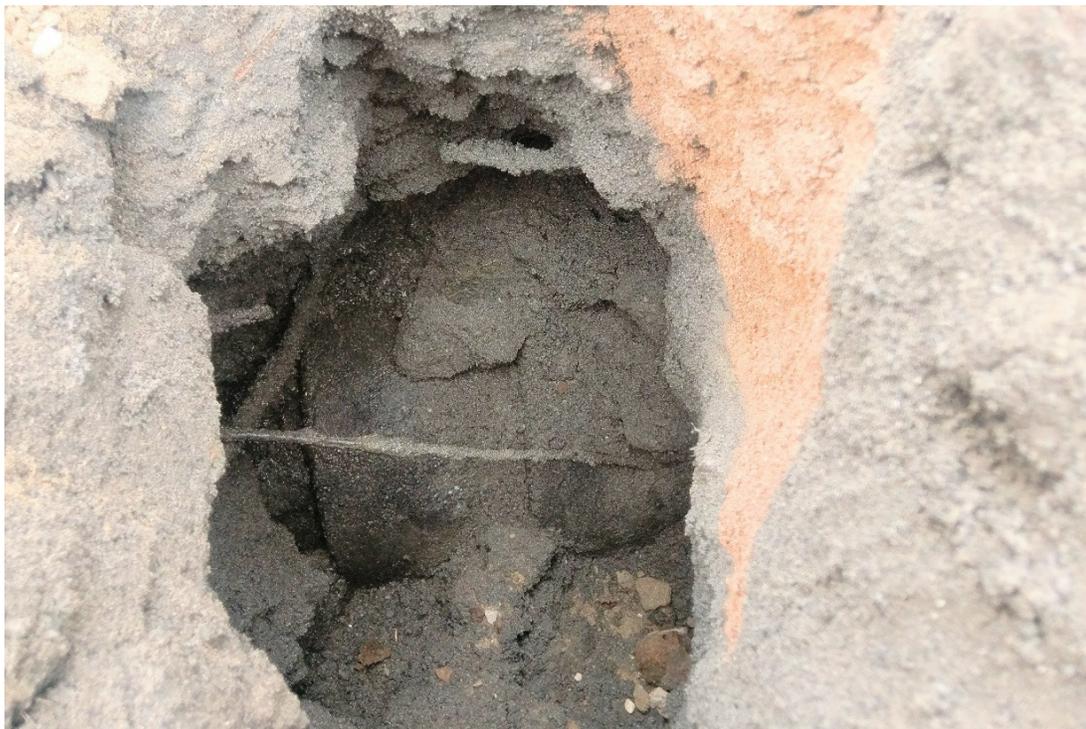
Photograph 2. The 8-inch-diameter concrete inlet pipe outside (west) of the junction box curving west to southwest via conjoined bell joints (September 5, 2017).

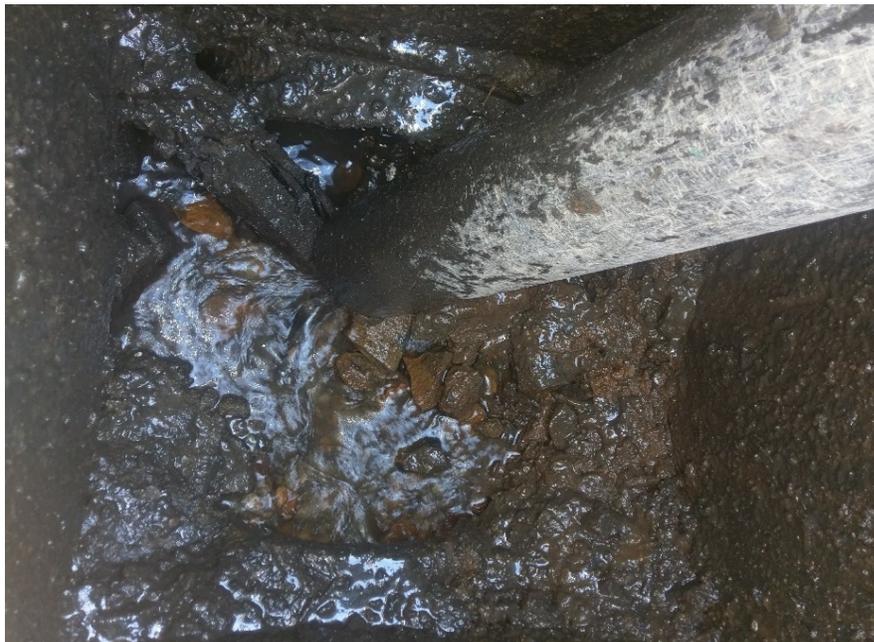
During the investigation as the tide was going out, the water level outside of the junction box was observed to be at a higher elevation than inside the box and the water inside the box was observed exiting the box via the 12-inch-diameter outlet pipe. The work was completed before high tide, so it was not clear if the water was entering the box from the outlet pipe (tide flow) only or if the groundwater level was rising from the bottom. The bottom of the box was full of 2-inch-diameter angular rock and it is not clear if there is a solid bottom or not.

Photograph 3. Clearing out mud and rock from the junction box. Photograph taken during ebb tide, causing water (river water) to flow into the box from the inlet pipes and out of the box through the outlet pipe (September 22, 2017).

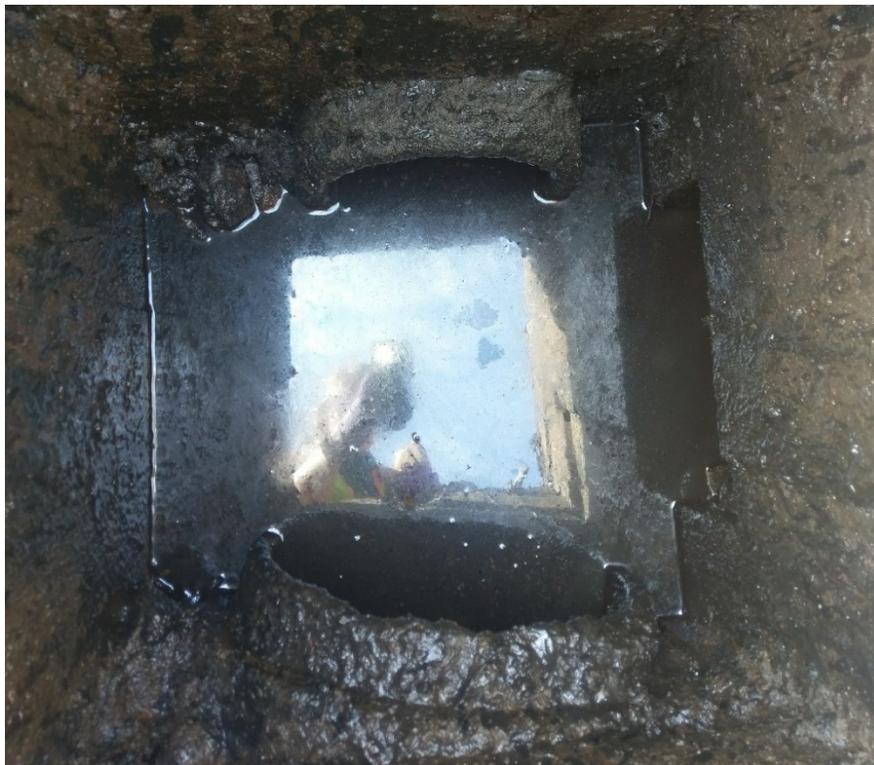
On September 22, Floyd|Snider performed a second field exploration event to further investigate the junction box and 8-inch-diameter concrete pipe using sonde technology provided by Floyd|Snider’s subcontractor Innovative Vacuum Services, Inc. (Innovac) and a portable vacuum extraction unit from ESN Northwest. The junction box was uncovered and hand tools were used to fully clear the inside of the box to better access the pipes. Starting near the top of the pipes, angular rock approximately 2 inches in diameter was encountered and appeared to fill the bottom of the box and near pipe inlets and outlet (refer to Photograph 3 of Attachment 1). The rock was removed down to the pipe inverts and as much as possible from the pipe interiors. During this work, a second 8-inch-diameter concrete pipe oriented to the northwest was discovered inside of a cutout in the north side of the box. All three uncovered pipes had approximately the same invert elevation (refer to Photographs 4 and 5 of Attachment 1). There was no evidence of a pipe or cutout on the south side of the box.

Photograph 4. Inside view of the junction box. The box interior includes the 12-inch-diameter concrete outlet pipe to Outfall LLO-07 (bottom), the 8-inch-diameter concrete inlet pipe traveling north from the box toward the barrier wall and asphalt cap (right), and the 8-inch-diameter concrete inlet pipe traveling west toward the property line (top) (September 22, 2017).

To address the unknown off-site source of arsenic that is discharging via Outfall LLO-07 and potentially acting as an on-going source of arsenic to the subsurface of the Site at the junction box, Weyerhaeuser and Pacific Topsoil propose to cap or plug the inlet and outlet pipes from

within the junction box and to subsequently fill the wooden junction box with concrete. Sealing the box and associated pipes would eliminate the flow of river water from the Snohomish River into and out of the junction box via the outfall and piping, would eliminate the outfall as a pathway for contamination to the river via discharge out LLO-07, and would prevent off-site contamination from impacting Site soils.

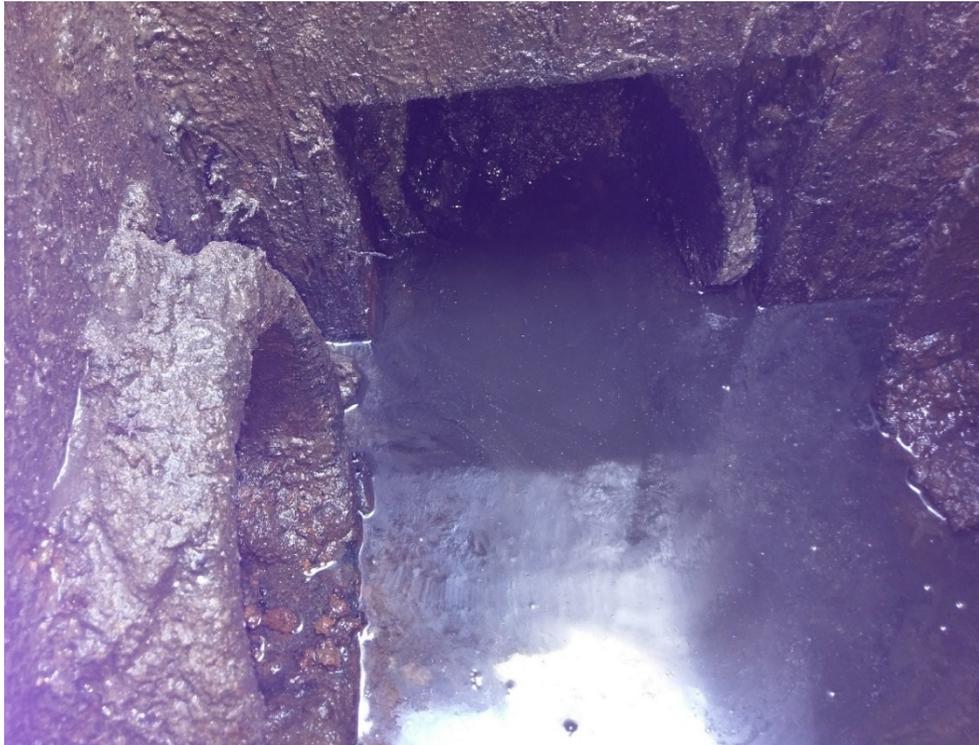
The 8-inch-diameter pipe observed entering the junction box to the north was traced from the junction box using a sonde probe. The sonde verified that the pipe ran straight in a north/northwest direction toward the barrier wall and cap; however, the sonde hit an obstruction at approximately 40 feet. The pipe was then potholed at this location and confirmed to be intact with no visible signs of damage or other indication of the unknown blockage. It was decided to discontinue further potholing along the pipe alignment to the north due to the concern of moving closer to the barrier wall and asphalt cap.

Photograph 5. View of the 8-inch-diameter concrete pipe on the north side of the junction box. A buildup of rock and mud was visible inside all three pipes (September 22, 2017).

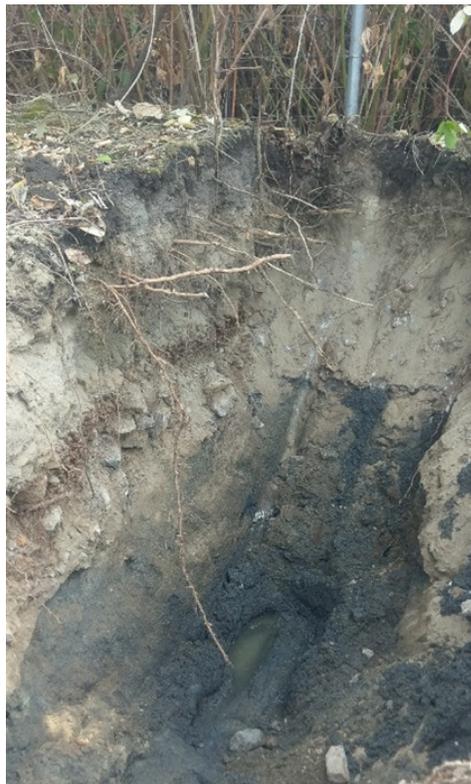
The 8-inch-diameter pipe on the west side of the junction box (assumed stormwater pipe) was traced using a sonde probe approximately 45 feet before reaching an impassable obstruction. This obstruction occurred just before the property line. The pipe was then potholed at this location and confirmed to be intact with no visible signs of damage or obstruction (refer to

Photograph 6 of Attachment 1). This was the farthest this pipe could be potholed without crossing the property line or undermining the property line fence. Based upon the visual observation of the west 8-inch-diameter pipe, Floyd|Snider believes there is sufficient evidence to reasonably infer that this pipe crosses the property line intact and drains, or previously drained, an unknown area away from and off of the property. The origin of the pipe remains unknown.

Photograph 6. View of the exposed 8-inch-diameter pipe on the west side of the junction box at the property line (September 22, 2017)
