STATE OF WASHINGTON
DEPARTMENT OF ECOLOGY

November 30, 2017

Re: Further Action at the following Site:

- **Site Name:** Lake Stevens Cleaners
- **Site Address:** 303 91st Avenue NE, C302, Lake Stevens, Washington
- **Facility/Site No.:** 11757
- **VCP Project No.:** NW3116
- **Cleanup Site ID:** 13076

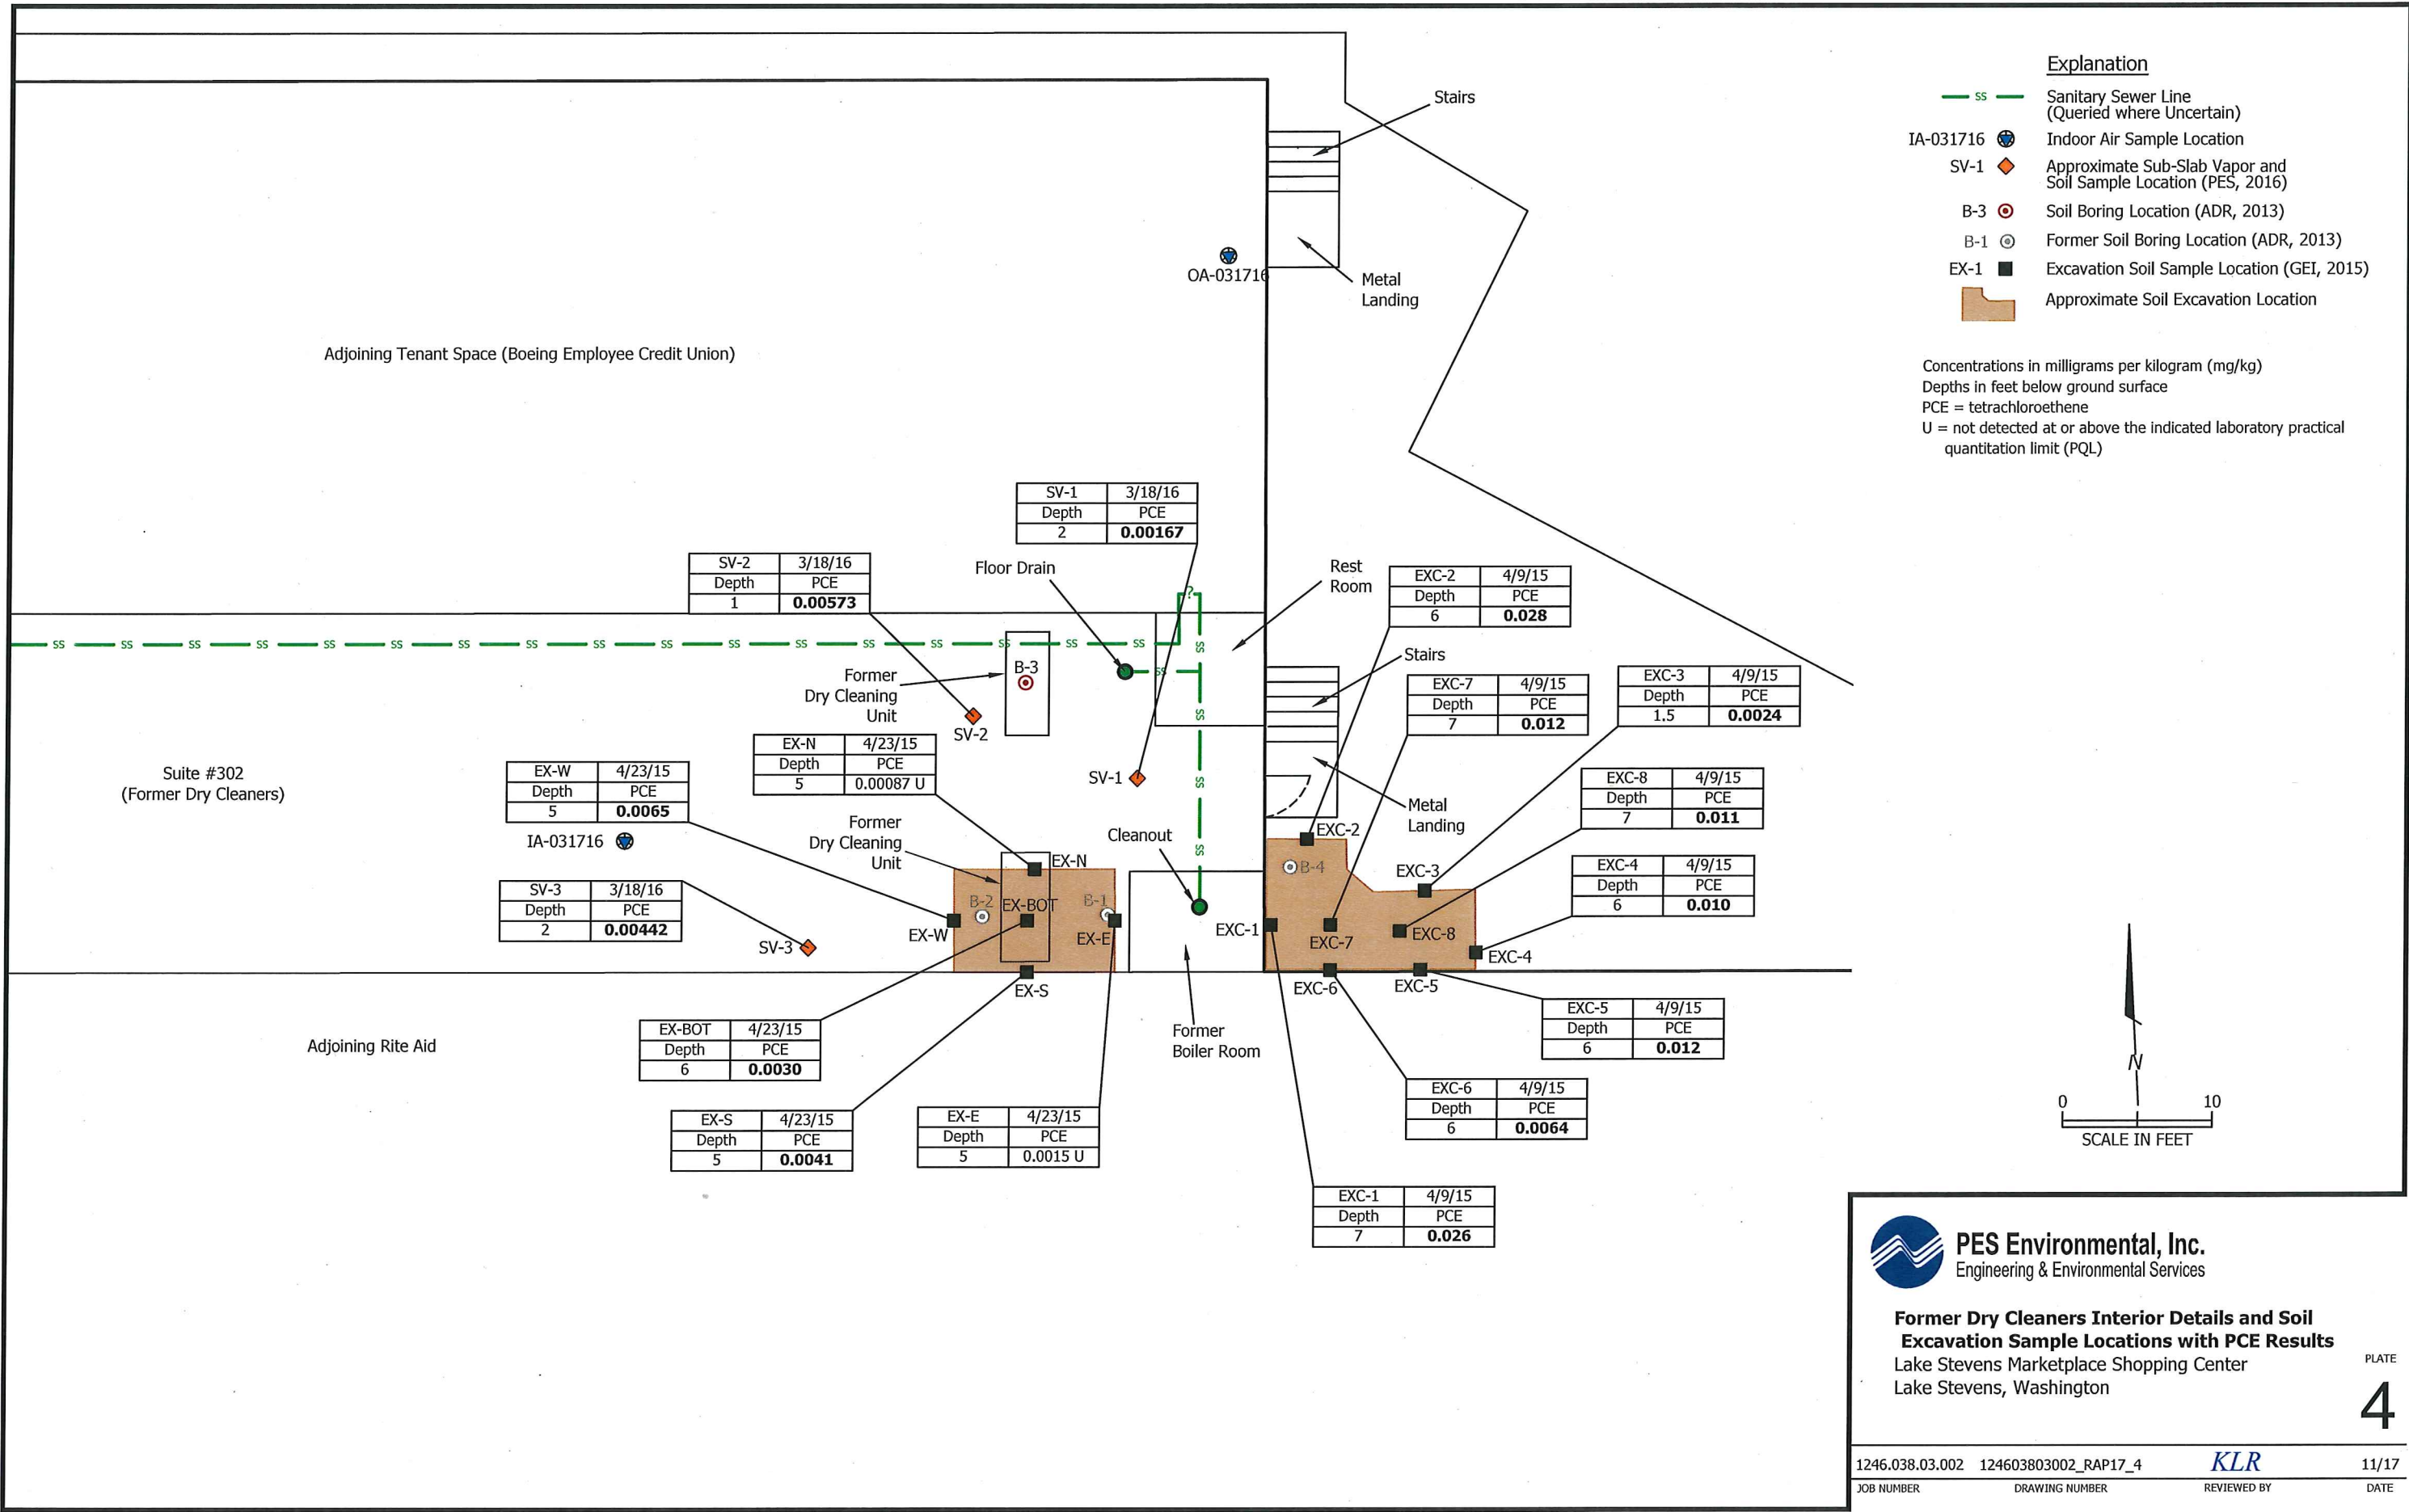
Enclosure A: Figure 3

- PCE concentrations exceeded the MTCA Method A soil cleanup level in the soil samples collected at 8 feet below ground surface (bgs) from boring TW-7 located east of the Lake Stevens Cleaners suite building, and at 7.5 feet bgs from the monitoring well MW-5 located north of the building. Additional evaluation is needed east and north of the building to determine and delineate the extent of PCE contamination in soil.

Site Investigations and Cleanup Actions: Environmental Investigations and Cleanup Actions were conducted at the Site since October 2013. All of the soil, ground water, soil gas, and indoor air sampling locations are depicted on Figure 3 and Figure 4 of the Site Diagrams. Soil excavation limits are also depicted on Figure 3 and Figure 4 of the Site Diagrams.

Release and Extent of Soil and Ground Water Contamination: As stated above, two areas of PCE releases were identified, including inside the former dry cleaners suite and the landscaped area east of the former dry cleaners suite. In-situ soil treatment and remedial excavations were conducted, and the majority of the PCE-contaminated soils (approximately 63 tons) were removed from the two source areas. However, PCE concentrations above the MTCA Method A soil cleanup level remained in soils at boring TW-7 and well MW-5 located east and north of the former dry cleaners suite, respectively. Because the soil sample from well MW-5 was collected below the seasonal high water table and the ground water in this area is impacted, the detected PCE concentration in MW-5 may be due to the presence of contaminated ground water. However, further evaluation is needed in both areas to determine and/or delineate the remaining soil contamination.

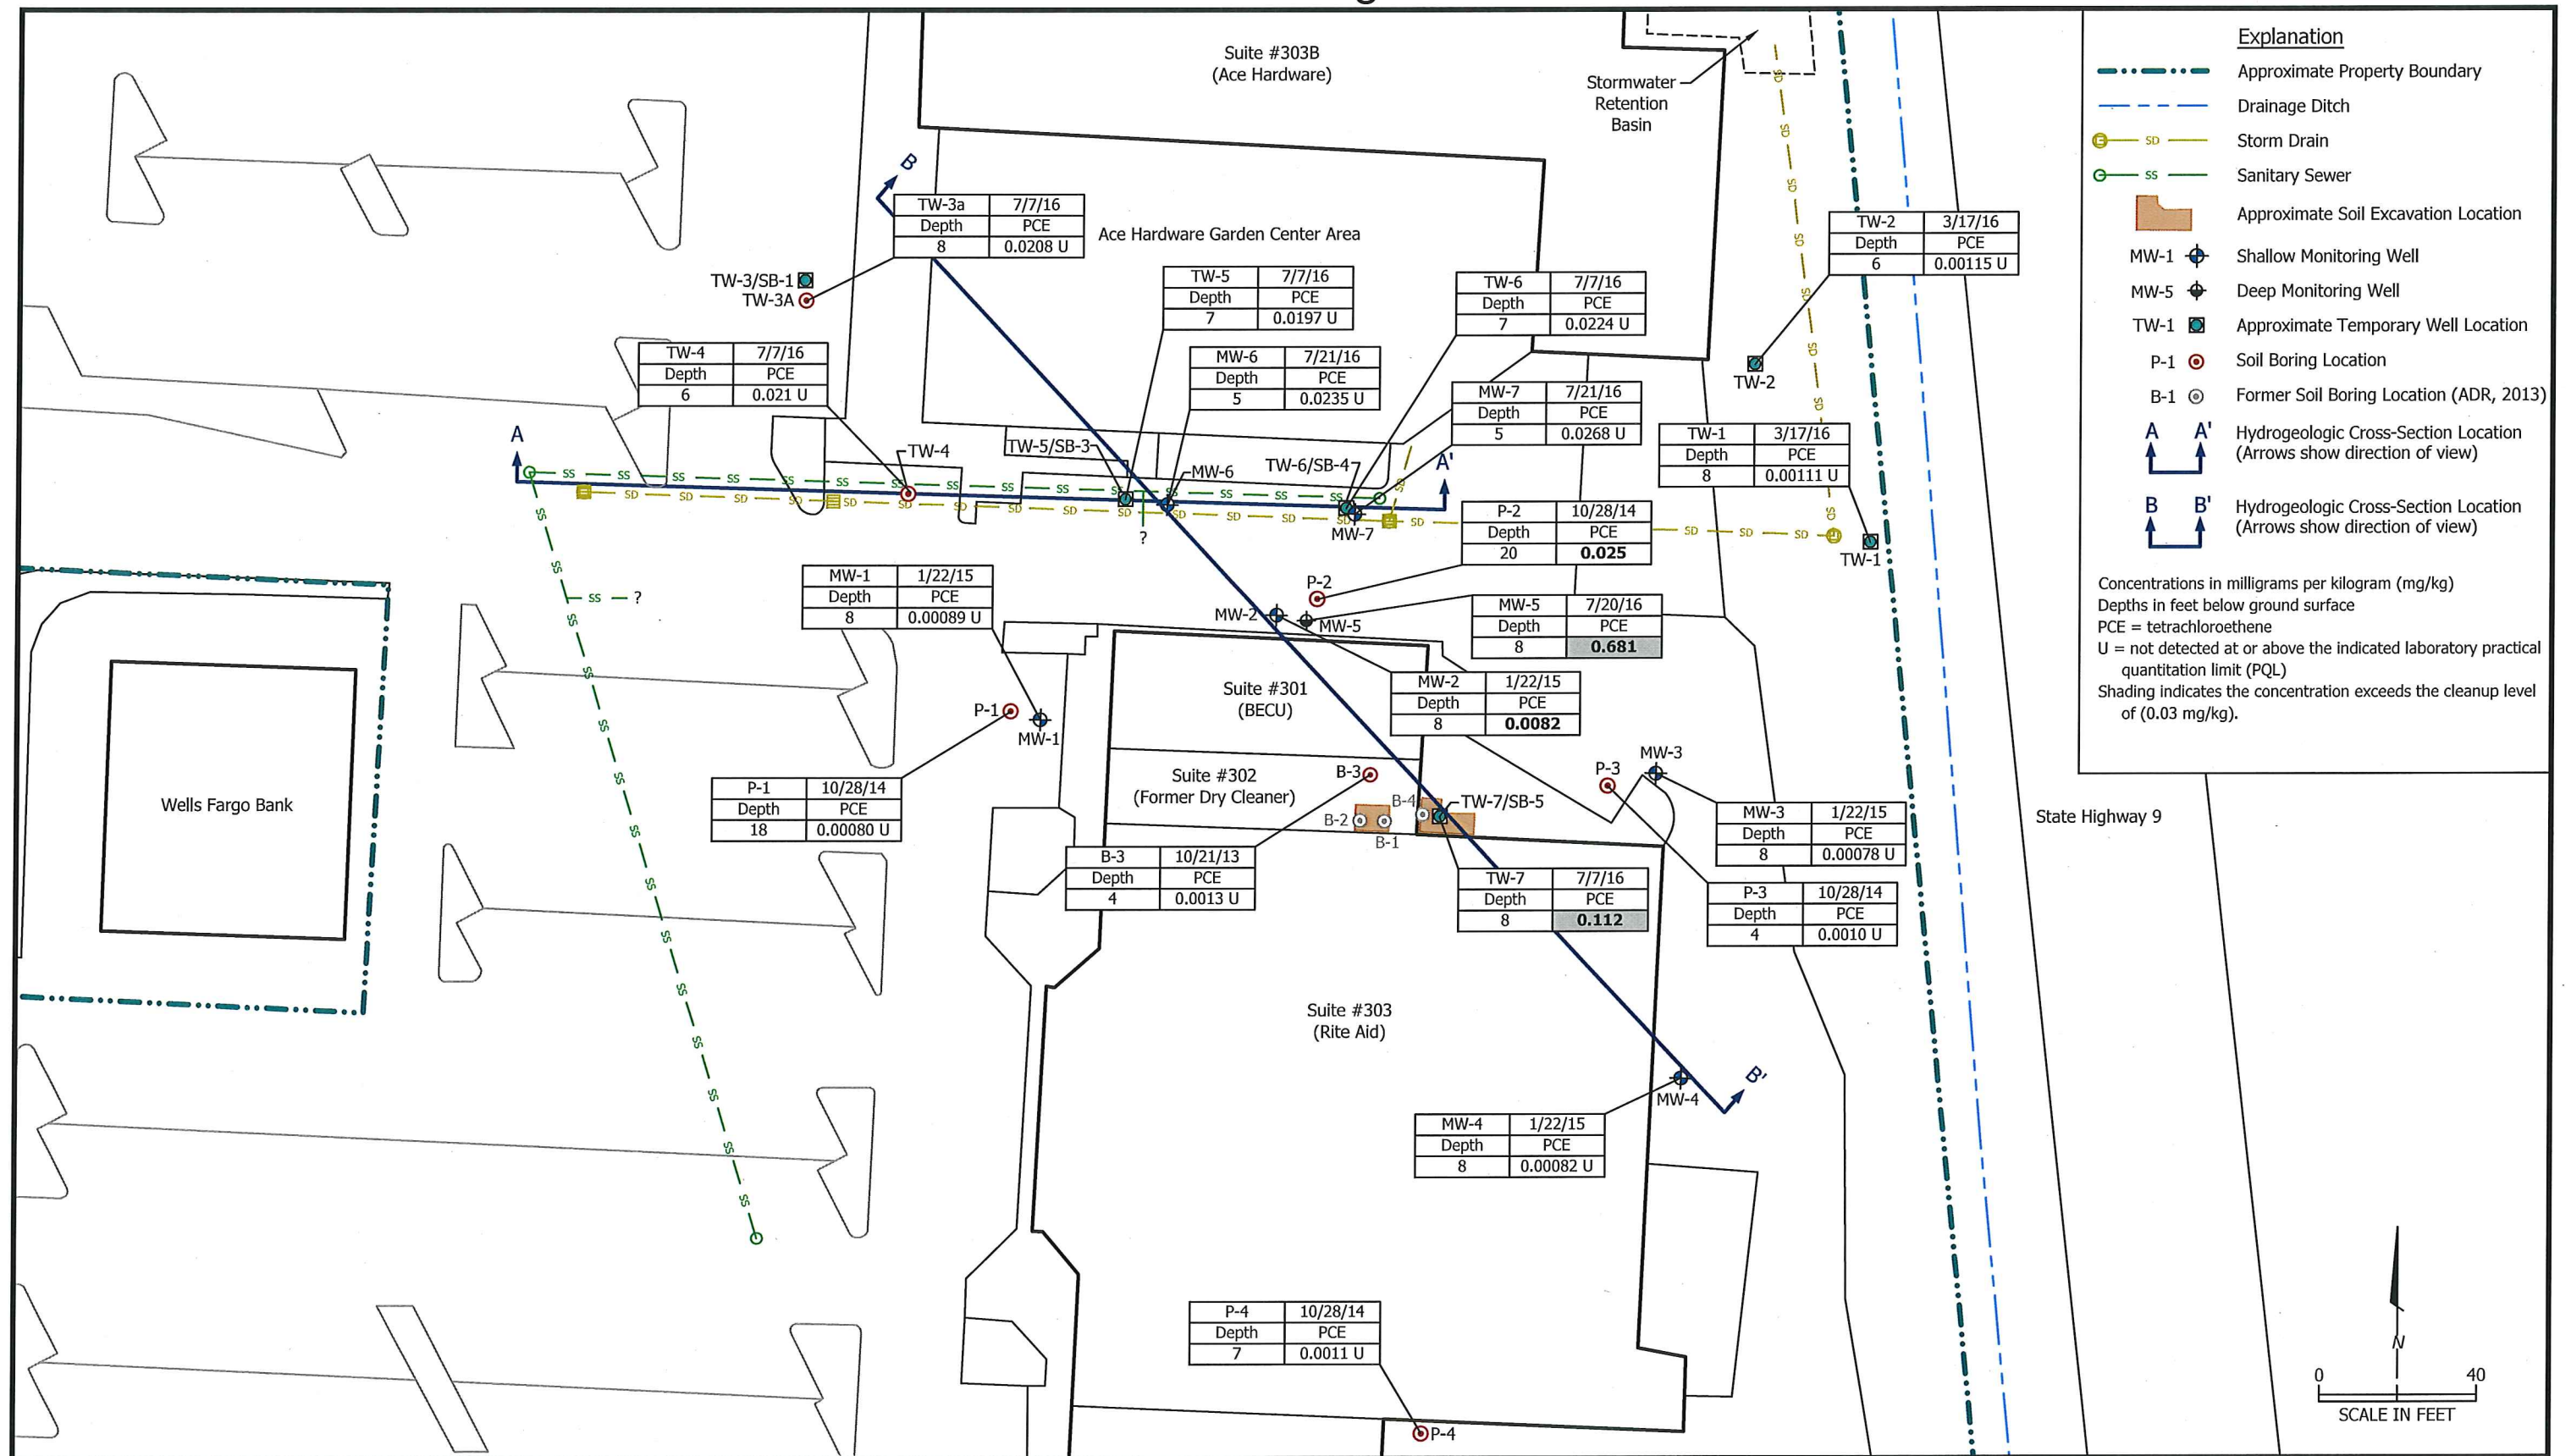
Enclosure A: Figure 4

PCE concentrations above the MTCA Method A ground water cleanup level are currently present in the ground water in monitoring wells MW-2 and MW-7 located north of the former dry cleaners suite. The vertical extent of the ground water plume is defined by the clean ground water data from deep monitoring well MW-5. The lateral extent of the ground water plume is partially defined by monitoring well MW-6 and temporary well TW-3 to the northwest, and temporary wells TW-1 and TW-2 to the northeast. However, the lateral extent of the ground water plume is not fully defined. Based on the variation of the ground water flow directions, additional monitoring wells may be needed northwest, northeast, and north of monitoring well MW-7.
