# PHASE I ENVIRONMENTAL SITE ASSESSMENT

Maryatt Industries 773 Valley Street Seattle, Washington

Nue 23, 1992

# **ROUX ASSOCIATES**

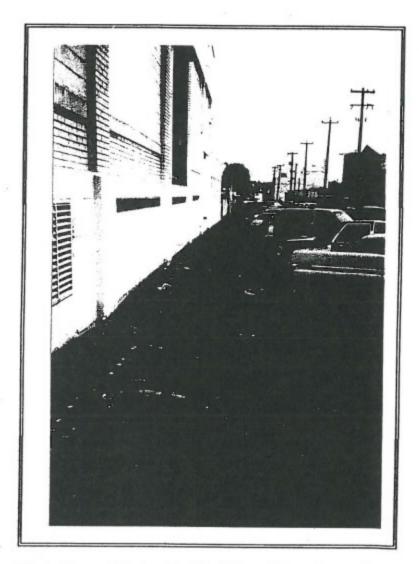
Photo 3. East wall of building. Note depression in sidewalk at middle of photo.

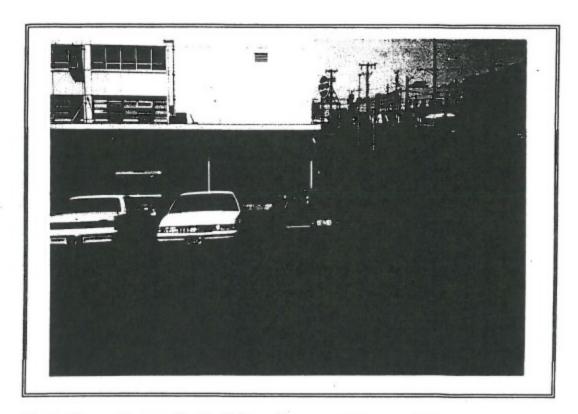
While examining the yard area, the presence of three underground fuel tanks was revealed to Roux by various Maryatt staff. Maryatt staff indicated that there were three tanks: one 500-gallon tank and two 1,000-gallon tanks. They were installed in about 1946 and reportedly were made of steel. A fuel island was positioned directly

over them near the current gate entrance. The estimated past location of the tanks and fuel island are shown on Photograph 6. According to Maryatt, while reconstruction of the yard area progressed, one of the fuel tanks was either cracked or partially crushed. At some later date, this crushed tank and the other two were removed. Fire department permit records indicate a 1990 removal date. According to Maryatt staff involved in the removal, additional soil was also removed from the yard area excavation and hauled off-site. No records were available related to the quantity of soil removed, the areal extent or concentrations of fuel in the soil, or whether the excavation extended into shallow graphd water.

- The use and storage of mel on-site in the past in the yard area is of concern since there was little documentation available which identifies the extent of the fuel found in the subsurface (if any) after the tank removal. Based on comment from various Maryatt personnel, there may have been an extensive fuel release. We conclude it is very likely that fuel, possibly both gasoline and diesel, were released into the subsurface at the former fuel tank site. Prior to the construction of the fuel island in about 1947 (now removed), it is not clear whether or not fuel was used or stored on-site at that location or elsewhere on-site.

Photo 6. East wall of building. Former underground storage tank location and fuel island.

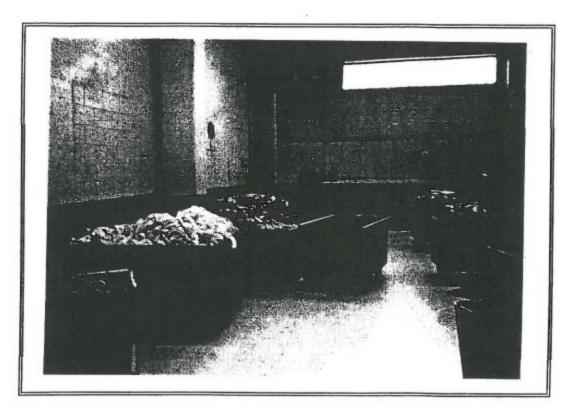
- The use of solvents has been discontinued at the Site, but the former use, handling and disposal is only partially known. Little specific information regarding the disposal of solvents in the past was available. Without specific information regarding the solvent operations, a significant unknown potential for Site contamination remains.

Photo 10. Former dry cleaning location.
