CITY OF SEATTLE

SITE INVESTIGATION TO ASSESS SOIL CONTAMINATION
AND LOCATE UNDERGROUND STORAGE TANKS

802 ROY STREET
PARKS DEPARTMENT SHOPS COMPLEX
SEATTLE, WASHINGTON

May 1992

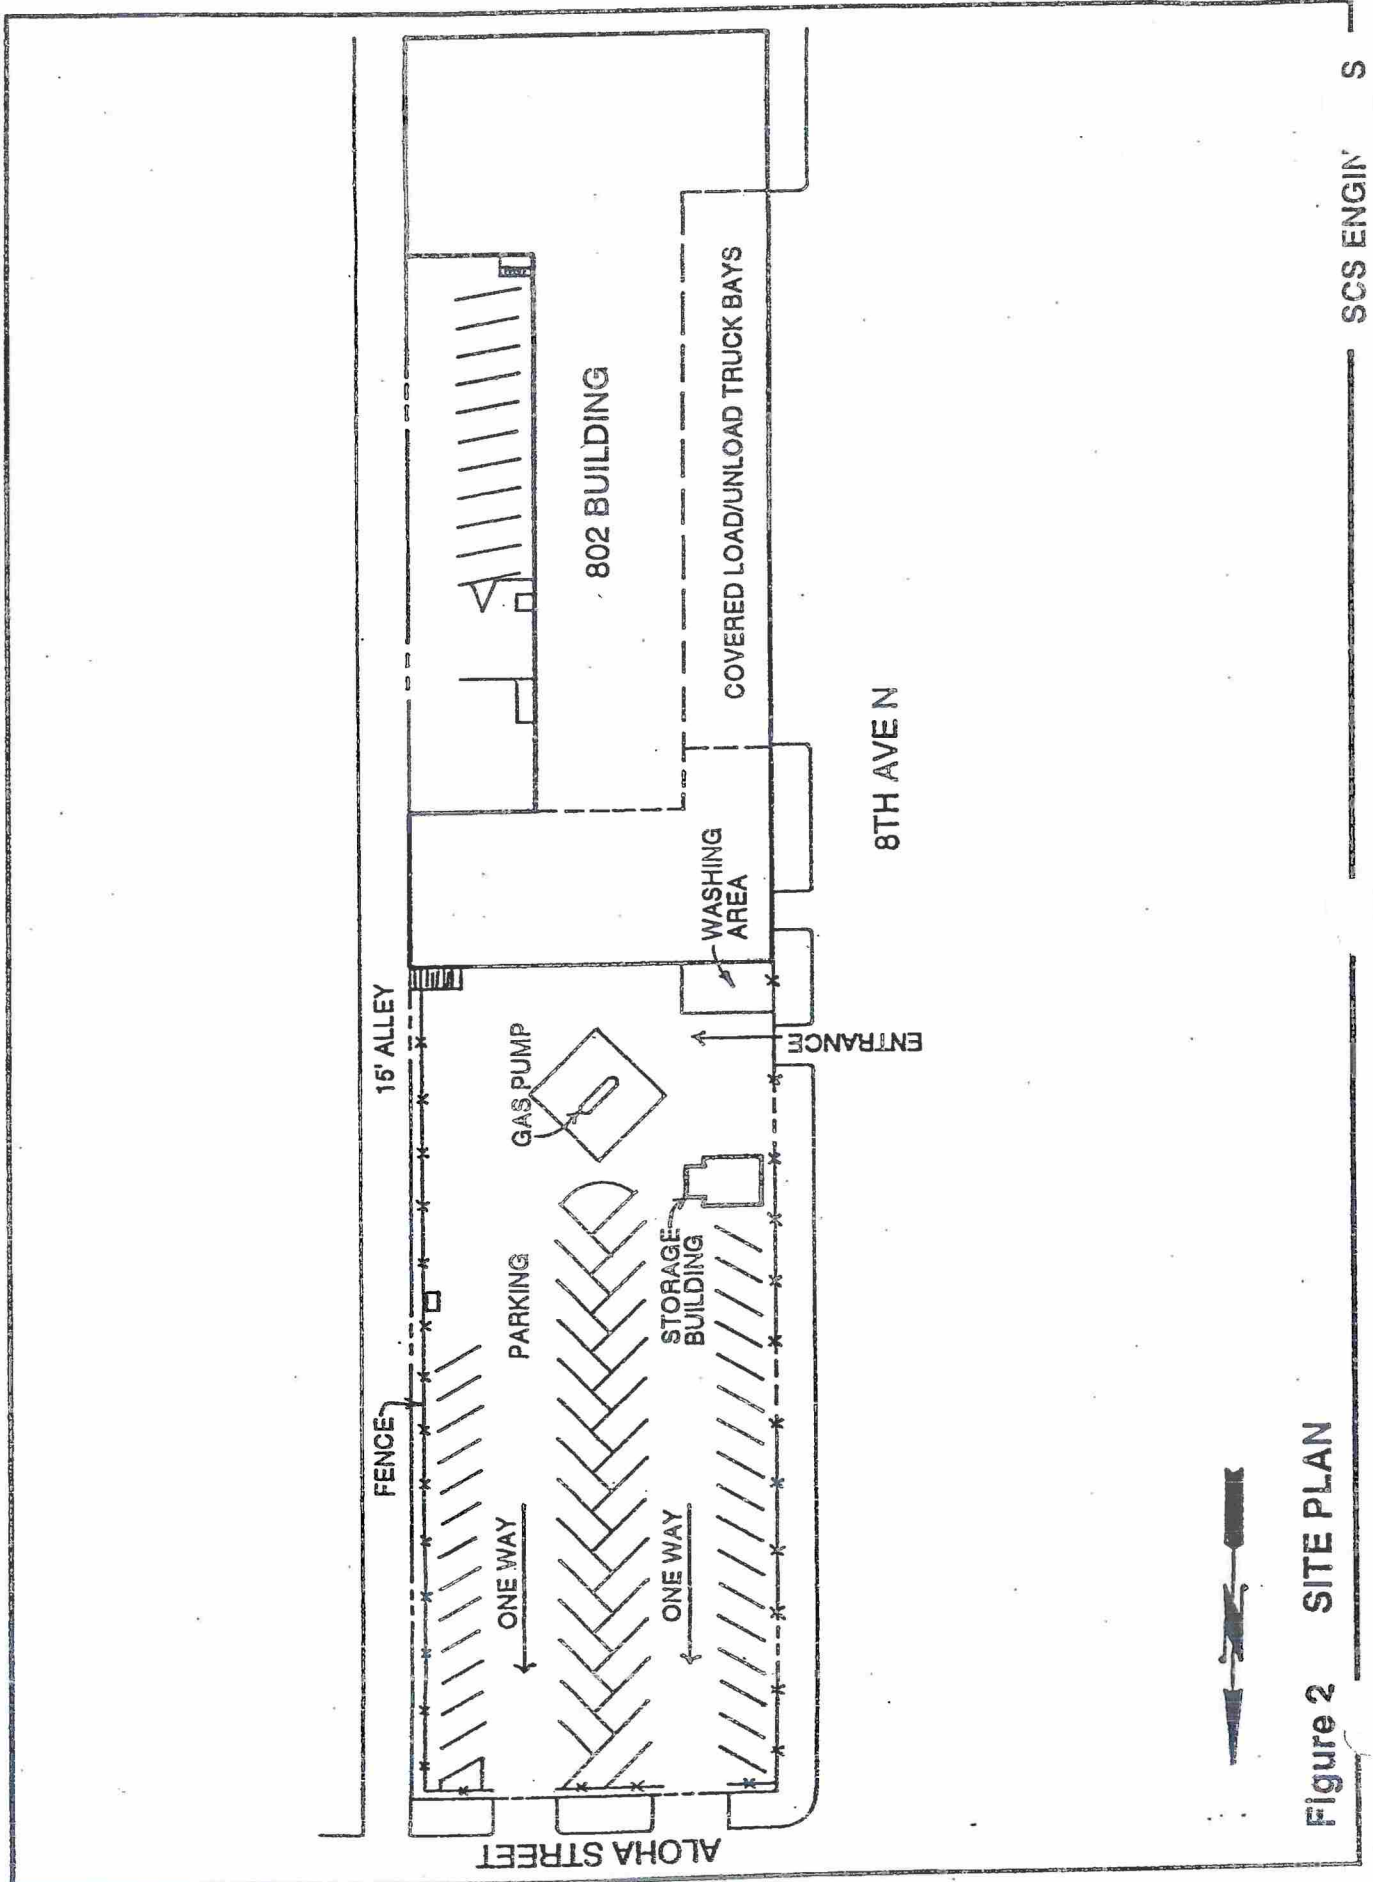
Figure 2 SITE PLAN

This investigation was conducted at the City of Seattle Parks Department Shops Complex located at 802 Roy Street in Seattle, near the south end of Lake Union. A site map of the facility is illustrated in Figure 2.

The Roy Street Shops Complex is situated on about a one acre parcel of property that includes an administrative office building and adjoining service shop, a truck bay area on the west side of the main building and a ten stall vehicle parking area on the east side of the building. The main vehicle parking area and fueling service area is located adjacent to the north end of the service shop building.

The existing fueling system consists of one 2,700-gallon unleaded gasoline tank, one fuel pump, and a service island. The tank dimensions are six feet diameter by approximately 12 feet in length. According to an engineering drawing provided by the City, the existing tank was formerly used as a lard cooking unit and was intended to be fabricated for use as a gasoline storage tank. The drawing is dated January 24, 1944 and was prepared for Puget Power & Light Company.

Another drawing, also prepared for Puget Power & Light Company, indicates existing conditions as of June 1955. This drawing shows that the tank is located approximately 20 feet from the north end of the building. The bottom of the tank rests on an inverted concrete saddle at a depth of 14 feet. A vent line extends from the tank to the north wall of the service building. These plans also indicate the presence of a 550-gallon gasoline tank at the northwest corner of the service shop.

This 550-gallon abandoned UST was located at the site during a recent visit. A fill cap and a vent line were observed in the northwest corner of the service shop. The tank bottom is eight feet below the ground surface and is currently empty. Small particles of rust and a gasoline odor were detected on the bottom of a tape which was inserted into the tank. An engraved metal tag tied around the fill pipe reads "Do not fill- tank leaks".

A December 1967 engineering drawing, prepared for City of Seattle Department of Lighting shows approved plans for the installation of a 4,000-gallon diesel fuel tank and piping system at the site. The tank location is adjacent to an Oil Storage Building (existing storage shed), approximately 60 feet north of the main service building on the west side of the property.

The 1967 plans also show a different configuration for the existing fuel pump island than the older drawings. The 1967 drawing shows the pump island as it now exists. It is situated in a northeast-southwest position and is oblique to the underground tank. The 1944/1955-updated drawing shows a pump island parallel to the tank, between the tank and the service shop. The drawing indicates that the old pump island was located where the fuel line valve box presently exists.

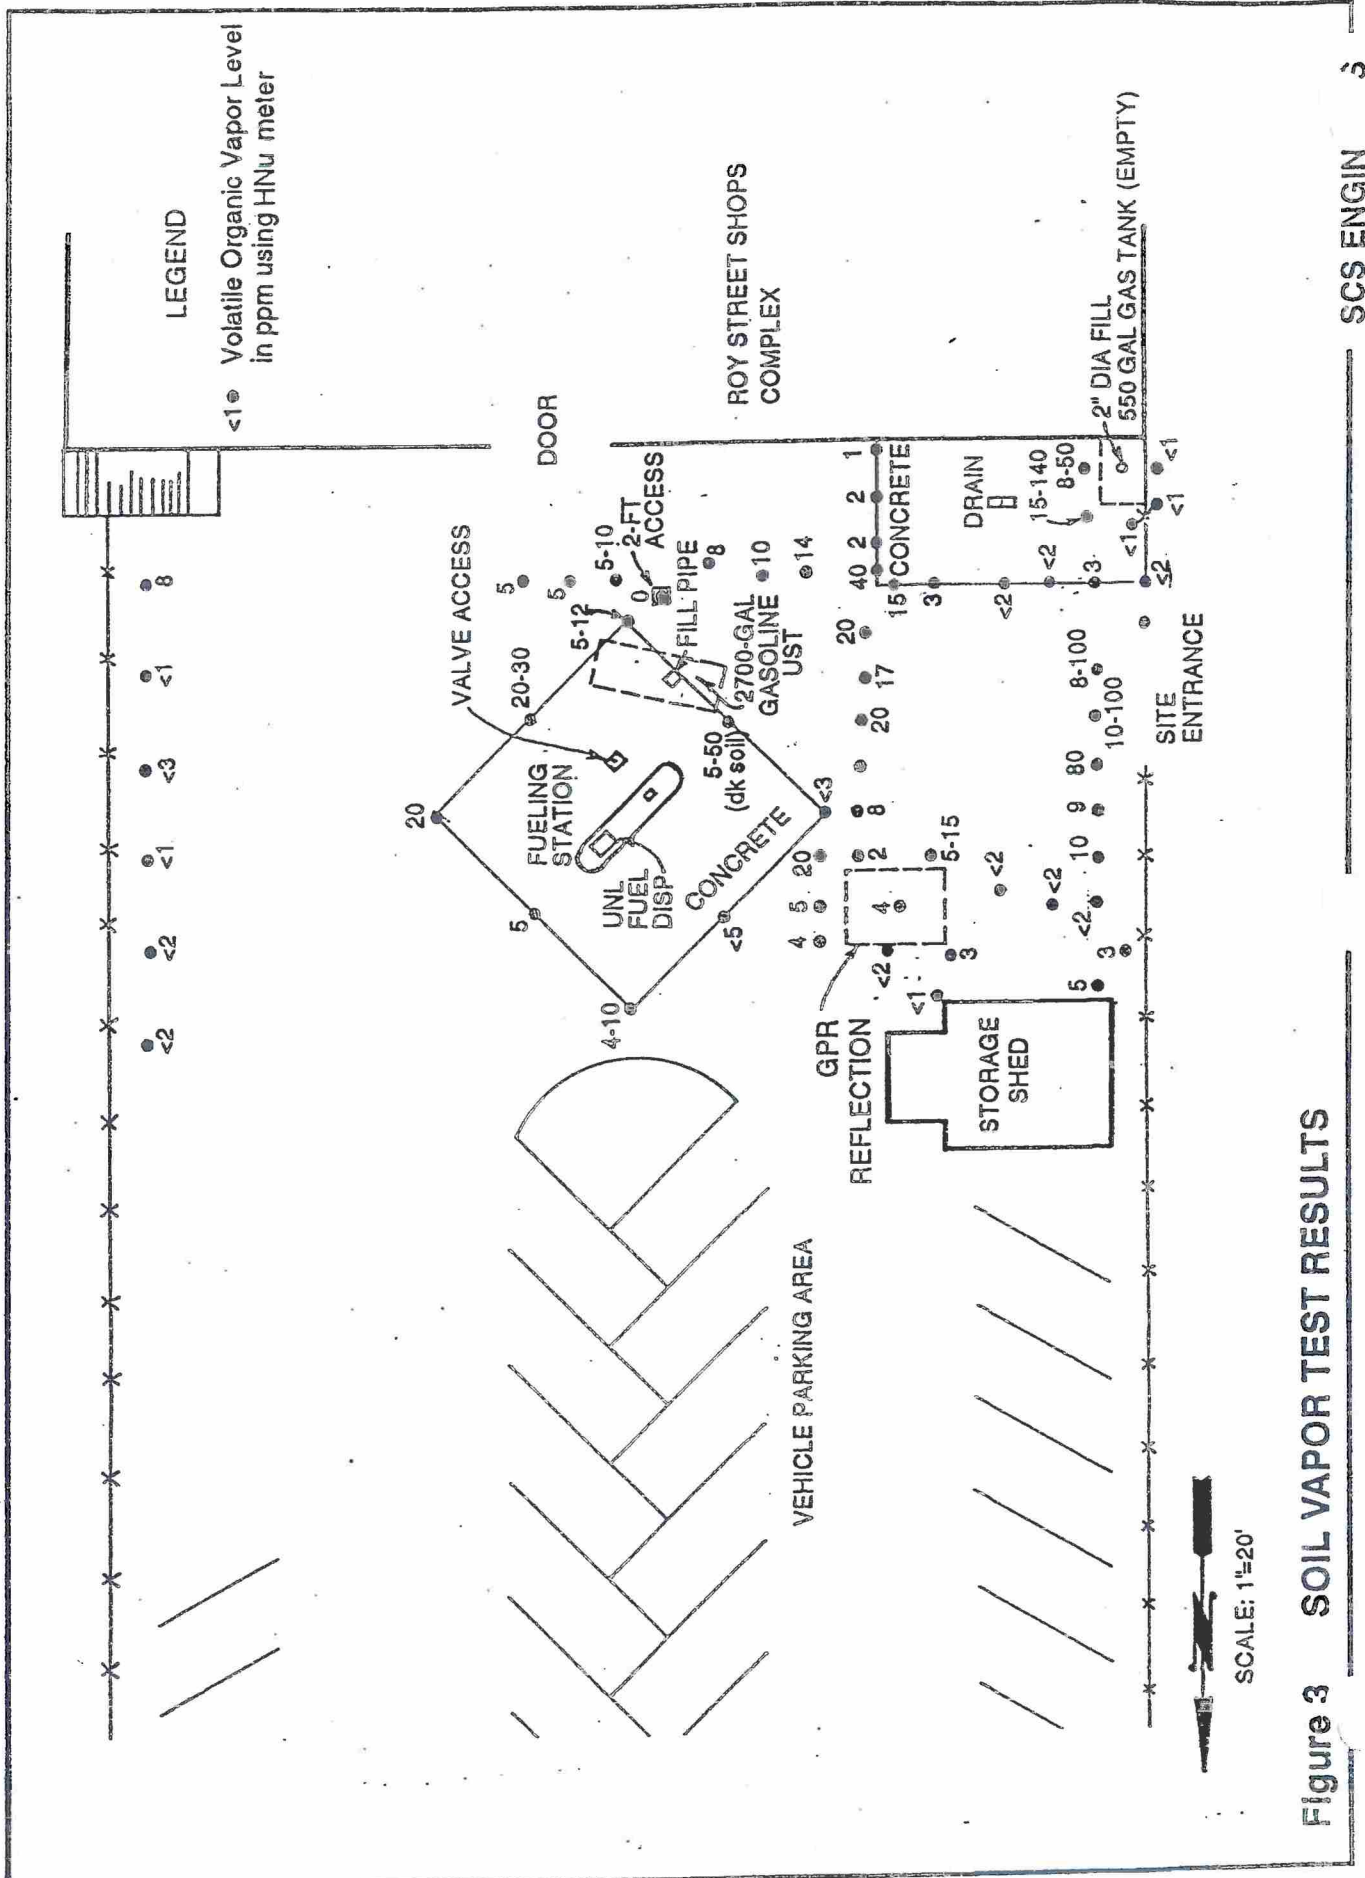
Figure 3 SOIL VAPOR TEST RESULTS

A soil vapor survey was conducted at the site by SCS Engineers on April 28, 1992. A total of 62 locations were tested for the presence of volatile organic vapors in the shallow subsurface soil at the site. The locations and results of the survey are illustrated in Figure 3.

Several transect lines are shown in Figure 3 which illustrate the area traversed. Test locations were usually spaced five to ten feet apart, except for around the fuel island where each test location was separated by a distance of 15 feet.

Soil vapor test results ranged from no detection to 140 ppm. The results indicate that the property does not appear to be extensively impacted by gasoline spills or fuel leaks. Readings around the fuel island and existing underground tank ranged from less than 5 ppm to 30 ppm. Volatile organic vapors in this area are likely from infiltration of product drippings from re-fueling activities, routine vehicle service, or traffic in the yard.

The highest levels of volatile vapors were recorded near the abandoned 550-gallon underground tank and the area at the gate entrance on 8th Avenue, about 20 to 30 feet north of the tank. Volatile organic vapors were recorded up to 140 ppm on the east side of the tank and up to 100 ppm near the main gate. The high vapor readings appeared to be isolated and were limited to within about 10 feet in any one direction.

Soil vapor readings around the GPR anomaly in Area B, southeast of the storage shed, suggest that the soil is not significantly impacted by lighter fraction petroleum hydrocarbons, such as gasoline. This was the approximate location of a 4,000-gallon diesel tank, shown on the 1967 engineering drawing.

Six locations were also tested along the east property boundary for volatile vapors. This area was selected for testing to assess the possibility of any off-site migration of contamination because of the eastward slope of the surrounding topography. The readings ranged from <1 to 8 ppm, which are very low and insignificant levels of volatile organic vapors.

The soil vapor survey indicated the presence of moderately high volatile vapors on the east side of the abandoned 550-gallon tank and near the center of the main gate entrance. This is an indication that subsurface soils in these areas could be contaminated with petroleum hydrocarbons.

- Proceed to abandon and decommission the 550-gallon UST in accordance with State regulations. Since there is evidence of soil contamination adjacent to the tank, we recommend to excavate the tank only if it does not involve disrupting or otherwise undermining the foundation to the service shop building. The soil adjacent to the tank should be tested for BETX (benzene, ethylbenzene, toluene, and xylene) and total lead contamination, since the tank previously stored gasoline.

- Excavate a shallow test pit at the main gate to inspect for subsurface soil contamination. Collect and test several soil samples from the excavation to document levels of petroleum hydrocarbon (BETX and TPH) contamination.

- Excavate the area just south of the storage shed to determine if an abandoned UST is present. If present, proceed to properly abandon and decommission the tank in accordance with State regulations.

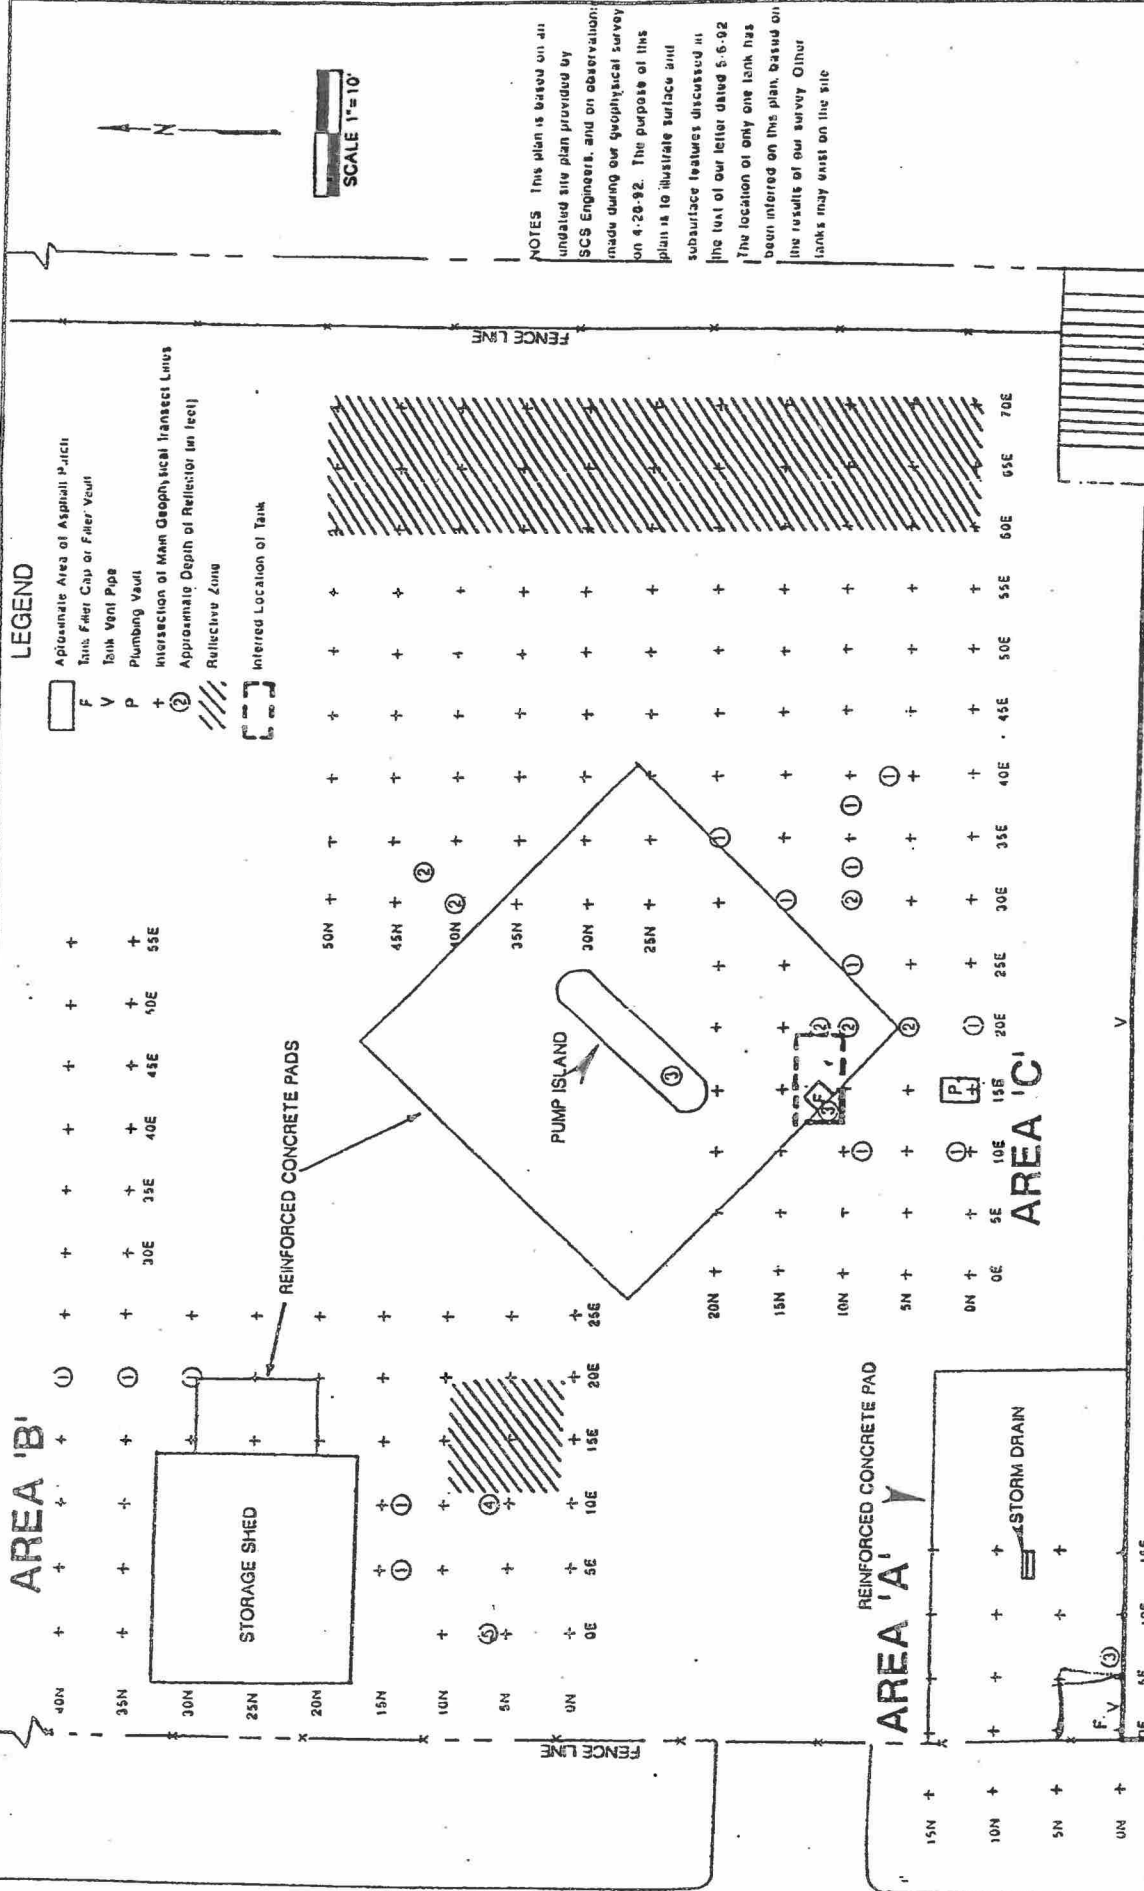
SITE PLAN
 ROY STREET SHOPS COMPLEX
 SEATTLE, WASHINGTON

Three general areas were explored in the southern portion of the north parking lot. Area A is located immediately north of the northwest corner of the existing complex. Area B is around a storage shed, north of Area A. Area C was around and east of the existing pump island. The exploration grids, mapped reflection depths, and pertinent site features are shown on the attached Site Plan.

Area A is surfaced with a steel reinforced concrete slab. A filler cap and vent pipe are visible at the southwest corner of Area A. Based on tape measurements obtained through the filler cap, it was determined that the tank was installed at least four feet below the ground surface. Due to the concrete slab and rebar, the penetration depth of the GPR was reduced to less than four feet. This was not deep enough to image the tank, despite its apparent location.

A very shallow reflective point, about six inches below the surface, was imaged at grid location 6N, 0E. In general, the area where the tank was expected to be, displayed very poor reflectivity. A faint, hyperbolic reflection was detected four feet down at 6N, 10E. This is near the east end of a tank shown on the as-built plan. The zone immediately east of the poorly reflective area is highly reflective, indicating a sharp change in subsurface conditions. It appears that the Area B tank was backfilled with a non-reflective, or absorbing, material such as concrete or wet clay.

As in Area A, the concrete pad limited the penetration depth of the GPR. However, a hyperbolic reflector characteristic of a tank was detected just outside the limits of the pad at 10N, 12E. In addition, a two foot deep reflector was encountered along the 20E grid alignment between ON and 15N. This shallow reflector aimed towards a tank vent, which was visible on the side of the existing shops building. Based on the partial tank image, the location of the filler cap, and the vent alignment, it appears this tank was installed as shown on the as-built, with its long axis oriented east-west.

Further survey of Area C encountered old and new, shallow piping. A reflective zone was also mapped between gridline 60E and 70E. This area of high amplitude reflection appears to be a drainage pipe alignment surrounded by very wet soils.
