PES Environmental, Inc.
Engineering & Environmental Services

July 20, 2011

**2011 FINAL COVER INVESTIGATION AND EROSION REPAIR REPORT
LEACHATE GENERATION REDUCTION CONSTRUCTION PROJECT
CLOSED OLYMPIC VIEW SANITARY LANDFILL
KITSAP COUNTY, WASHINGTON**

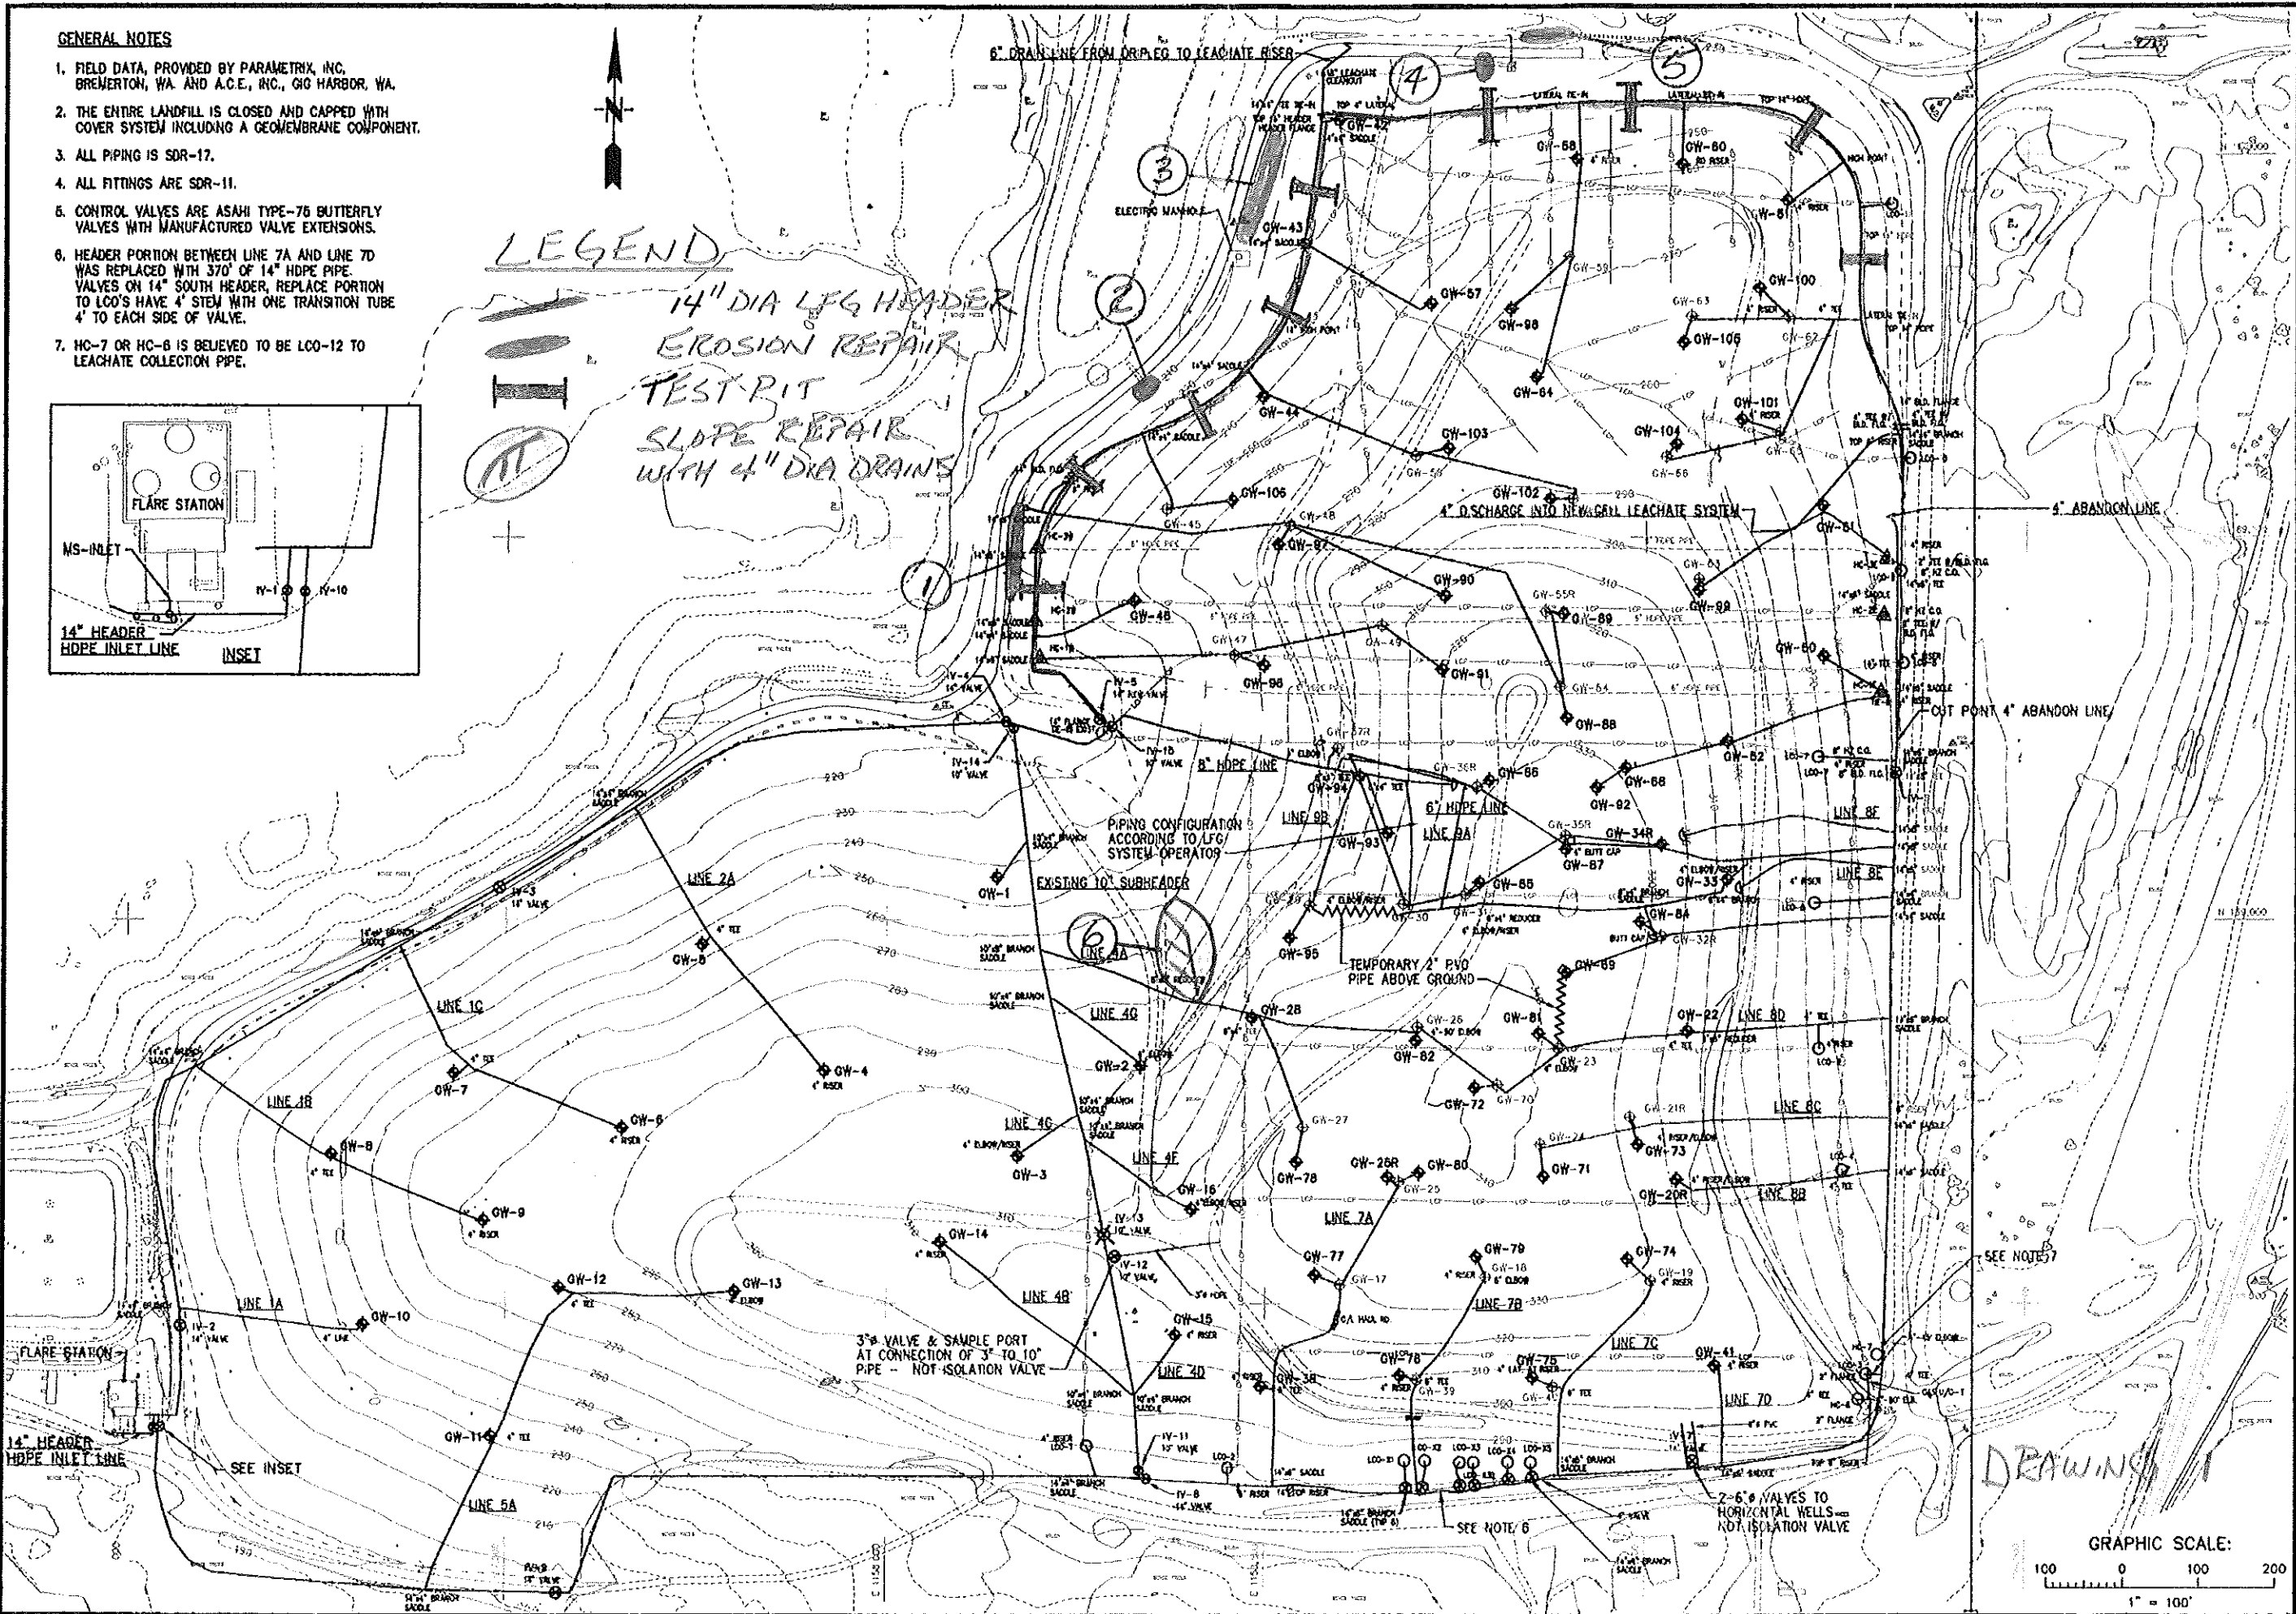
SHEET TITLE
GAS CONVEYANCE PIPING PLAN

In all 10 test pits, PES found no indication that the final cover had been removed to install the LFG header, or that the final cover geosynthetics were otherwise disturbed, removed, repaired, or damaged in any way. Seams for the geocomposite panels were oriented down the slope (perpendicular to the slope contours), which is consistent with the orientation you would expect for the initial installation. If the final cover was removed at some point to install the LFG header, we would have expected to see seams in the geocomposite that ran parallel to the LFG header pipe, but in no case did we find that condition. In four test pits, a 20-foot long knife-cut was made through the geocomposite to investigate the geomembrane barrier condition. In all four cases, a textured geomembrane was found directly under the geocomposite, and in one case we found a geomembrane seam that was also oriented down the slope, which again would be consistent with the initial geomembrane installation. In the other six test pits, short (less than 12-inches) slits were cut through geocomposite to confirm the geomembrane was in place, which it was.

During the winter of 2010 and 2011 storms caused minor erosion damage at the landfill. Most of this damage occurred as a result of a 24-hour, 7-inch rainfall that occurred in December of 2010. The damage generally involved soil erosion and displacement of erosion control rock in drainage ditches. The drawing in Attachment 1 indicates areas where erosion repair was completed. In general the work involved installing, or replacing erosion control rock in areas where the existing erosion control rock had eroded or was displaced.

In addition to the erosion problems discussed above, two small areas of final cover began to show indications of instability and sloughing of the surface soil. These areas are just east, and outside of the final cover repair work completed by PES in 2010, and is identified as Area 6 on the drawing in Attachment 1. These areas were no greater than 500 square feet in total area, and did not appear to be increasing in size as of June of 2011. The cause of this slope failure is undetermined, but was likely due to the soil cover becoming saturated and unstable during the 7-inch rainfall event.

1. Area 1 – Existing crushed concrete (3/4-inch minus) installed in this 2 percent sloped ditch was displaced by stormwater. The crushed concrete was replaced with 2 to 4-inch sized erosion control rock.

2. Area 2 – Existing 3 to 6-inch rounded erosion control rock installed at a drop inlet was displaced. The rounded erosion control rock was replaced with 4 to 8-inch angular erosion control rock. An additional layer of 16-ounce geotextile was placed over the existing geocomposite drainage layer and under the 4 to 8-inch angular erosion control rock to provide additional puncture protection for the geocomposite/geomembrane lined ditch.

3. Area 3 – An over-steepened slope had eroded. The area was re-graded to flatten the slope.
4. Area 4 – A short section of steep ditch eroded. The steep areas were lined with 4 to 8-inch erosion control rock, and flatter areas entering and exiting the ditch were lined with 2 to 4-inch erosion control rock.

5. Area 5 – A ditch at the outlet of a culvert had eroded. The ditch was re-graded, lined with a layer of 16 oz non-woven geotextile, and covered with 4 to 8-inch rock at the culvert outlet, and 2 to 4-inch erosion control rock downstream of the larger rock.

- Installed approximately 300 lineal feet of 4-inch diameter geotextile-wrapped perforated ADS drainage pipes in trenches excavated to the base of the final cover soil;

- Placed the perforated pipes in direct contact with the geocomposite drainage layer and at a slope to drain into an existing stormwater control ditch;
- Backfilled the trenches; and
- Re-graded and compacted the sloughed soil cover.
