SCS ENGINEERS

June 19, 2007

Subject: Summary of Completed Work
Landfill Gas System Repairs, Modifications & Investigation
Olympic View Sanitary Landfill

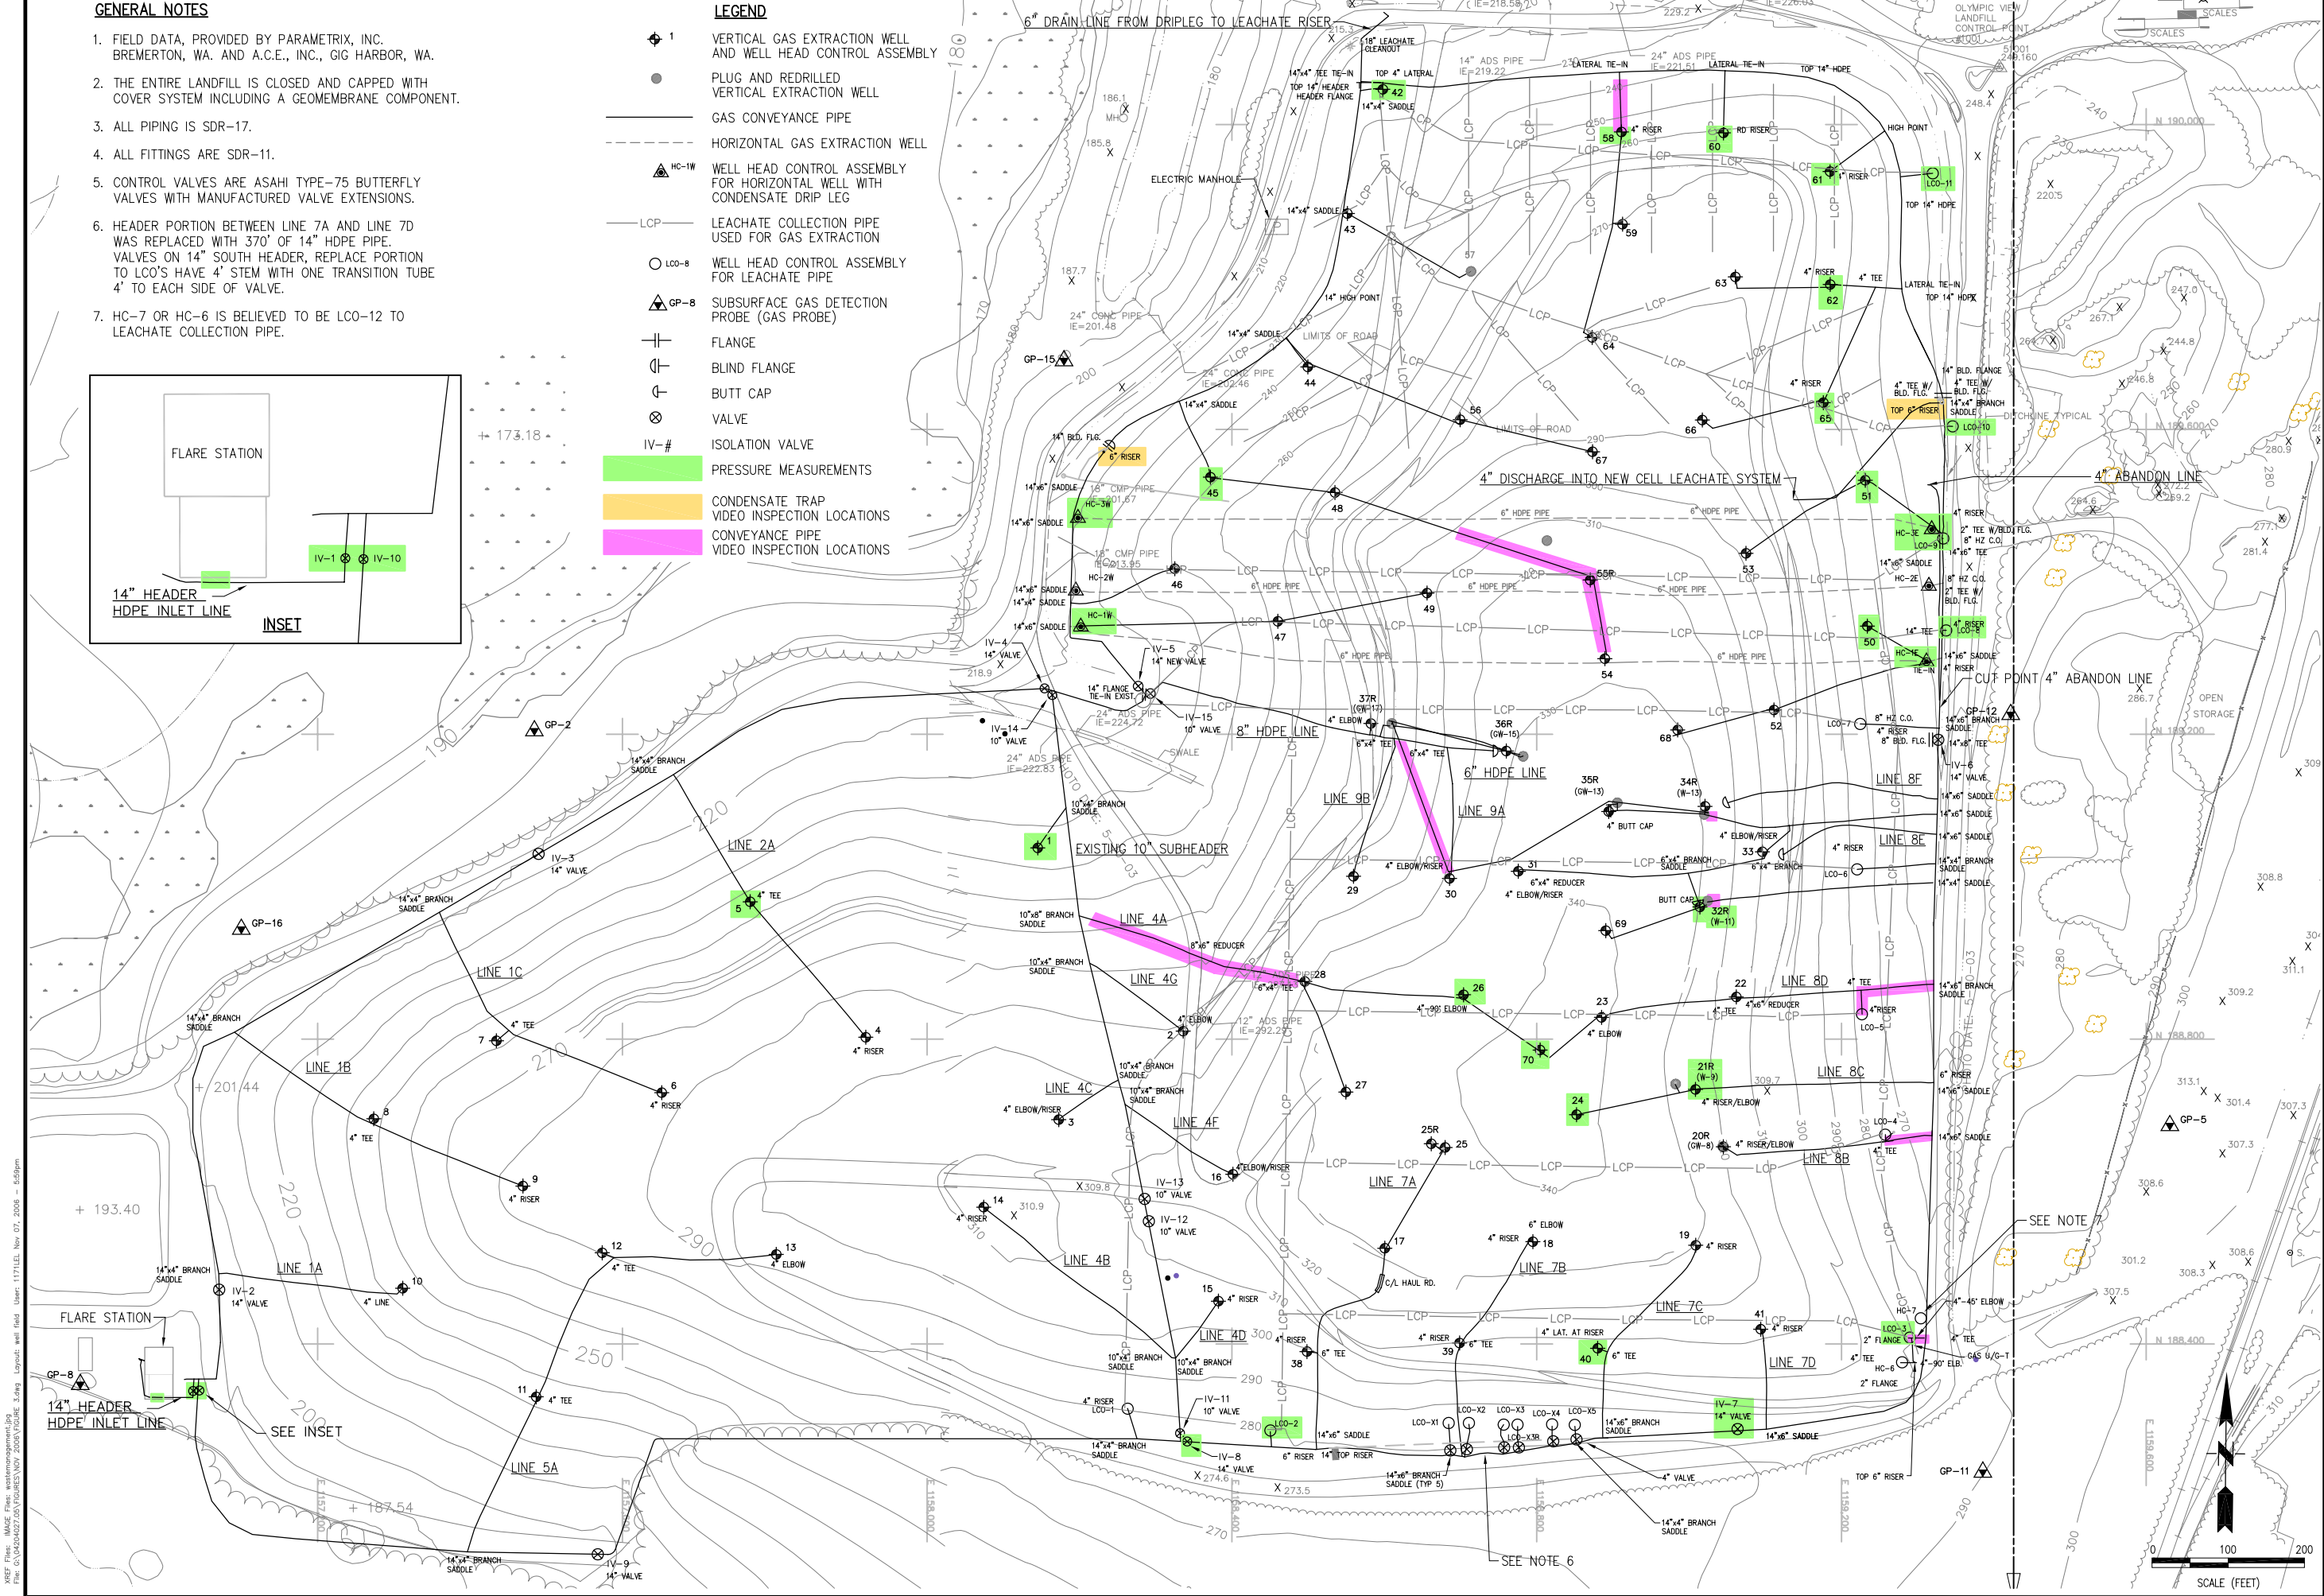
In lieu of this approach, SCS: a) took pressure measurements at well heads near the header pipe and lateral pipes; b) took measurements at newly installed sampling ports; c) tested condensate drain traps; and d) performed a video inspection to locate pipe with obstructions and identify the cause of obstructions. Figure 1 shows the location of pressure measurements, condensate drain traps, and segments of pipe inspected by video camera.

SCS measured pressure (i.e., system vacuum) at select locations along and near the header pipe to identify segments of lower vacuum indicating problems of pipe obstruction. Low pressures and surging pressures were observed along segments of the header pipe near the condensate traps on the west side and east side of Phase 2 (near HGW-3W and LCO-10). Low pressure was also observed at VGW-32 and VGW-58. Table 4 provides a list of monitoring results and comments relative to each location.

The above activities found a partial condensate obstruction of the header pipe at CT-1. Water is backing up into the header pipe at this location when operating under a vacuum of -22.5 in. H₂O at the flare station. Since there is adequate drainage from this condensate trap, this indicates that there is not enough elevation difference between the invert of the header pipe and the invert of the discharge pipe from the trap. This partial obstruction becomes greater when the system is operated at higher vacuums and causes reduced vacuum distribution to lateral pipes and associated wells in the vicinity (VGW-42, 43, 44, 45, 46, 47, 48, 49, 54, 55, 56, 67, HGW-1W, 2W, and 3W). This can result in less extraction (i.e., less flow) of landfill gas from affected wells.

Inspection also identified a blocked pipe on the lateral to VGW-58 near the junction of the header pipe. The obstruction is due to a crimped pipe and causes reduced vacuum distribution to wells VGW-58, VGW-59 and VGW-64. This can result in less extraction (i.e., less flow) of landfill gas from affected wells.

In addition to this, inspection identified a blocked pipe on the lateral to VGW-32. The obstruction is due to condensate and causes reduced vacuum distribution to wells VGW-32 and VGW-69. This can result in less extraction (i.e., less flow) of landfill gas from affected wells.

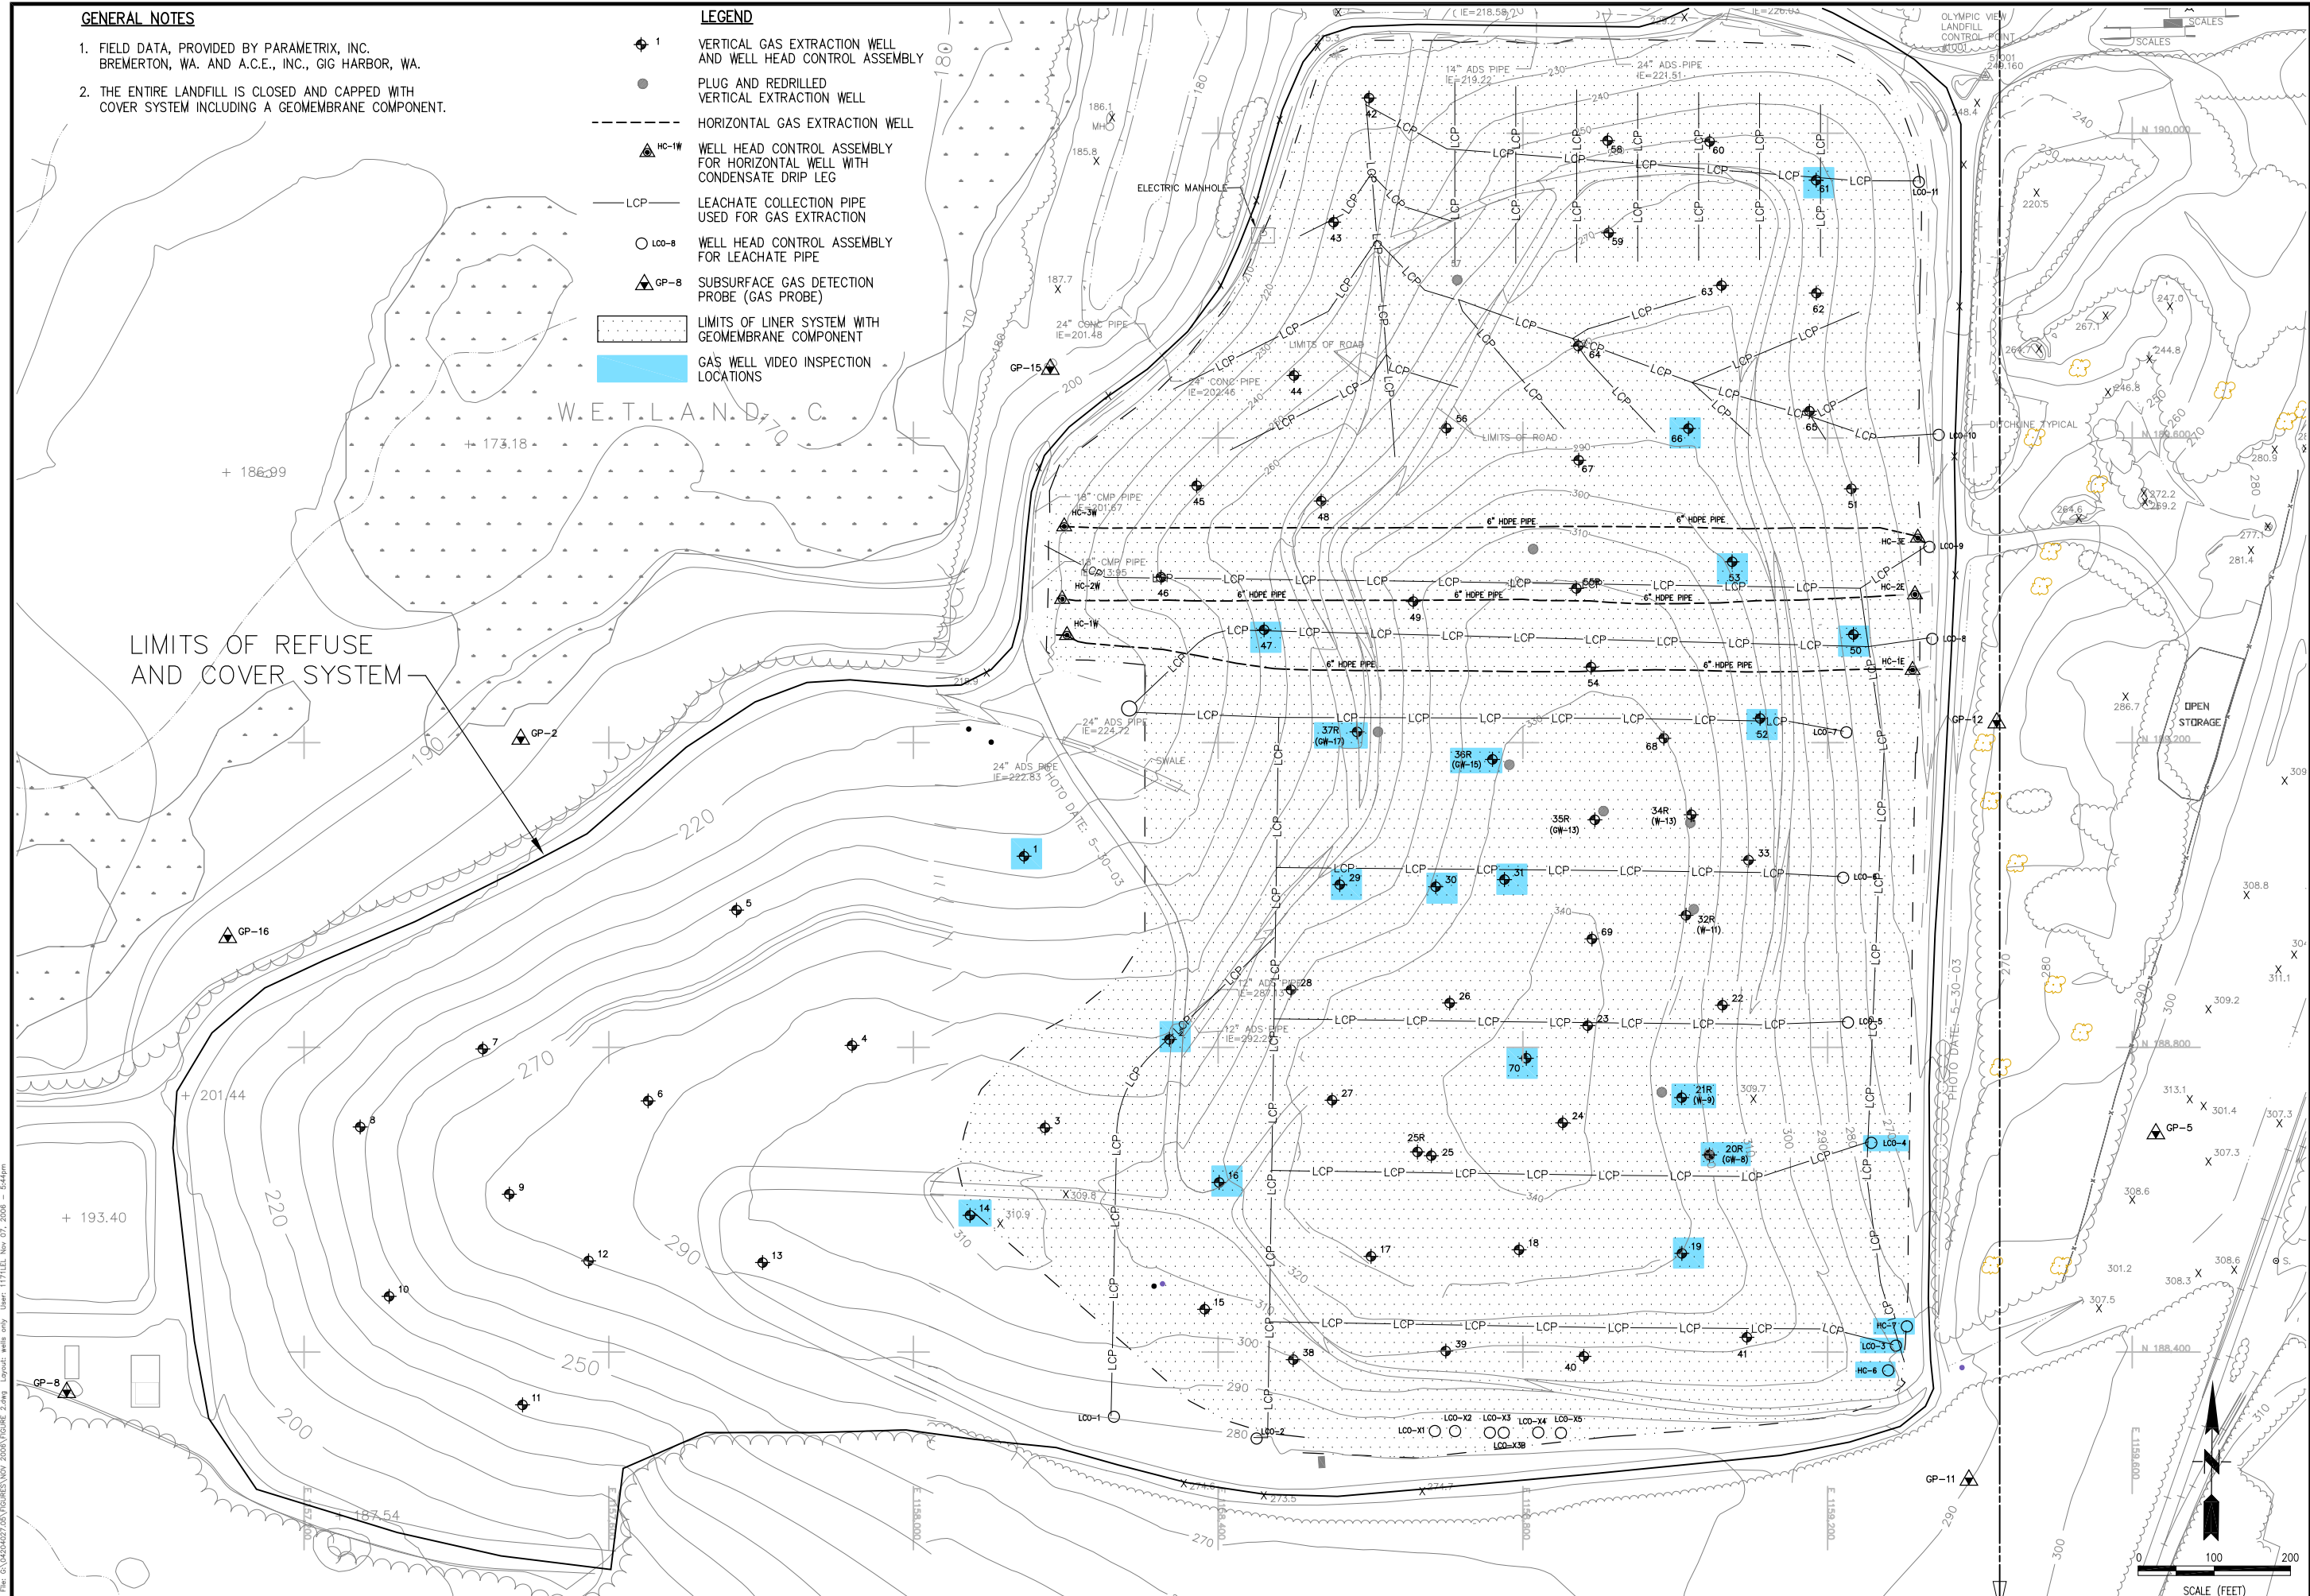
SCS performed down-hole camera inspection of 19 vertical well casings believed to be pinched, contain water obstruction, and/or be separated. SCS inspected vertical gas wells 1, 2, 14, 16, 19, 21, 23, 29, 30, 31, 36, 37, 47, 50, 52, 53, 61, 66, and 70. SCS also performed video inspection on horizontal gas wells HGW-6 and 7 as well as leachate cleanouts LCO-3 and 4.

The above activities have found substantial obstructions in 12 of the 19 vertical gas wells. All of these obstructions were due to collapsed or crimped pipe. The majority of these obstructions (7 of 12) were above the perforated pipe, thus restricting flow substantially.

Results also found a substantial obstruction in 1 of the 4 horizontal gas wells. This obstruction was due to collapsed corrugated pipe (HGW-7). Partial obstructions due to water were found in two of the horizontal gas wells.
