**PERIODIC REVIEW REPORT
FINAL**

**Dickman Mill
Facility Site ID#: 74734464
Cleanup Site ID# 3112**

**2423 Ruston Way
Tacoma, Washington 98421**

December 2017

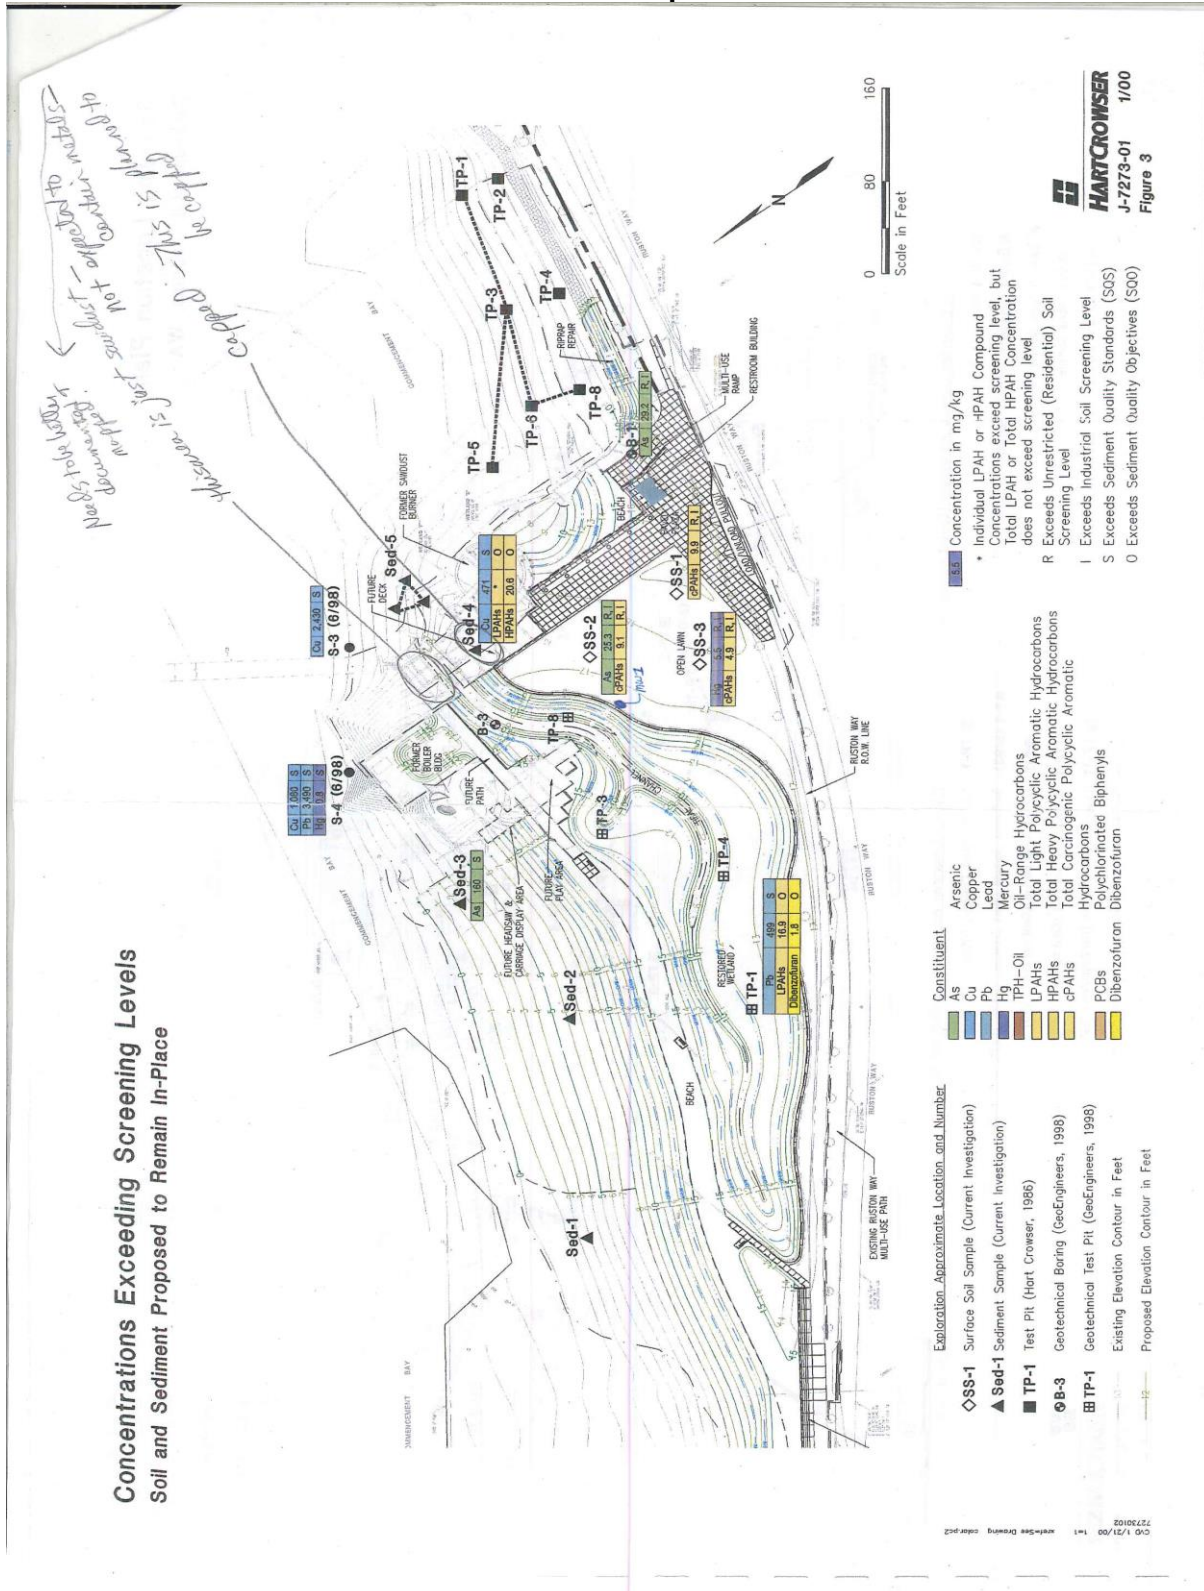
Locations of Contaminant Concentrations left-in-place

In addition, an estimated 1,675 cubic yards of contaminated materials were over excavated from below the design subgrade from grids 2 through 13 within the tidal channel as part of the cleanup action. Areas of proposed for over excavation with contaminant concentrations exceeding screening levels, a cross-section of over excavation areas, and proposed areas where the contaminant concentrations will remain in-place exceeding screening levels are shown in Appendix 6.9.

The over excavation was conducted to remove the buried shredded creosote timber, lead (1,680 mg/kg) and petroleum (oily wood waste and saw dust) contaminated sediments within the tidal channel at least 2 feet below the design elevation to cap the remaining contaminated material with 2 feet of clean cap material to the designed elevation. Performance and conformational sediment samples were collected to determine the final contaminant concentrations remaining in the tidal channel and wet land areas 2 feet below the design grade/elevation. The performance and conformational sampling locations and results in the tidal channel and wet land areas are included as Appendix 6.9.

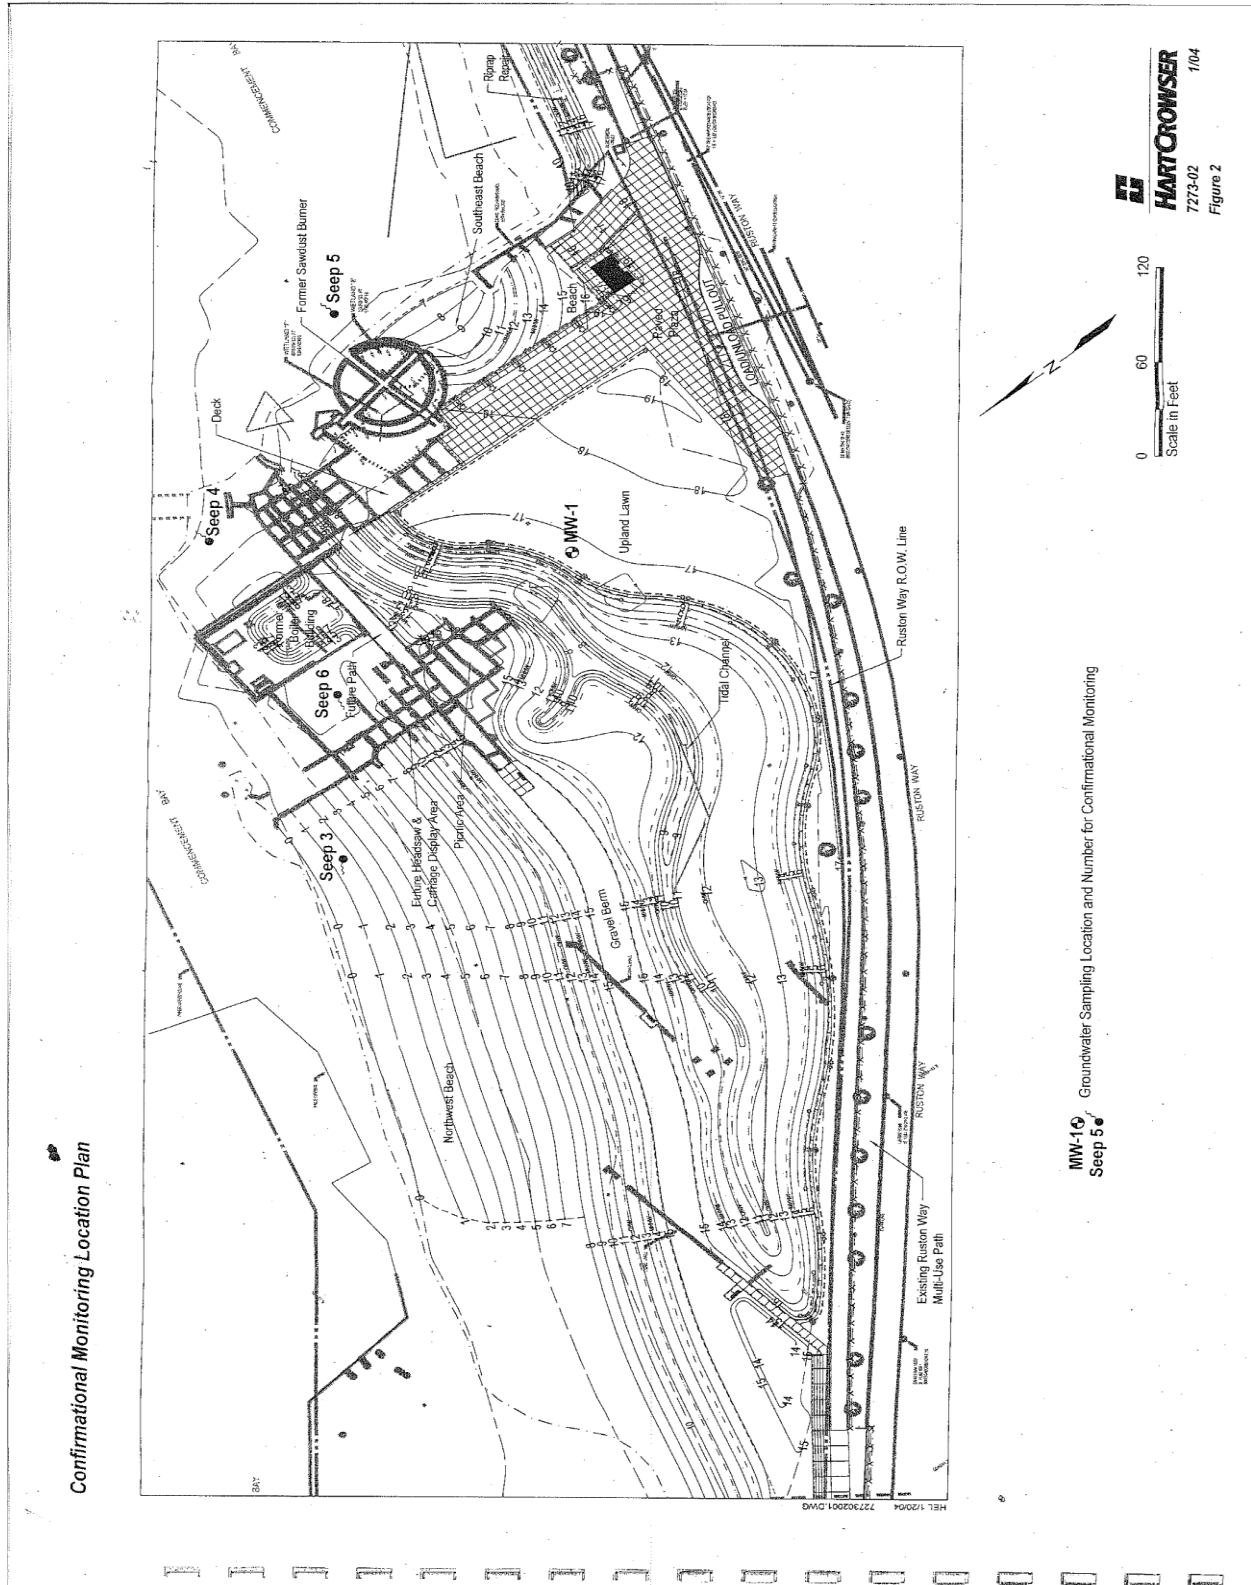
6.10 Conformational Groundwater Monitoring Locations

Results of groundwater monitoring revealed that few SVOCs, TPH-O, arsenic, copper, lead, and mercury were detected. However, phenanthrene (11 µg/l), TPH-D (1.3 mg/l), copper (6.87 µg/l to 41.2 µg/l), and mercury (0.52 µg/l to 0.78 µg/l) were exceeded their respective cleanup levels

of 4.6 µg/l, 1 mg/l, 5 µg/l (arsenic and copper), and 0.1 µg/l, respectively. The arsenic was detected during one or more occasions. Detected groundwater concentrations (3.19 µg/l to 54.8 µg/l) exceeded its cleanup level of 36 µg/l. However, the detected arsenic concentrations were similar to the concentrations detected in the seawater reference sample collected from Owens Beach. Based on the results of two years of post-construction conformational groundwater monitoring, it was concluded that the construction activities did not appear to have significantly impacted the groundwater quality at the Site. The groundwater monitoring was discontinued, the steel well points were removed and the groundwater monitoring well (MW-1) was abandoned consistent with the requirements of WAC 173-160 in early 2006. Groundwater monitoring sampling locations are included as Appendix 6.10.

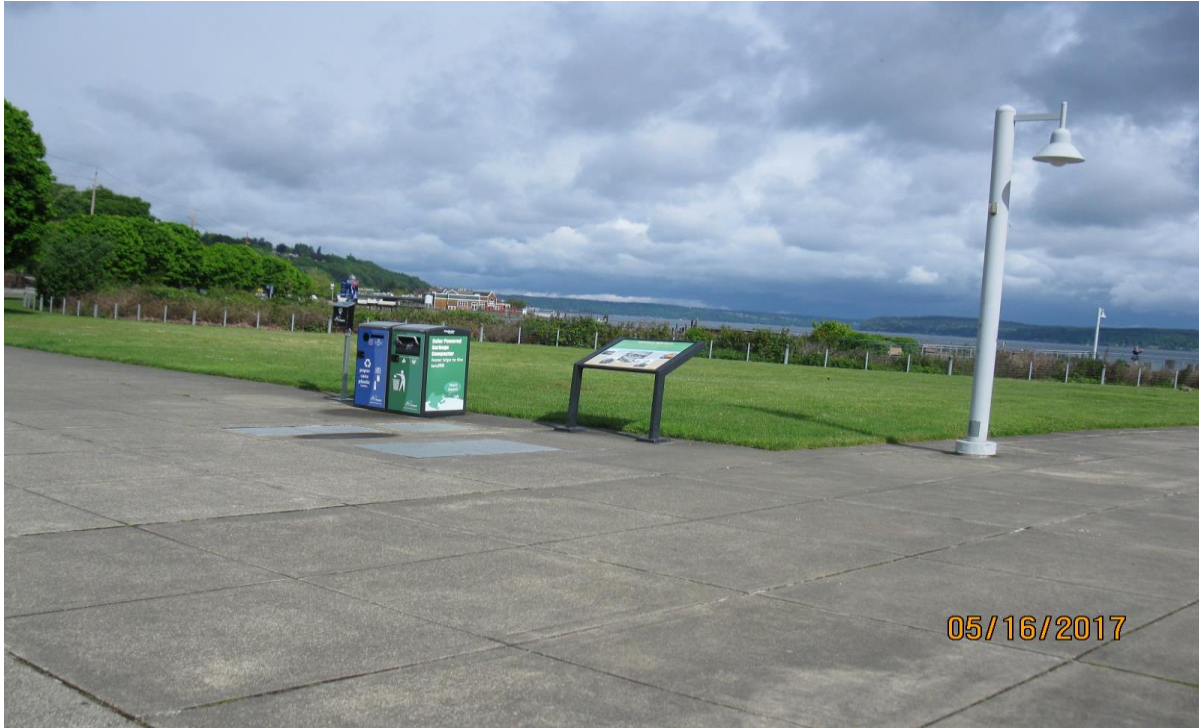
Photo 1: Dickman Mill Park – from the Southeast

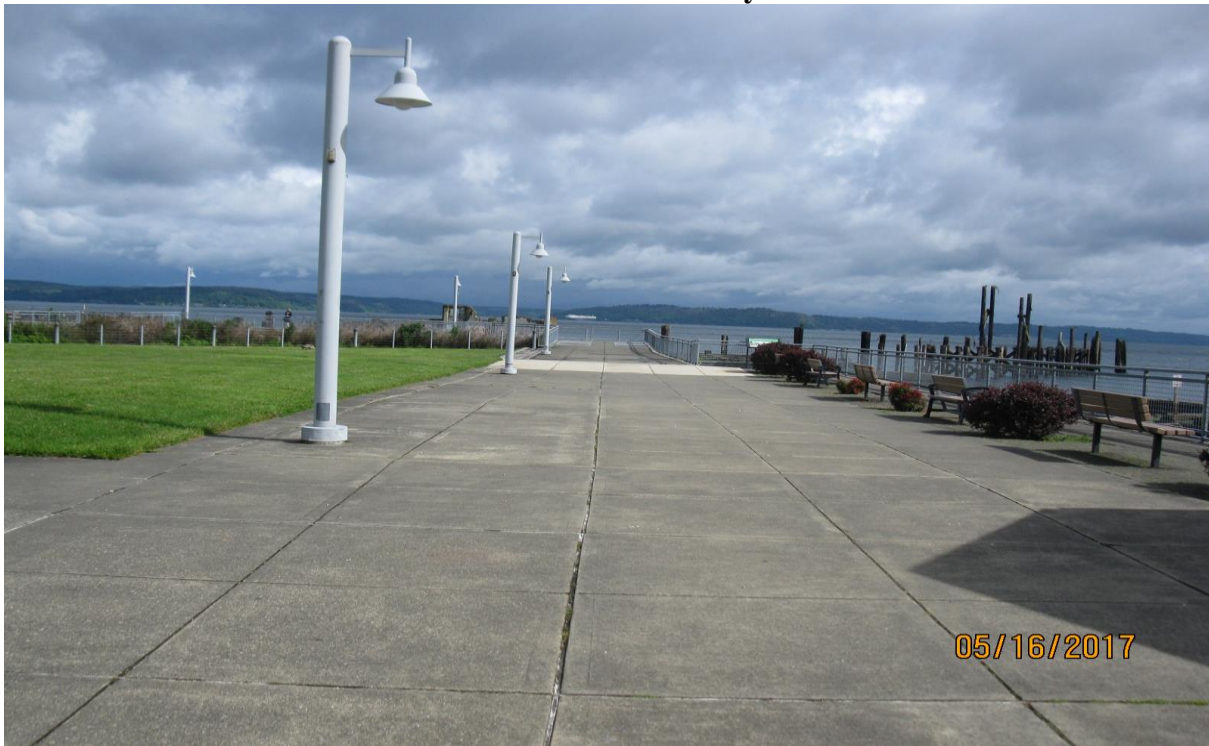
Photo 2: Dickman Mill Park Entrance from Ruston Way – from the South

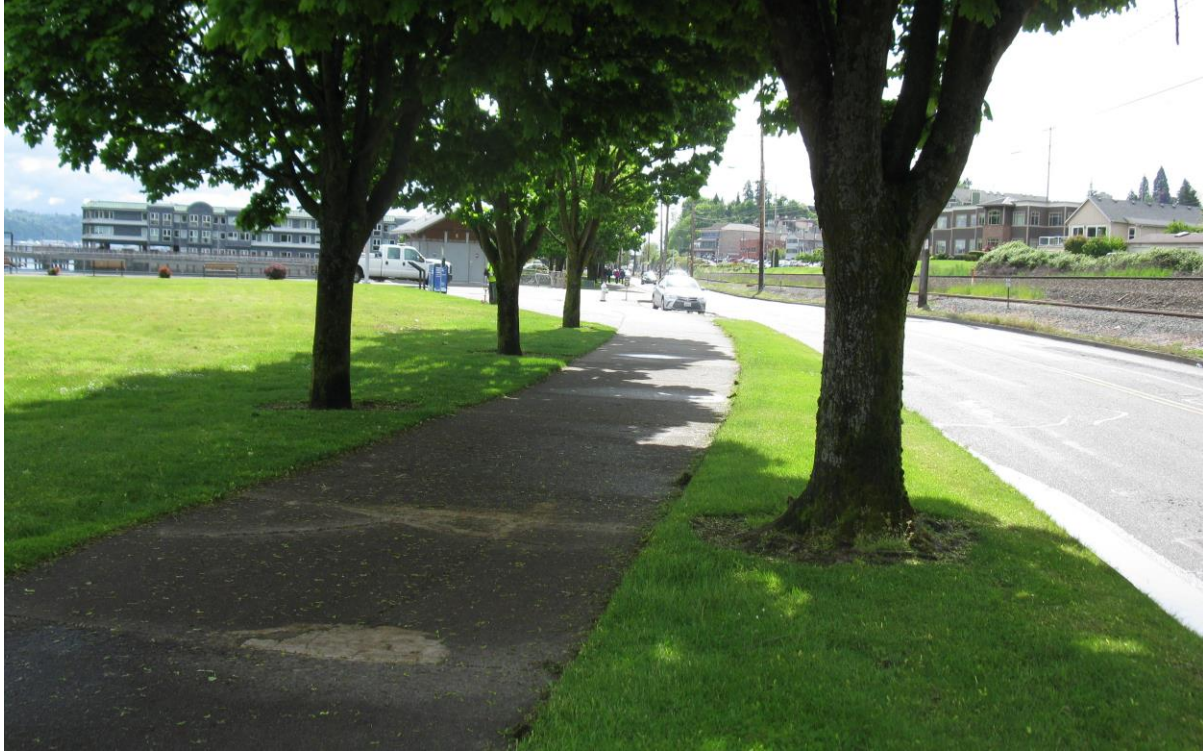
Photo 3: Dickman Mill Park and the Ruston Way to the Right – from the West

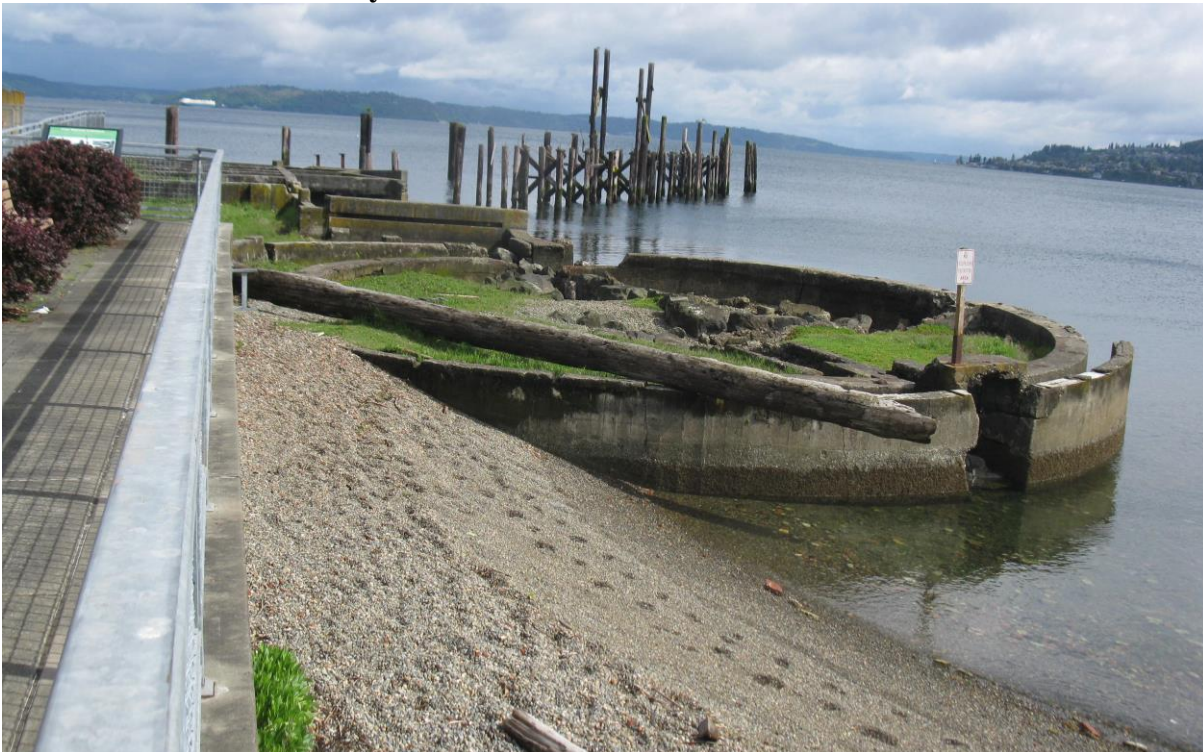
Photo 4: Remaining Sawdust and Wood Burner Foundation, Restored Beach and the Commencement Bay – from the South

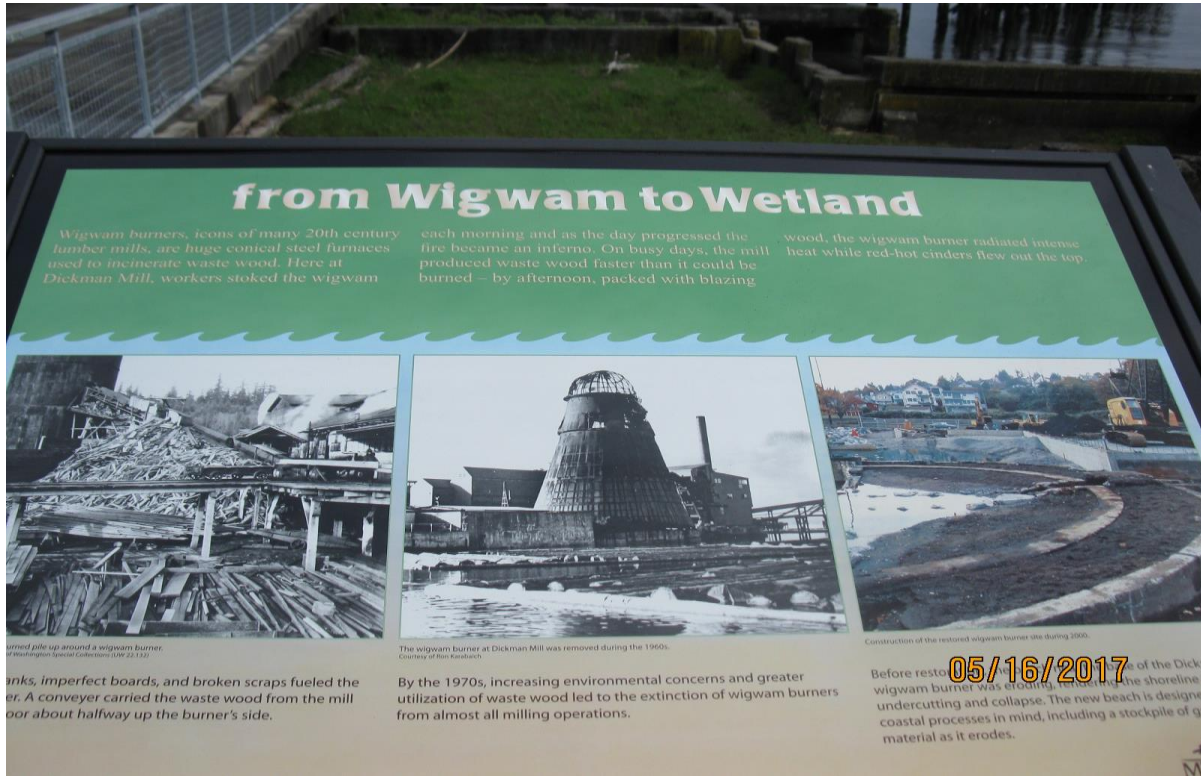
Photo 5: Former Sawdust and Wood Burner

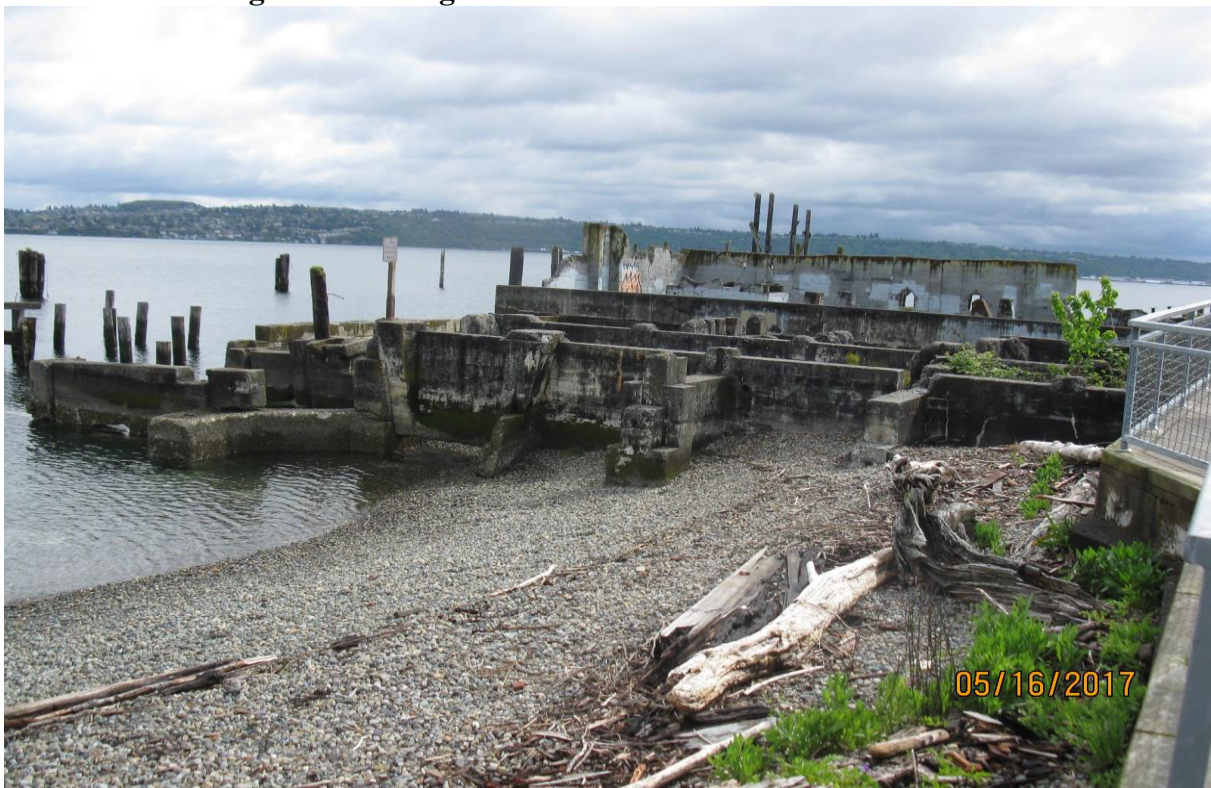
Photo 6: Remaining Mill Building/Foundation and Intertidal Area – from the West

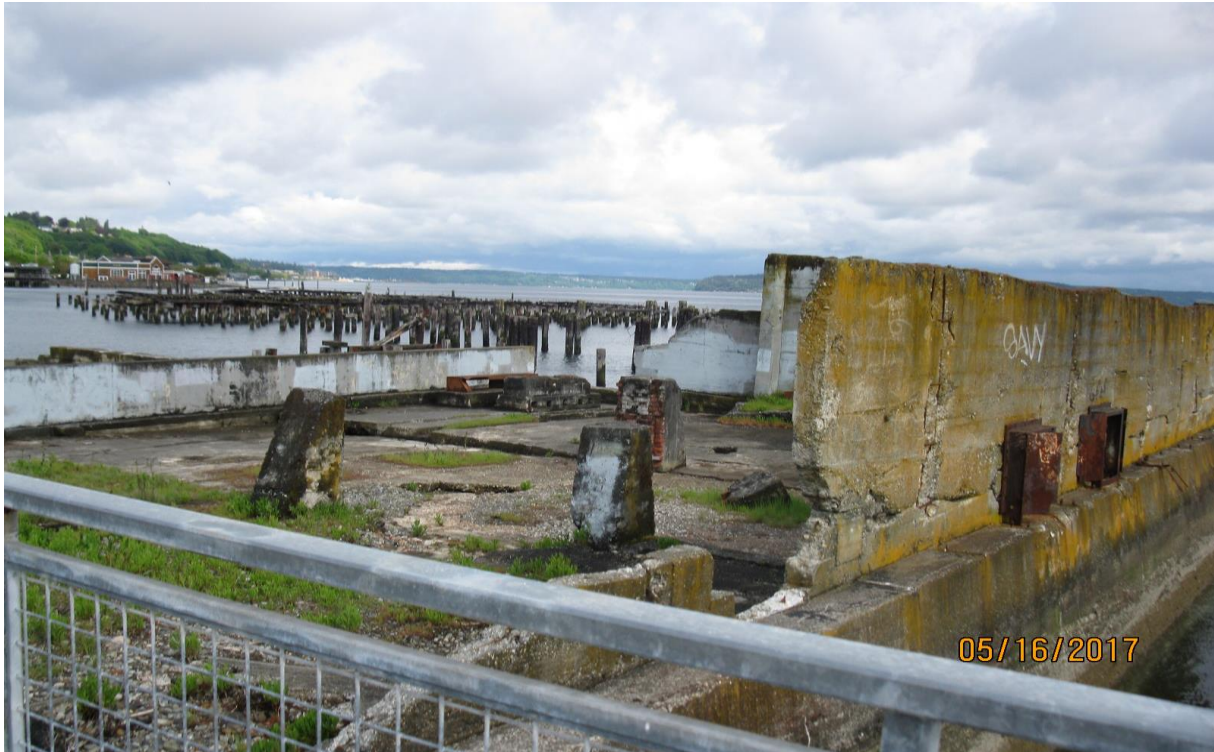
Photo 7: Remaining Mill Building/Foundation and Pilings in the Commencement Bay – from the Southeast

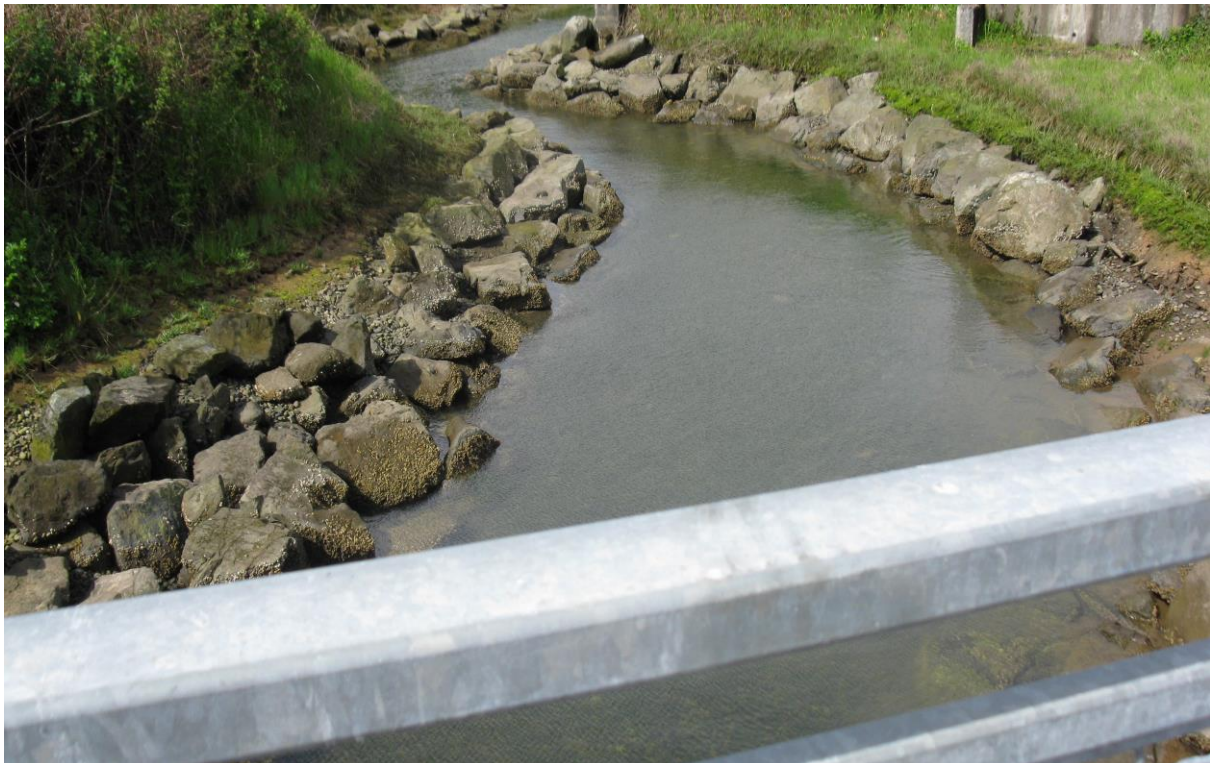
Photo 8: Tidal Channel between the Park and Intertidal Area – from the East

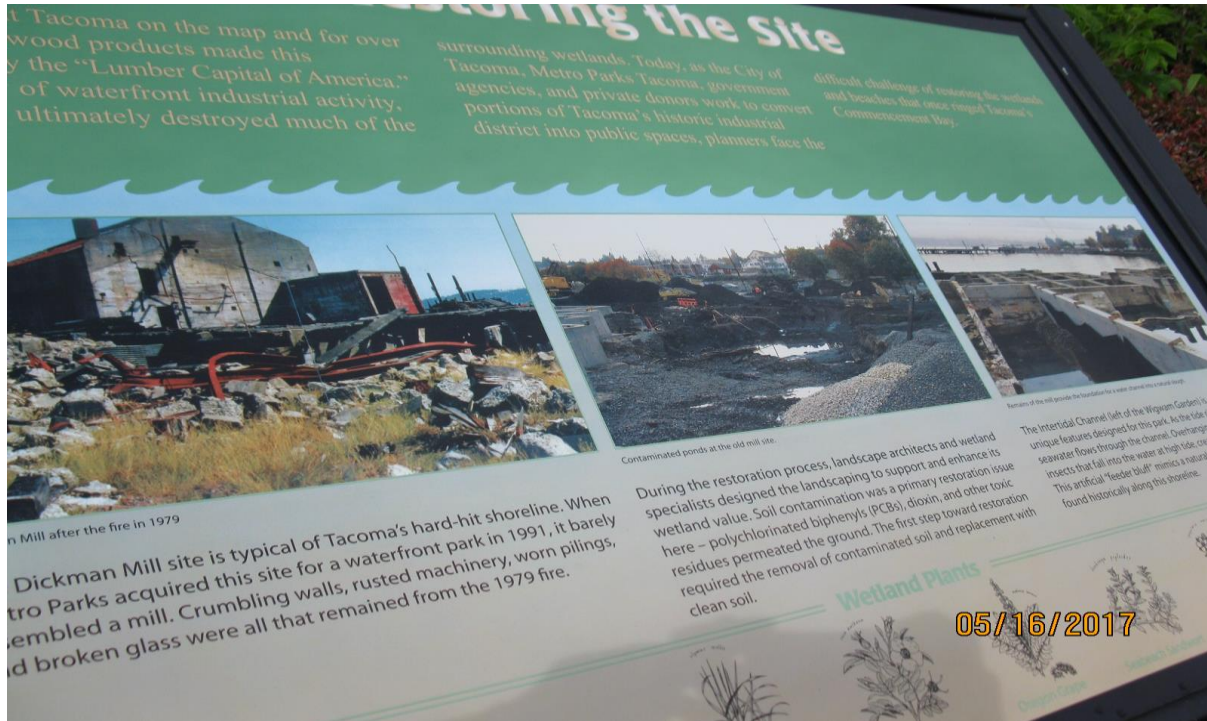
Photo 9: Remaining Former Mill Building after 1979 Fire, Site Restoration and Remaining Mill Foundation

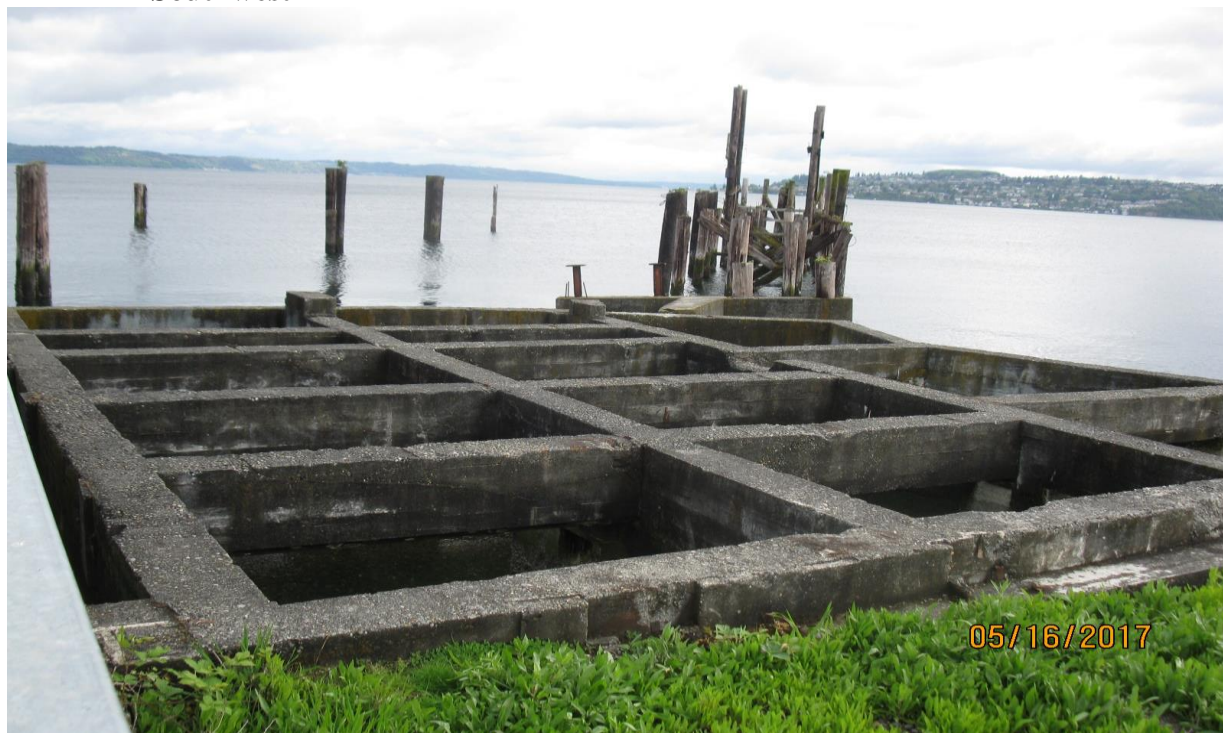
Photo 10: Remains of the Mill Foundation and the Commencement Bay – from the Southwest
