SUPPLEMENTAL SITE EXPLORATION

Mac's One Hour Cleaners
10825 SE 176th Street
Renton, Washington

June 2, 2010

JN-20209-1X

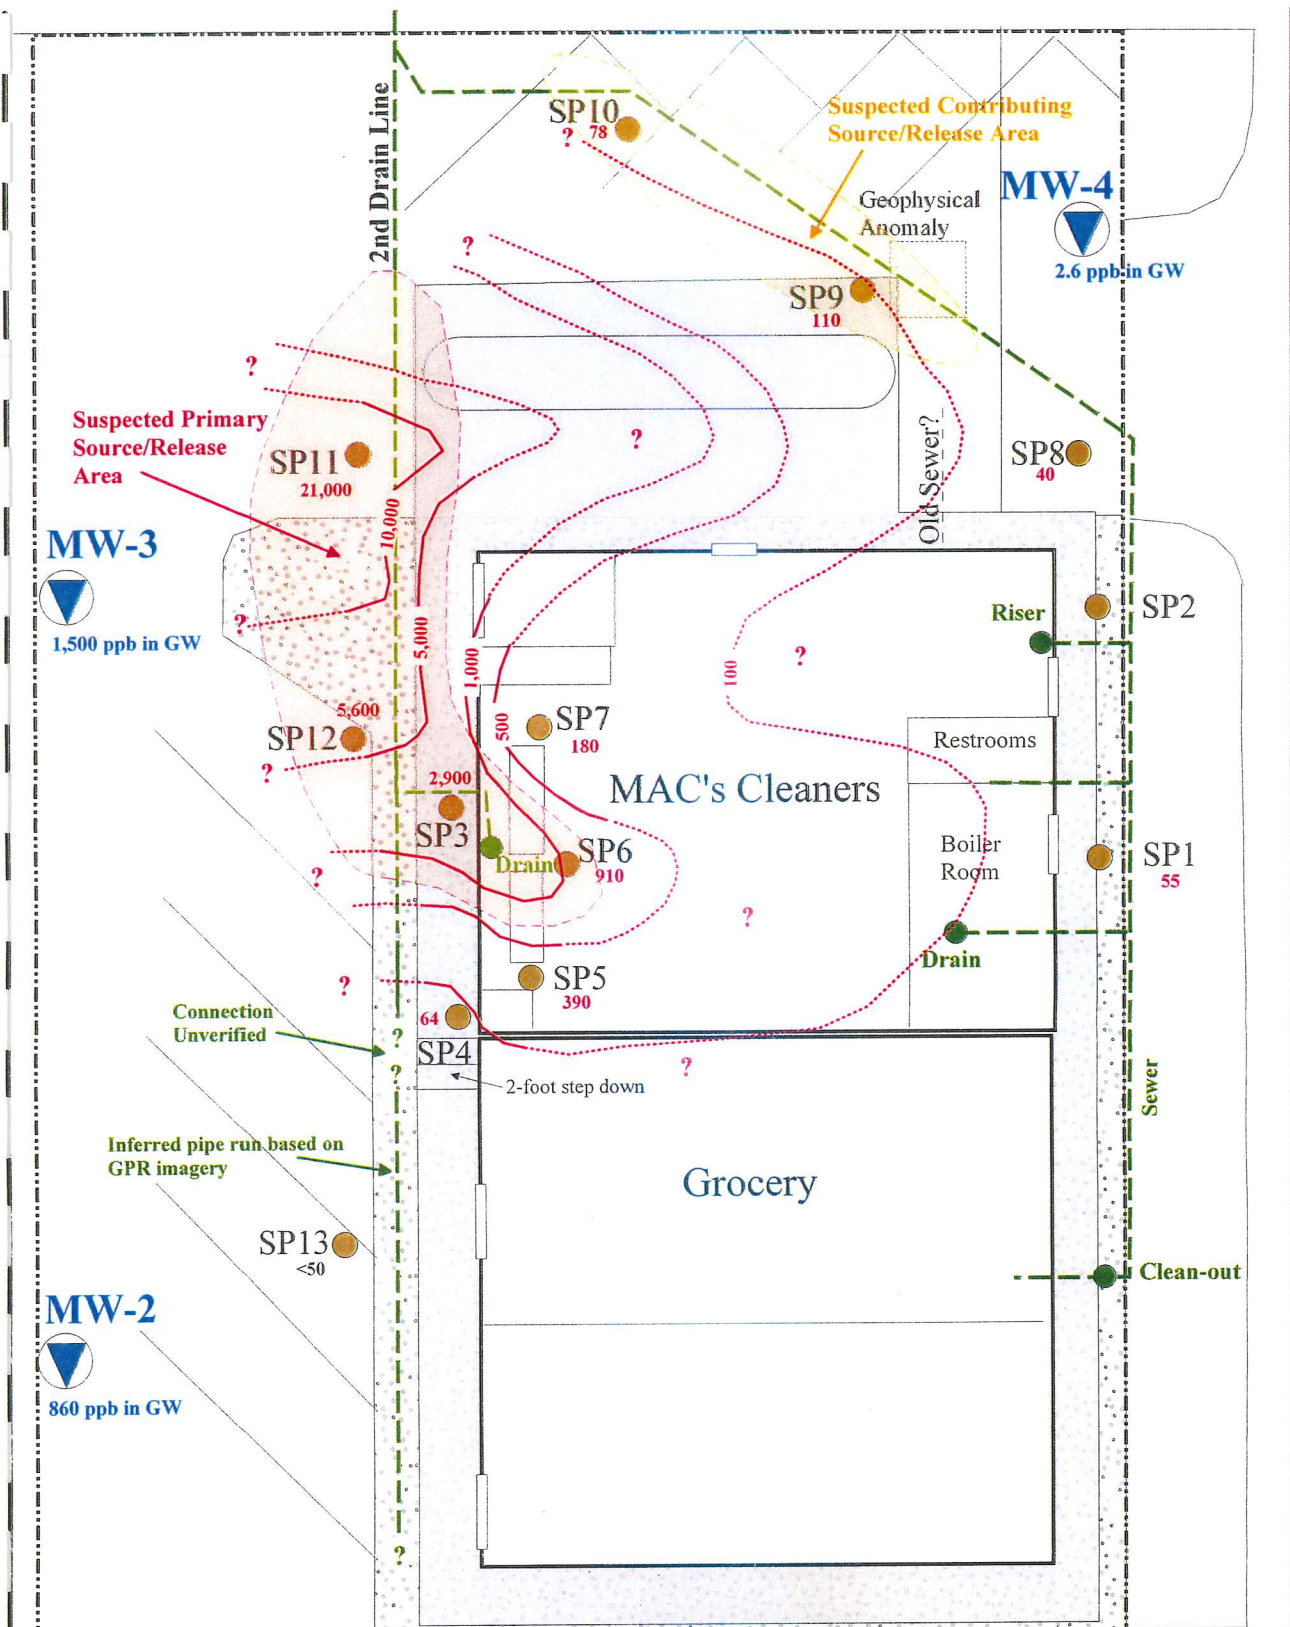
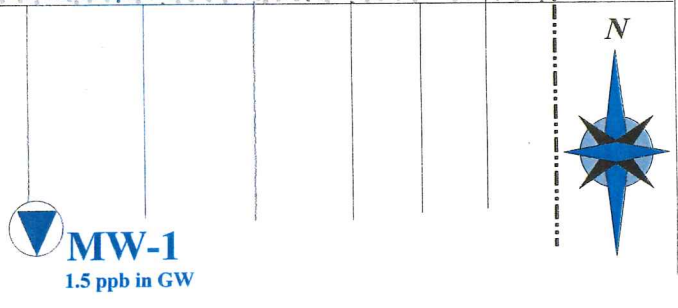
PCE Distribution in Soil

The soil sampling results are presented in Table 1, attached to this report. Of the 12 soil samples analyzed, the dry-cleaning solvent perchloroethene (PCE - also known as "perc" or tetrachloroethene) was detected at concentrations above the laboratory's minimum detection limit of 20 parts per billion (ppb) or 0.02 parts per million (ppm). Of the 11 detections of PCE, ten (10) samples contained PCE at a concentration above the WDOE's Method-A target compliance level of 50 ppb (or 0.05 ppm), intended for unrestricted land use. The concentrations of PCE detected in the selected soil samples are listed in Table 1 and are also graphically noted on Plate 2, PCE Distribution in Soil.

Contour lines of inferred “equal concentration” are depicted on Plate 2. These contour lines are solid in areas where the density of data points is relatively high. The contour lines are dashed in areas where uncertainty remains elevated and could potentially be further refined by completing additional explorations. Specifically, the depicted 100 ppb contour line within the dry-cleaner’s interior space and the majority of the concentration contour lines north of the building between SP9 and SP11 may include artificial exaggerations due to the lack of data points between the western and eastern explored areas. Despite these nuances in interpolation methodology, at least two (2) potential contaminant source areas appear to be apparent in the developed data set.

The suspected “primary” source area appears to exist in a broad arch encompassing the western interior floor drain area and extending northerly along the western sanitary sewer alignment. This inferred “hot-spot” in soil is graphically represented as the area in “red tinting” on Plate 2.

A “lesser” potential source area in soil also appears to exist in the vicinity of the geophysical anomaly and extending northwest along the eastern sewer alignment to the vicinity of SP10. This area may also be contributing to the overall site impact and is represented by orange tinting on Plate 2.

The highest concentration of PCE detected in soil to date is at location SP11, along the western sewer line. This location was of particular interest and was selected for exploration due to the geophysical survey noting possible tributary lines (possibly from roof drains) that may tie into the main sewer line in this area, and with all the connections, a greater chance for leakage may exist in this section of line. Additionally, the SP11 area appears to be directly up-gradient from on-site monitoring well MW-3, which in January 2010 had the highest detected concentration of PCE in the shallow groundwater.

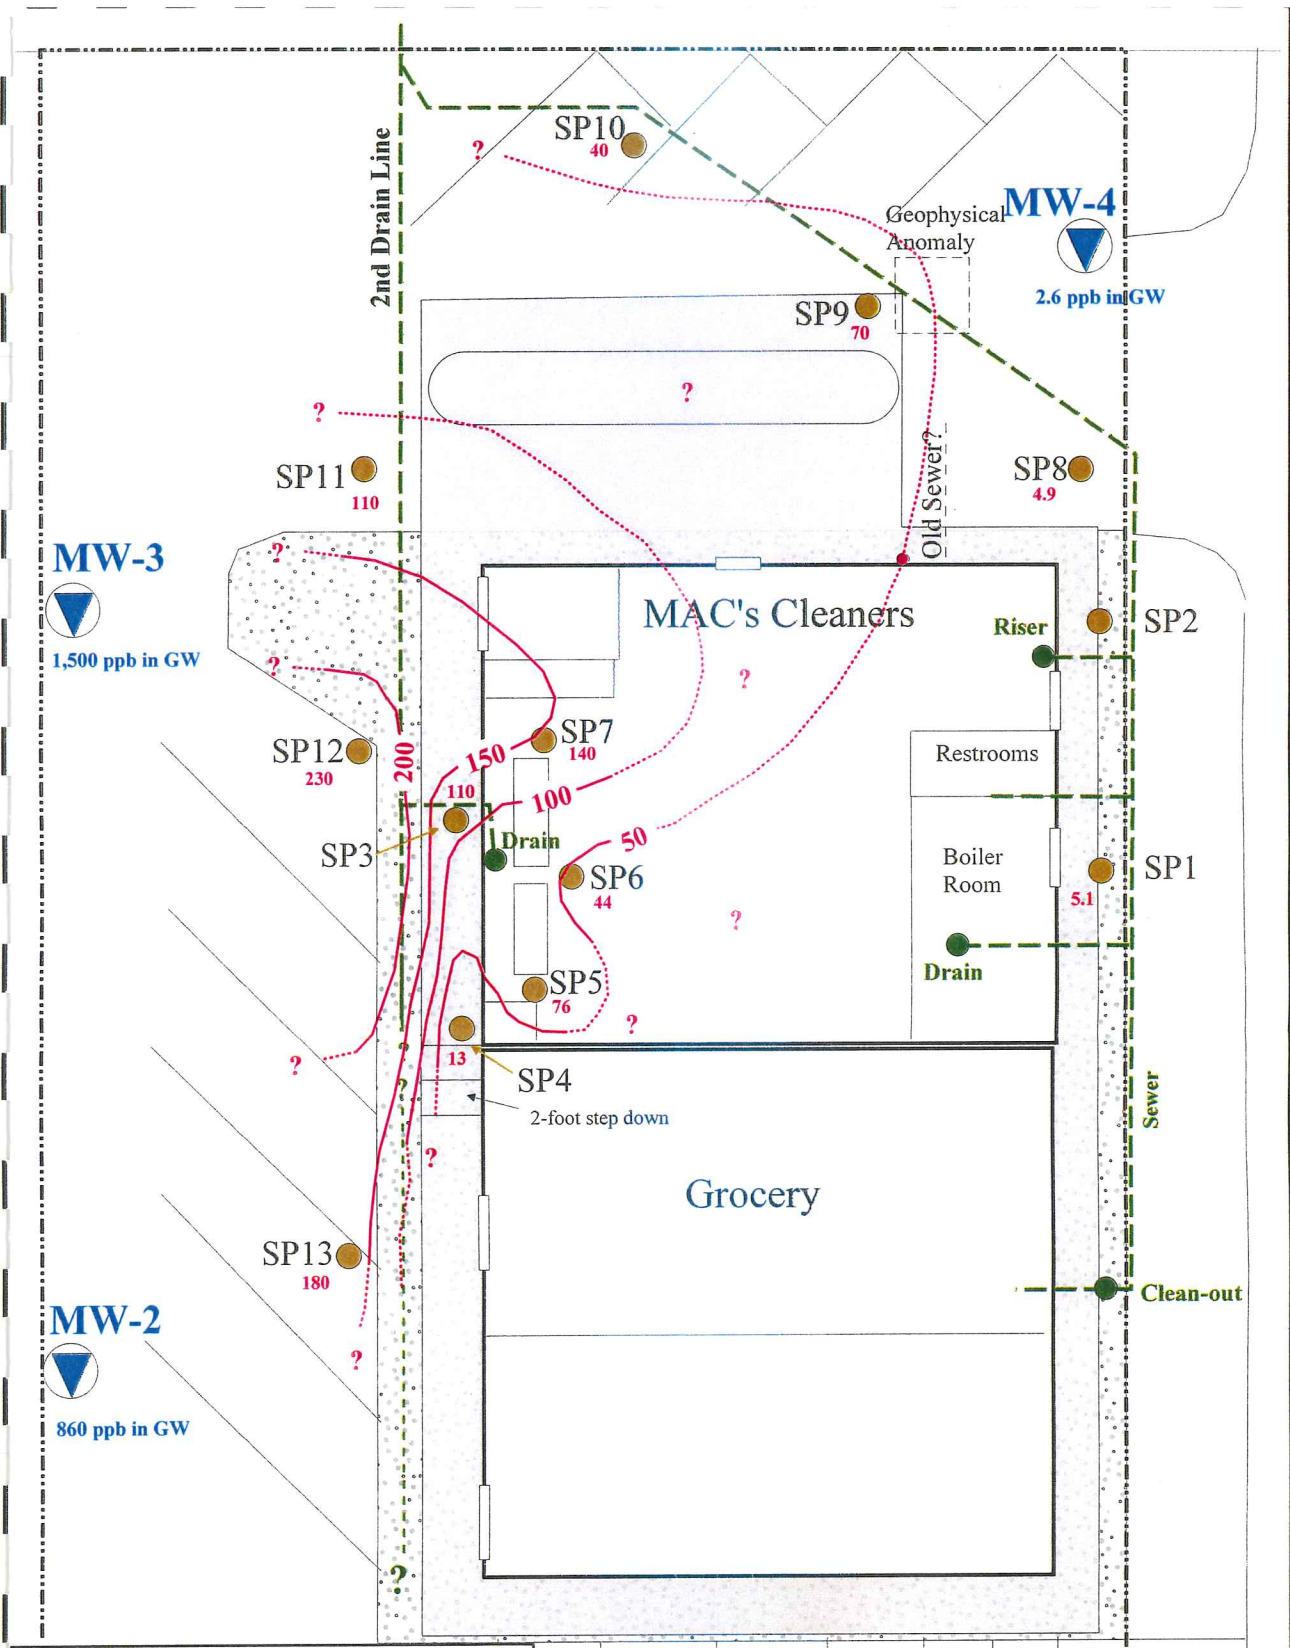
Groundwater results are presented in Table 2 and are graphically included on Plate 3, PCE Distribution in Groundwater. Dissolved concentrations of PCE were detected in all 12 groundwater samples. Eleven (11) of the 12 samples contained PCE at concentrations above the WDOE’s target compliance level of 5 ppb, ranging between 5.1 and 230 ppb.

Similar to the format of the map for soil, Plate 3 contains interpolated contour lines for PCE concentrations detected in the groundwater samples. Additionally, as with the soil data, the dashed contour lines on Plate 3 represent areas where the contour lines may be skewed due to limited data between distant points. This effect is most notable for the area north of the subject building, between SP9 and SP11.

A comparison of the groundwater data on Plate 3 to the soil distribution data on Plate 2, depicts a strong correlation, where the highest concentration of dissolved PCE in the Strataprobe groundwater samples appear to be focused around the floor-drain and western sanitary sewer alignment. As with the soil distribution, a lesser "hot spot" also appear to exist in the vicinity of the geophysical anomaly and SP10.

Another observation of potential significance is the elevated concentration of dissolved PCE in the groundwater at SP13 to the southwest of the dry cleaners. Whereas the concentration of PCE in soil did not appear to extend significantly toward the south, this elevated concentration of dissolved PCE at SP13 may be an indication that the sewer alignment is acting as a preferential pathway for impacted groundwater migration, which in turn may explain the elevated concentration of PCE in groundwater at MW-2.
