**SUPPLEMENTAL MONITORING  
WELL INSTALLATION**

Mac's One Hour Cleaners  
10825 SE 176<sup>th</sup> Street  
Renton, Washington

January 26, 2011

JN-20209-3

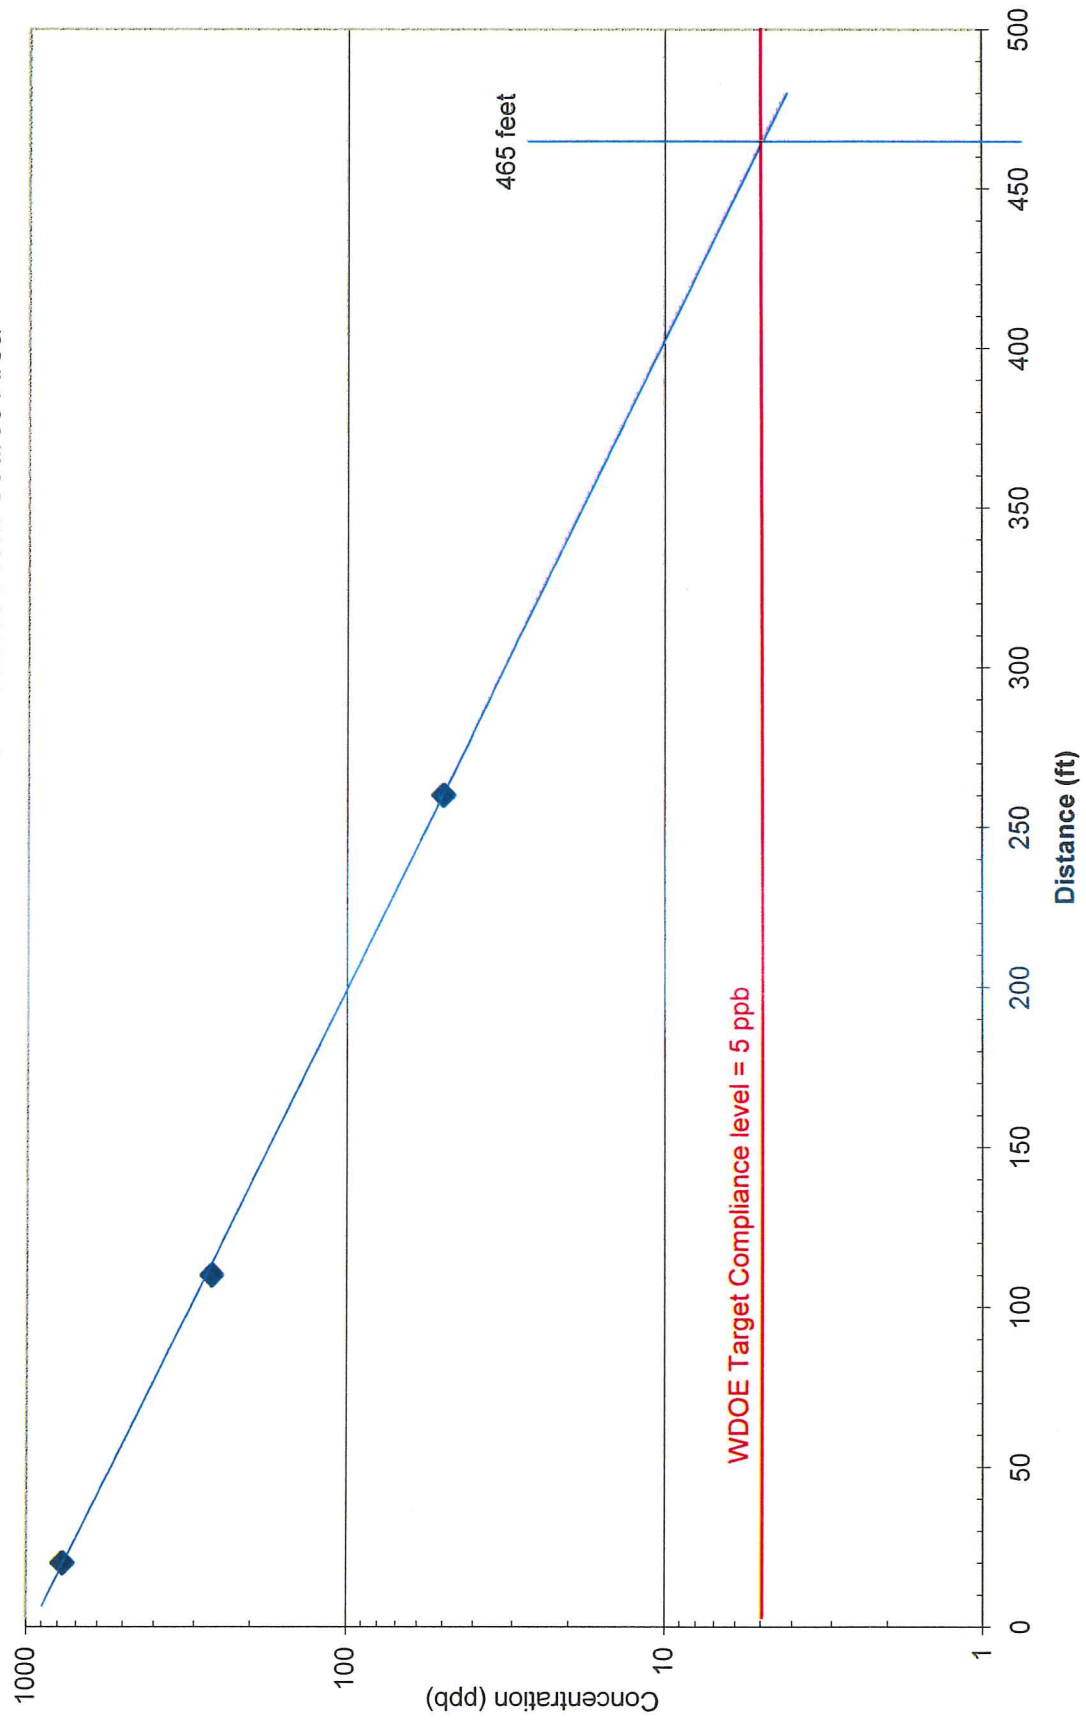
Chart 1: PCE Concentration In Groundwater Vrs. Distance From Source Area

Examining Chart-1, a log-normal linear relationship does appear to exist, bolstering the inference that the groundwater plume appears to be in a “steady state” condition. As a valuable key understanding for the report user, if this is the case, then it may be reasonable to consider that the length and width of the groundwater plume may be at or close to their maximum extent for the current hydrological and source strength conditions. The slope of the trend line in Chart 1 can also be used to make a preliminary estimate on a probable down-gradient extent of the plume, by extending the trend line until it crosses the 5 ppb concentration line (corresponding to the WDOE target compliance level). Doing this yields an estimate of approximately 465 feet west-southwest of the suspected source area. That distance would place the down-gradient extent of the ground water plume somewhere near the west side of 108<sup>th</sup> Avenue SE.

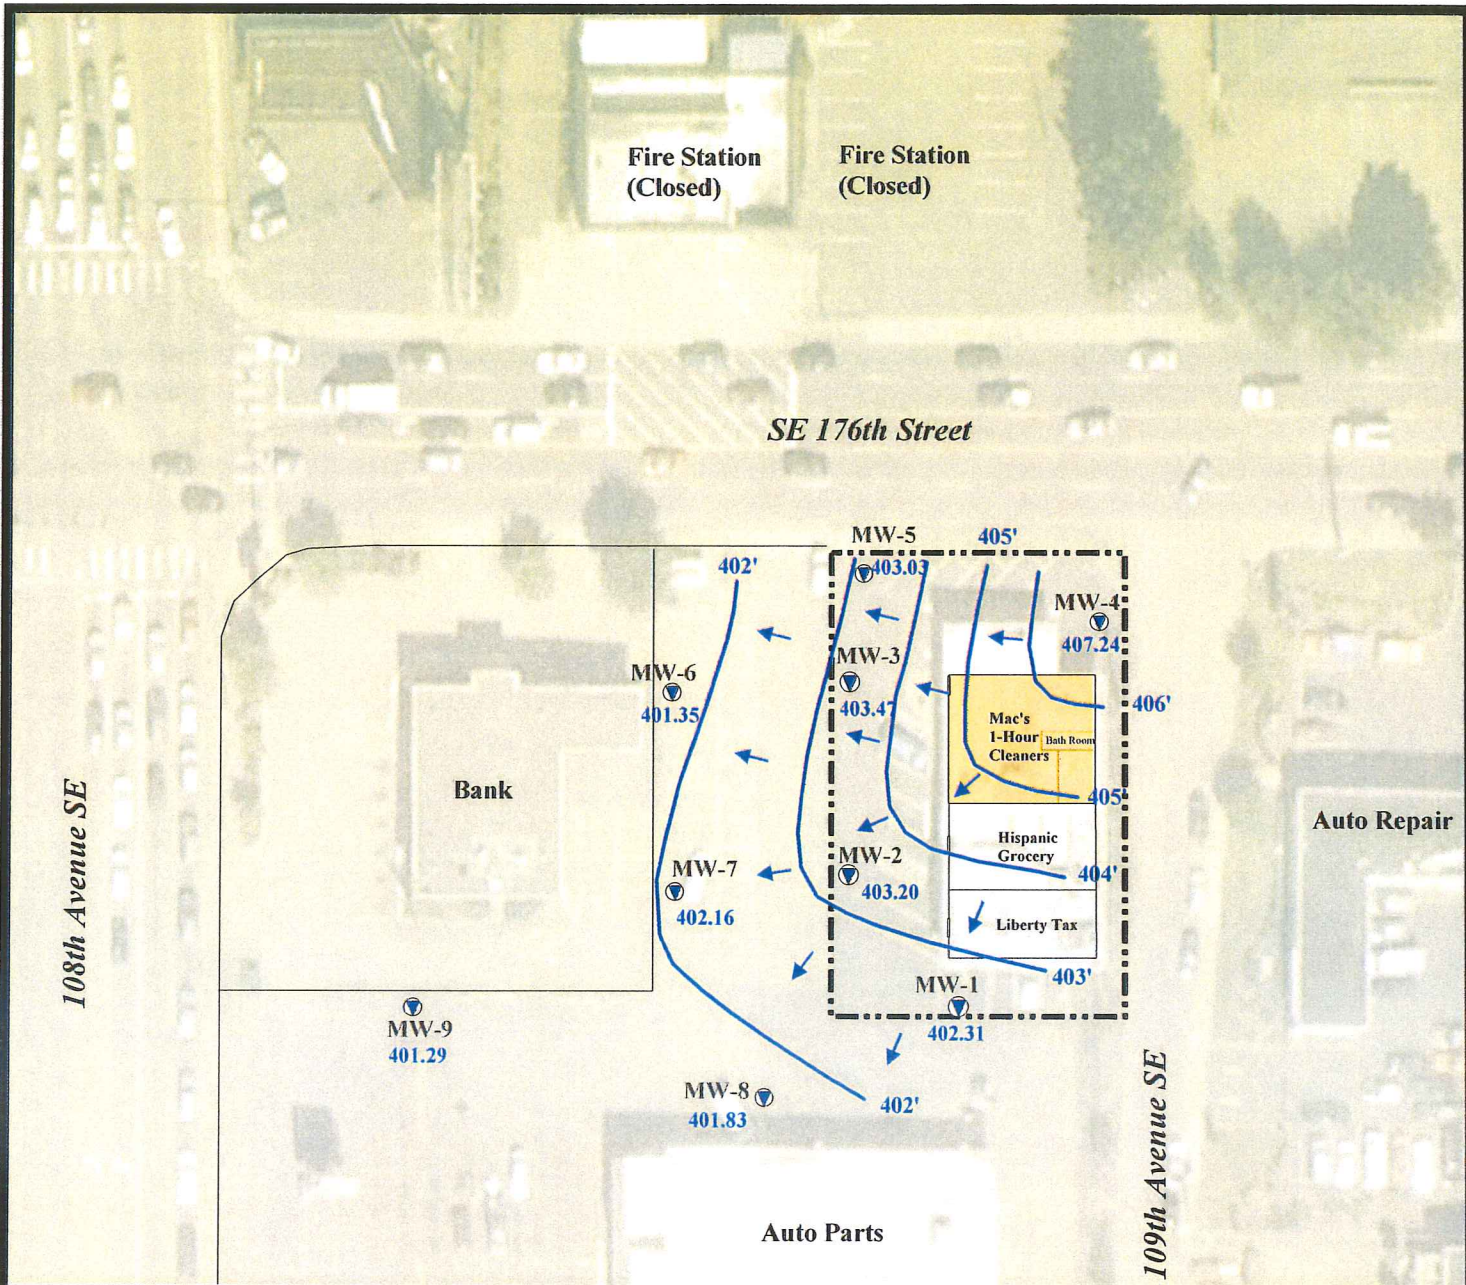
## WATER TABLE SURVEY

Examining Plate 3, groundwater flow appears to be westward with a southwesterly radial influence further south in the study area. A minor degree of northwesterly flow may also be occurring in the general vicinity of MW-5. The groundwater flow regime appears generally consistent with that deduced with the original four (4) on-site monitoring wells and further, appears to validate the selected positions for the additional monitoring wells MW-5 through MW-9.

In regard to the northern margins of the study area, based upon the PCE concentrations observed at MW-5 and upon groundwater flow interpretations presented on Plate 3, Water Table, some degree of contaminant migration beyond the northern boundary of the site parcels may be occurring. Given a predominantly west-southwest groundwater flow direction and the presence of numerous subsurface utilities underlying SE 176<sup>th</sup> Street, it tentatively appears unlikely that parcels north of the roadway from the subject site have been impacted.
