**Re: Dangerous Waste Compliance Inspection on September 2, 2014 at Treoil Industries,
4242 Aldergrove, Ferndale, WA 98242 - RCRA Site ID: N/A Facility Site ID: 2919**

Washington State Department of Ecology Hazardous Waste and Toxics Reduction Program

NOTICE TO COMPLY

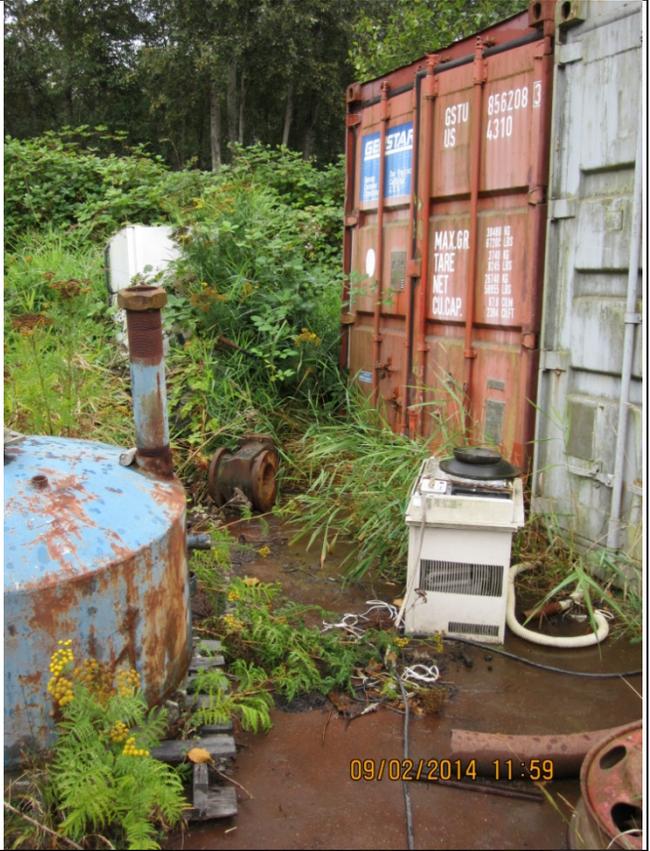
Area & Description	Photographs
<p>#1</p> <p>Location: Eastern Facility Boundary</p> <p>The air conditioner in the foreground of this photograph and the refrigerator in the background (under blackberry) may contain hazardous waste refrigerant gases or contaminated compressor oils.</p>

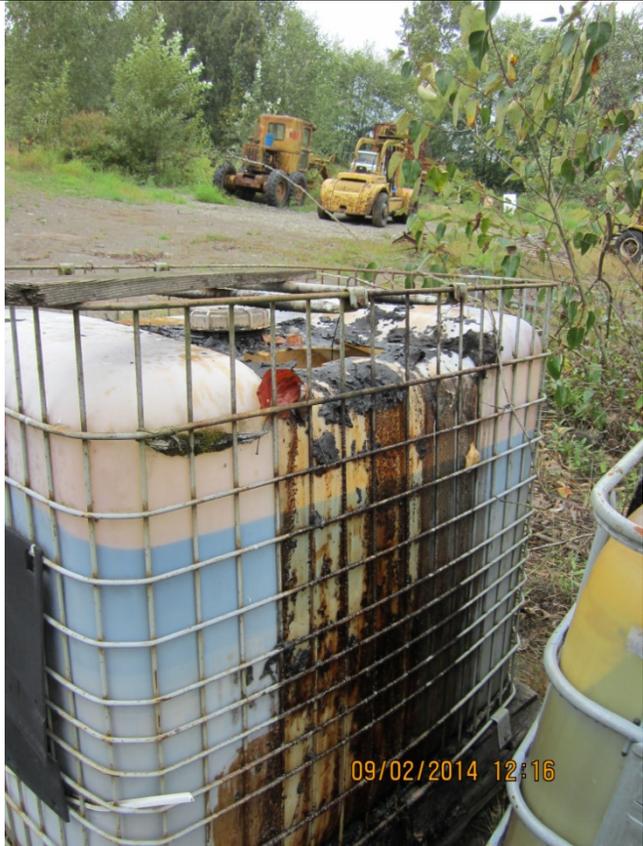
Area & Description	Photographs
<p>#5</p> <p>Location: Eastern Facility Boundary</p> <p>This photograph depicts a tote of waste suspected to be contaminated tall oil or tall oil distillates. Note the top is cut open and waste has spilled on the container and ground.</p>

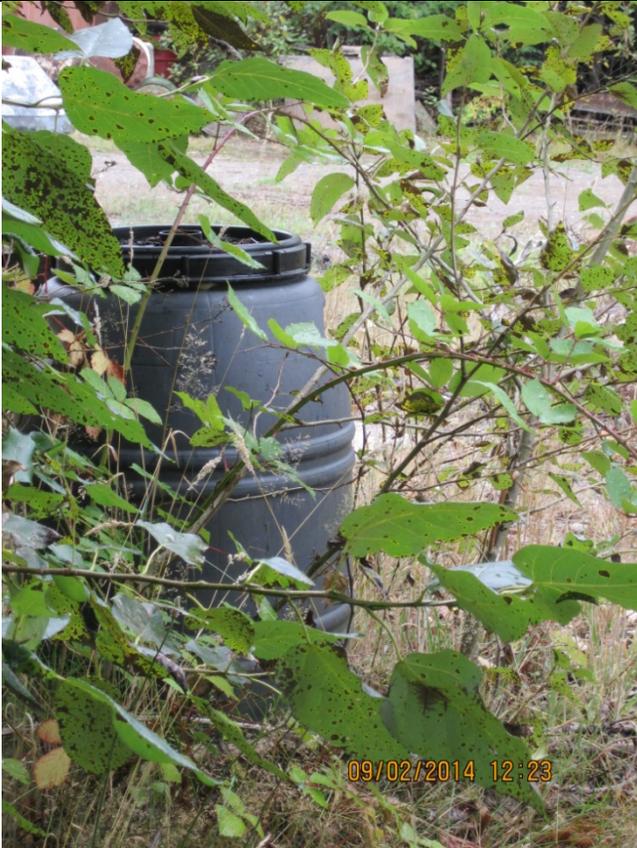
<p>#8</p> <p>Location: Eastern Facility Boundary</p> <p>This photograph depicts the same 55-gallon drum of an unknown liquid as photograph #7.</p>

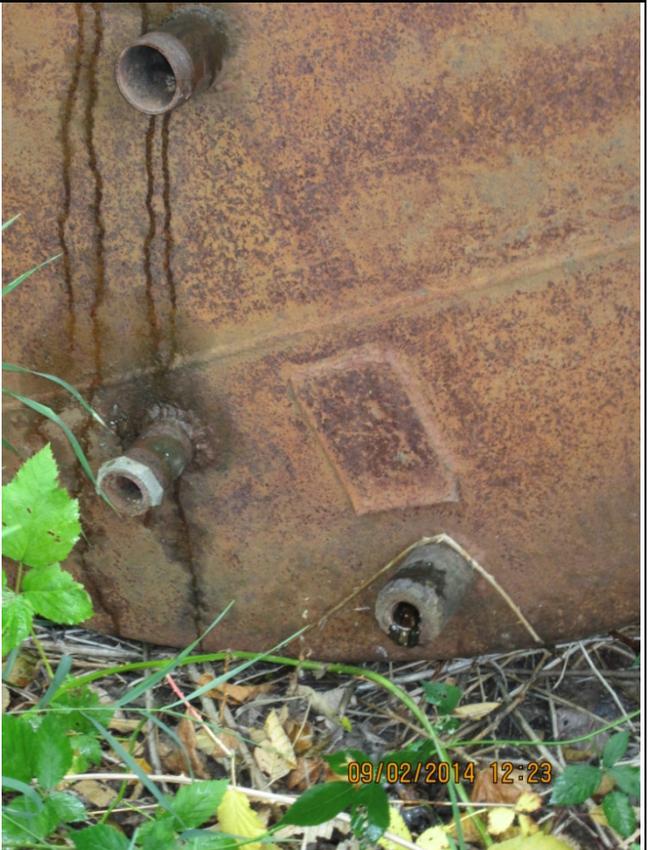
Area & Description	Photographs
<p>#9</p> <p>Location: Eastern Facility Boundary</p> <p>This photograph shows a tank with unknown contents. Note that the port in the bottom appeared to be leaking a black viscous material.</p>

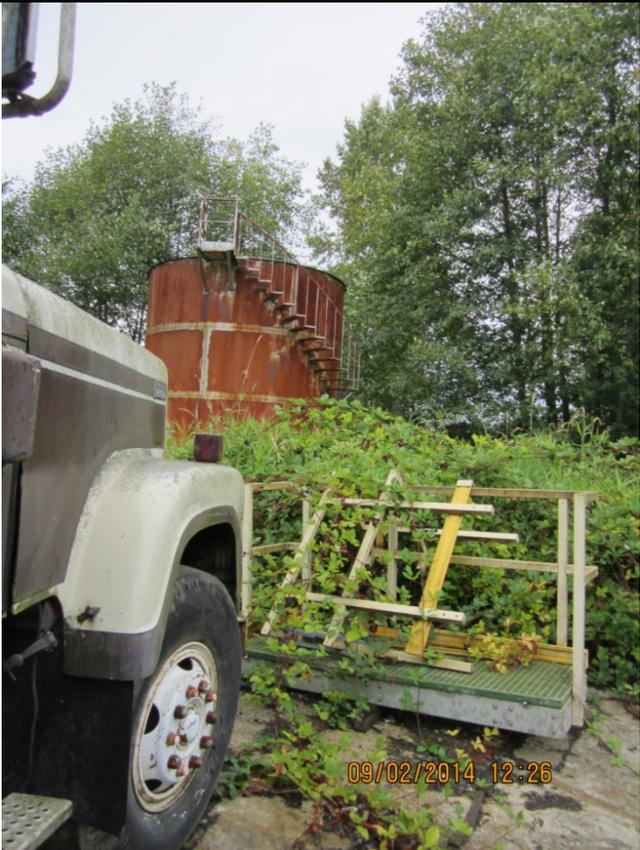
Area & Description	Photographs
<p>#10</p> <p>Location: Northern Facility Boundary</p> <p>This photograph shows another tank at the facility with unknown contents.</p>

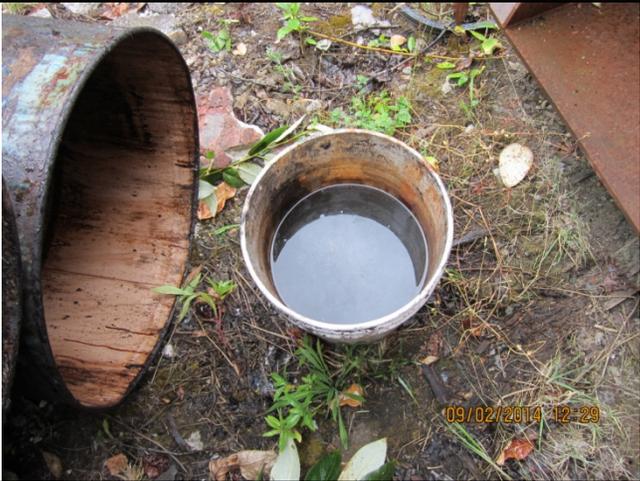
Area & Description	Photographs
<p>#12</p> <p>Location: Plant Perimeter</p> <p>This photograph shows a 5-gallon poly container of unknown contents and contaminated rainwater.</p>

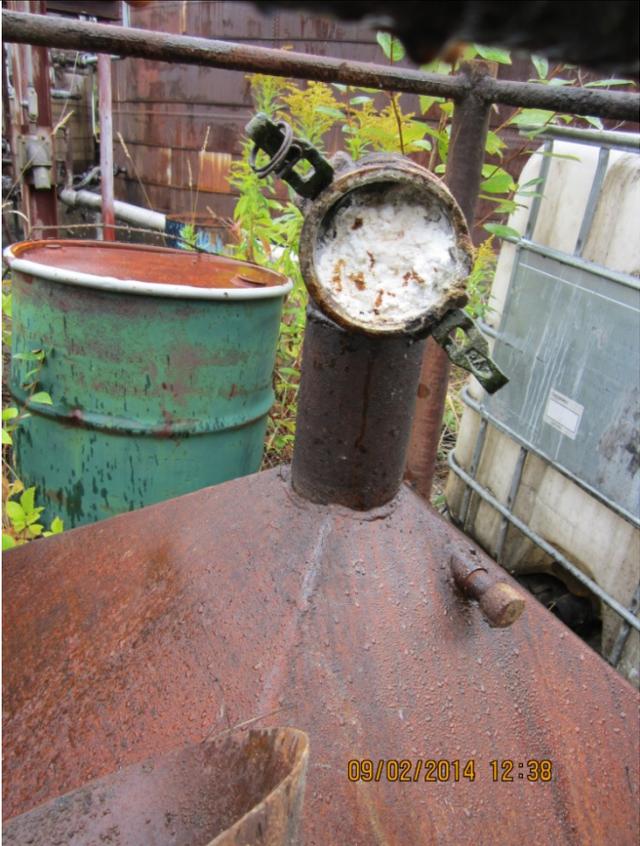
Area & Description	Photographs
<p>#16</p> <p>Location: Plant Perimeter</p> <p>This photograph depicts a 55-gallon drum of an unknown liquid in the background. An unknown white waste is also stuck in the pipe of a piece of contaminated equipment in the foreground.</p>

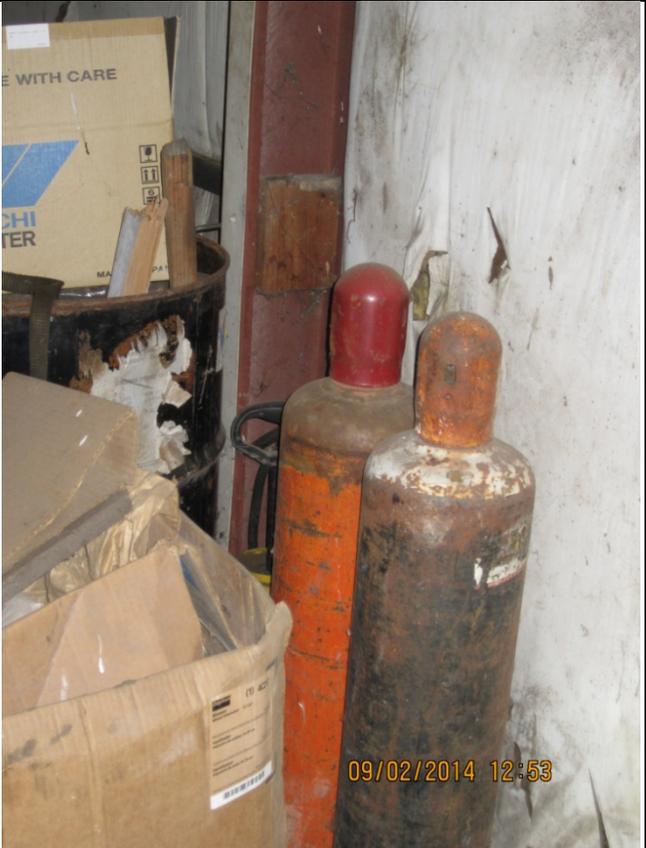
<p>09/02/2014 12:50</p>
<p>#22</p> <p>Location: Fabrication Building</p> <p>This photograph depicts two cylinders of an unknown gas.</p>

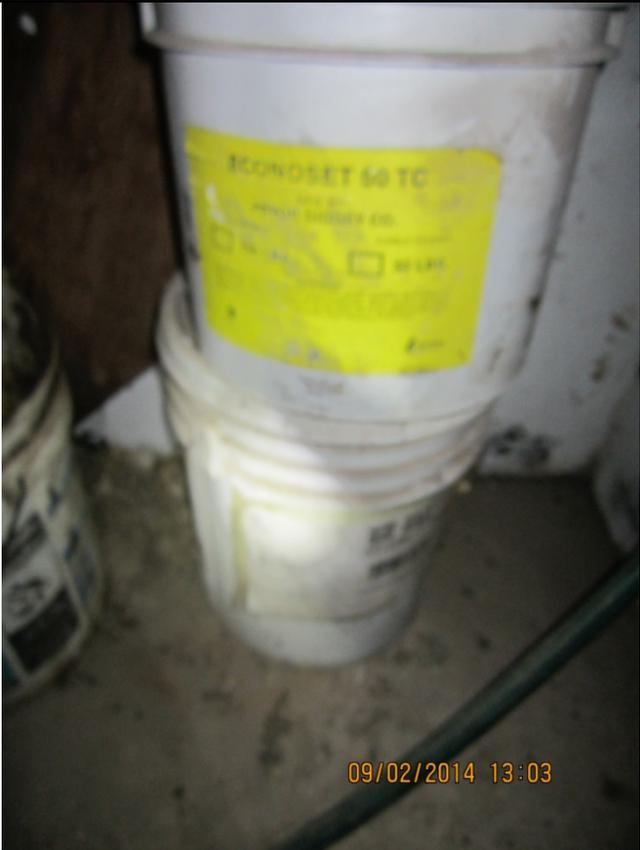
Area & Description	Photographs
<p>#28</p> <p>Location: Fabrication Building</p> <p>This photograph shows two 5-gallon poly containers or waste Econoset 50 TC.</p>

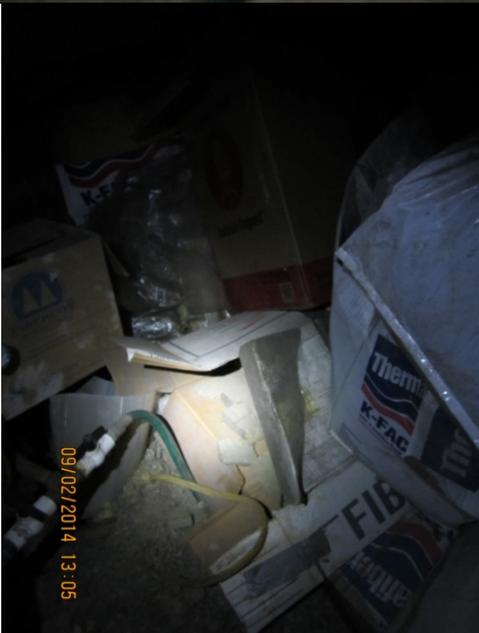
<p>09/02/2014 13:03</p>
<p>#29</p> <p>Location: Fabrication Building</p> <p>This photograph depicts a pile of mixed solid wastes and loose refractory insulation waste.</p>

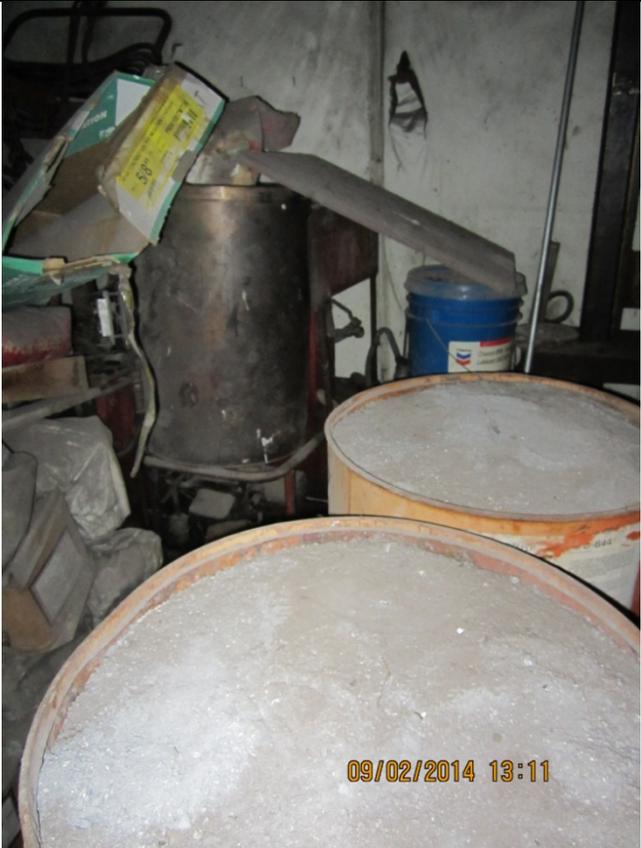
<p>#31</p> <p>Location: Fabrication Building</p> <p>This photograph depicts two 55-gallon open drums of refractory waste.</p>

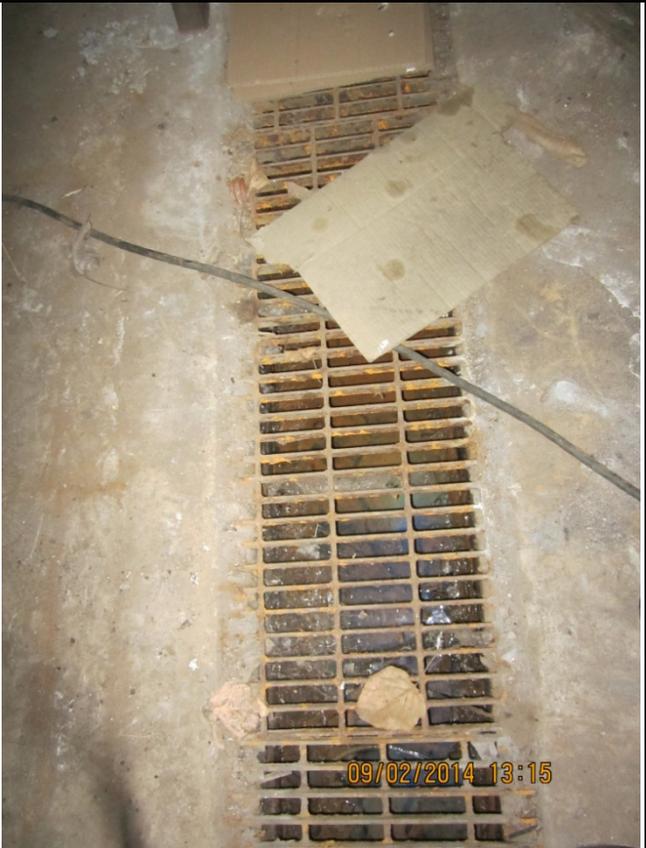
Area & Description	Photographs
<p>#34</p> <p>Location: Fabrication Building</p> <p>This photograph depicts waste accumulated in the floor drain of the Fabrication shop. The drain contained sludge, water, and sheen.</p>

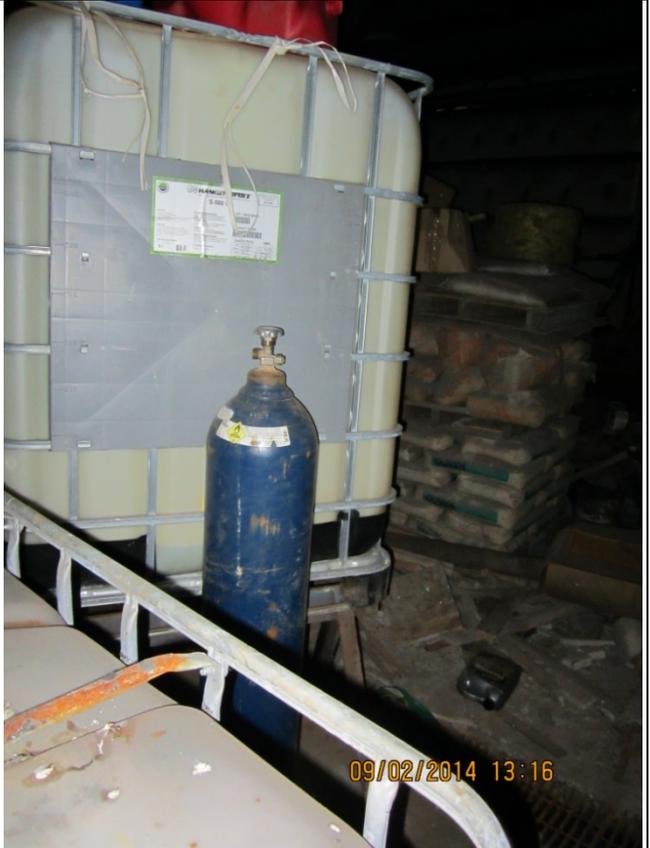
Area & Description	Photographs
<p>#35</p> <p>Location: Fabrication Building</p> <p>The cylinder in this photograph is marked as containing oxygen. The totes were stated to contain tall oil or tall oil distillates.</p>

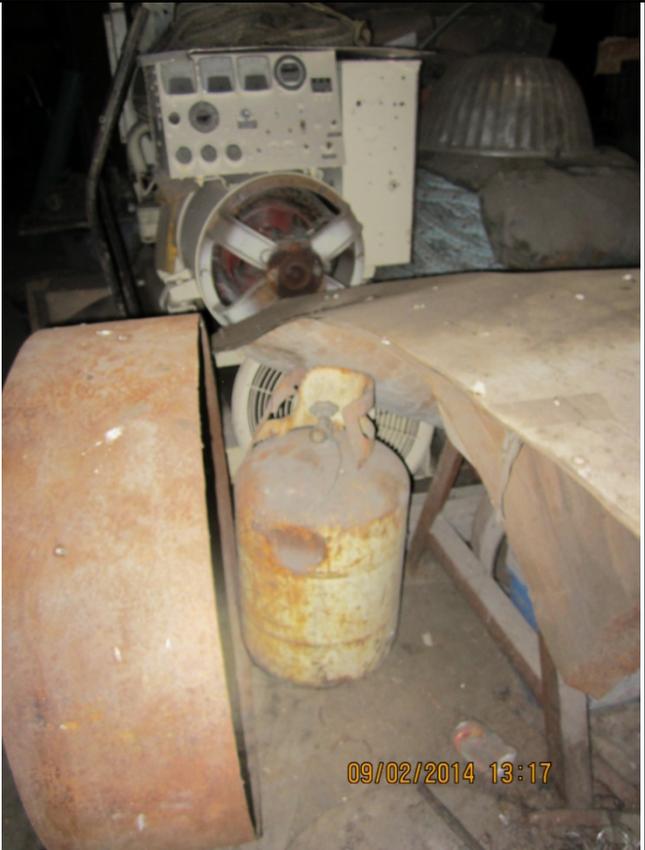
Area & Description	Photographs
<p>#36</p> <p>Location: Fabrication Building</p> <p>This photograph depicts an unknown gas cylinder.</p>

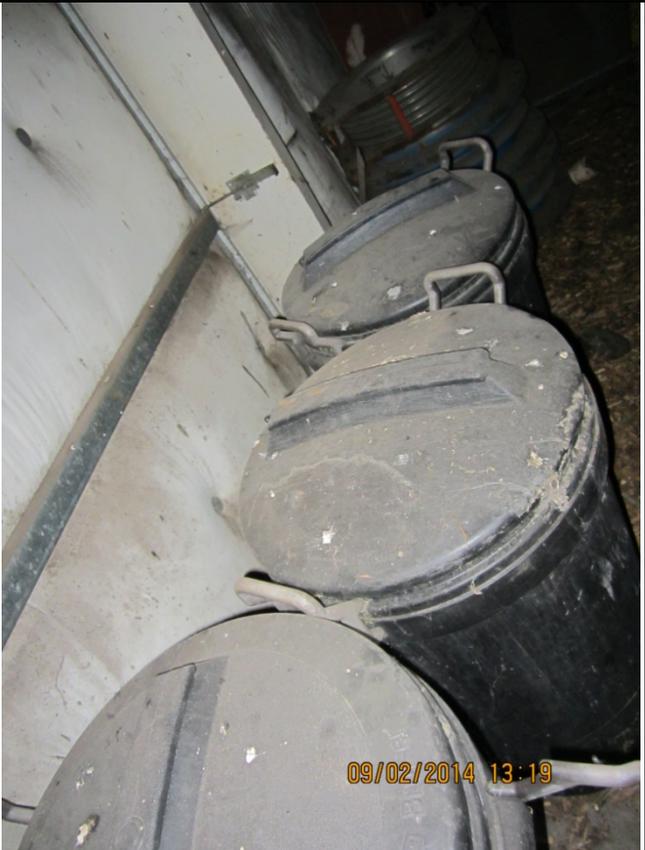
Area & Description	Photographs
<p>#37</p> <p>Location: Fabrication Building</p> <p>This photograph depicts three containers accumulating refractory waste.</p>

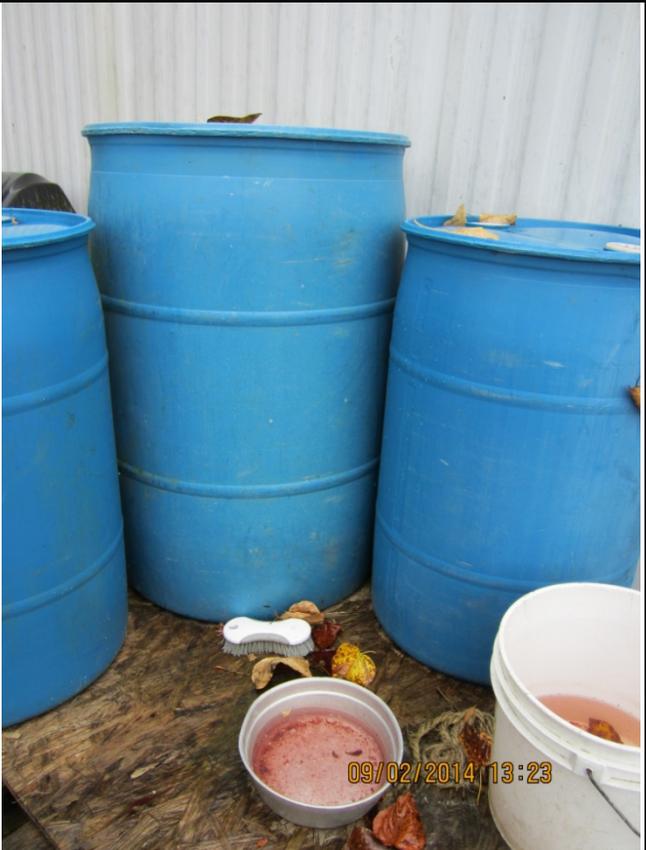
Area & Description	Photographs
<p>#38</p> <p>Location: Western Facility Boundary</p> <p>This photograph depicts two 30-gallon drums and one 55-gallon drum unknown liquids.</p>

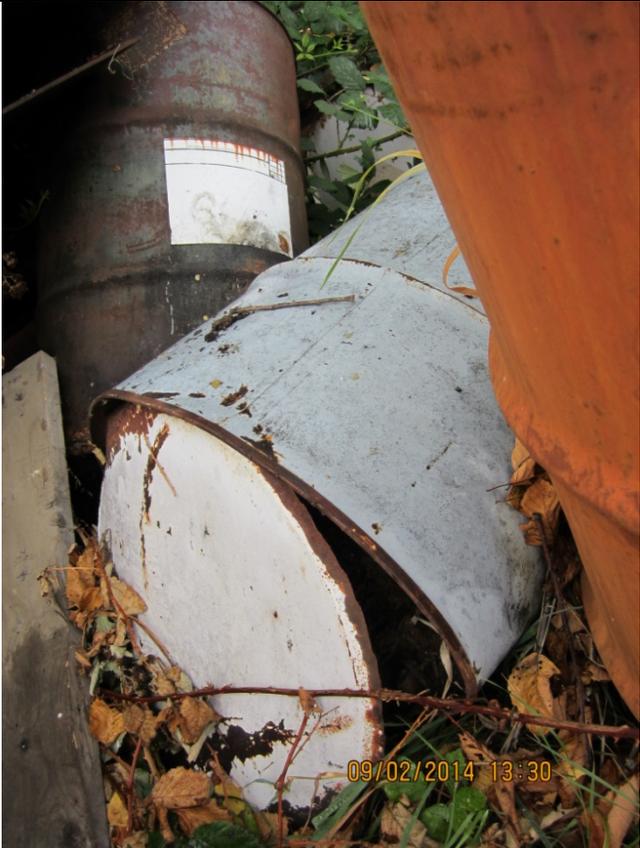
<p>09/02/2014 13:27</p>
<p>#41</p> <p>Location: Western Facility Boundary</p> <p>This photograph shows three compromised drums of tall oil spill cleanup debris.</p>

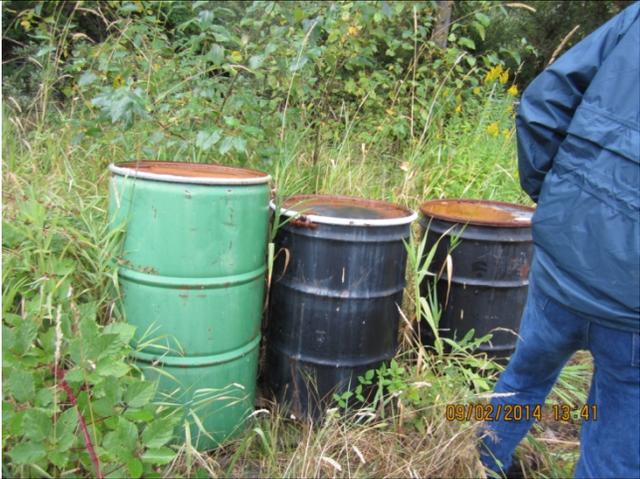
Area & Description	Photographs
<p>#47</p> <p>Location: Western Facility Boundary</p> <p>This photograph depicts three drums of unknown wastes.</p>

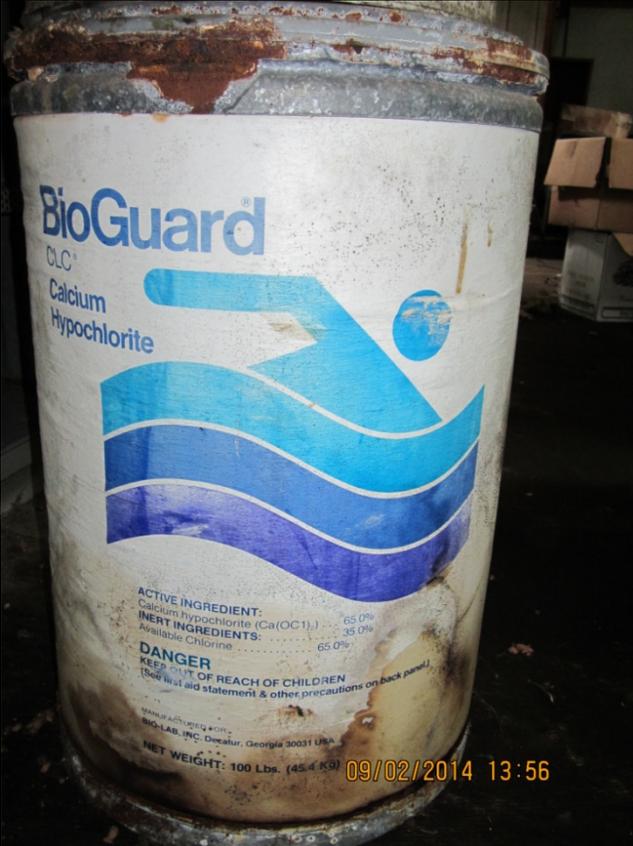
Area & Description	Photographs
<p>#57</p> <p>Location: Laboratory</p> <p>This container holds 100 pounds of calcium hypochlorite. Note the container is deteriorating.</p>
