**Re: Current Environmental Conditions Report  
Former Grays Harbor Paper Mill Facility  
Hoquiam, Washington  
Project No. 0016046.010.020**

**Current Environmental Conditions Report  
Former Grays Harbor Paper Mill Facility  
801 23<sup>rd</sup> Street  
Hoquiam, Washington**

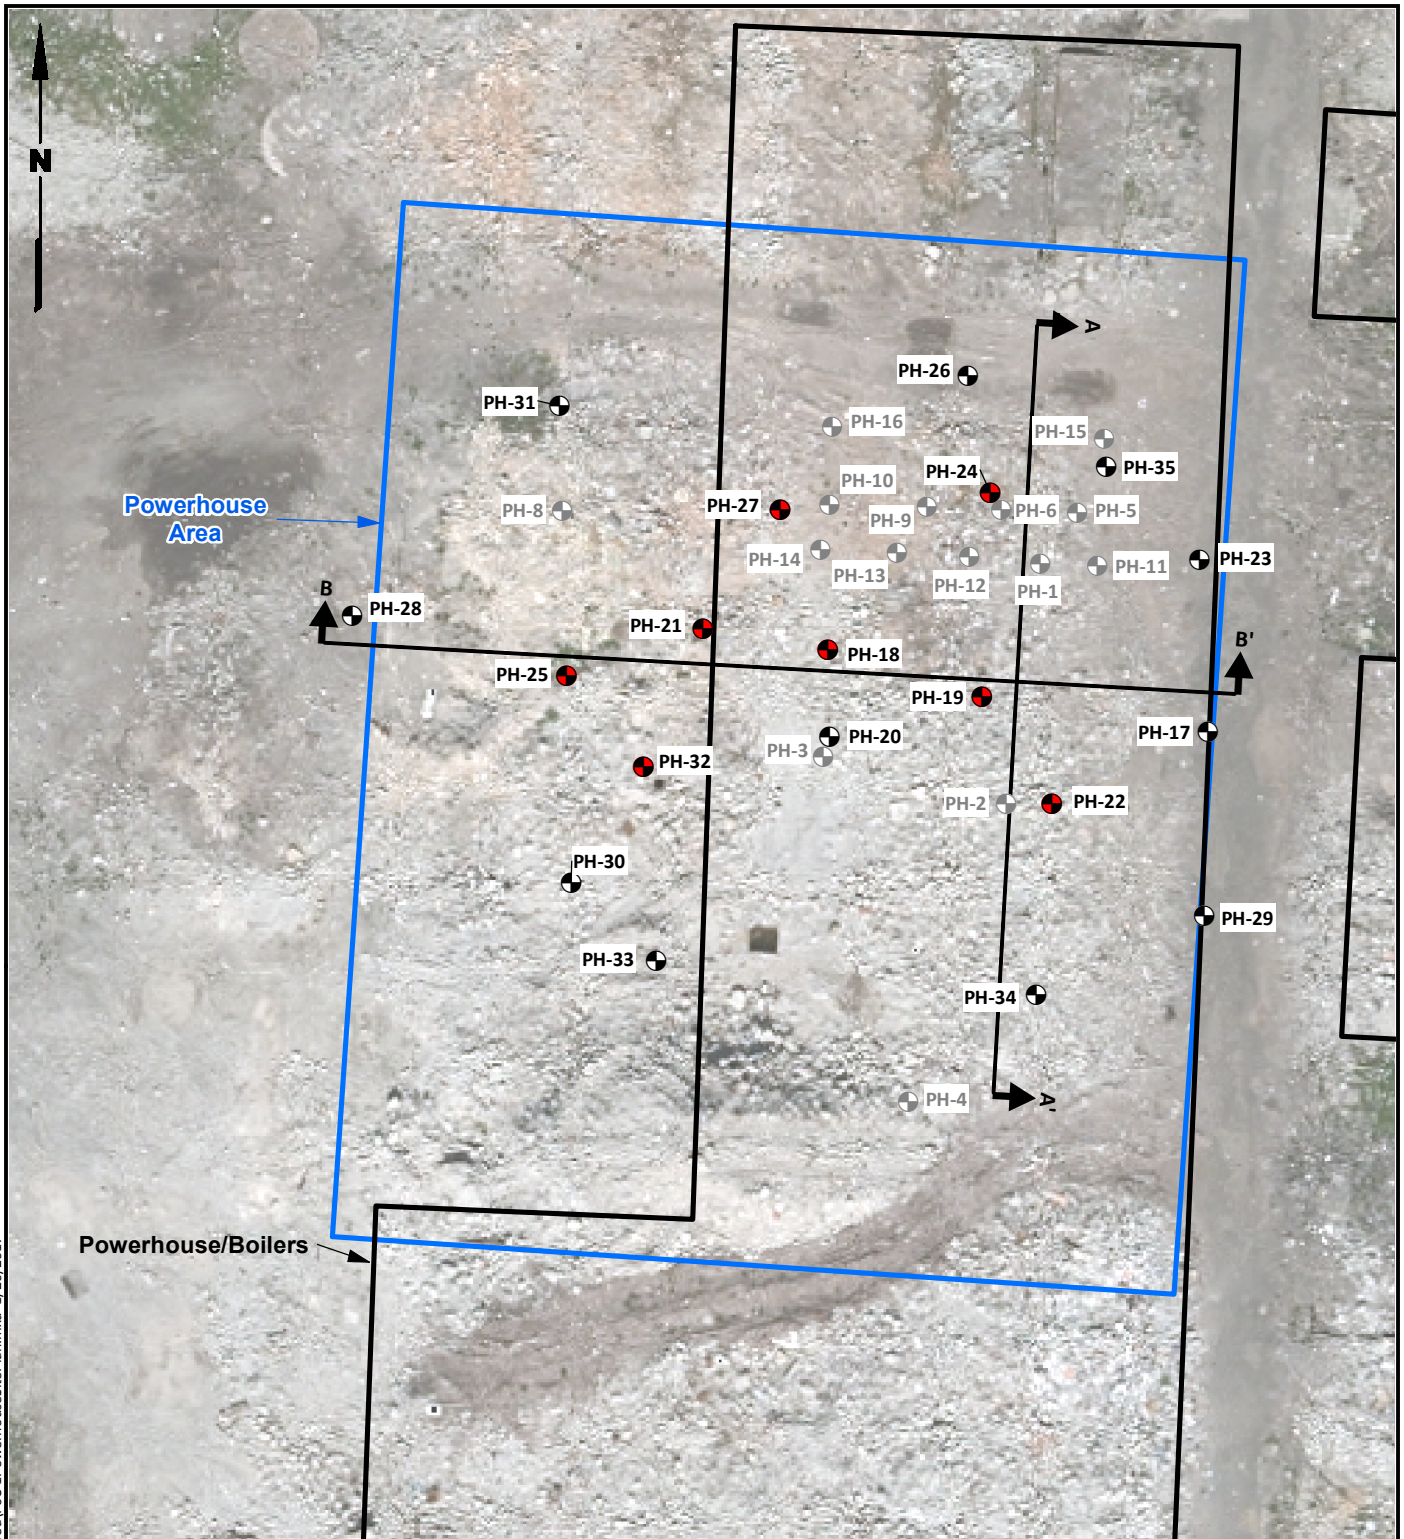
Figure  
**B-1**

the 1990s, the contamination has not migrated beyond the boundaries of the former Powerhouse building. NAPL was identified in a horizontal area approximately 80 ft by 120 ft. NAPL was identified at a maximum depth of 13 ft bgs. The extent of NAPL contamination in each boring (PH-17 through PH-36) is provided in Table B-1.

During the course of the investigation, an extensive network of surface and subsurface concrete infrastructure was encountered. The surface-level concrete (2-ft-thick concrete slabs containing 1- to 1.5-inch-diameter rebar) and the subsurface concrete (1- to 2-ft-thick pile caps and grade beams with 1- to 1.5-inch-diameter rebar) present logistical challenges for removal of the residual soil contamination. The same concrete infrastructure presents benefit to the state of the residual soil contamination: the concrete foundation functions as a surface cap to prevent groundwater infiltration.

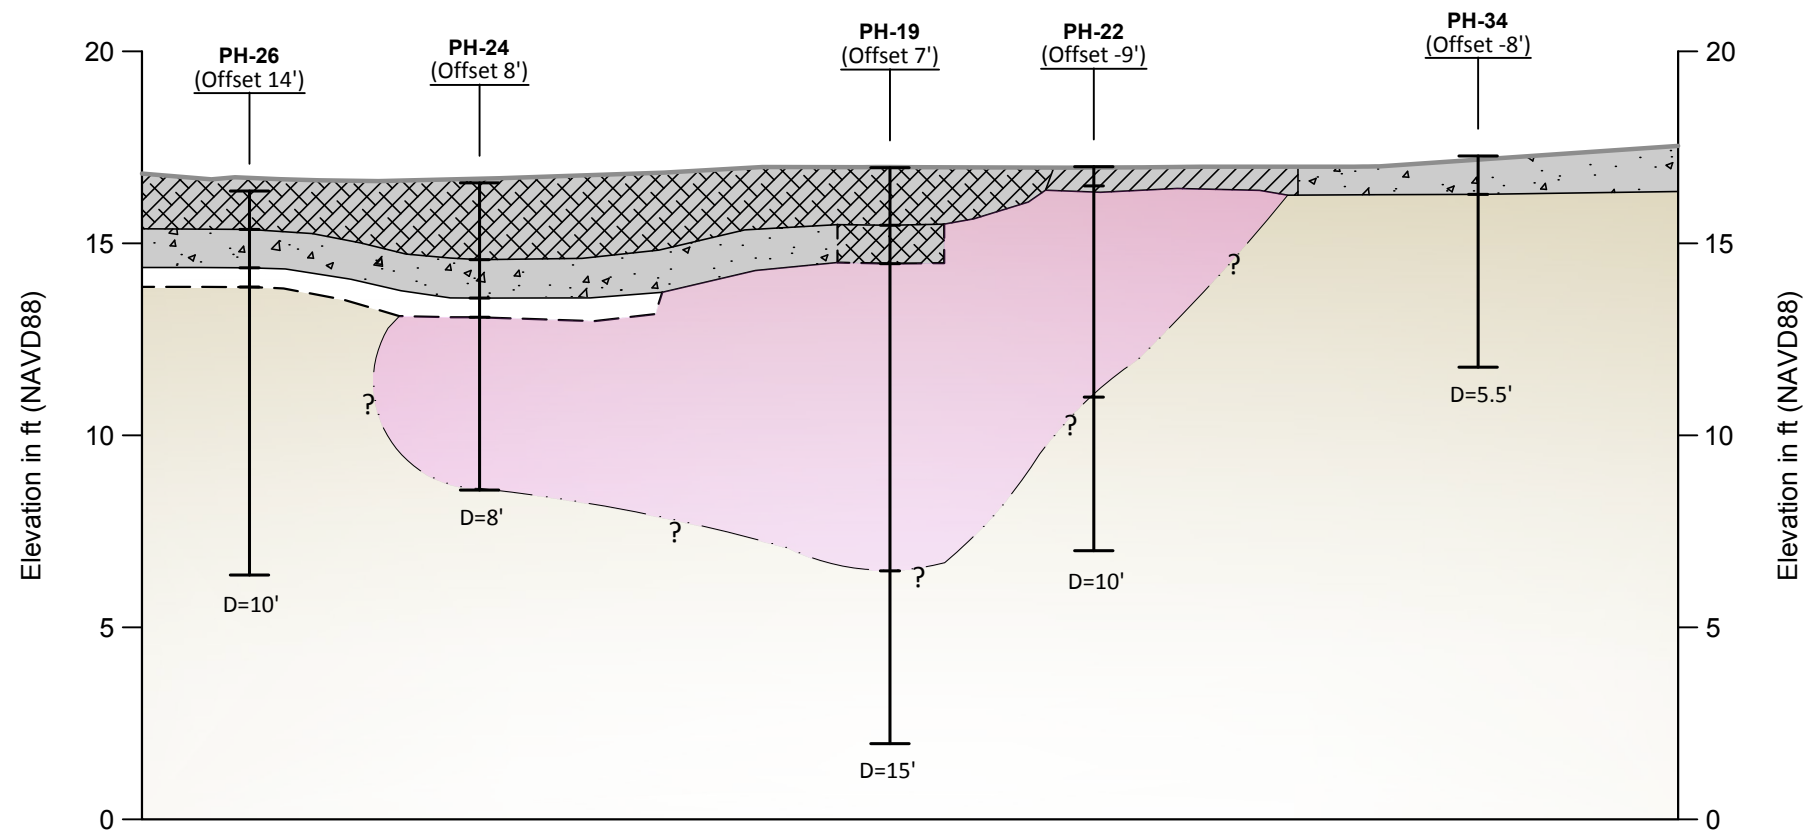
Figure  
**B-2**

Cross-section Figures B-2 and B-3 present features observed during drilling activities, including the approximate extent of No. 6 fuel oil NAPL contamination in soil. Contamination in soil consisted of a dark brown to black, viscous and low-mobility petroleum product typical of degraded No. 6 fuel oil. Samples exhibited a strong sheen (during field sheen tests), variable odor, and generally dark color. Soil encountered was generally fill material consisting of sands or silty sands, construction debris, and some potentially native material (deepest depths only). The native material, higher in silt content, was not observed to contain No. 6 fuel oil NAPL and is likely acting as a barrier to further vertical migration on the contamination.
