## MEMORANDUM

**To:** Linda Berry-Maraist, Pope Resources/Olympic Property Group      **Date:** October 7, 2016  
**From:** Kathy Ketteridge, Ph.D., P.E., and John Laplante, P.E., Anchor QEA, LLC  
**Cc:** Clay Patmont, Anchor QEA, LLC  
**Re:** Port Gamble Bay Cleanup Project Coastal Engineering Evaluation of Shoreline Erosion

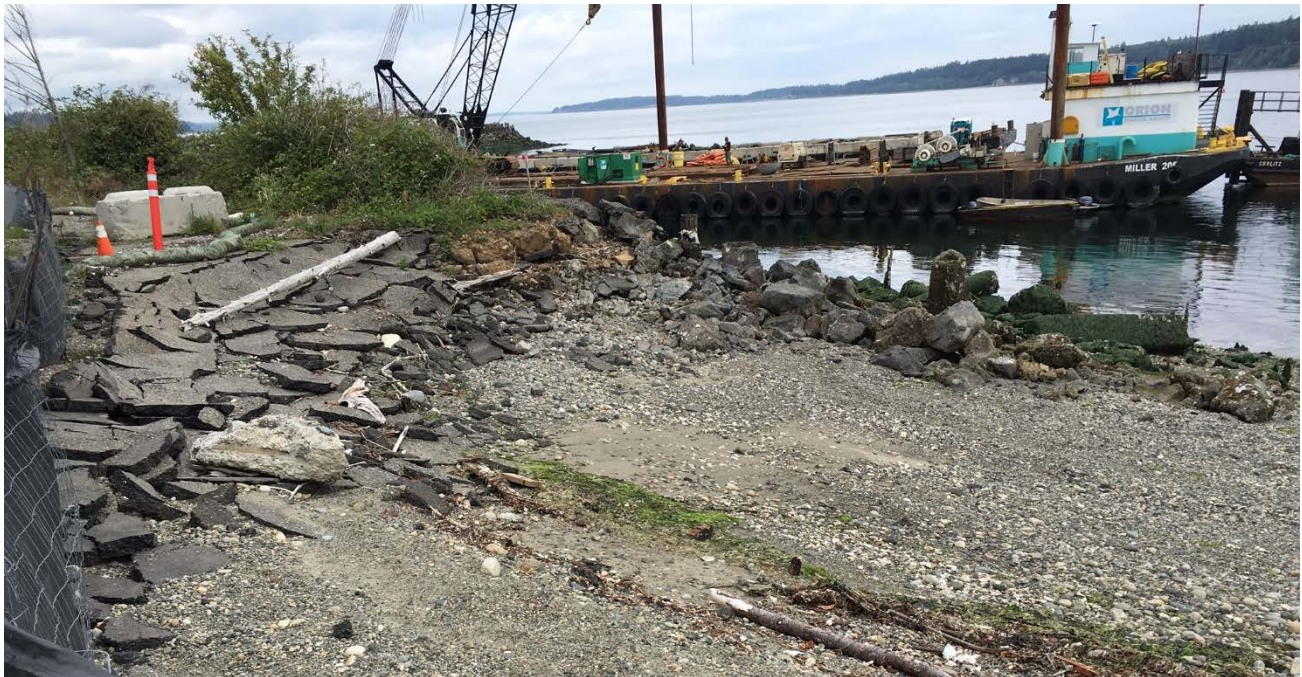
**Photograph 1**

The shoreline erosion in this area occurred after creosote-treated piling were removed as part of Site remediation. The shoreline area above mean higher high water has eroded in this area, undermining asphalt paving at the top of the slope, as shown in Photograph 1. Figure 2e shows a pre- and post-storm survey transect that illustrates the erosion that has occurred at this location. In general, the slope of the beach in the upper intertidal area is adjusting to match the milder slope present in the lower intertidal area.

**Shoreline Erosion in Area 1**

Design recommendations to address shoreline erosion in this area are shown in Figure 2e. Damaged asphalt at the top of the slope will be removed and the top of the bank at the landward extent of existing asphalt will be armored with Type 2 cap material with

Type 3 cap material placed underneath as a filter layer. Damaged asphalt shown in Photograph 1 has already been removed.

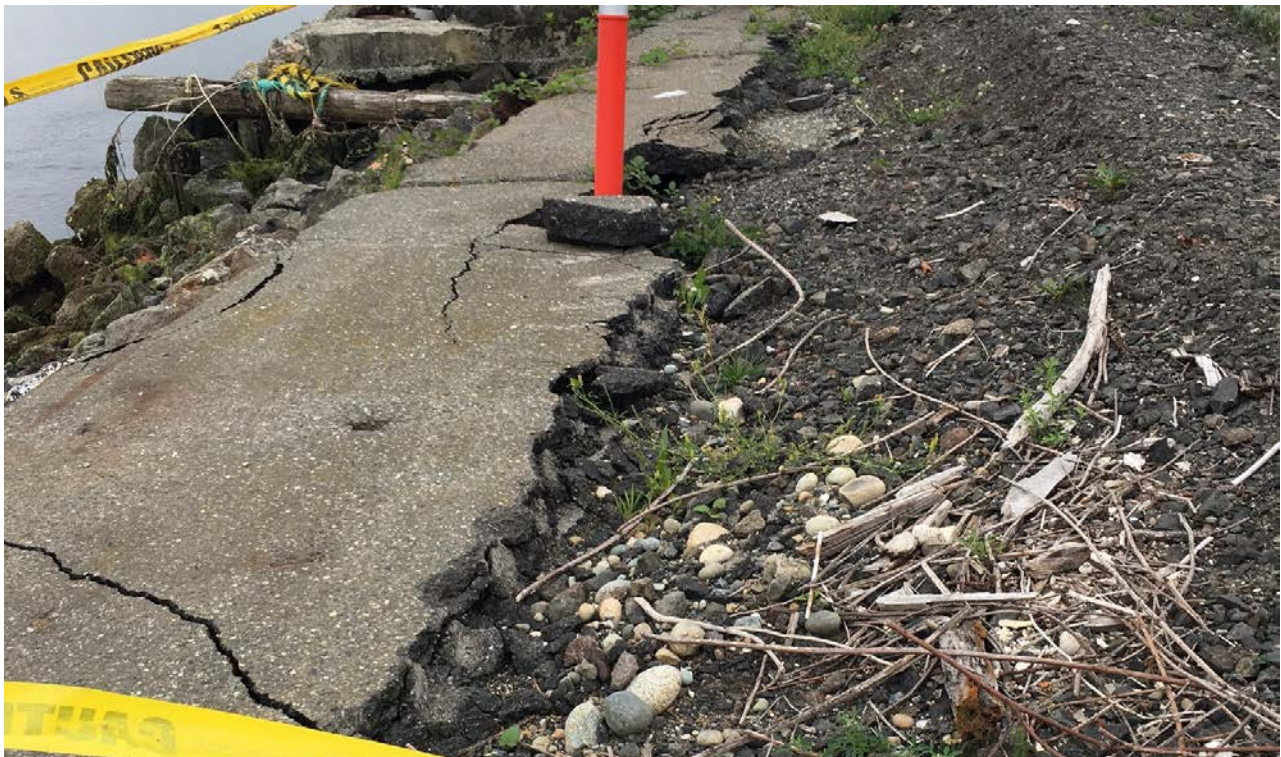
**Photograph 2**

Similar to Area 1, asphalt at the top of the slope was damaged due to wave runup and overtopping, as shown in Photograph 2, which occurred after the structure in this area (the former Eastern Wharf) was removed. Figure 2d shows a pre- and post-storm survey transect that shows no movement of the armor rock on the slope occurred as a result of the storm events.

**Shoreline Erosion in Area 2**

- Damaged asphalt at the top of the armored slope was removed
- Armor rock at the top of the slope was left in place
- The area where asphalt was removed was armored from the top of the remaining armor rock on the slope to the top of the bank
- Placed armor consisted of Type 3 material covered with large salvaged armor rock

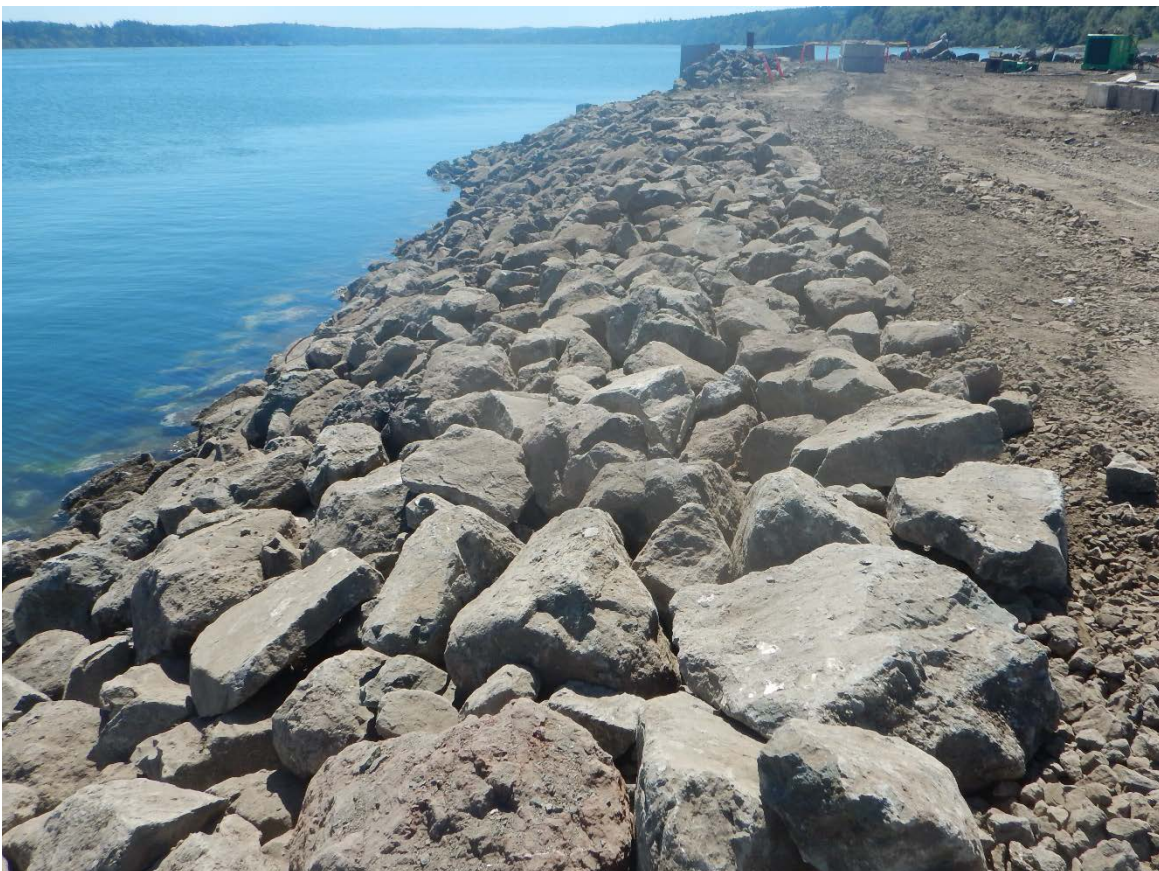
**Photograph 3**

The work described above was completed on August 12, 2016. The completed stabilization work is shown in Photograph 3.

**Completed Shoreline Repair in Area 2**

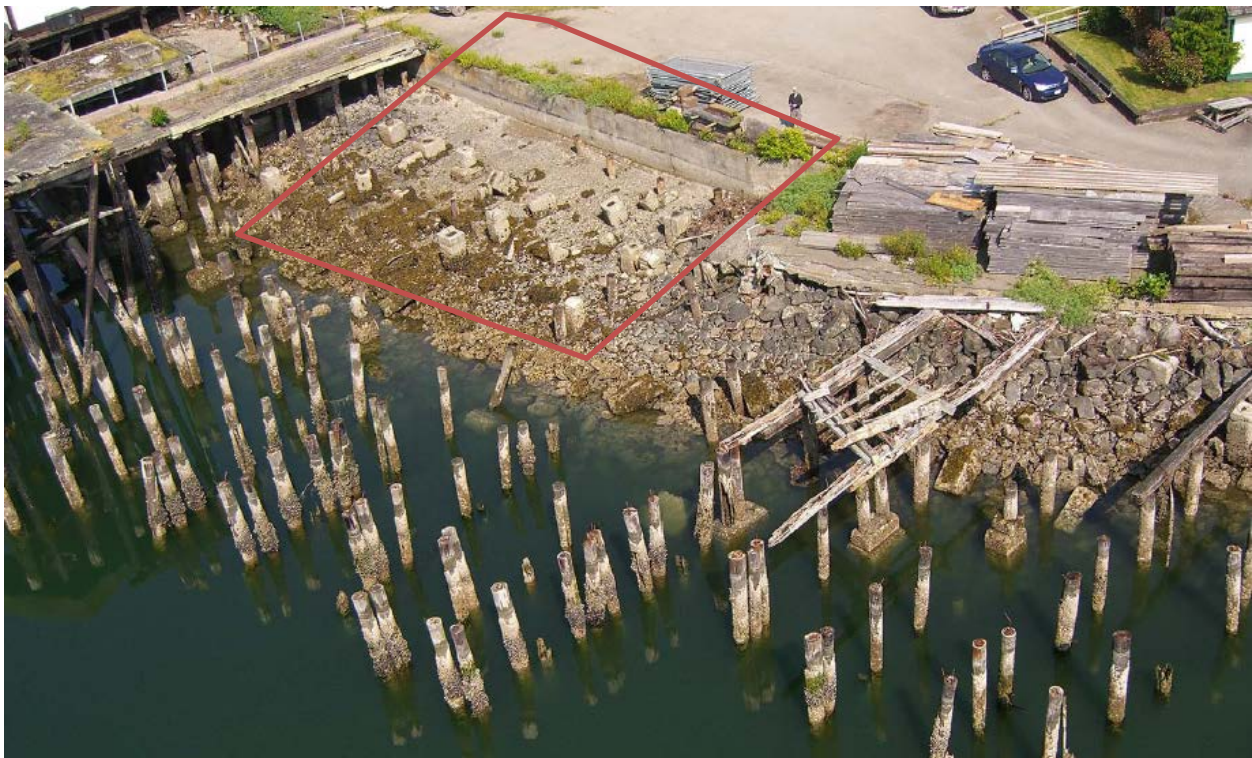
**Photograph 4**

Area 3 is located between the temporary transload facility and the eastern end of the Type 2 intertidal cap in SMA-2. Structures and piling were removed from this area as part of demolition for Site remediation. Photograph 4 shows the condition of the shoreline in Area 3 prior to structure removal; the approximate extent of Area 3 is outlined in red in Photograph 5. Following demolition work, the shoreline in Area 3 was not significantly armored.

**Shoreline Conditions in Area 3 Prior to Structure and Pile Removal**

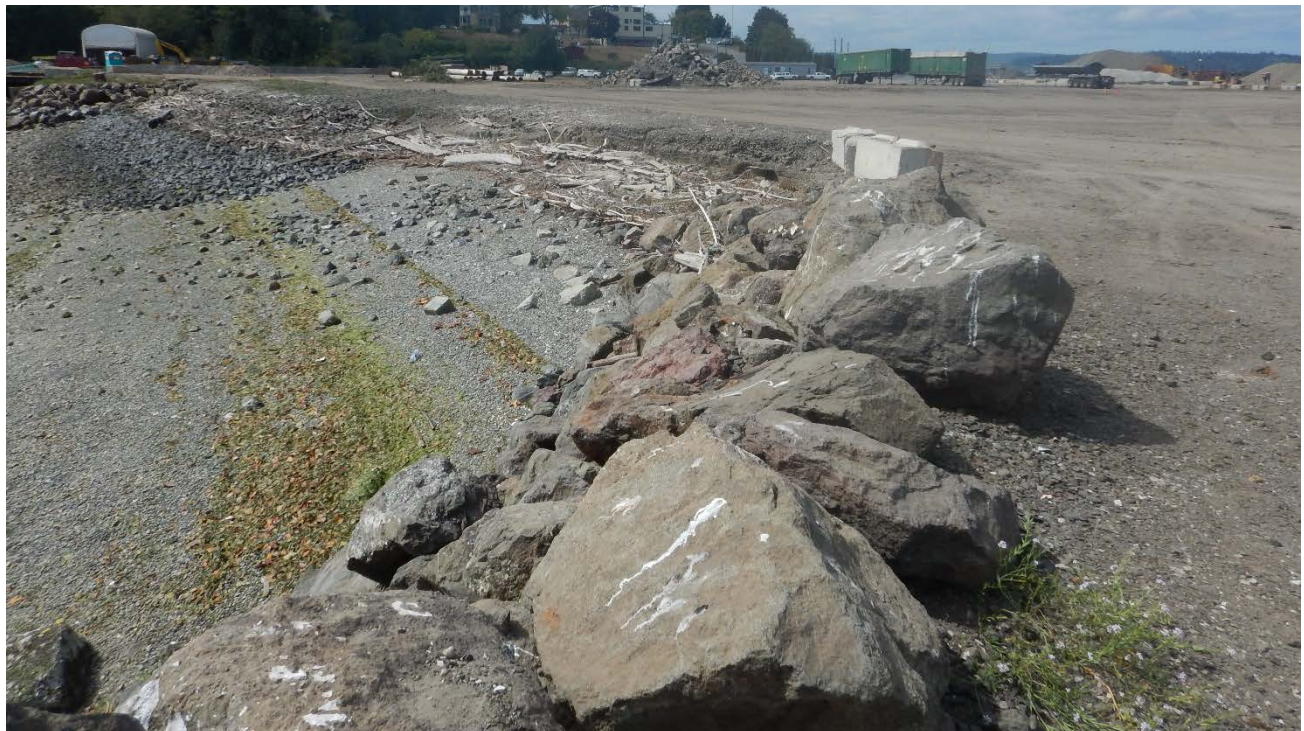
**Photograph 5**

Erosion of the area during this storm event was intensified due to the two adjacent armored areas (the capped area to the west and the transload facility to the east), as seen in Photograph 5. Figure 2c shows a pre- and post-storm survey transect that shows the

shoreline erosion in this area. Similarly to Area 1, the upper shoreline has eroded back to a milder slope to match the existing slope in the lower intertidal area.

**Shoreline Erosion in Area 3**

Design recommendations to address shoreline erosion in this area are shown in Figure 2c. The shoreline in this area will be armored between the end of the Type 2 cap area and the armored shoreline at the location of the temporary transload area. Armor will consist of a layer of Type 3 material covered with large salvaged armor rock. The armor will extend from the top of the bank down to elevation +5 feet mean lower low water. A launching toe section will be placed at the toe of the armor (an extra two layers of Type 2 cap material) to provide toe scour protection for the newly constructed armored slope. These design recommendations are focused on preventing erosion at the top of the bank and preventing loss of uplands due to future storm events. The armoring detail shown in Figure 2c will be blended into the Type 2 capped area to the east and the armored slope replaced at the transload facility once it is removed (as discussed above).

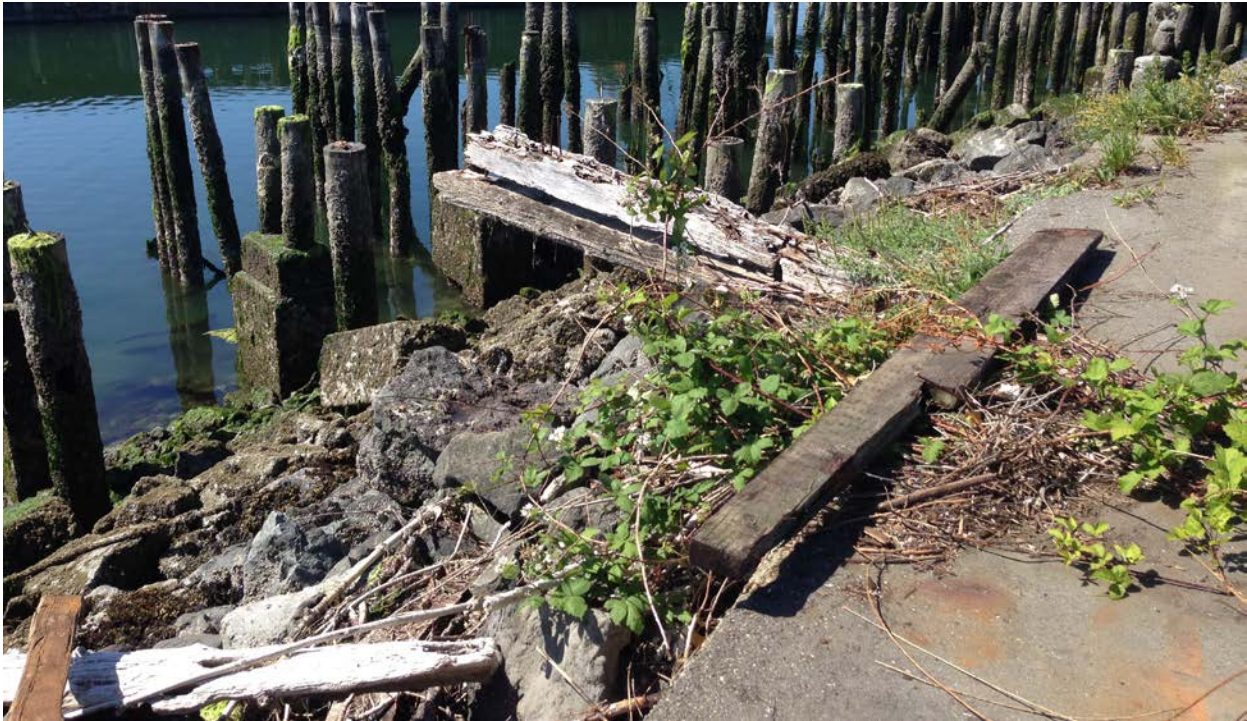
**Photograph 6**

The shoreline area where the transload facility was constructed was armored prior to construction of the transload facility, as shown in Photograph 6. Following removal of the transload facility, that area will need be restored to similar pre-project conditions with shoreline armoring that blends into the proposed remedy for Area 3.

**Pre-Construction Shoreline Conditions at the Transload Facility**

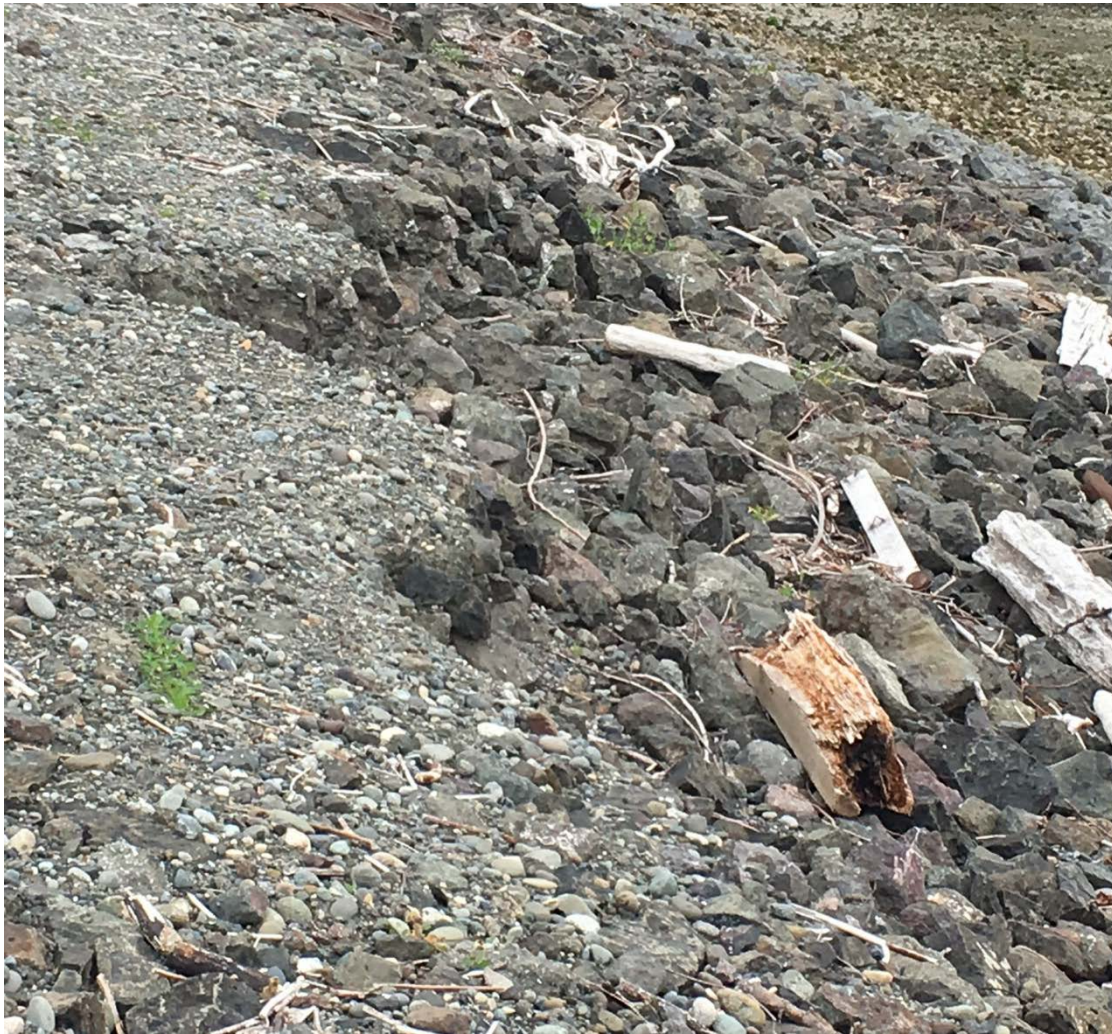
**Photograph 7**

The upper intertidal shoreline in Area 4 was capped with Type 2 armor rock. Some of the armor rock was displaced in the upper inner tidal zone due to wave impact from the storm events. As stated previously, localized movement of armor rock can occur during a design storm event; this design decision allows for a balance of using a more habitat-friendly armor rock size while still ensuring the protectiveness of the remedy. The March 13 storm, as documented in Section 1, was up to a 100-year storm event based on wind velocity data, which was the design storm event for the slope. In addition, the high winds that occurred during that storm event lasted for approximately 32 hours, which is significantly longer than the typical design storm event in the Puget Sound area.

Figure 2b shows a survey transect within Area 4 that illustrates Type 2 rock movement where the majority of the design rock thickness was displaced. However, as seen in Photograph 7, the extent of this level of damage is small, affecting approximately 20 to 30 feet of shoreline. Area 5, shown in Figure 2a, illustrates more typical and expected movement of rock on the slope; this area still has acceptable coverage of armor rock over the filter material. Survey data from Section A show more typical and expected movement of rock on the slope. Area 5 is representative of the conditions of the majority of the Type 2 cap area.

**Shoreline Erosion in Area 4**

Design recommendations to address movement of the Type 2 cap material in Area 4 include adding additional Type 2 rock or smaller salvaged armor rock in the areas where significant movement has occurred (the approximate extent of this damage is shown in Figure 1).
