STATE OF WASHINGTON  
DEPARTMENT OF ECOLOGY

**Re: Opinion pursuant to WAC 173-340-515(5) on Remedial  
Investigation/Feasibility Study for the following Hazardous Waste Site:**

- **Name:** Hers Industrial Park
- **Address:** 4403 Russell Road, Mukilteo, WA 98275
- **Facility/Site No.:** 127256
- **VCP Project No.:** NW1554
- **Cleanup Site ID No.:** 3971

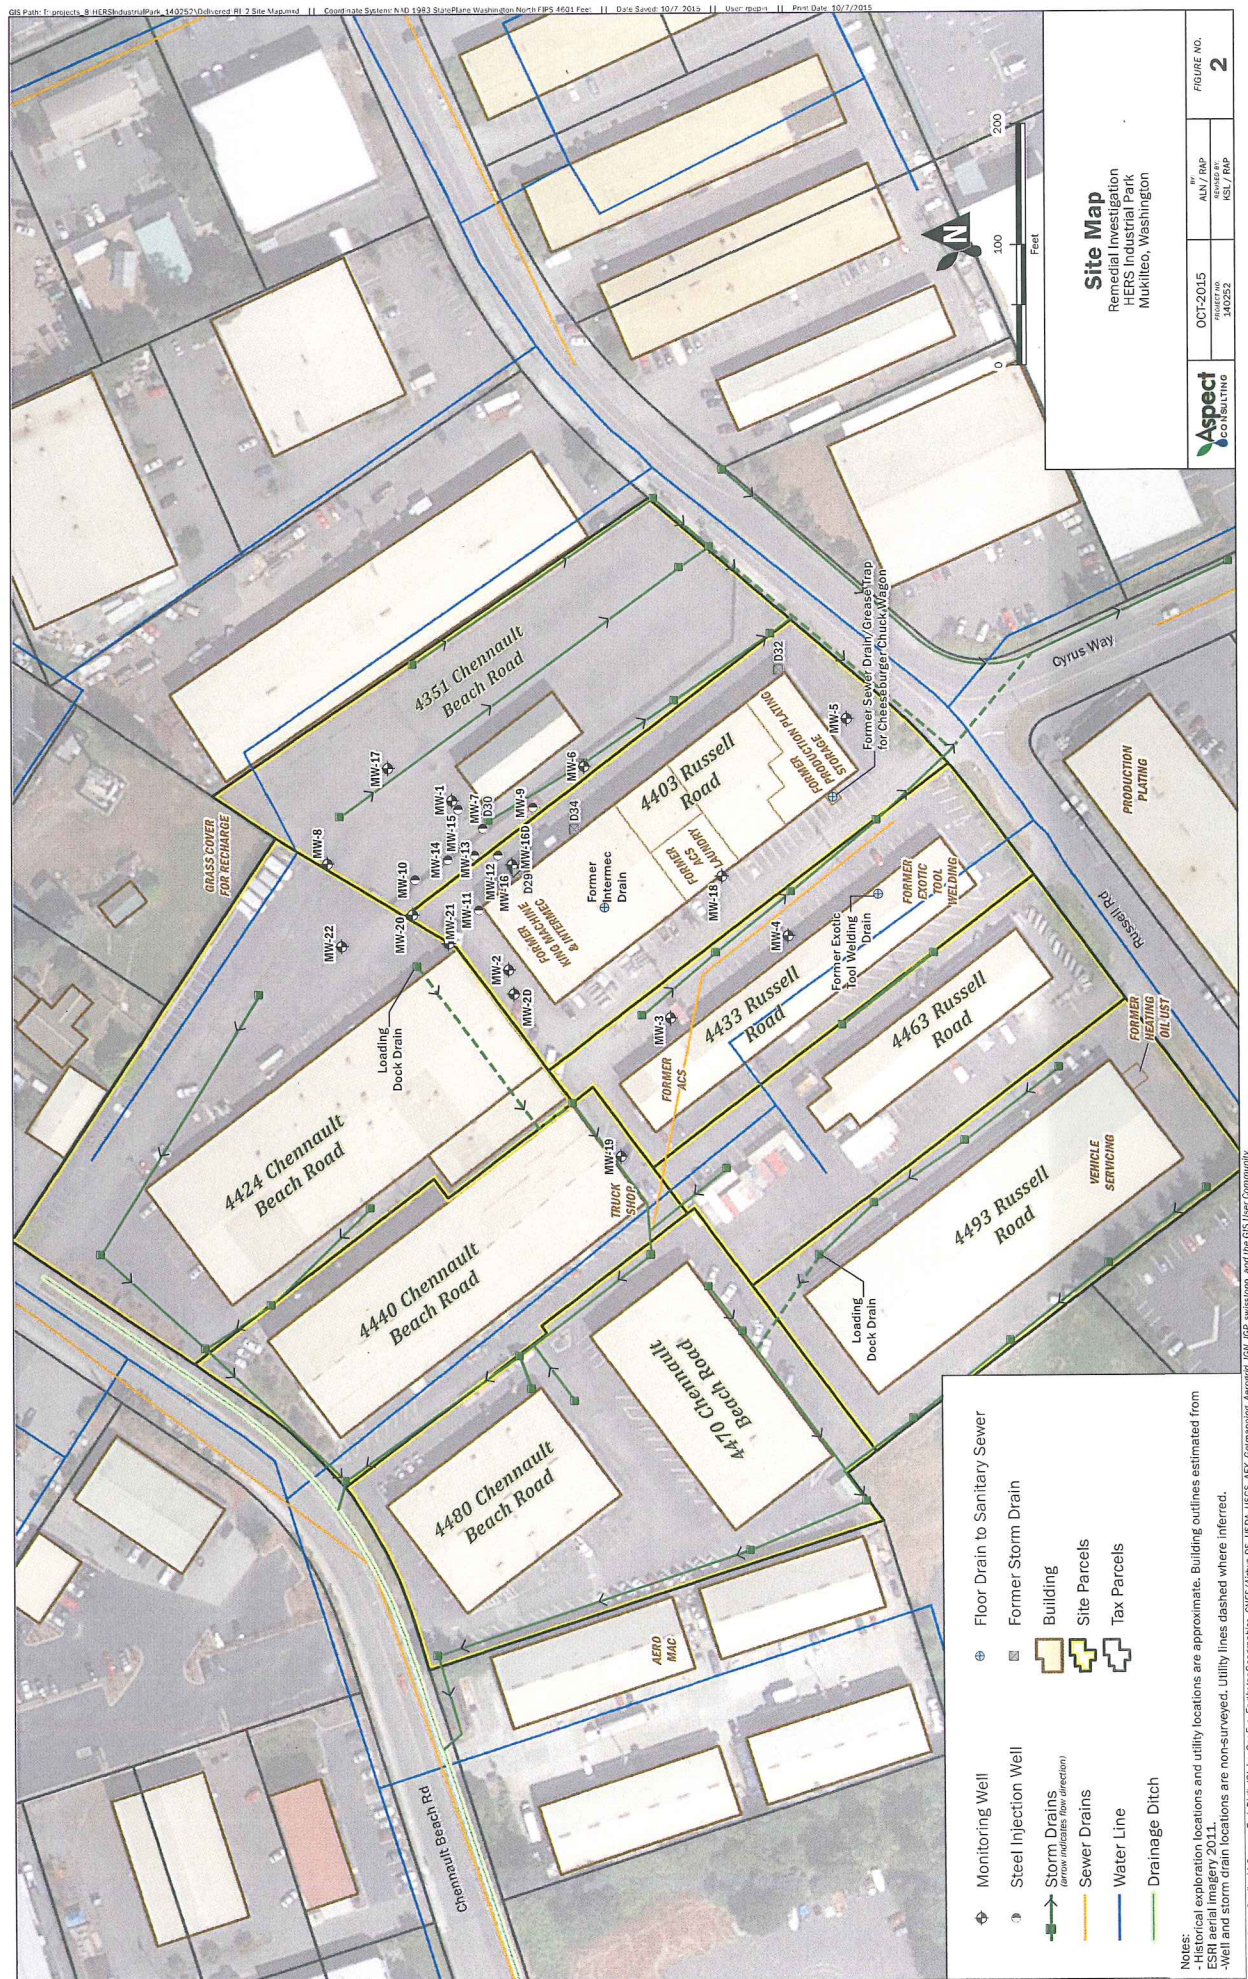
# **Site Map** Remedial Investigation HEPS Industrial Park Mukilteo, Washington

- Please show and label the surrounding industrial property locations (described in Section 2.3) that are adjacent or near the Site on Figure 2 (Production Plating is shown but two addresses are provided in the text) or on a separate figure. Industrial land uses on adjacent parcels should be described.
